Rail Safety Investigation Report

YASS JUNCTION

19 November 2002

Pacific National train G9821 derailed due to misalignment.

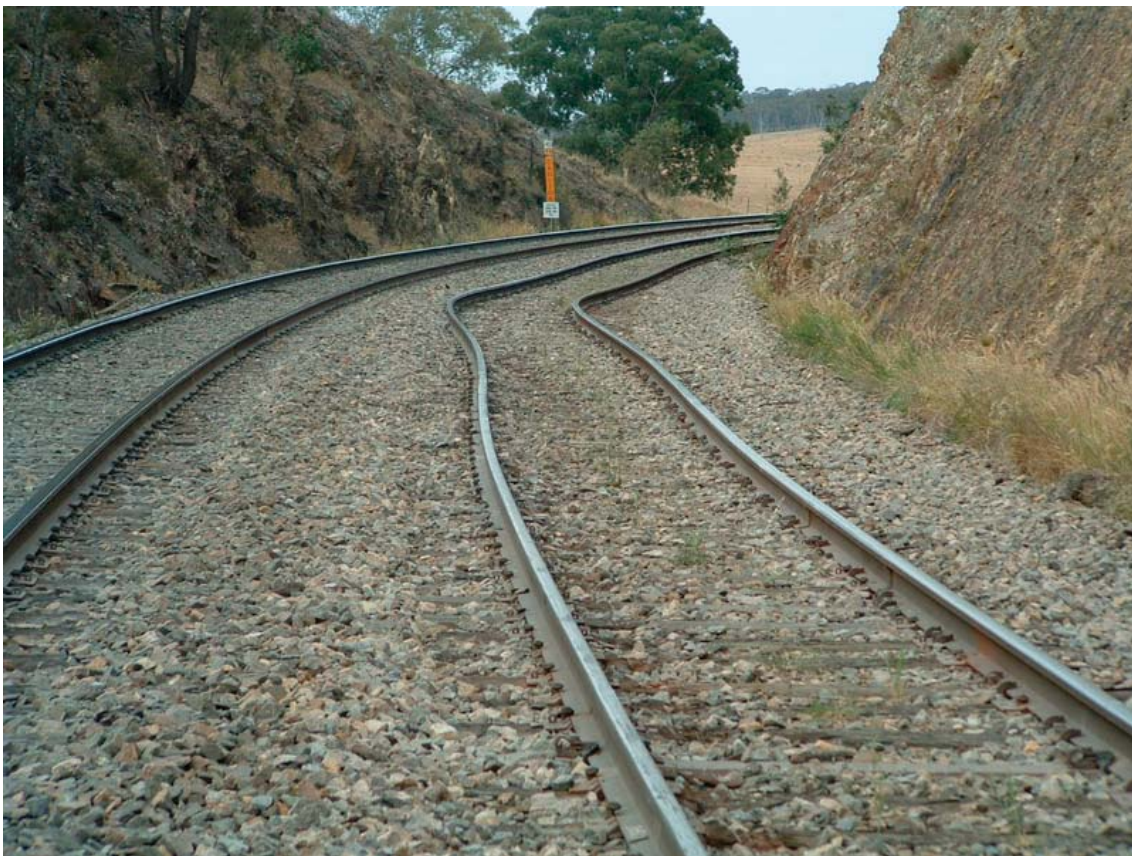
Refer to Figure 4.1 below depicting the misaligned track. A number of timber sleepers were broken along with damage to track anchors as a result of the derailment.

Figure 4.1 Misaligned track at 305.650km

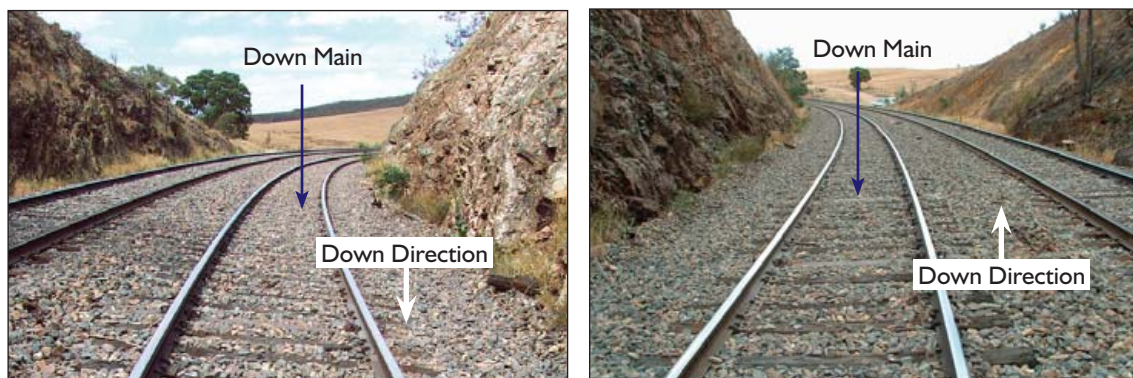
Figure 4.2 Down Main facing Up direction (left), Down Main facing Down direction (right) following track restoration at 305.650km

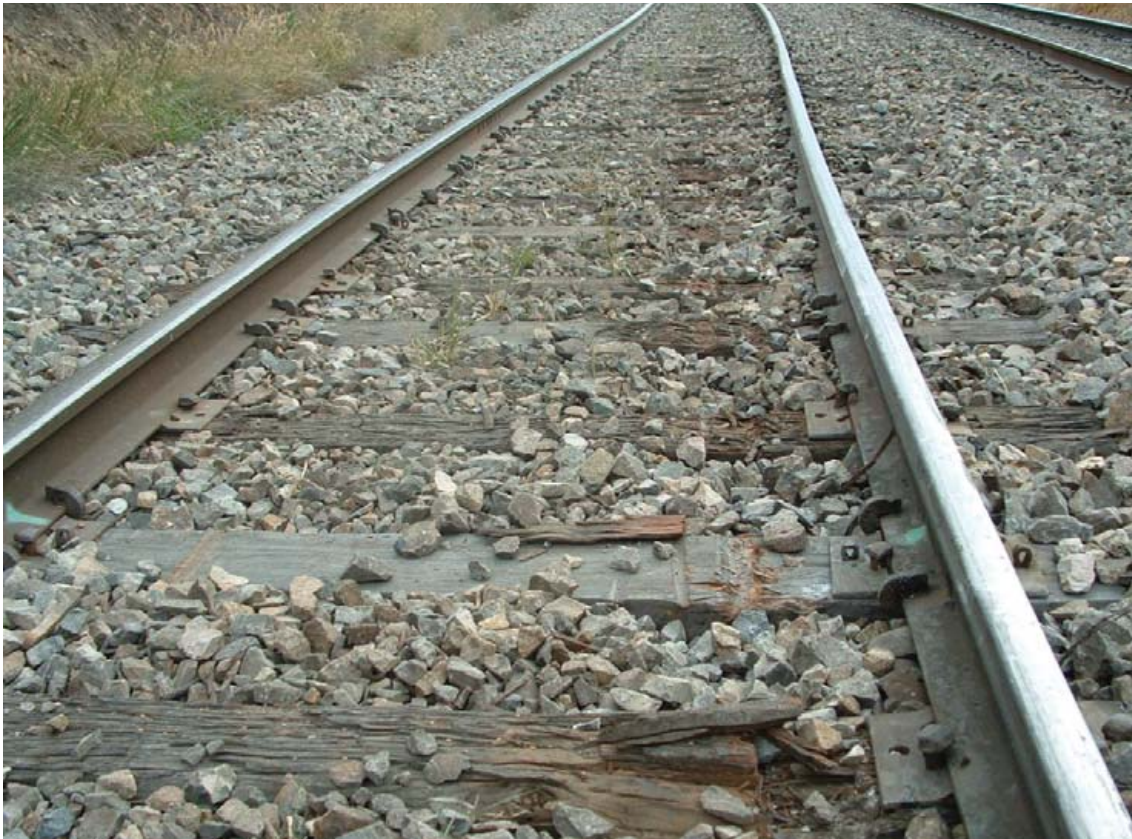
Considerable track damage was sustained due to the derailment. This damage included sleeper damage, broken shoulders on steel sleepers, and track out of alignment. Refer to Figure 4.4 depicting typical sleeper damage sustained during the derailment.

Figure 4.4 Sleeper damage sustained during derailment

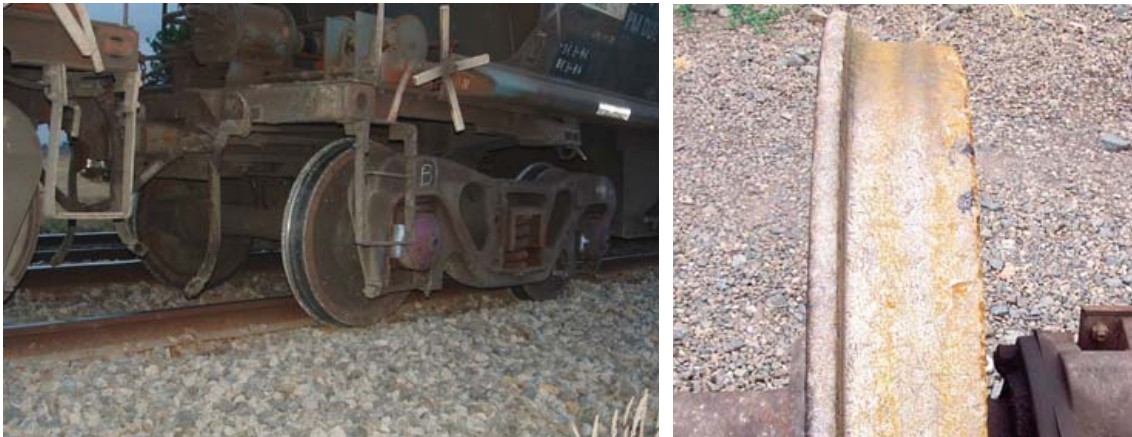
The leading bogies of the 23rd, 25th, 26th, 30th and 39th positioned vehicles derailed. All bogies sustained gouging on their wheelsets from contact with ballast and sleeper plates. Refer to Figure 4.5 depicting an example of the wheel tread damage sustained by one of the derailed bogie's wheelsets. Other minor rolling stock bogie damage was sustained necessitating the replacement of safety loops, king pins, constraps and radial pads.

Figure 4.5 Derailed wheel on leading bogie and ballast gouging damage sustained on one of the derailed wheelsets

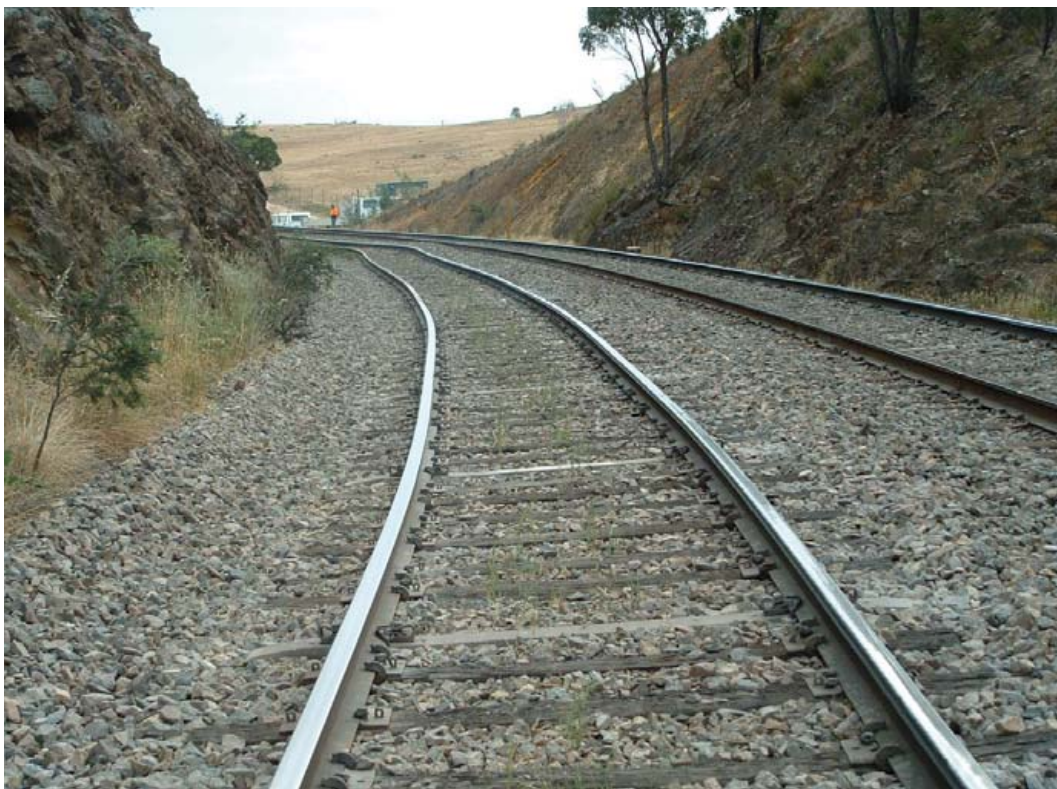
The ballast profile as identified following the derailment was considered “*full*”⁸ for both “*shoulder*”⁹ and “*crib*”¹⁰ throughout the misalignment site. Refer to Figure 4.7 depicting typical ballast profile throughout the misalignment site.

Figure 4.7 Typical Shoulder and Crib Ballast Profile throughout Misalignment Site.

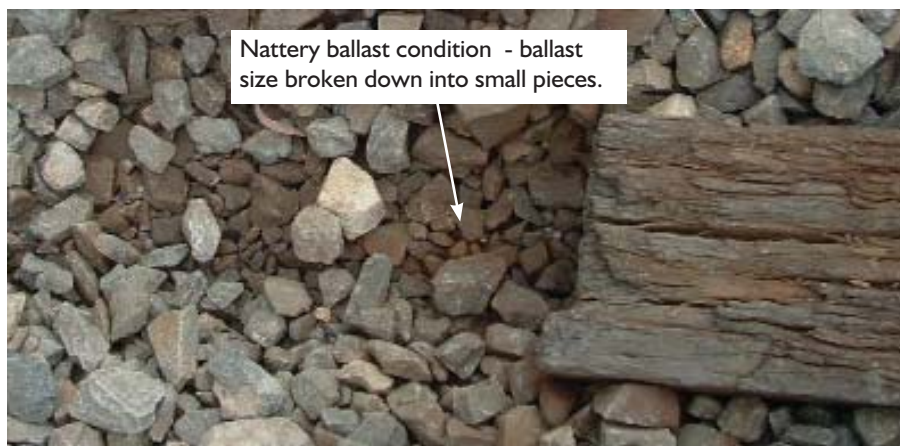
Nattery¹¹ ballast was identified throughout the misalignment site. Over time this type of ballast breaks down into small pieces and eventually fine particles of silt, where the interlocking properties of the ballast against a wooden sleeper are lost. Ballast that has broken down in this manner may also be referred to as a glazed ballast bed. Once the ballast and timber sleeper interlocking properties break down so too does the lateral stability of a timber sleeper within the ballast. As shown in Figure 4.8 small pieces of Nattery ballast were evident following movement of those timber sleepers subject to the misalignment. Following the misalignment a number of sleepers were replaced in and around the misalignment site. The exposed sleeper pods¹² revealed smooth surfaces where the Nattery ballast had broken down to an extent where there was little evidence of ballast interlocking with the timber sleeper surface.

Figure 4.8 Nattery Ballast Broken Down at Base of Sleeper Pod Following Movement of Sleeper after Misalignment.

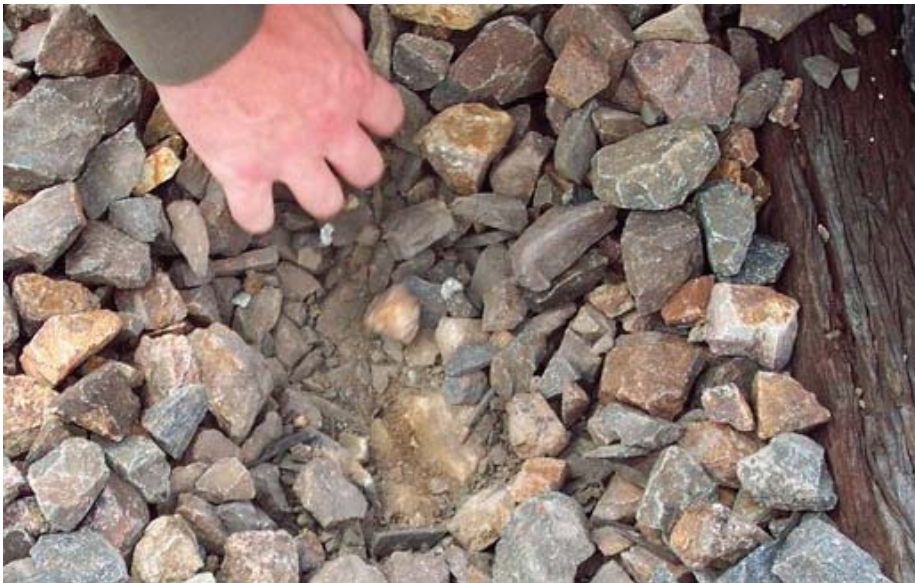
Foul ballast¹³ was identified to varying degrees throughout the misalignment curve. Refer to Figure 4.9 depicting the ballast condition just below the top surface of the ballast. Vegetation was also identified within the four foot throughout the

Figure 4.9 Foul ballast identified within the 500m WTSa section at 305.510km.

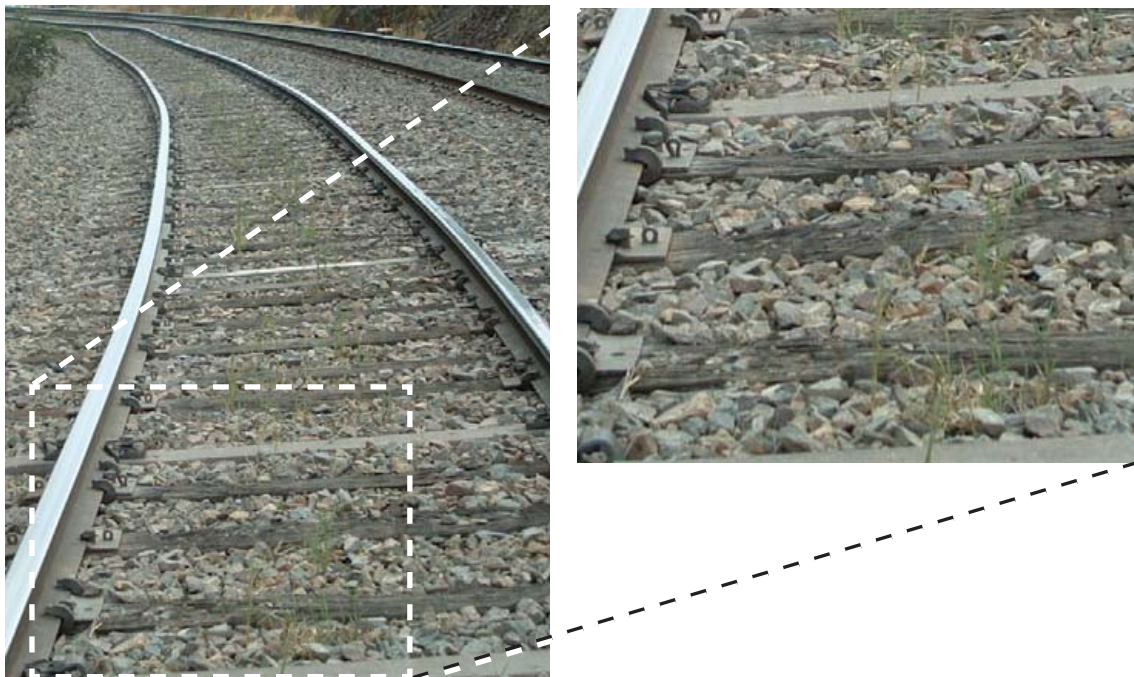
misalignment curve, as depicted in Figure 4.10, indicating the extent of foul ballast in this section of track. The vegetation was also noted to be more prevalent in the Down Main line compared to the Up Main line.

Figure 4.10 Foul ballast identified within the misalignment curve as evidence of vegetation in the four foot.

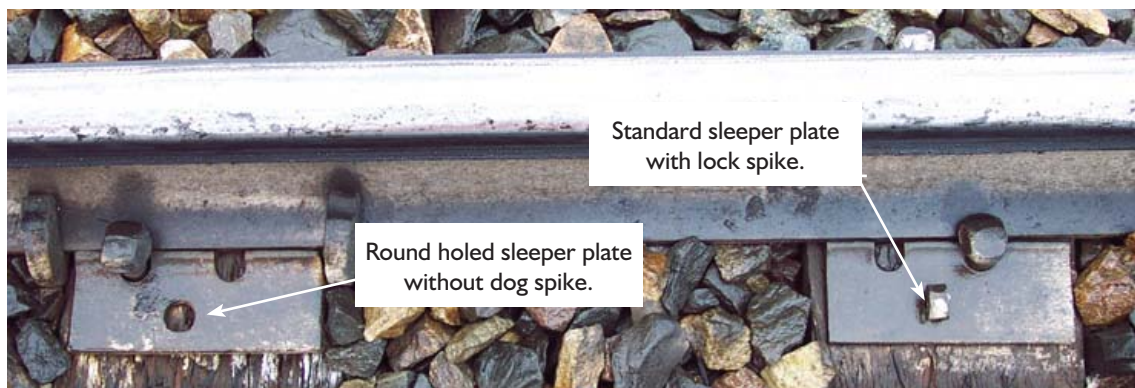
The fastener mechanism condition over the misalignment site varied from satisfactory to poor. A number of round holed sleeper plates without lock spikes were noted along with single sided sleeper plates as documented within the misalignment reports depicted within Appendix 9.8. Refer to Figure 4.11 below depicting a round holed sleeper plate without dog spike and Figure 4.12 depicting the location of sleepers with round holed sleeper plates without dog spikes relative to the misalignment. These sleeper plates are not standard requiring change on renewal of the applicable sleepers.

Figure 4.11 Round holed sleeper plate without dog spike at 305.650km.

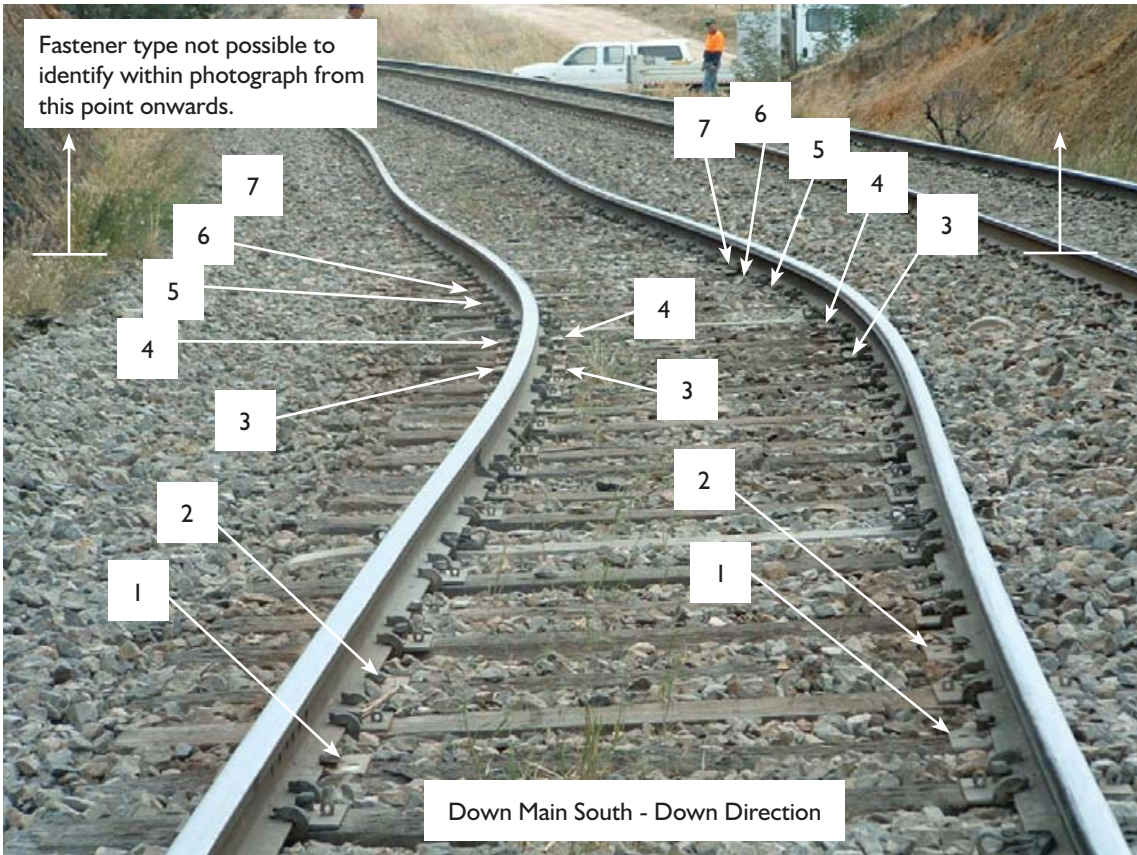
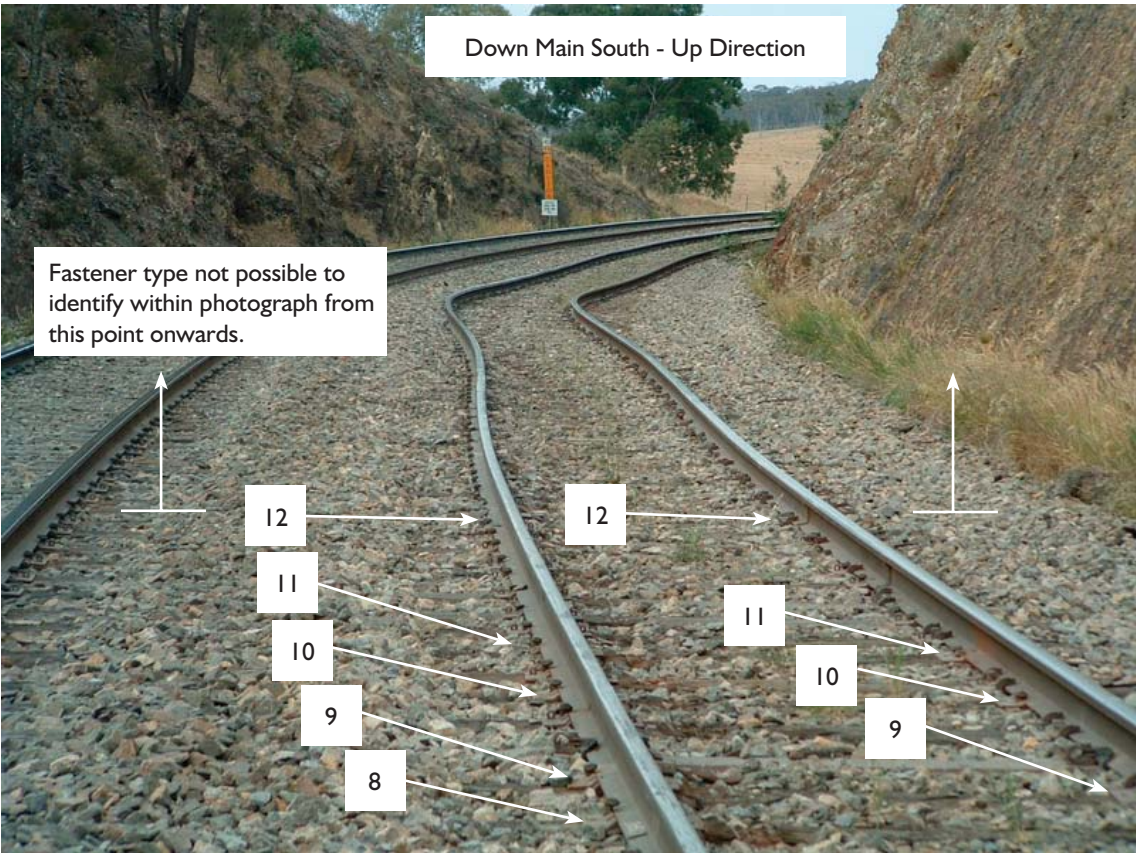
Figure 4.12 Sleepers Identified with Round Holed Sleeper Plates without Dog Spikes at the 305.650km misalignment site

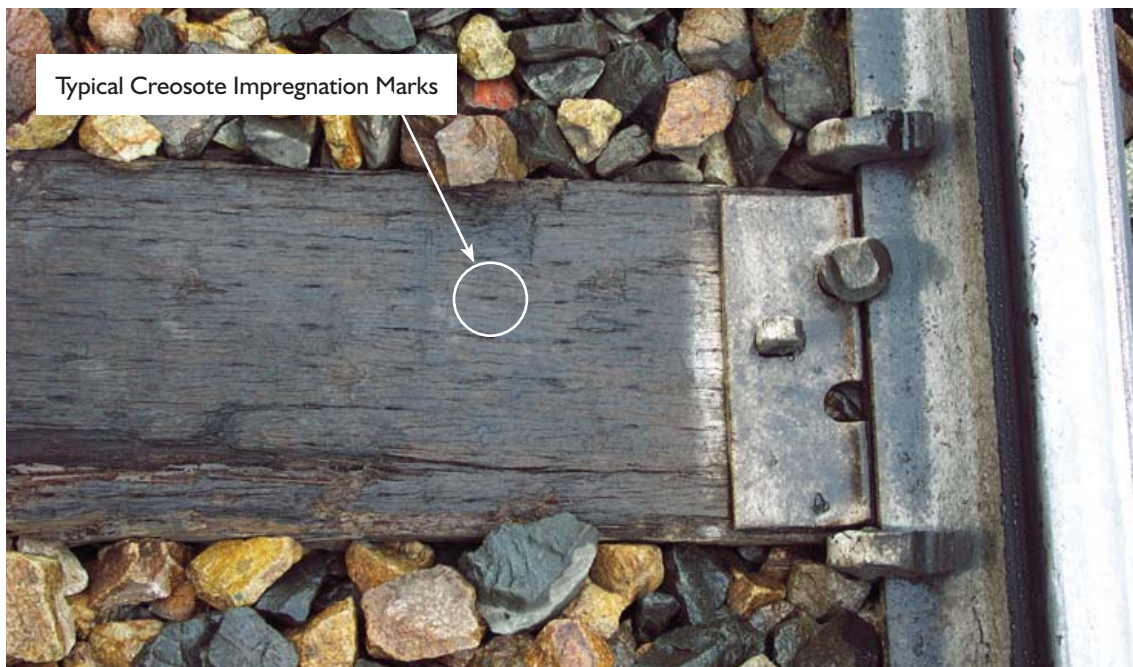
The sleeper condition within the misalignment curve was assessed as poor within the misalignment report as referenced in Appendix 9.8. At least 5 creosote sleepers were also identified within the misalignment curve. The ballast / sleeper interlocking properties are known to reduce significantly with this type of sleeper if the creosote starts to leach out of the sleeper thereby acting as a friction inhibitor. Refer to Figure 4.13 depicting a creosote sleeper and their typical impregnation markings.

Figure 4.13 Creosote Sleeper In Misalignment Curve

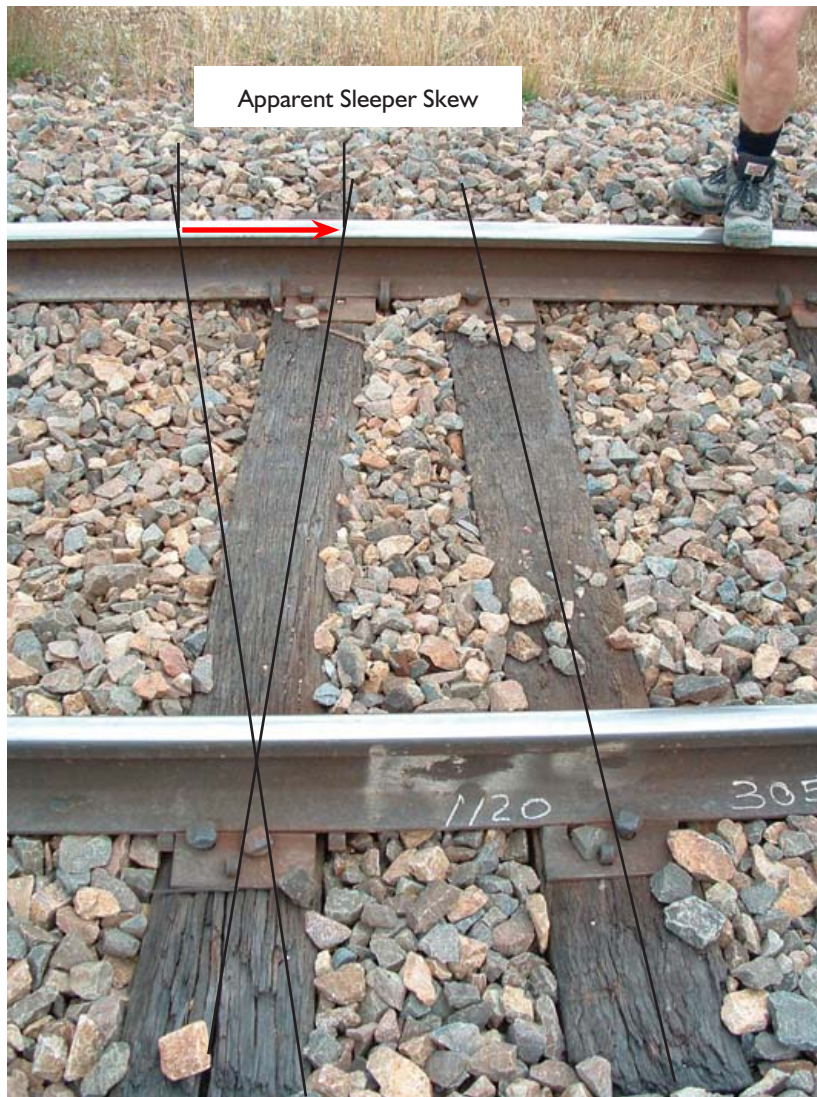
An inspection for the occurrence of sleeper skew was conducted at the incident site on 3 December and identified a number of skewed sleepers indicating that tangent rail creep¹⁴ had occurred in the vicinity of the misalignment site. Refer to Figure 4.14 to view sleeper skewing identified at the misalignment site.

Figure 4.14 Sleeper skew noted at misalignment site

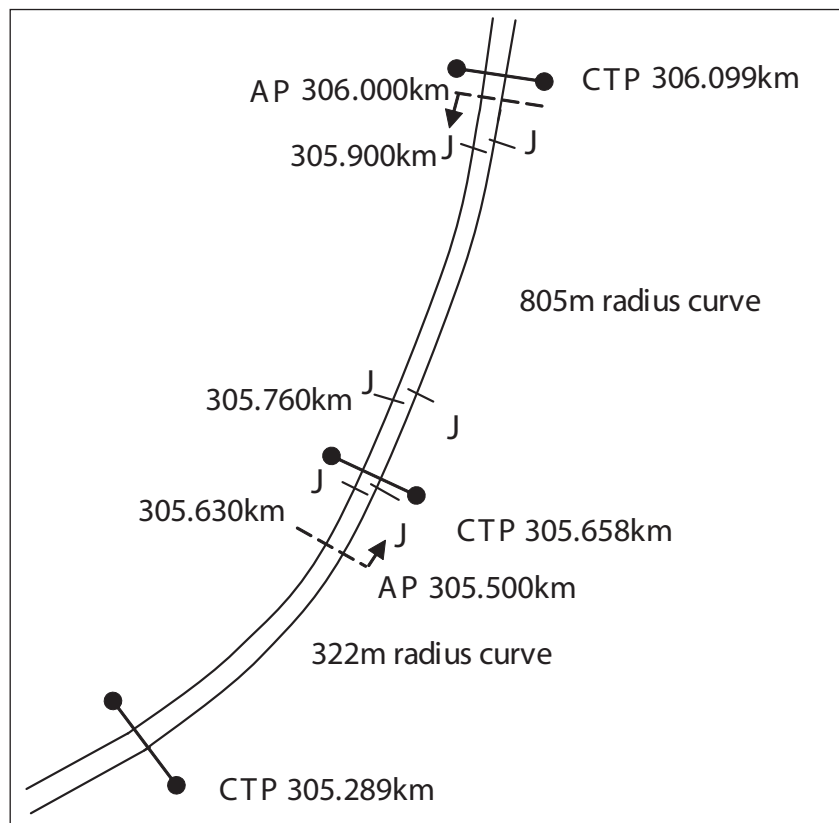
Figure 4.15 – Rail Joints Cut into Misalignment Curve During Restoration Works

- On the morning of 20 November 2002 the damage was assessed and marked out with the speed increased to 20km/h.
- On 22 November 2002 joints were cut into the rail in order for the track machines to realign the track as illustrated in Figure 4.15. Conversion of the track from Continuously Welded Rail (CWR) to Jointed Welded Rail (JWR) in this manner also provides an interim misalignment control measure. JWR track has a greater tolerance to endure heat induced longitudinal rail stresses by virtue of the temperature expansion gaps created at each joint. These expansion gaps allow for a degree of rail expansion as the rail heats up. Longitudinal rail stresses are therefore experienced when the rail gap closes.

As a part of the track restoration process the track was realigned, punch marked, cut and jointed. Following this procedure a check of rail adjustment was carried out where the conclusion was reached that there was no excess steel within the curve at 305.650km (refer to Appendix 9.9)

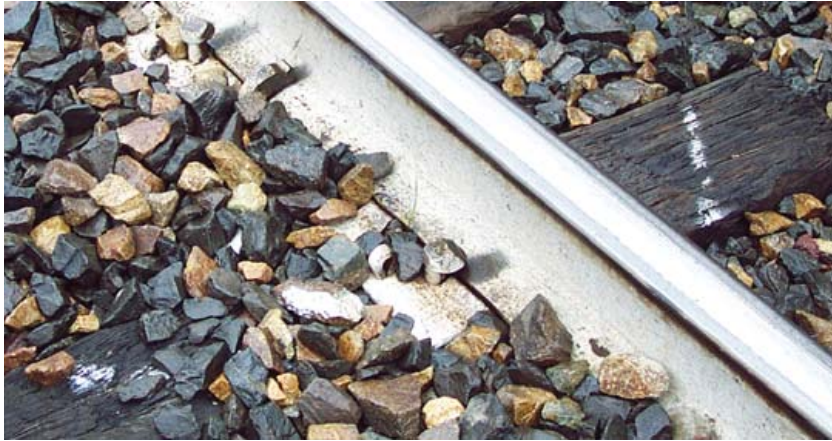
Figure 4.16 Rail Painting at Misalignment site 305.650km

In an attempt to reduce the rail temperature at Hot Spot locations within the Yass Maintenance Area, the rail web, foot and sleeper plates at these locations were painted white as depicted in Figure 4.16. This work was completed by the end of January 2003. Minimum rail temperature reductions of 5°C, at ambient temperatures of 30°C, were recorded in the Yass maintenance area compared with sections of rail without paint. Rail temperature reductions of up to 10°C have also been reported on rails painted within the North Coast Maintenance area. Refer to Appendix 9.14 detailing rail painting product information.

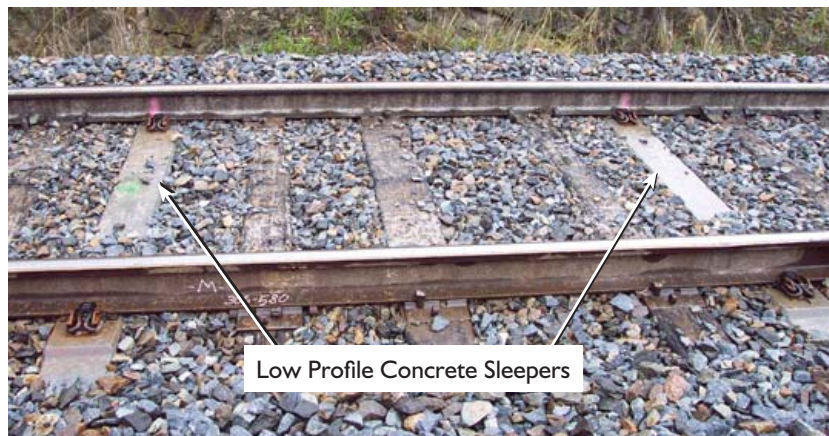
Figure 4.17 Low Profile Concrete Sleepers at 305.650km Up Main South.

In an attempt to improve the lateral track stability of Yass Hot Spot locations, low profile concrete sleepers have been installed in a 1 in 4 pattern at these locations. Low profile concrete sleepers installed in the Up Main South at 305.650km are depicted in Figure 4.17 below.

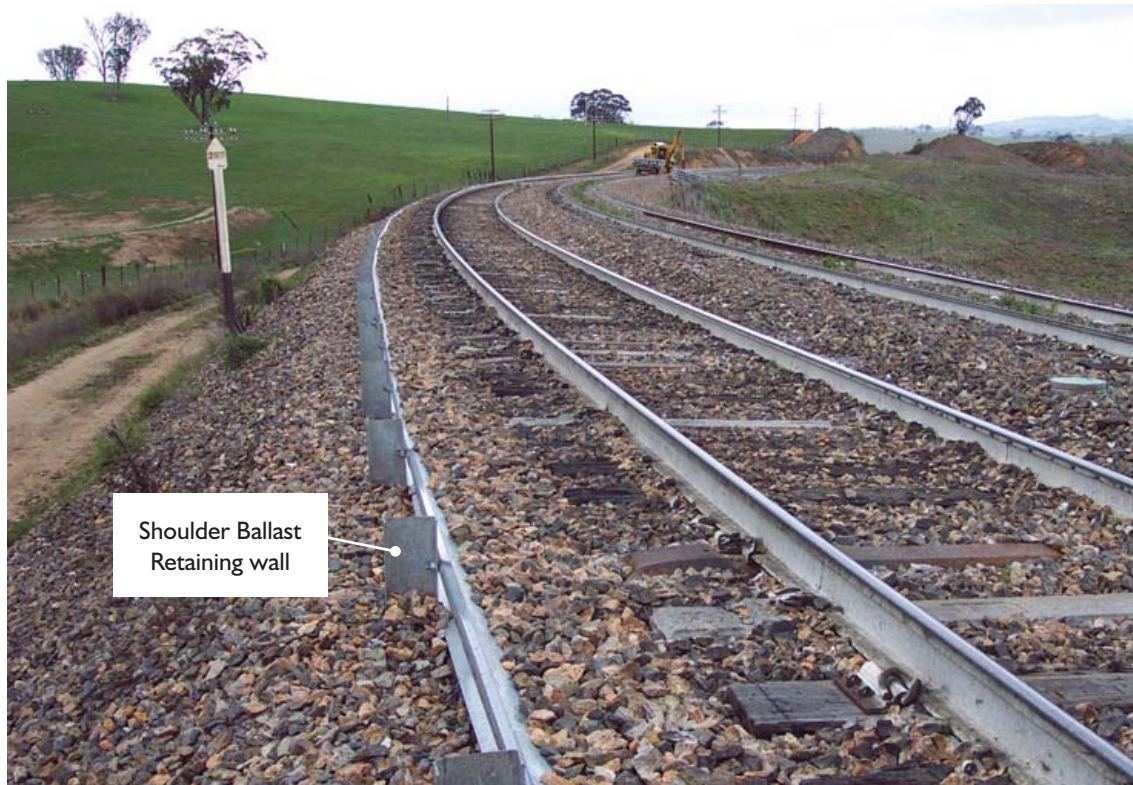
Figure 4.18 Shoulder Ballast Stabilisation, Low Profile Concrete Sleepers and Rail Painting at 267.500km Down Main South.

In an effort to improve the lateral track stability at 267.500km the Yass Maintenance Team constructed a retaining wall to retain the curve's shoulder ballast as depicted in Figure 4.18. Low profile concrete sleepers in a 1 in 4 pattern have also been installed at this previous Hot Spot location (April 2002) together with the rails being painted. Since the installation of these track stabilisation measures the curve at 267.500km has not displayed any signs of instability.

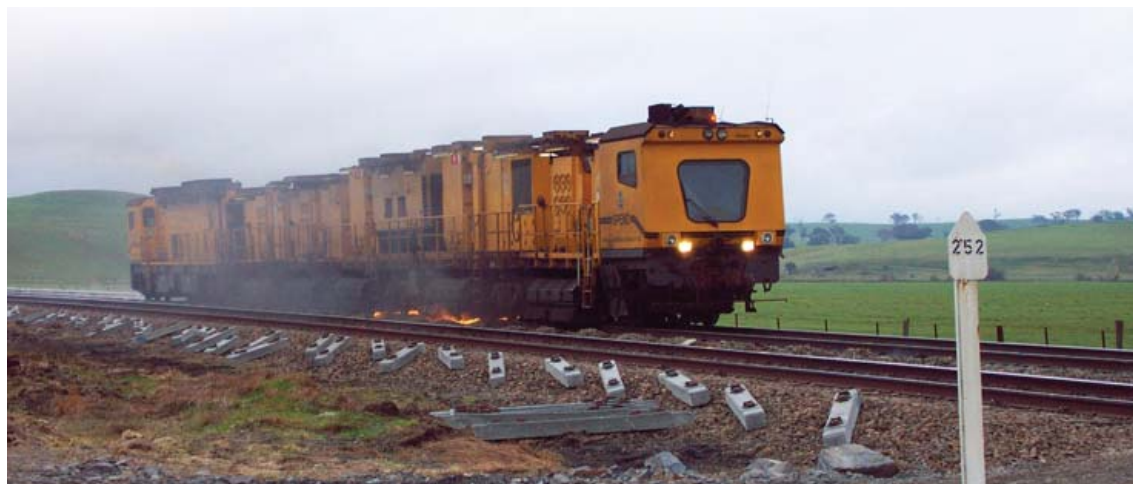
Figure 4.19 Rail Grinding and Low Profile Concrete Resleepering (sleepers placed ready for installation) at 252.500km Up Main South.

A program of rail grinding within the Yass maintenance area was conducted between July 03 and September 03 in conjunction with the concrete resleepering program. This program will improve the rail profile and reduce rail vertical displacements generated from the passage of trains, which in turn assists in maintaining lateral track stability. A total of 105km on the Up and Down Main South Lines within the Yass Maintenance Area has undergone rail grinding work. Refer to Figure 4.19 depicting rail grinding works at 252.500km Up Main South.
