## 4.8 Train Control

## 4.9 Environmental Factors

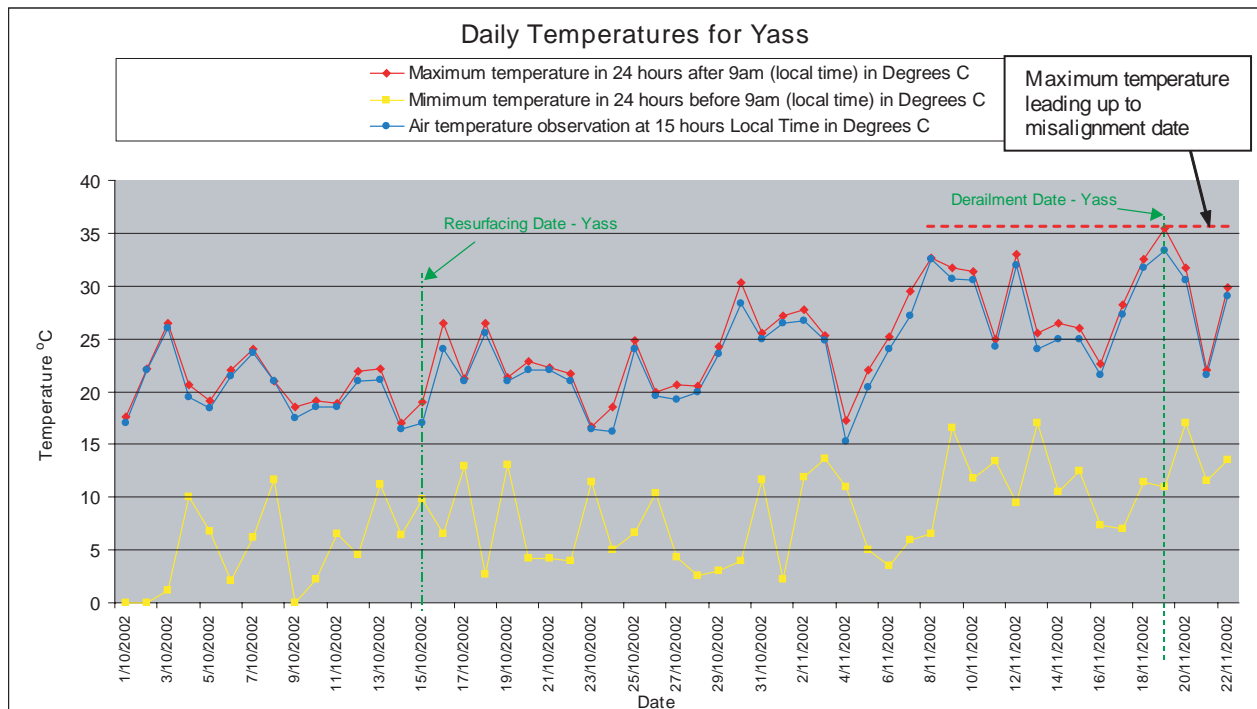
Figure 4.20 Daily Temperature for Yass Weather Station

Figure 4.20 below identifies that the day of misalignment registered the highest maximum temperature (35.5°C) recorded, since the winter of 2002, up to this date.

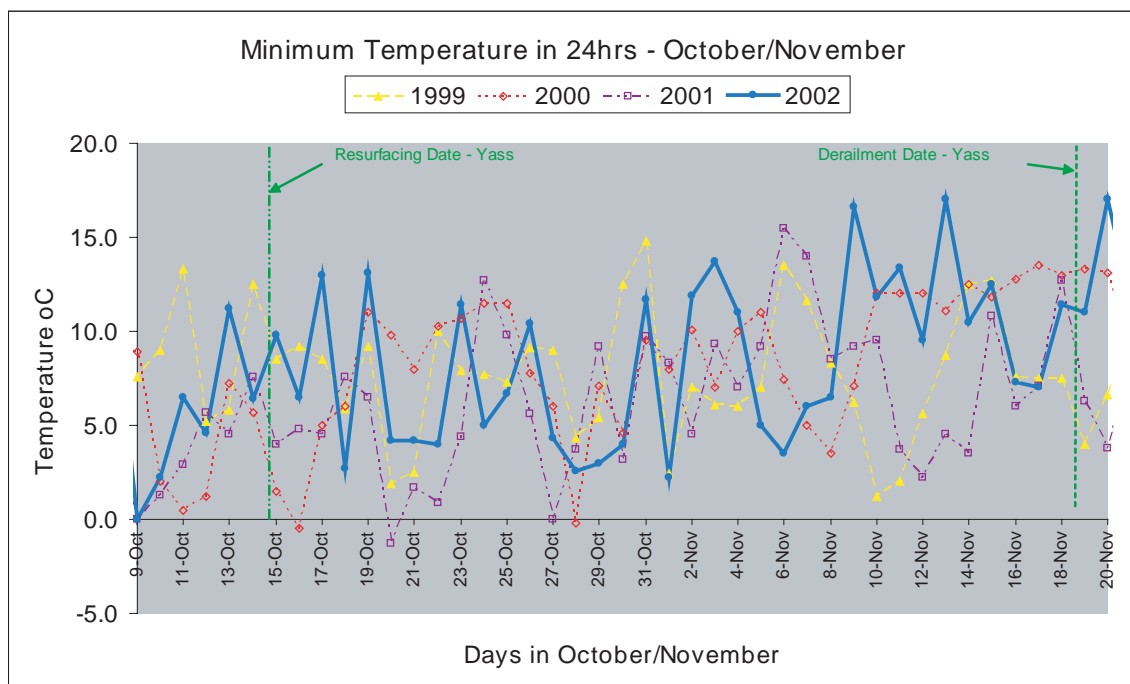
Figure 4.21 Minimum Temperature in 24hrs - October / November 1999, 2000, 2001 & 2002

Figure 4.21 below depicts the minimum temperature for 24hrs taken before 9:00 on the recorded day. This figure identifies that the minimum temperature in the month of October (month of track resurfacing works) for the Yass Region had not changed markedly over the last four years. The minimum temperature following track resurfacing works was registered as 2.2°C on 1 November 2002. Cold night time temperatures were also registered on 18 (2.5°C) and 28 November 2002 (2.5°C).

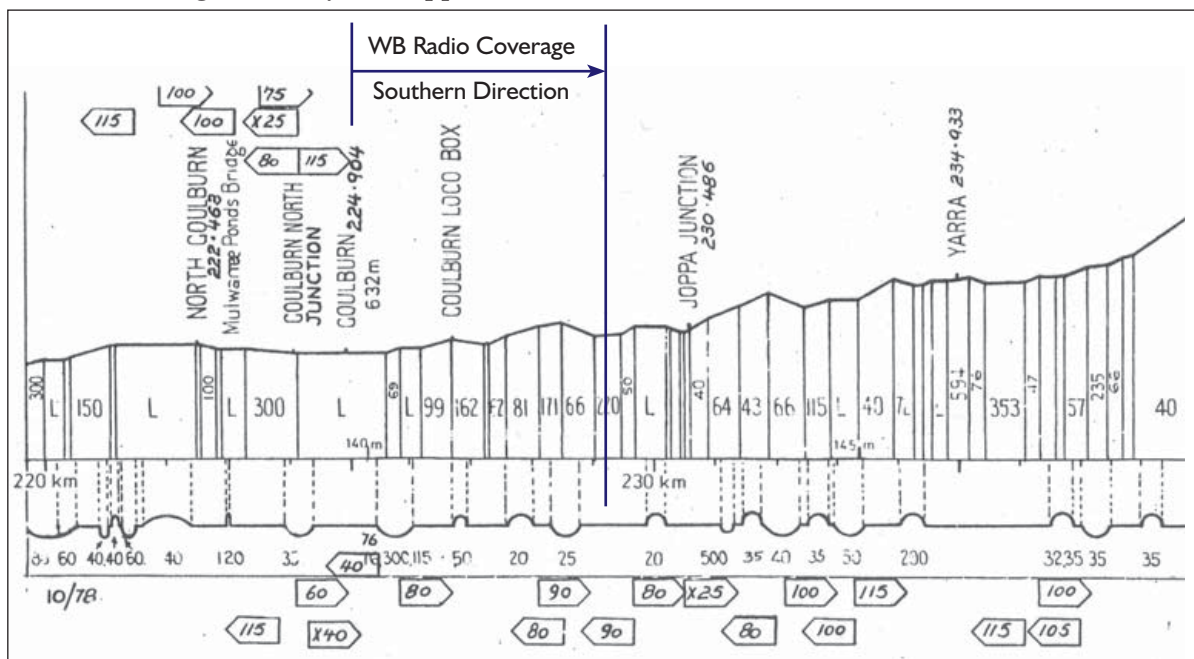
Figure 4.22 Curve and Gradient Diagram noting Goulburn, Joppa Junction and surrounding topography

The WB radio coverage for trains departing Goulburn Station (224.904Km) on the Down Main Line extends some 4.6km (229.200km) south in the vicinity of Joppa Junction (230.486Km). WB radio works on a line of sight principle, where unless the broadcasting and receiving equipment is unobstructed by a line of sight, the communication connection will not reliably take place. As identified within Figure 4.22 there are significant curves and gradients, including cuttings, from Joppa Junction in the down direction, that inhibits the WB radio coverage from extending south beyond Joppa Junction.

The approximate position of G9821 at the time when WB radio communication was attempted can be estimated at 8kms from Goulburn Signal box (233.0km).

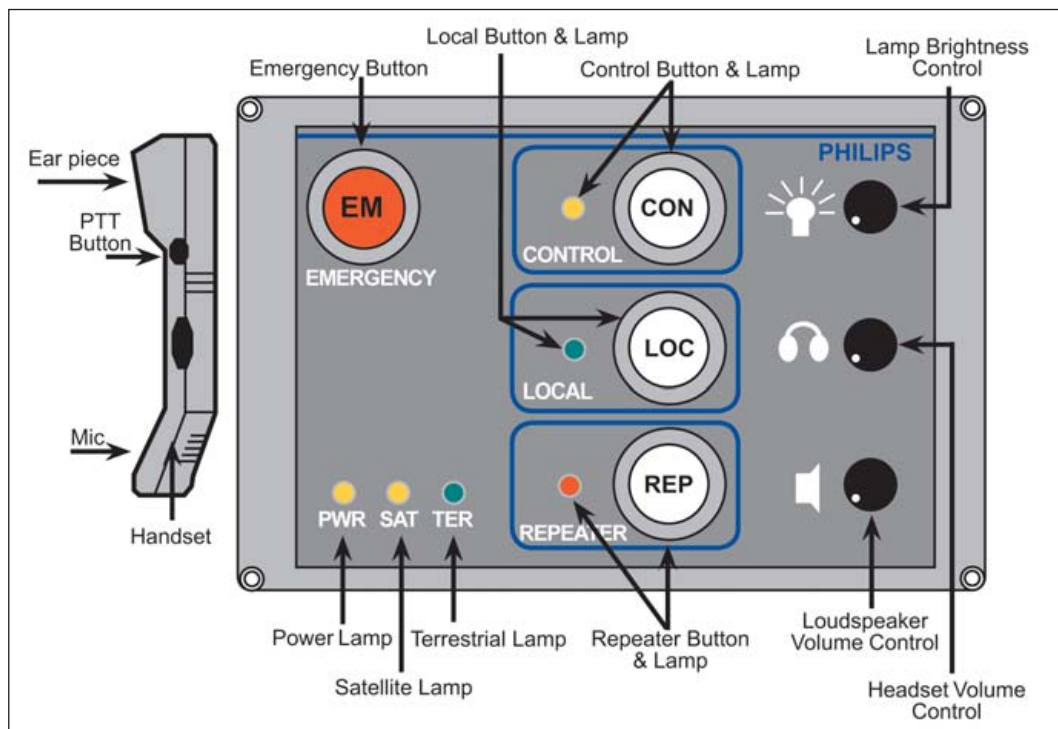
Figure 4.23 CountryNet Train Radio Operator Panel Representation

in time. The train crew in their recount of events prior to the incident did not indicate that an incoming train radio call was detected at approximately 14:02. The locomotive's train radio was found to operate correctly having successfully received and made calls to Junee Control following the incident. No locomotive or train radio maintenance record indicated any defects with the locomotive's train radio prior to or immediately following the incident.

The train crew has the ability to vary the train radio alert volume via the loudspeaker volume control knob as identified in Figure 4.23. The loudspeaker volume cannot be completely silenced having a minimum volume level preset to ensure an adequate alert volume within the confines of the locomotive's cab environment.

It is recommended that RailCorp consult with rail operators on improving the locomotive train radio call alert system to provide train crews with the ability to identify that an incoming call has taken place and has not been answered.

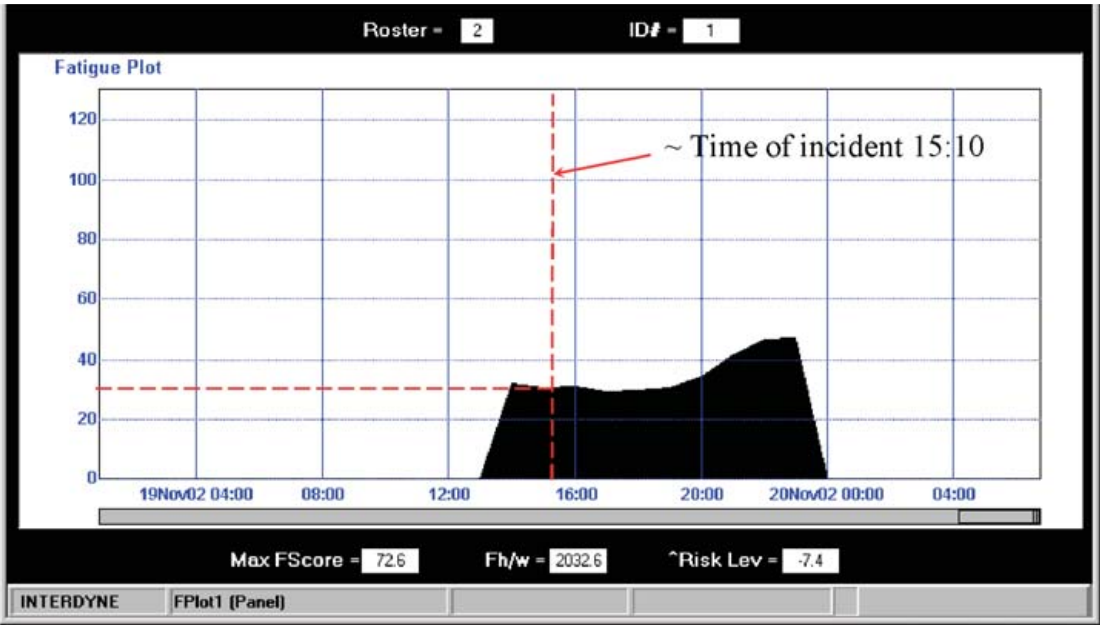
Figure 4.25 Driver's Roster Fatigue Plot ~ Fatigue Score at 15:10 ~ 30.3

Based on the Rail Safety Act 2002 fatigue management review described in Table 4.12, the incident date FAID fatigue plots shown in Figures 4.25 and 4.26 and the fortnightly fatigue plots depicted in Appendix 9.13, the Driver and Observer fatigue results can be summarised as:

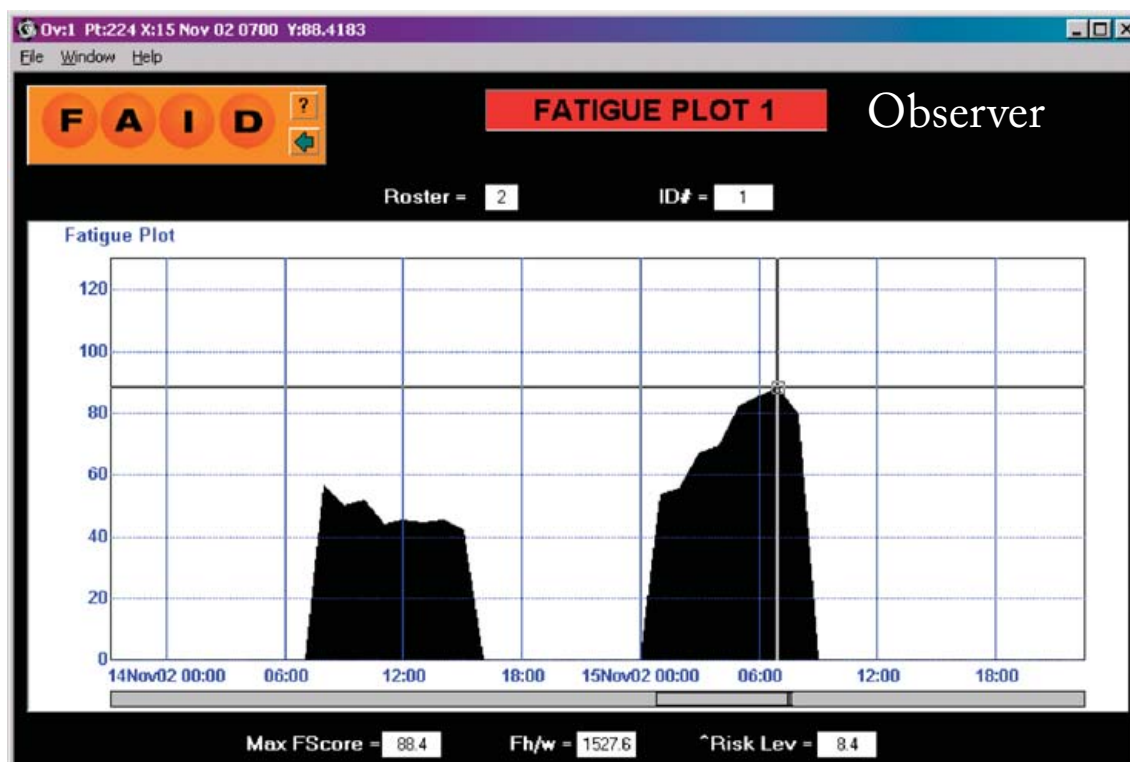
Figure 4.27 Observer's Roster Fatigue Plot ~ Maximum Fatigue Score over roster on 15 November 2002 = 88.4

- The Observer's rostered FAID fatigue rating indicated a very high level of fatigue for 1 of the 14 days assessed prior to the incident date.
- Rail Infrastructure Corporation's Derailment Investigation Manual and Pacific National's Incident Investigation Manual do not explicitly define the expected rolling stock inspection reporting criteria required following a misalignment related derailment. The level of competency required to carry out such an inspection is also not specified.
