Office of Transport Safety Investigations

RAIL SAFETY INVESTIGATION REPORT

DERAILMENT OF PACIFIC NATIONAL TRAIN 7SP5

16 OCTOBER 2005

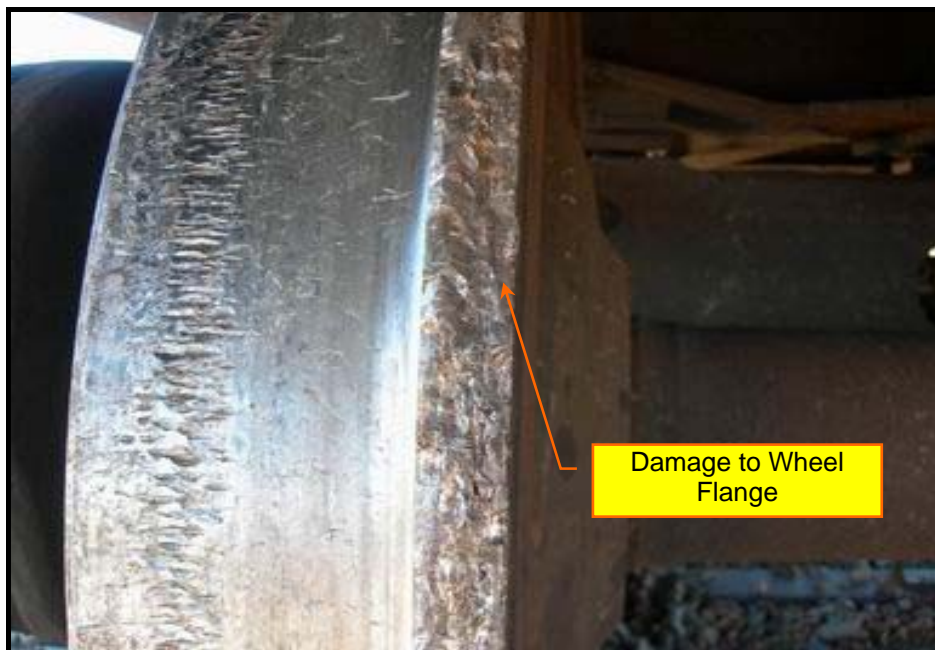
- 1.7 An inspection of the train by the Driver revealed that the brake pipe isolating cock between the 30th wagon (RQKY 02034E) and the 31st wagon (RQSY 34342U) was in the 'up' (closed) position. This disrupted the supply of air necessary to hold the brakes 'off' which resulted in the progressive application of the brakes on the wagons behind the 30th wagon. The Driver also observed that the rear wheels on the 30th wagon were severely damaged (see *Photo 1*) and noticed ballast and debris on the following wagon. These two conditions were consistent with the 30th wagon having derailed at some point.

Photo 1: Damage to wheel on RQKY 02034E

- 1.16 There was significant damage to the ‘B’ end (RJYD 422) bogie wheel set on the 30th wagon. The damage to the track was extensive with 11,256 steel and 416 timber sleepers having to be replaced and continuously-welded rail having to be repaired or replaced in 150 locations over the 34.803km affected by the derailment.
- 1.17 The corridor between Broken Hill and Parkes was closed for four days, resulting in the cancellation of several freight and passenger services. It was reopened at 10:09pm on 20 October 2005, albeit with speed restrictions in place in a number of areas.

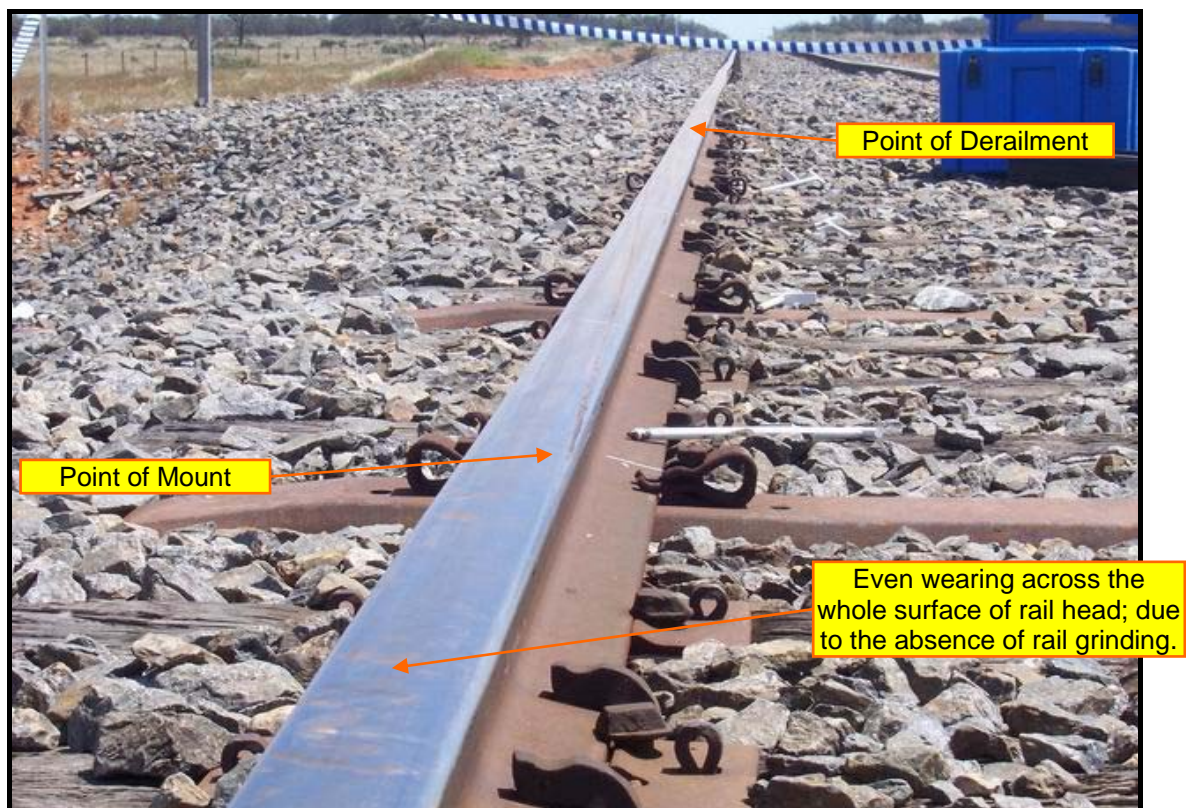
- 2.1 An inspection of the track revealed markings on the 'Down' rail consistent with a wheel mounting the rail at 781.286km (point of mount (POM)) and dropping off the rail at 781.295km (point of derailment (POD)) (see *Photo 2*). The damage to the wagon showed that it was only the rear wheel set of the rear bogie, RJYD 422, that derailed. The train travelled a further 34.803km before the wheel set re-railed as revealed by marks on the pavement at the Cobb Highway level crossing near Ivanhoe.
- 2.2 In a derailment it is expected there will be evidence, in the form of marks or gouging, of the derailing wheel/s climbing the rail at and prior to the POM. No such signs or marks were found during an inspection of the site by both ARTC and PN representatives.

Photo 2: Points of Mount and Derailment

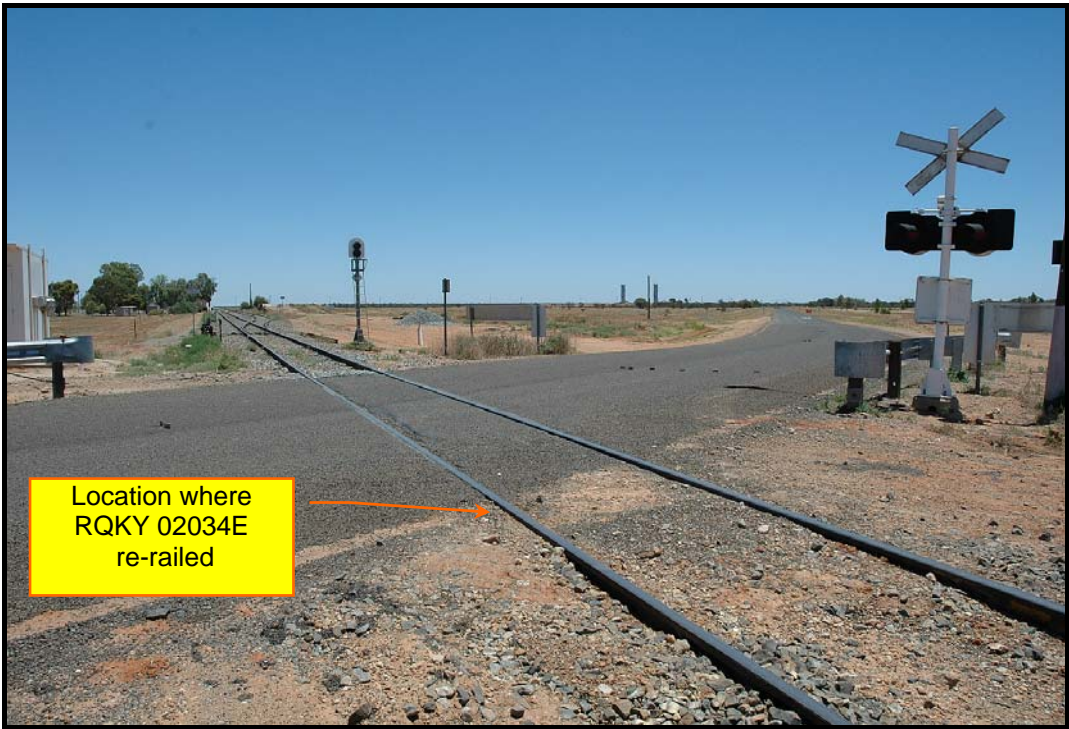
Photo 3: Level Crossing at which wagon re-railed

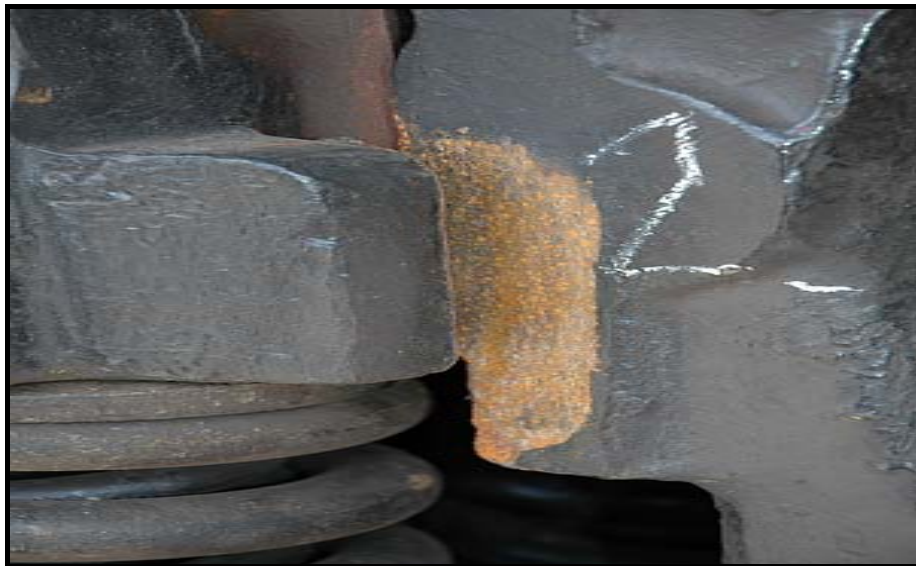
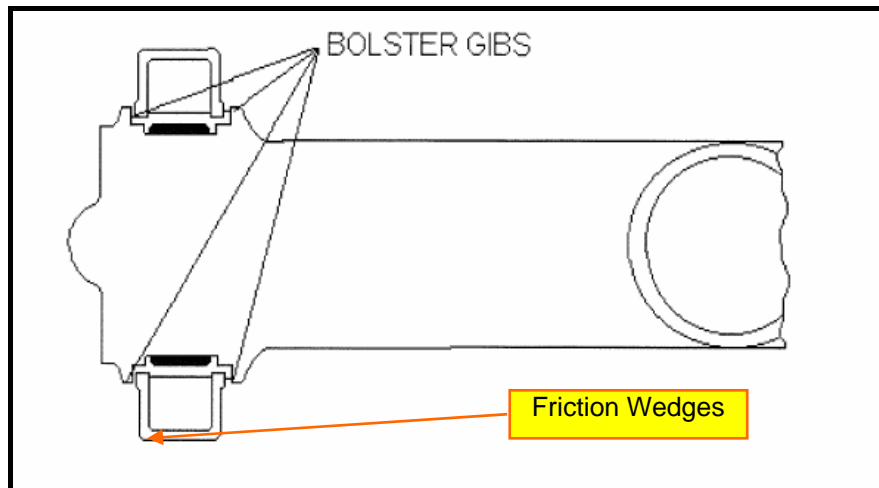
- 2.5 On request, PN completed a report on the condition of the bogie (see *Appendix 7*) which included the following points of note:
- almost all bolster gibs showed signs of contact and wear (see *Figure 4* and *Photo 5*);

Photo 5: Indication of wear to the bolster gib and bogie side frame

- 2.6 Some of the wear marks on the gibs might have been caused by the forces imparted while the wagon was derailed. However, other indications, such as the wear marks from twist locks on top of the wagon deck (see *Photo 6*) and the extensive wear to the gibs, are consistent with longer term wear.

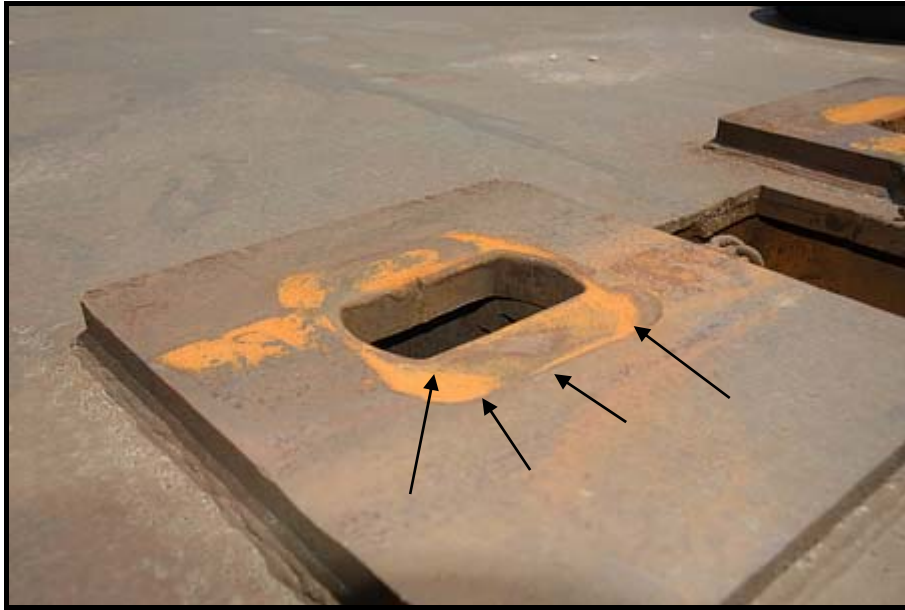
- the sides of all (friction) wedges were highly polished;
 - twist lock surfaces were marked and worn (see *Photo 6*);
 - tie-down loops on the sides of the wagon were highly polished and worn from continual contact with the side walls of containers;

Photo 6: Twist lock wear-marks showing the effects of 'hunting'

- 2.31 An inspection of the derailed wagon identified indications that were consistent with 'hunting'. On closer examination, it was also found that the wagon had been fitted with incorrect resilient blocks. These blocks are intended to dampen forces that impact on the wagon and that can potentially cause it to derail. OTSI concluded that the 30th wagon, which was unloaded and which would have been subjected to additional forces from the loaded wagons that were trailing it, had been hunting and that the forces that had induced the hunting were exacerbated when the wagon passed over an area where there was a high incidence of steel sleepers and where, as a

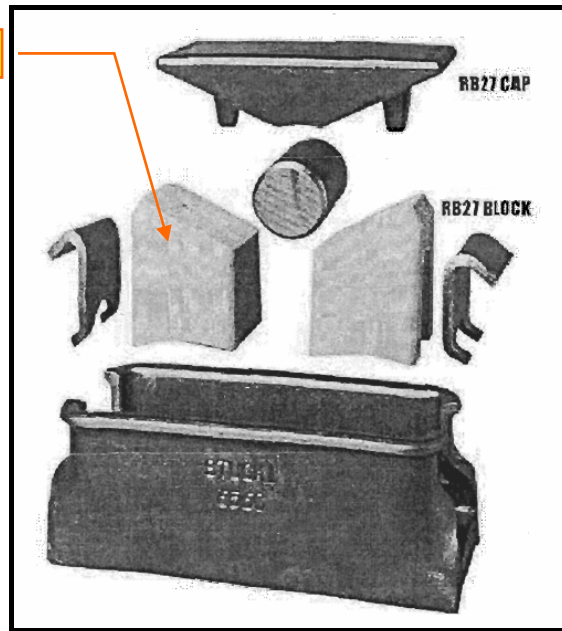
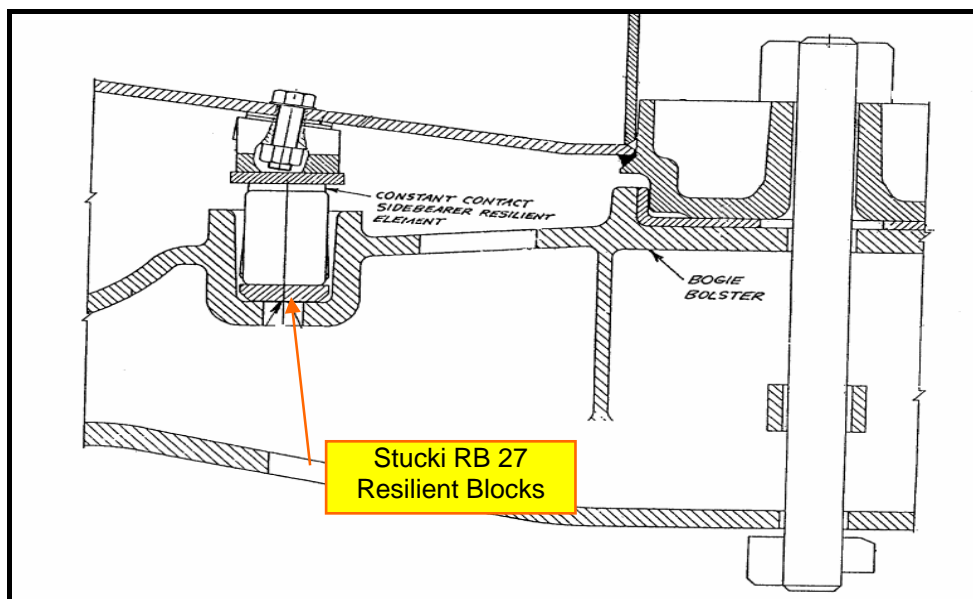
- 2.7 The Stucki resilient blocks were badly worn. These blocks are intended to ensure that pre-load tensions are appropriate and that lateral forces acting on wagons during running are dampened. The blocks, in conjunction with other components and, in particular, a manganese cap often referred to as a 'wear' or 'friction block', form the constant contact side bearer (CCSB) assembly. In addition to providing dampening, the assembly is also intended to stiffen the bogie against lateral forces.

- 2.8 Further investigation established that the blocks were of the wrong type and that RQKY 02034E had travelled approximately 65,000km fitted with RB 35 instead of RB 27 Stucki resilient blocks (see *Figures 5 and 6*). This explains the extent of the wear apparent on the resilient blocks. It also means that effectively there was very little, if any, dampening of lateral forces acting on the wagon by the CCSBs and that the body of the wagon would have moved laterally in a vigorous manner, causing further instability.⁷ Using RB 35 blocks almost halved the required preload for the wagon.⁸

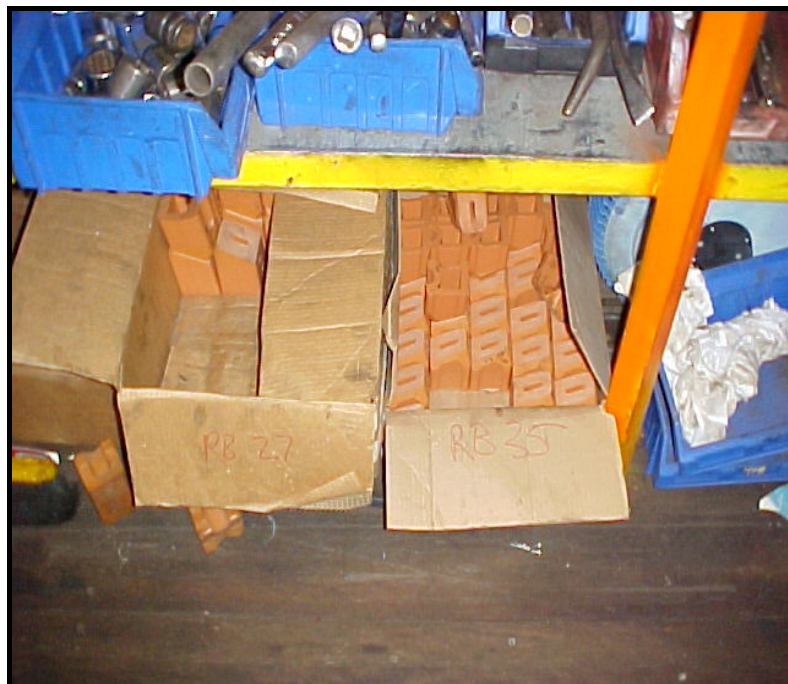
- 2.10 An examination of the circumstances under which the maintenance work was undertaken revealed that the replacement of the resilient block on this bogie and others at the same location had been undertaken by a team of three employees, one of whom was relatively inexperienced. In the previous week, this team had been installing RB 35 resilient blocks exclusively, albeit to another type of wagon. There was considerable scope for error in mistaking RB 27 and RB 35 resilient blocks for one another in that they were the same colour and shape. Further increasing the potential for error was the rudimentary manner in which these parts were stored (see *Photo 7*). In addition to improving storage arrangements and quality assurance measures in the maintenance facility, it may be possible to make blocks more readily distinguishable from one another by colouring them differently or by altering the 'housing' within which they fit in a way such that only the correct block will fit.

Photo 7: Storage of resilient blocks at PN's Perth Maintenance Facility

- reviewed storage arrangements at its maintenance centre in Perth and in other locations throughout Australia;
- inspected the condition of CCSBs across its fleet;
