## **RAIL SAFETY INVESTIGATION REPORT**

**DERAILMENT OF CITYRAIL SERVICE 312A**

**THIRROUL**

**11 SEPTEMBER 2006**

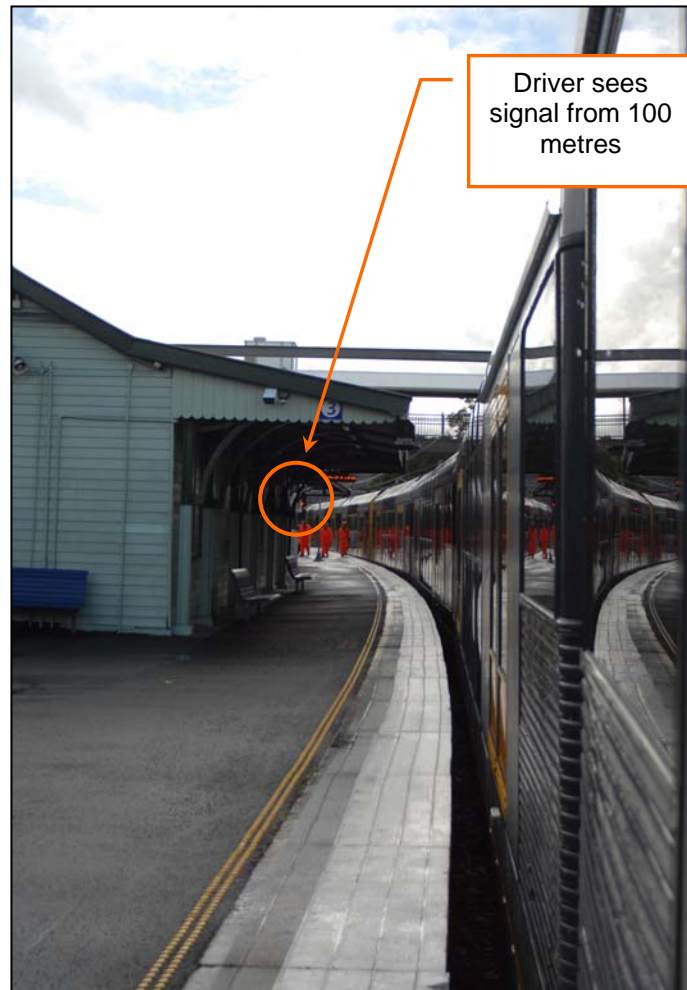
**Photo 3: Signal WG 568D viewed from 100 metres.**

- 1.14 The Driver saw Signal WG 568D displaying a 'Stop' indication at a distance of approximately 100 metres, approximately halfway down the No. 3 Platform track (see *Figure 2 and Photos 3 and 4*).

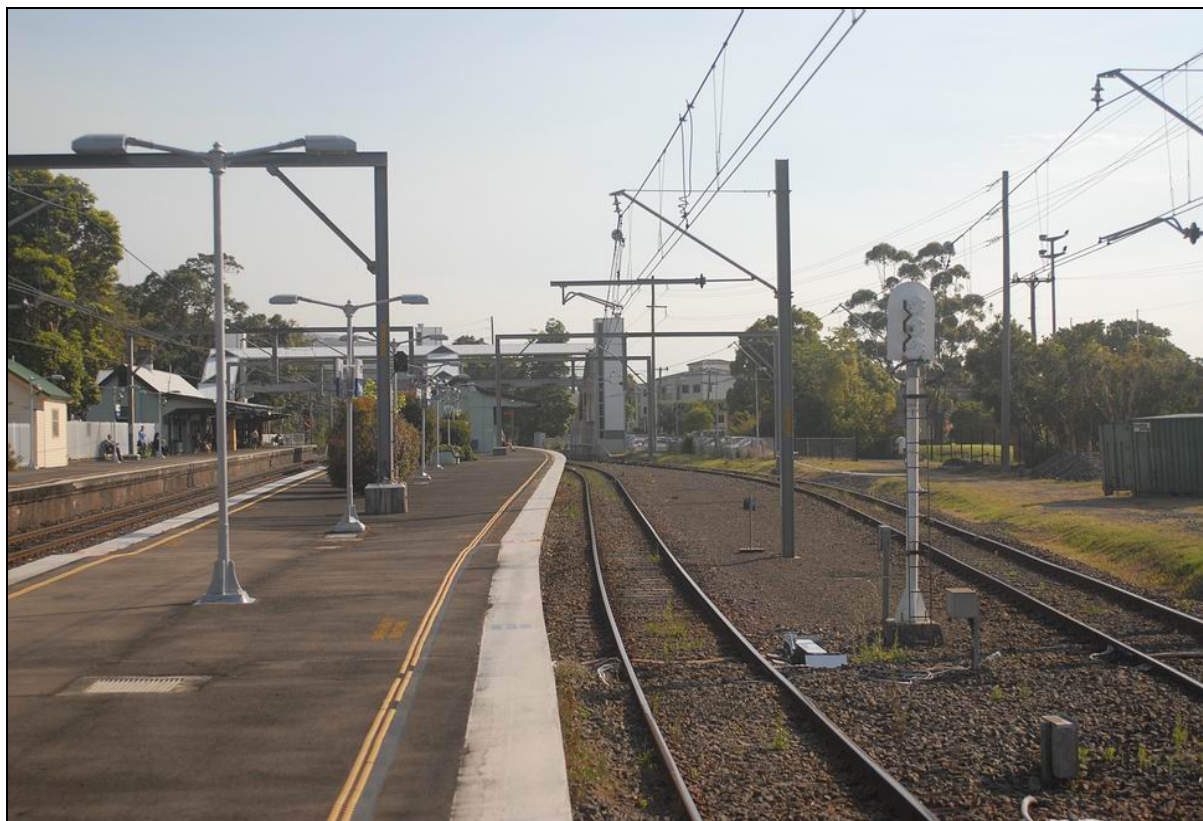
**Photo 4: Direction of travel on number three platform track, in dry conditions.**

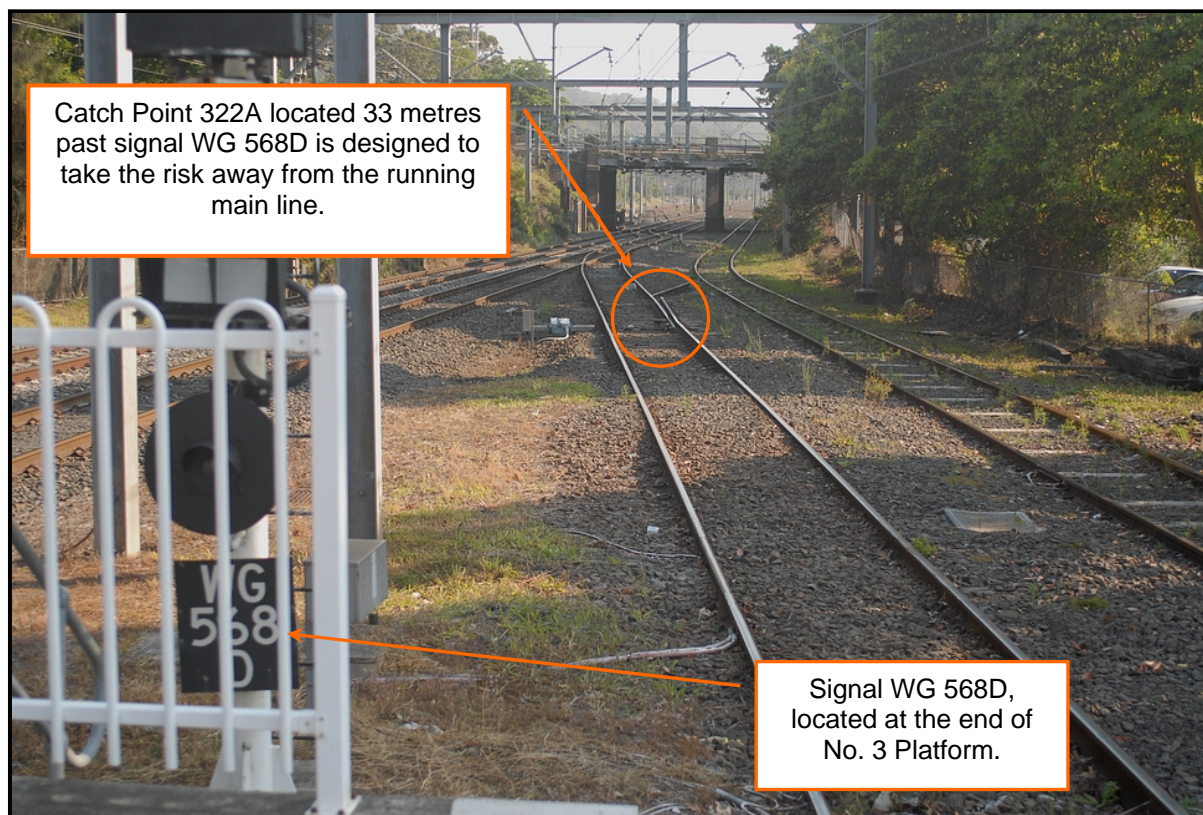
**Photo 5: Signal WG 568D and catch-points.**

- 1.16 The train subsequently skidded past Signal WG 568D and then encountered the 322A catch-points positioned 33 metres beyond. This caused the four leading wheels of the leading car to derail, after which the train continued for a further 13 metres in the track's substructure (see *Photo 5*).

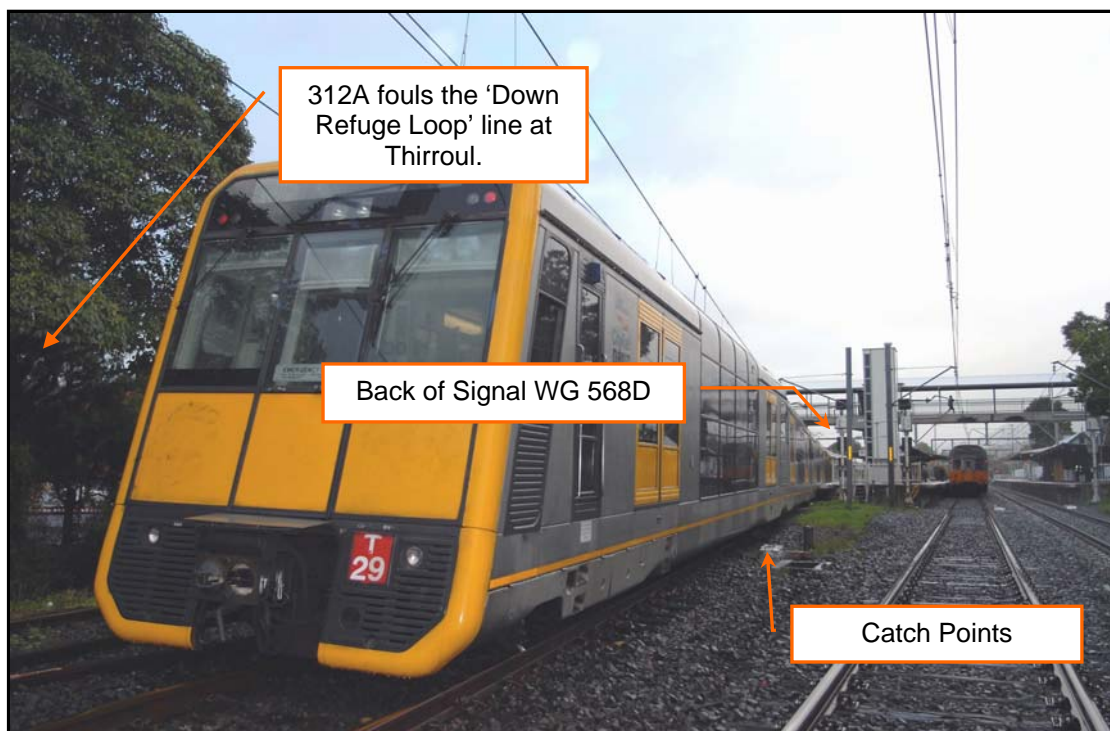
**Photo 6: Tangara 312A located 46 metres past Signal WG 568D.**

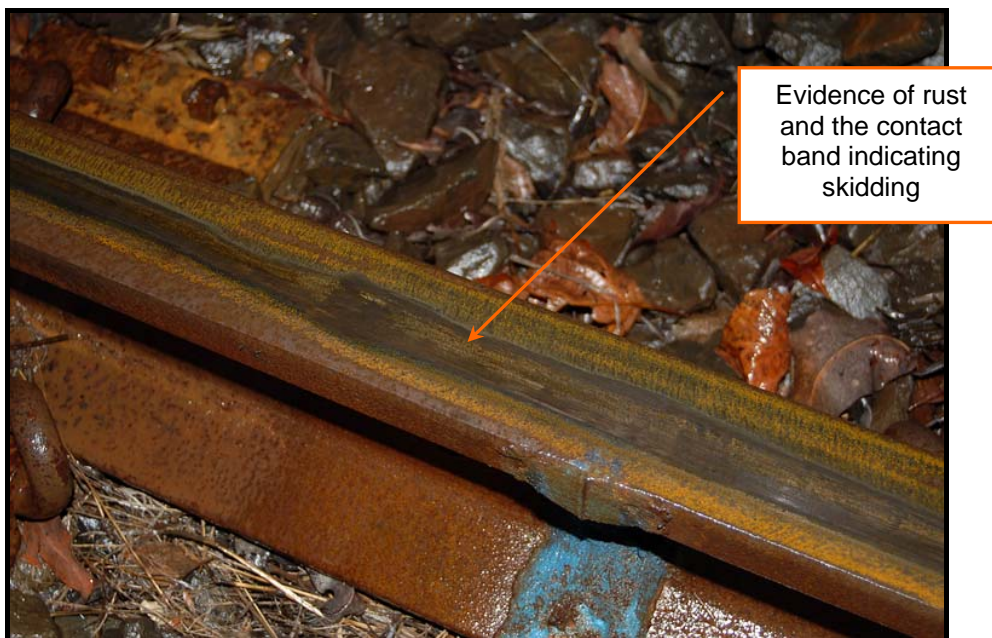
- 2.11. The track on which the derailment occurred had not had a train pass over it in the preceding 58 hours during which time strong southerly winds and wet conditions had prevailed. It is considered highly likely that these conditions, in combination with salt spray generated by the extreme surf conditions at nearby beaches, would have promoted the superficial rust that was apparent on the No. 3 Platform track. There was clear evidence of skid marks over a distance of 46 metres under the Tangara (see *Photos 7 and 8*).

Evidence of rust  
and the contact  
band indicating  
skidding

**Photo 7: Evidence of rust emulsion and skid marks on the railhead.**

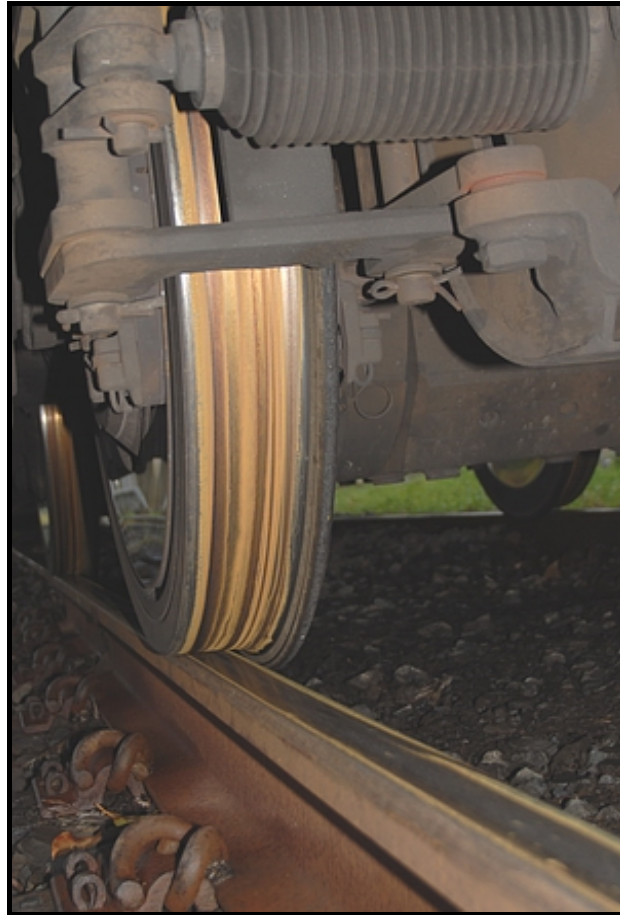
**Photo 8: Evidence of rust emulsion and skid marks on the wheel and rail.**
