Office of Transport Safety Investigations

RAIL SAFETY INVESTIGATION REPORT

UNSECURED CONTAINER GATE STRIKES STATION INFRASTRUCTURE

WOY WOY

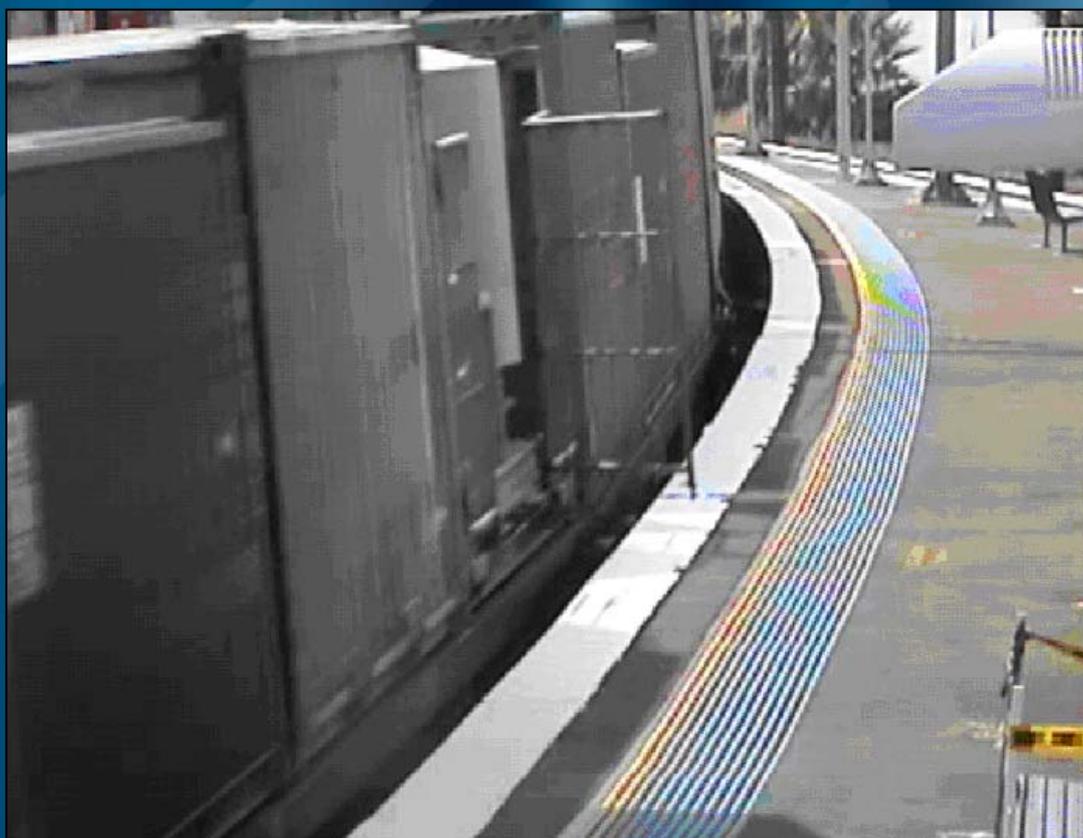
- 1.22 The Driver and Co-driver were unaware of the incident and continued on their journey. They were also not aware that the first gate on the right side was now swinging out of gauge as was revealed from CCTV footage from Woy Woy Station (see *Cover Photograph*).

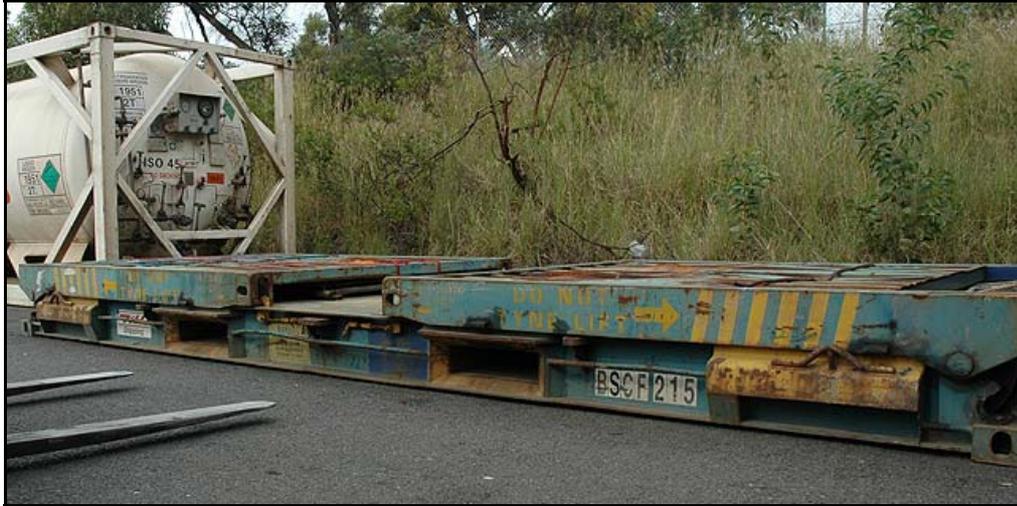
Photograph 1: Container BSCF 215 in folded configuration

1.4 When empty, the container can be stored flat with the ends folded down onto the base and the gates removed and stored on the same base (see *Photograph 1*). This allows for up to eight empty containers to be stacked for movement by rail, sea or road.

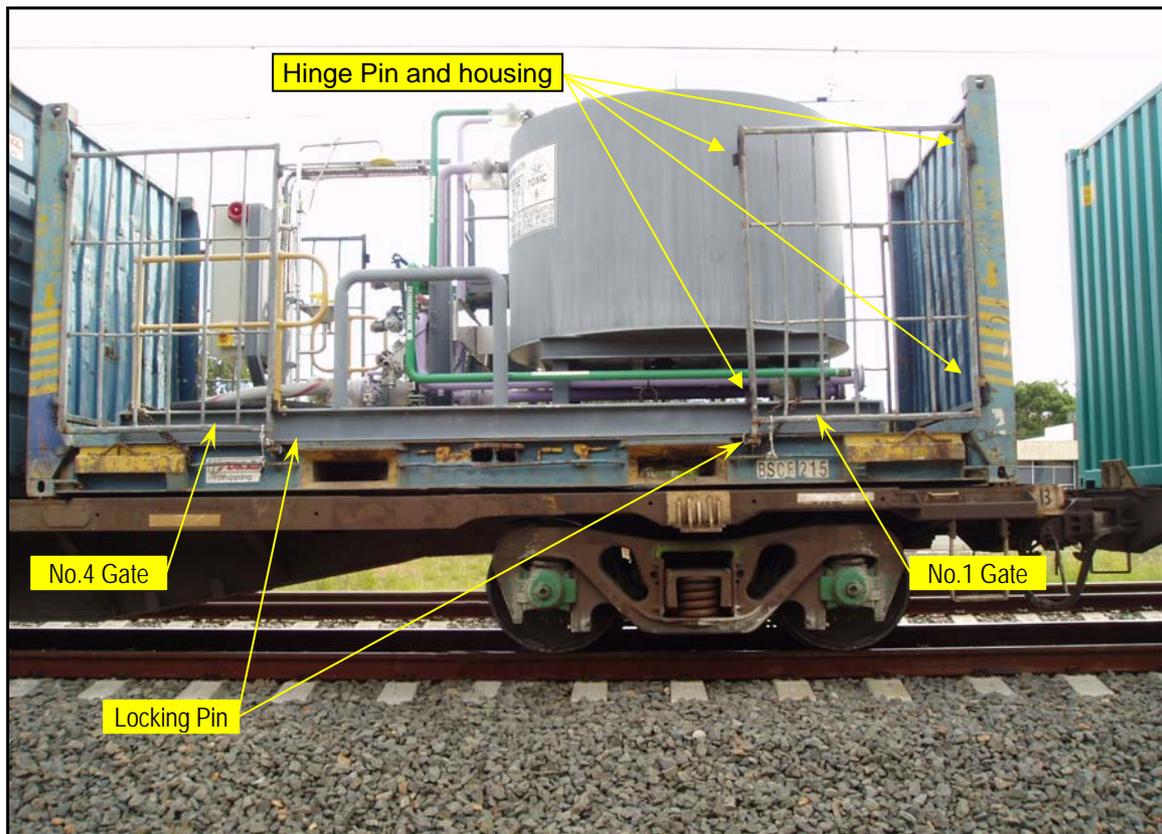
Photograph 2: Right side of Container BSCF 215 (after the incident)

- 1.6 Initially, this particular model of container was produced with four side gates, two on either side. As the gates were too heavy for a single person to lift, the configuration was discontinued and replaced with eight gates, four on either side. All gates are fitted with two fixed hinge pins on one side and a locking pin at the base of the opposite side (see *Photograph 2*). The hinge pins fit into housings on the end walls in the case of the first and last ('end') gates on both sides, and into housings on the 'end' gates in the case of the 'internal' gates. All gates are secured from swinging by the locking pin which locates into a lug welded to the side of the container base. Spreader bars, webbing straps and tarpaulins are utilised in the same manner as for the original configuration.

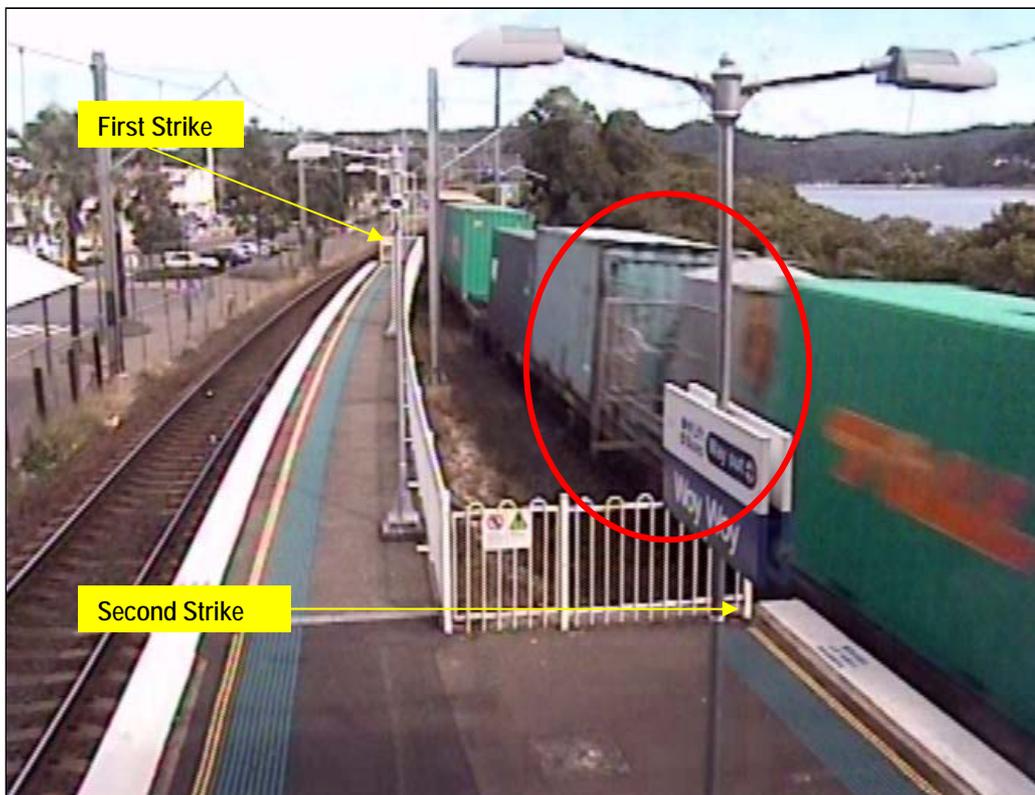
Photograph 3: CCTV footage of swinging gate after first impact at Woy Woy

- 1.21 At approximately 11:45am, as 7MB4 was passing the platform structure, an open, unsecured gate on container BSCF215 struck the fence on the Sydney end of Platform 1 (see *Photograph 3*). The gate, still in the open position, then struck the fence on the end of Platform 2 and became dislodged from the two retaining pins attached to the supporting gate. After striking the fence, CCTV footage shows the gate become airborne, then landing on and skidding across the platform for approximately 20 metres before smashing into a seating bay glass windbreak partition between the two platforms (see *Photograph 4*).

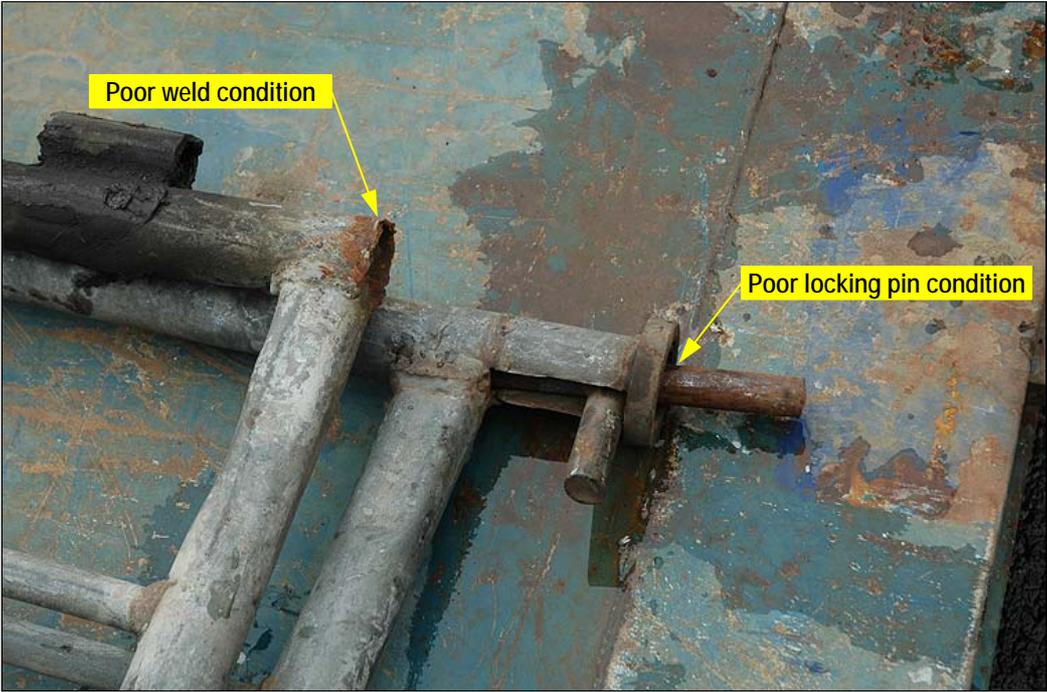
Photograph 5: Weld and locking pin condition

- 1.27 The locking pin housings are welded to the bottom of the gates (see *Photograph 5*). Examination of the gates revealed evidence of a poor standard of welding and repairs having been made to most gates over time. The locking pin housing was missing from one gate and it is probable that this gate was the one with "*a bolt on the bottom ... missing*" secured by the Co-driver at Yerong Creek.

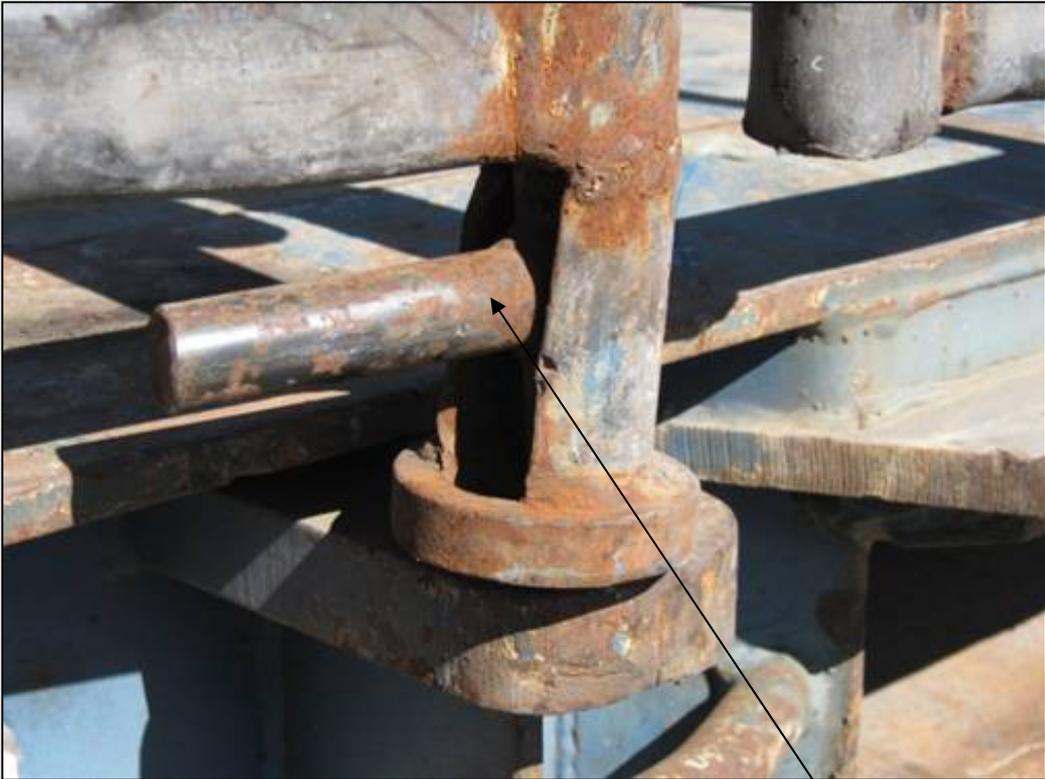
Photograph 6: Locking pin not housed in base

- 1.28 The locking pins did not fit snugly into the lugs on the sides of the container base and were not all the same length. In effect, they are simply drop pins (see *Photograph 6*). Without some type of additional restraint to hold the gates in place a bumpy ride could cause a locking pin to dislodge, thereby releasing a gate to swing laterally and otherwise unconstrained. This was the case for several gates as evidenced by the CCTV footage from stations en route.

- 2.1 The second gate on the right side of container BSCF 215 detached from the container as it struck platform fencing on Woy Woy Station because its locking pins had dislodged from their retaining lugs and it was not adequately restrained from swinging laterally out of gauge.
