Office of Transport Safety Investigations

RAIL SAFETY INVESTIGATION REPORT

SAFEWORKING INCIDENT

UNANDERRA

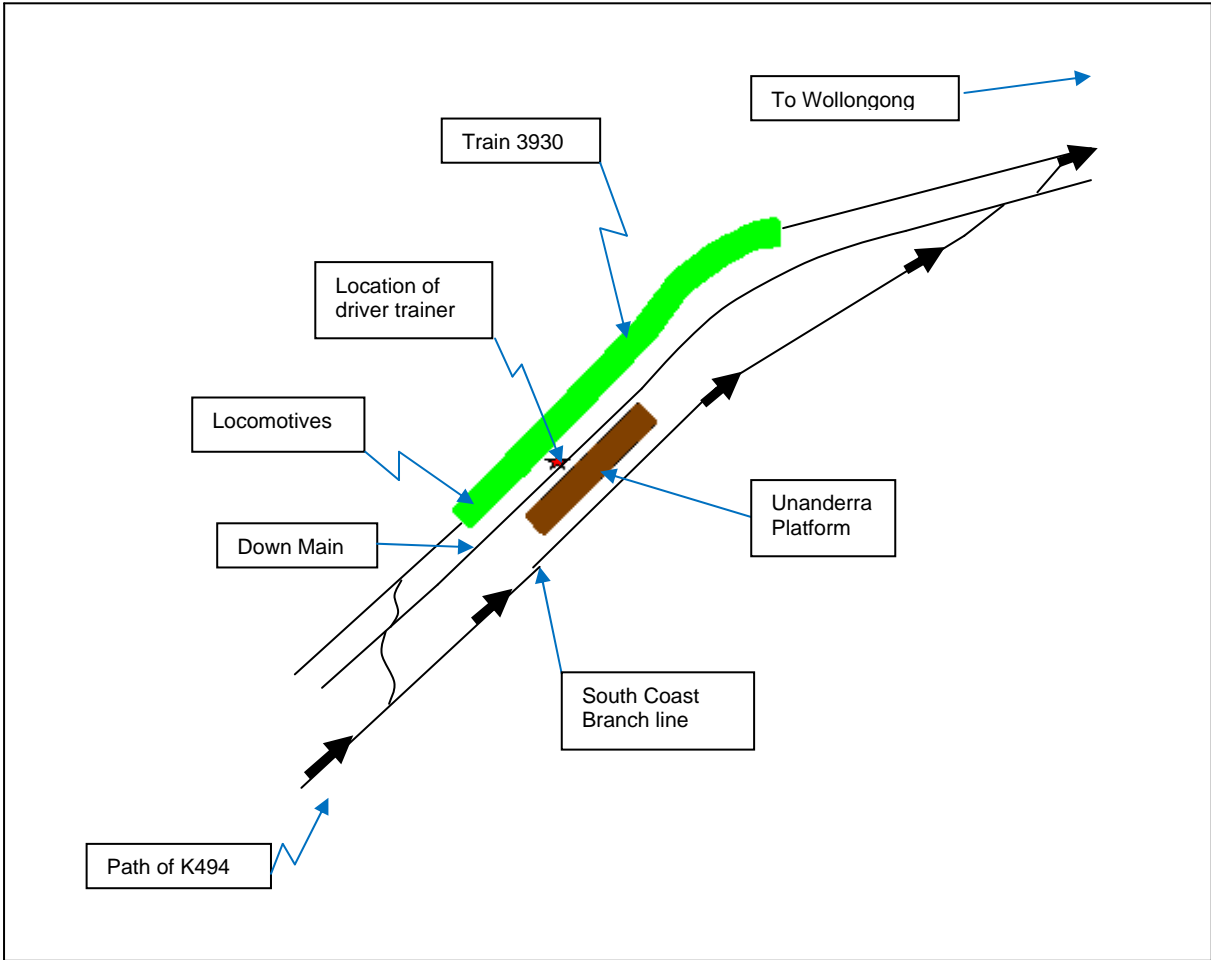
Figure 2: Unanderra incident site

- 1.35 At 12:51am the cab of K494 reached the Southern end of Platform 2. As it was on the Branch line, on the opposite side of the platform to train 3930, it posed no risk to the driver trainer.

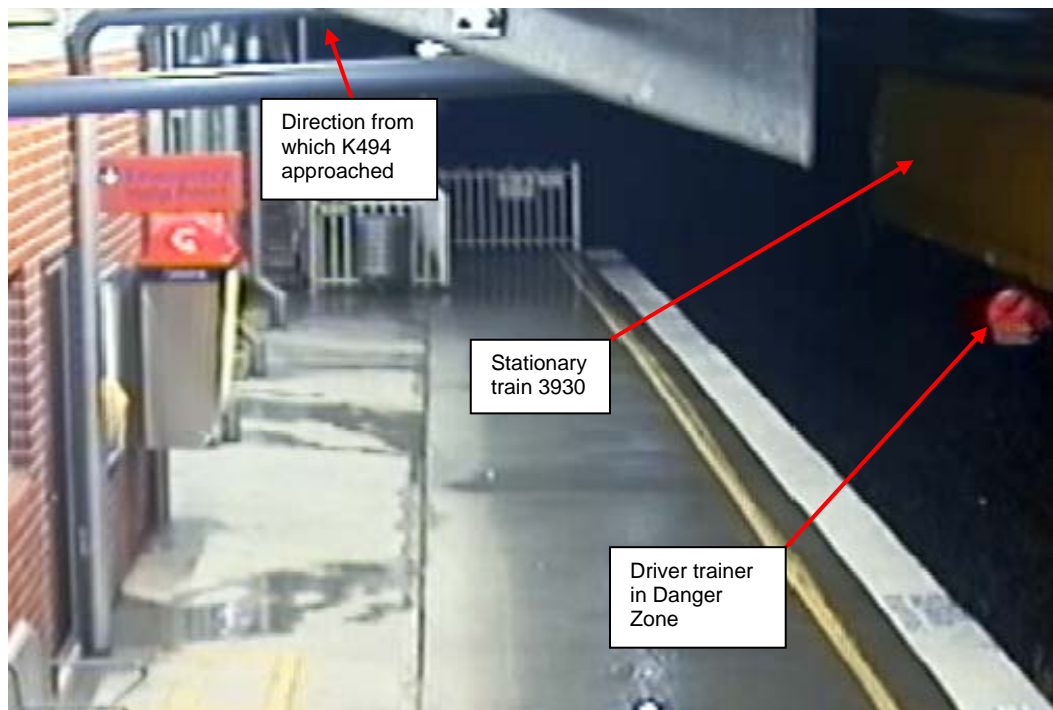
- 1.47 The incident occurred during the hours of darkness and heavy rain was being driven by a strong wind which reduced visibility. The driver trainer reported that it made working conditions somewhat difficult and unpleasant (see *Photograph 3*).

Photograph 3: Working environment at the time of the incident: dark and wet

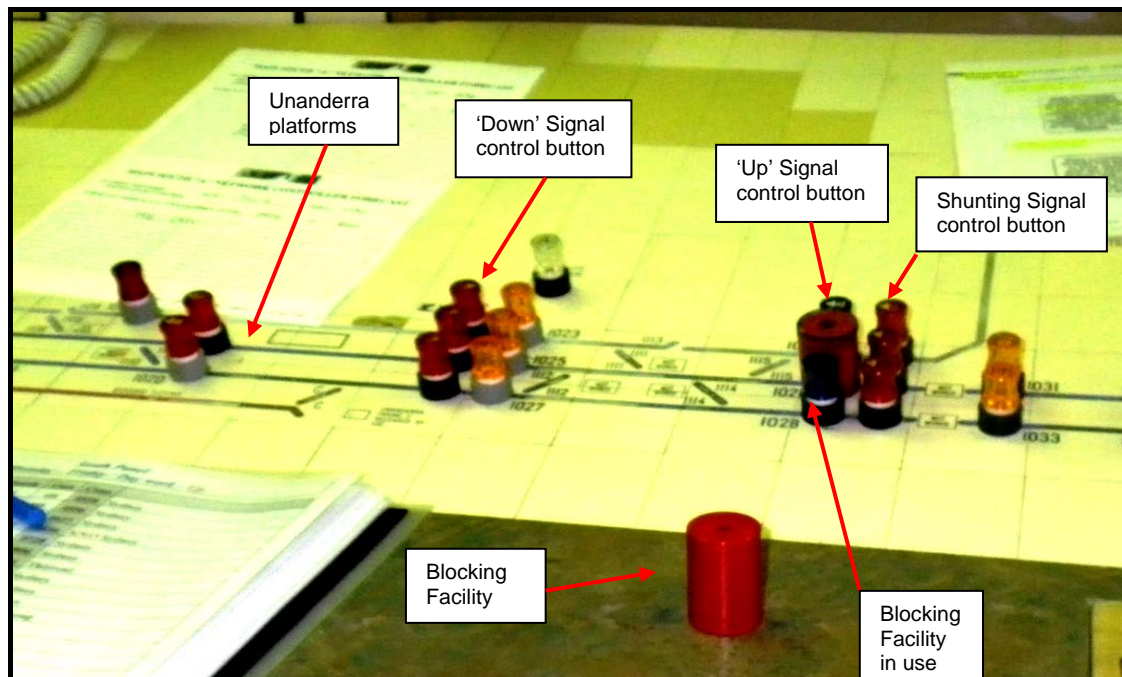
Photograph 4: Unanderra signalling panel

The system used is 'route set relay interlocking', the equipment having been installed in the early 1980s. Routes are set by pressing the relevant signal control button on the desired route followed by its 'finish' button. The finish button is generally the next signal button in the same direction. Any sets of points on the route will automatically move to facilitate the required route and before the protecting signals clear.

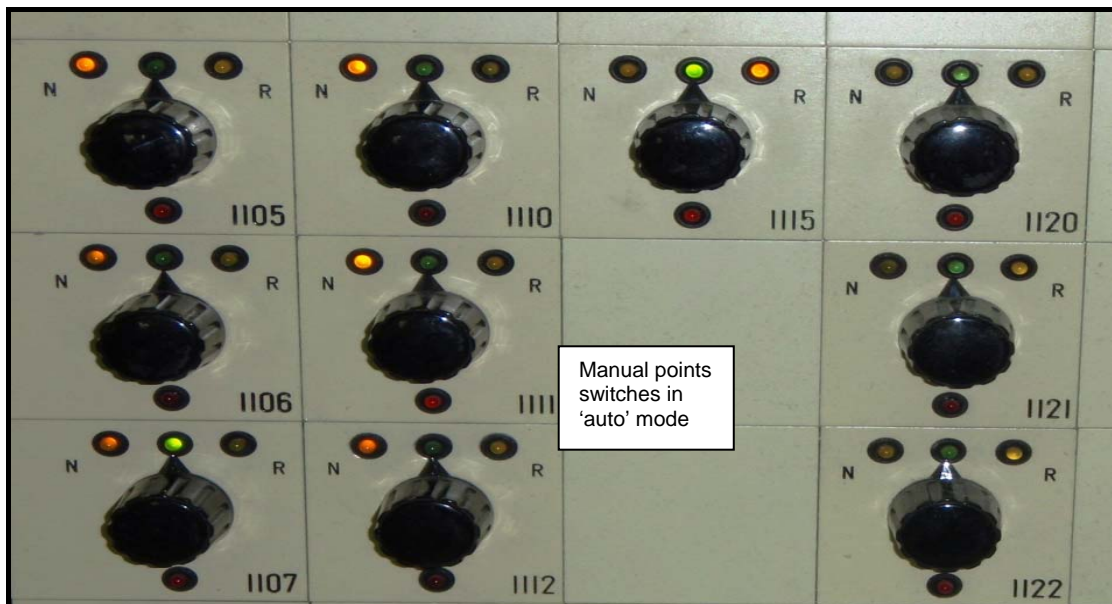
Photograph 5: Manual points switches

- 1.52 If a signal or finish button must not be operated (e.g., if a signal is being kept at 'Stop' to protect a worksite) then a blocking facility, a red 'thimble', is placed over the button (see *Photograph 4*). Points can also be set manually or locked in one position by using the toggle switches provided (see *Photograph 5*). If the toggle is turned to the left or right the points will move to and lock in 'Normal' (N) or 'Reverse' (R) as indicated. While the system does record the movement of points and the state of signals (i.e., at 'Stop' or showing a proceed indication), it cannot record the placing of a 'thimble' nor does it record the manual locking of a set of points.

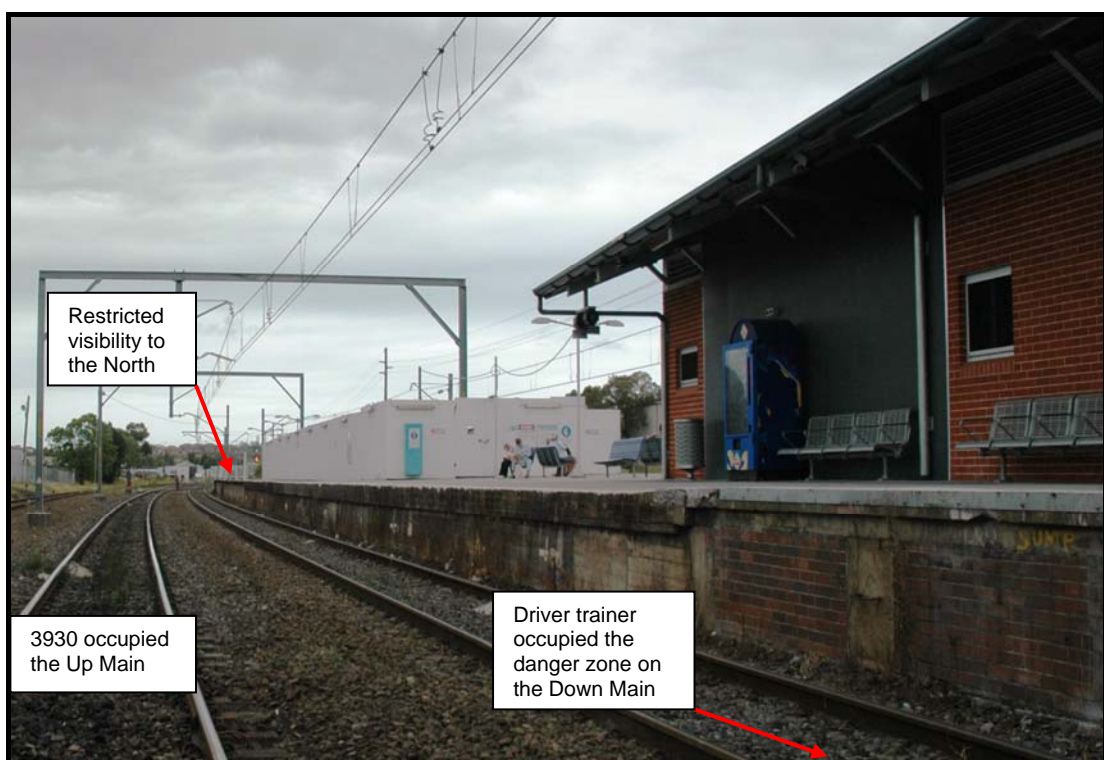
Photograph 6: View looking North from incident site

- 2.4 For this location the driver trainer assessed that ‘Lookout Working’ was not suitable to access the danger zone. This was because, in a Northerly direction from the Down Illawarra Main line, visibility was restricted by an eastward curve in the line and obscured by structures on the station platform (see *Photograph 6*). Additionally, a suitable safe place was not readily available. At interview the driver trainer noted that he “*would not have left the cab without CSB*”.
