RAIL SAFETY INVESTIGATION REPORT

DERAILMENT OF EL ZORRO GRAIN SERVICE 5CM7

RENNIE

3 JANUARY 2013

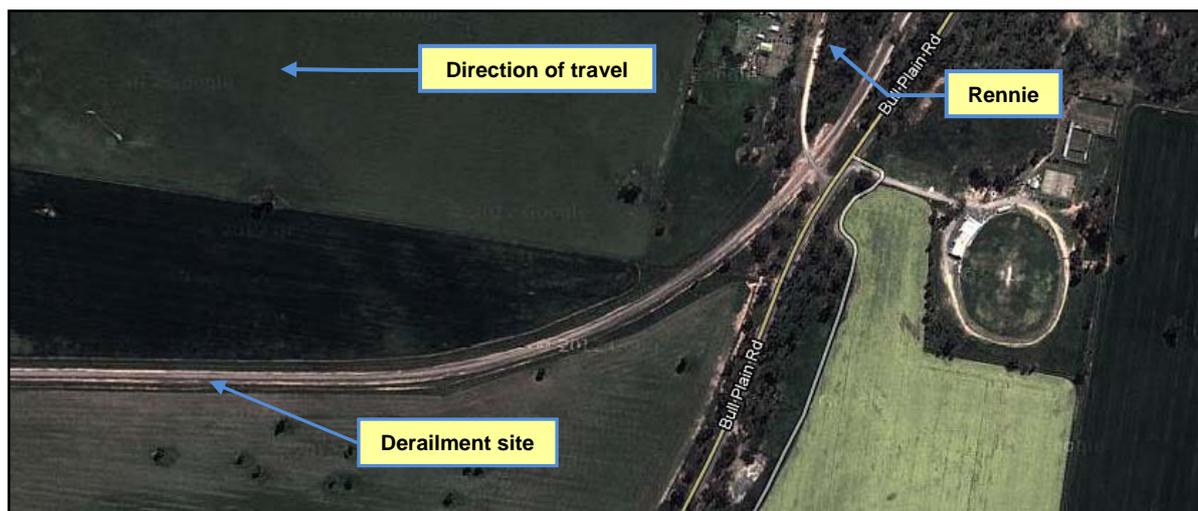
1.2 The derailment occurred on the outskirts of Rennie, a small township in the lower south west region of NSW on the single line section between Oaklands and Benalla. The train was in the process of exiting an 805 metre radius right-hand curve when the derailment occurred (see *Figure 2*).

Figure 2: Derailment site

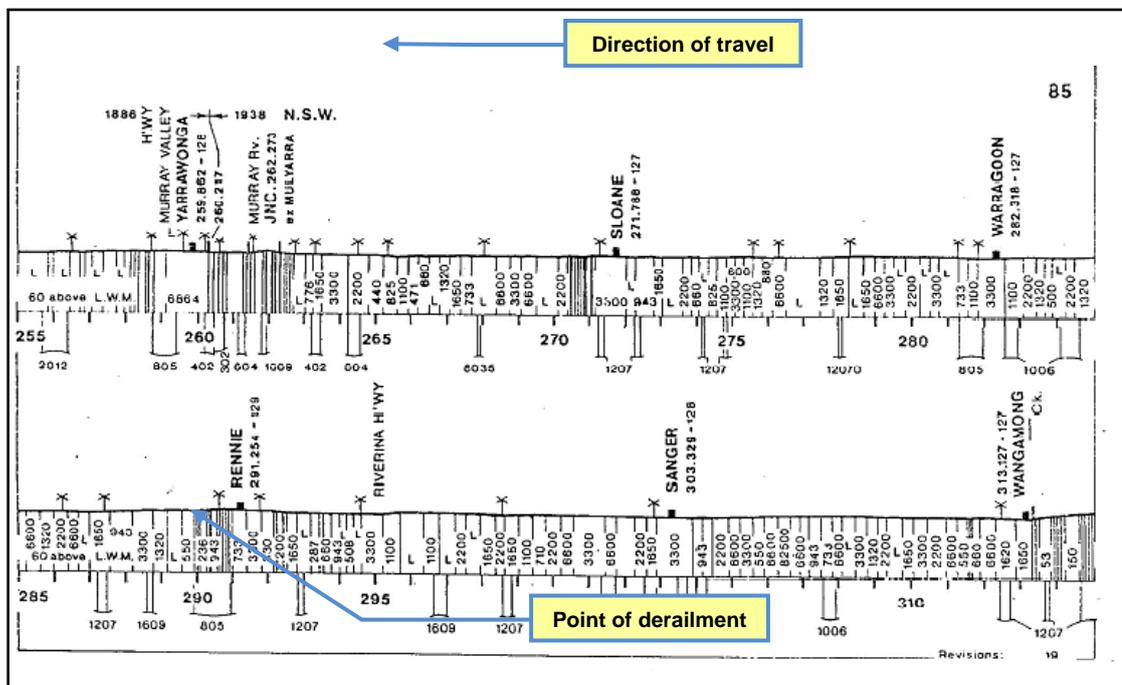
Figure 3: Curve and gradient diagram

- 1.9 The section of track was managed as a Class 4 track (as defined in the Victorian Civil Engineering Circulars (CECs) up until January 2012. From this point the track was classified under the National Code of Practice (NCoP) as a Light Weight Line. The line consisted of staggered, jointed and bolted 40 to 43 kg/m rail with some 47 kg/m rail. The rail was fastened to timber sleepers using dog spikes and base plates, and anchored at intervals using 'fair' type anchors. The track is comparatively flat with a gradient of 1:550 in the vicinity of the derailment (see *Figure 3*). Train working for the section is managed by 'staff only' working.² The posted track speed at the point of derailment was 50 km/h.

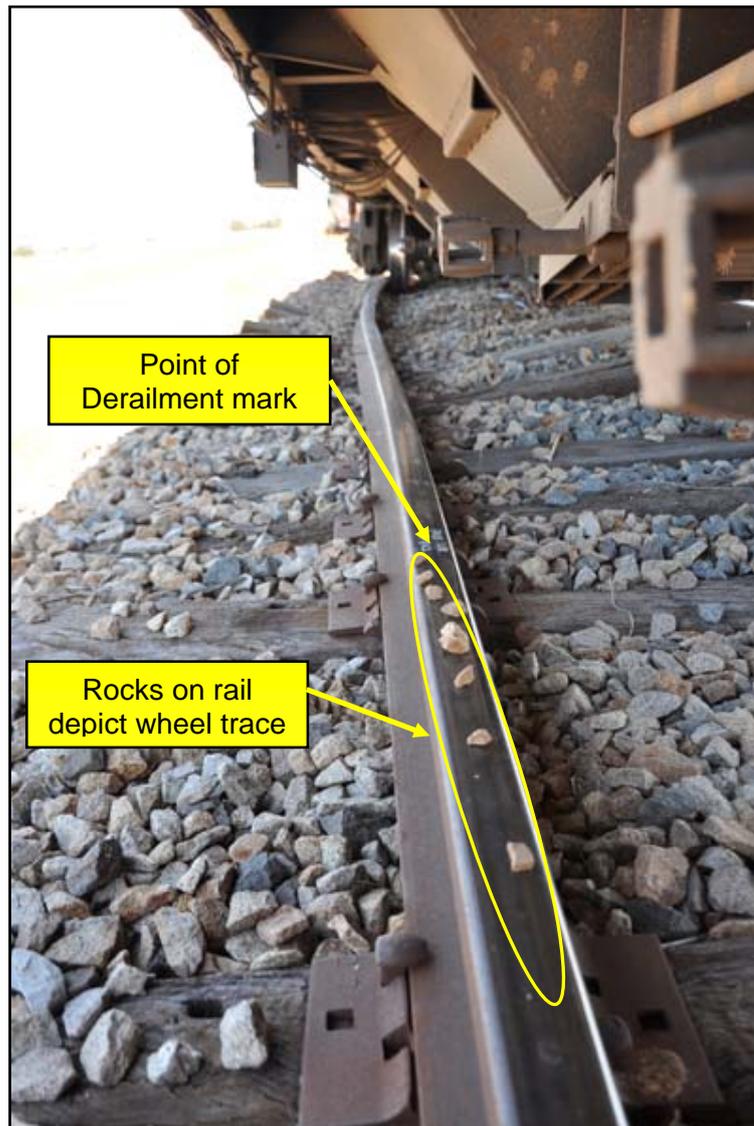
- 2.4 Examination of marks on the Up rail³ identified the point of mount (POM) at km 289.850 and point of derailment (POD) at km 289.852 (see *Photograph 1*). Such a relatively short distance between the POM and the POD is consistent with a derailment due to buckled track. Corresponding marks were also identified on the Down rail where the wheels dropped off the rail.

Photograph 1: Point of derailment marks on the Up rail

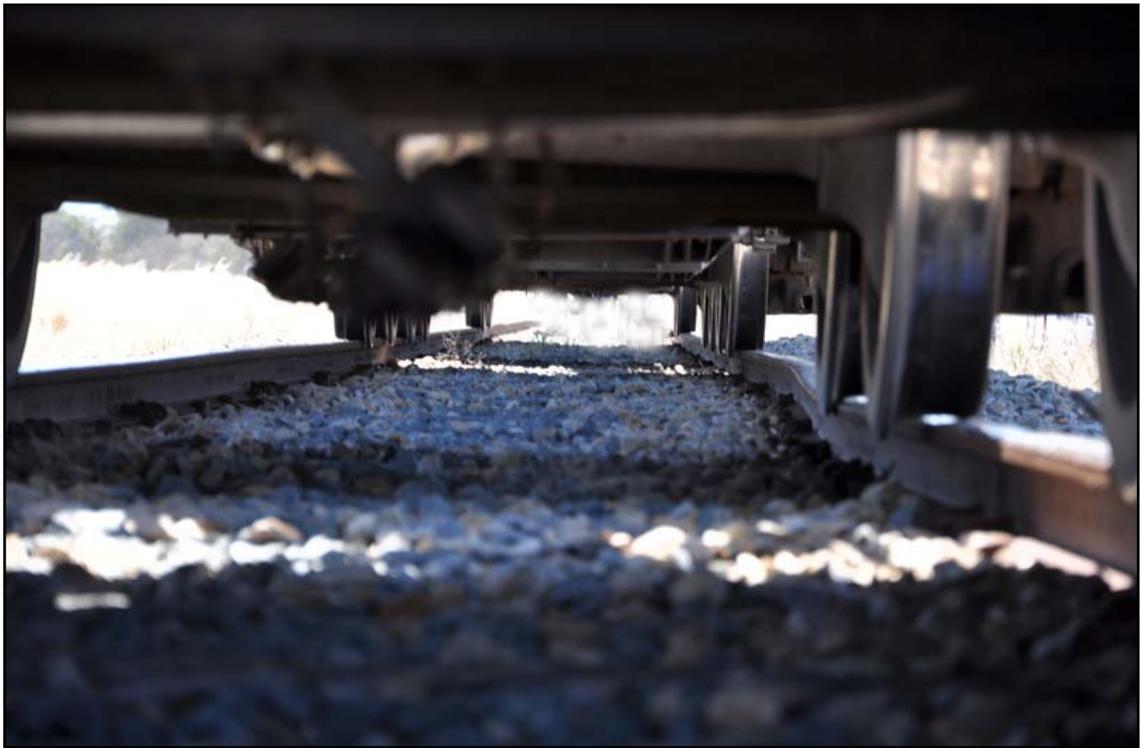
- 2.5 Post-derailment, investigators observed a buckle under the 39th wagon approximately 10 metres prior to the POM (see *Photograph 2*). At the apex of the buckle the track had displaced 70 mm towards the Up (eastern) side. The radius of the curvature was estimated to be between 100 and 150 metres. (The design speed for such a radius would generally be less than 15 km/h).
- 2.6 Due to the severity of the curvature it is likely that the loaded grain wagon WGBY 1083 lurched violently and at km 289.850 the wheels of the wagon's rear bogie mounted the Up rail. It travelled for approximately two metres before the wheel set dropped off and derailed. The resulting damage to infrastructure caused the next trailing nine wagons to also derail.

Photograph 2: Buckle visible under the 39th wagon

In the absence of evidence of other contributory factors, it is concluded that the combination of the listed track conditions was the primary cause of a buckle which lead to the derailment.

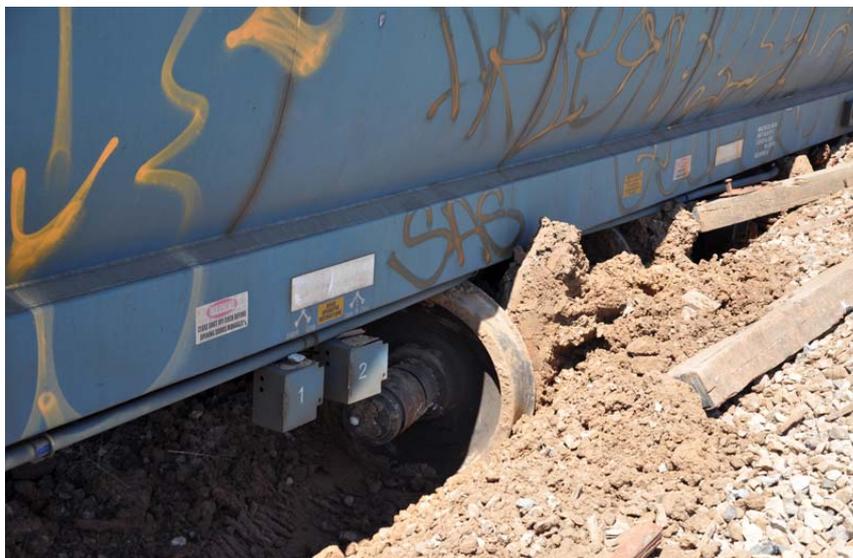
- 2.7 Because it was travelling at a low speed, the train stopped in a relatively short distance under the automatic application of the train's brake. Contributing to the short braking distance was the effect of wheels acting as ploughs when some derailed bogies twisted at 90° to the track (see *Photograph 3*).

Photograph 3: Wheel from the 36th wagon acting as a plough

- 2.25 The track formation was composed primarily of a mixture of clay and sand (see *Photograph 3*). The ballast on the formation was fouled in places and its depth was found to be around 180 mm at best. Ballast shoulder widths were inconsistent and below standard in some place.
