FERRY SAFETY INVESTIGATION

SYSTEMIC INVESTIGATION INTO PUBLIC PASSENGER FERRY SERVICES OPERATED BY CAPTAIN COOK CRUISES WITHIN SYDNEY HARBOUR

SYSTEMIC INVESTIGATION INTO THE PUBLIC PASSENGER
FERRY OPERATIONS OF CAPTAIN COOK CRUISES WITHIN
SYDNEY HARBOUR

Investigation Reference: 04493

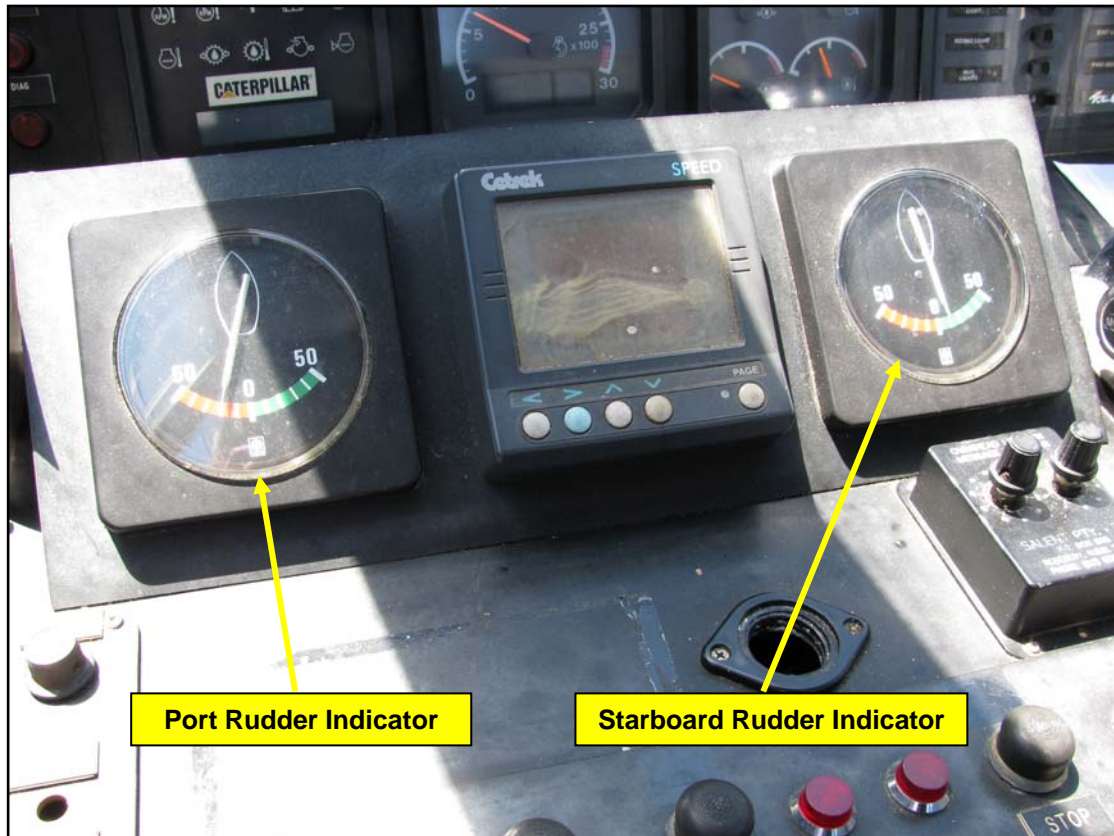
Photograph 1: *Jillian* Rudder Misalignment

- the rudders were 30 degrees out of alignment (see *Photograph 1*);
- the bilge alarm had been reported out of operation by all Masters since 15 November 2010 (resulting in the need for the GPH to visually check the engine room bilge every 30 minutes and engage the pump);
- the VHF radio needed to be replaced;
- washboards required for the Survey Class 1D could not be located;
and
- a number of trip hazard and signage matters needed attention.

1.67 The inspection of the *Jillian* on 29 March 2011 noted action had been taken on all these matters with the exception of the trip hazards and signage matters. A number of issues had been brought to the attention of management in November and December 2010, particularly those concerning trip hazards and signage.

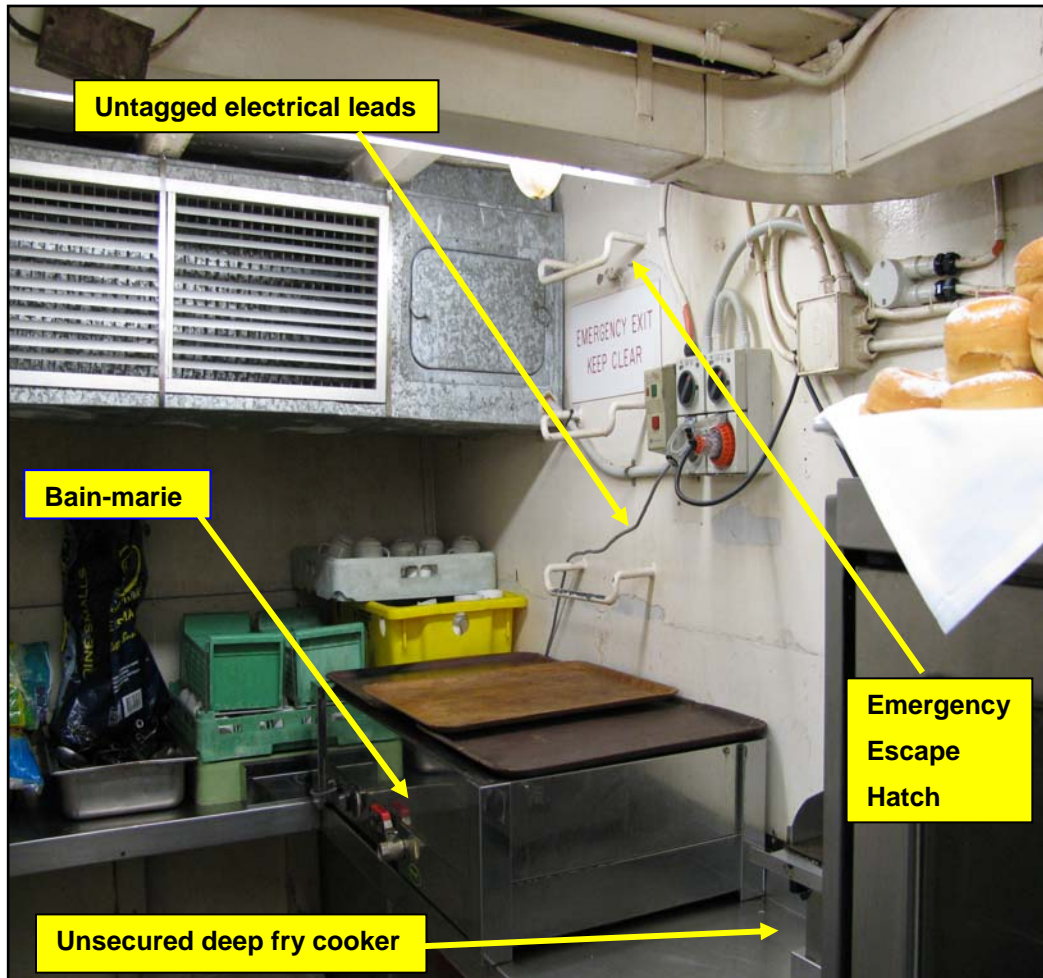
Photograph 2: Galley area of *Captain Cook II*

- 1.73 In the galley, the interior emergency escape hatch into the main saloon deck had no signage indicating its purpose or warning to keep the area clear of obstructions (see *Photograph 2*). Further, access to the hatch was obstructed by a bench on which there was a bain-marie. A deep fry electrical cooker was sitting unsecured on another bench.

- installation of emergency exit signs;
- unblocking of the emergency escape hatch from the galley where the position of a bain-marie made emergency escape impossible;
- securing of deep fryers;
- inspection and tagging of electrical appliance cords;
- signage identifying trip hazards on the aft stairway to the upper deck; and
- signage identifying the location of the emergency escape hatch in the engine room.
