**Office of Transport Safety Investigations**

## **BUS SAFETY INVESTIGATION REPORT**

**FIRE INVOLVING STA BUS MO4878**

**29 JULY 2011**

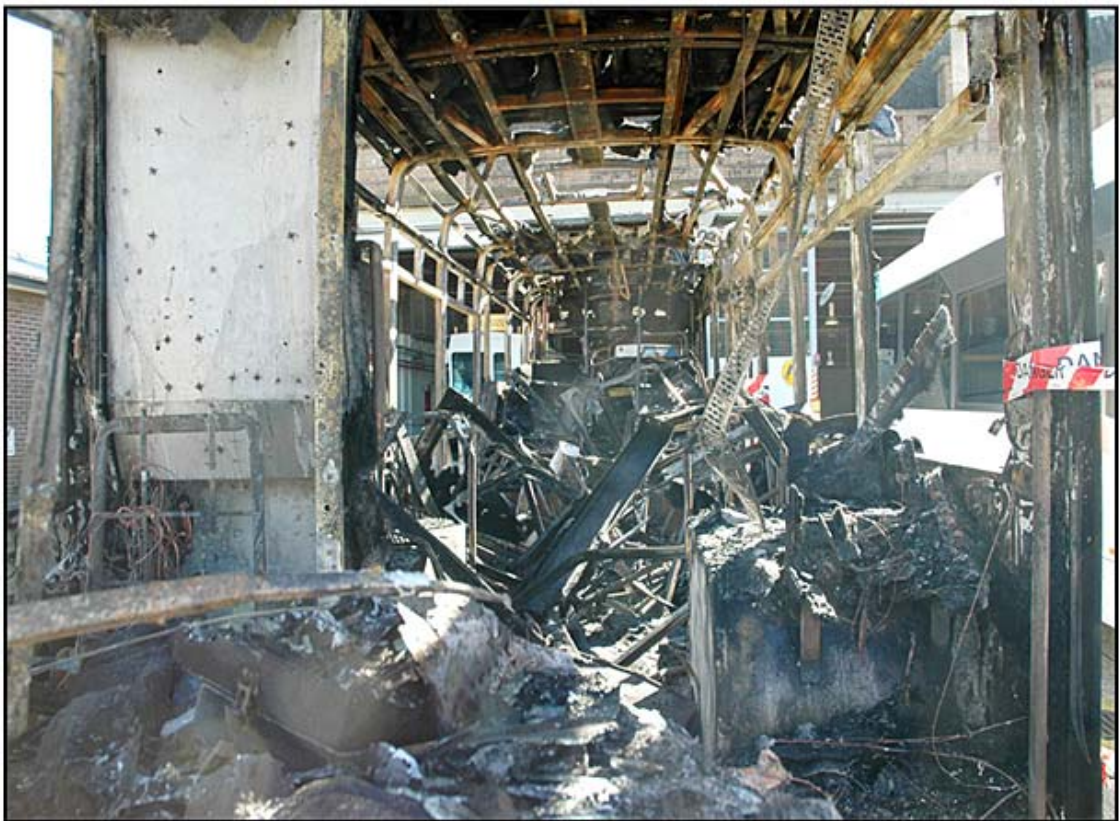
Photograph 1: Bus interior

- 1.1 At about 7.38pm<sup>2</sup> on Friday 29 July 2011, a State Transit Authority (STA) bus (MO4878) caught fire on Beachamps Road at Hillsdale when returning empty to the Port Botany STA Depot. Despite attempts by the driver and Fire and Rescue NSW units, the bus was destroyed (see *Photograph 1*).

1.19 The roof, windows, all interior fit-out and most of the side panels were destroyed by the fire. The stainless steel welded frame remained substantially intact but the sections supporting the roof in the middle of the bus were severely distorted. The flooring and inspection hatches at and towards the rear of the bus sustained significant fire damage but the tyres, wheels and chassis remained intact. The air-conditioning unit housed in a fibreglass pod and mounted on the roof at the rear of the bus was destroyed. The driver's console, including steering wheel and dashboard, and the driver's separation shield were all destroyed as was all internal electrical wiring, the CCTV cameras and the PTIPS unit.

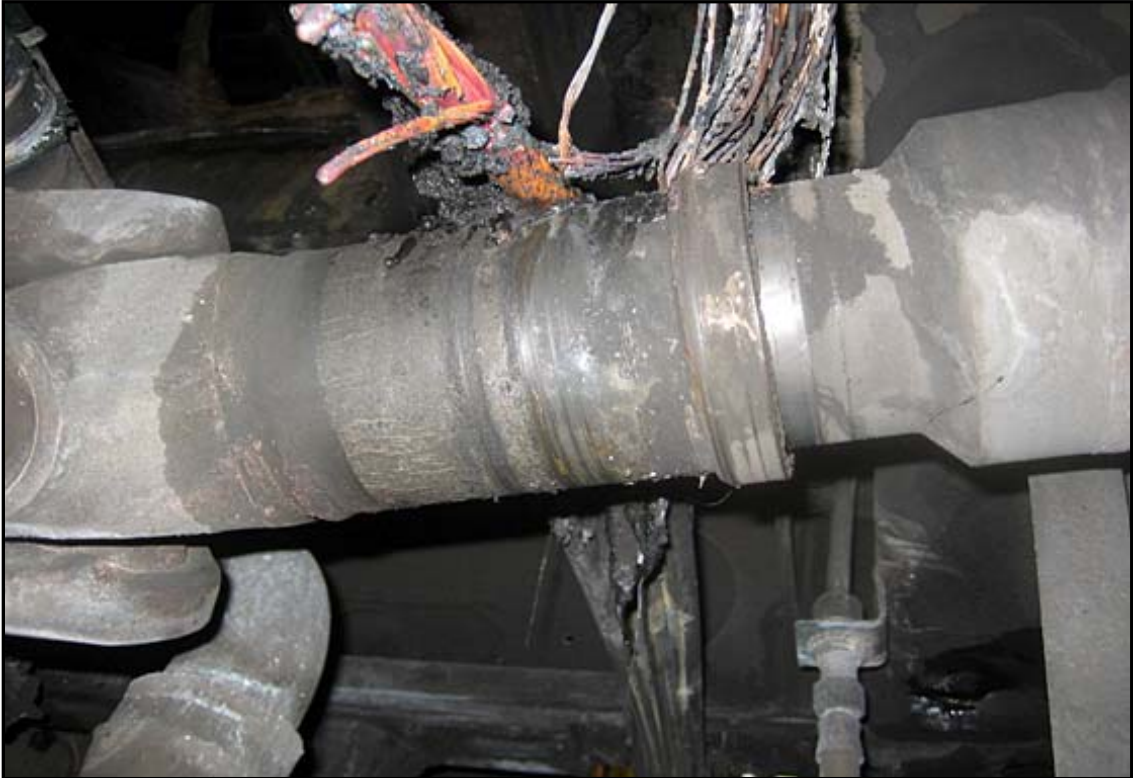
**Photograph 2: Electrical loom on tail shaft**

- 2.7 The main electrical loom from the batteries was burnt through with the remnants resting on the drive shaft (see *Photograph 2*). However, there were no markings on the drive shaft to indicate this cabling had come into contact with the shaft while the bus was moving. It was concluded, therefore, that the fire melted the plastic cable ties holding the wiring harness clear of the engine thereby allowing the harness to fall onto the drive shaft. Examination of several other undamaged buses of the same model and age showed the wiring harness was firmly secured and well clear of the drive shaft.

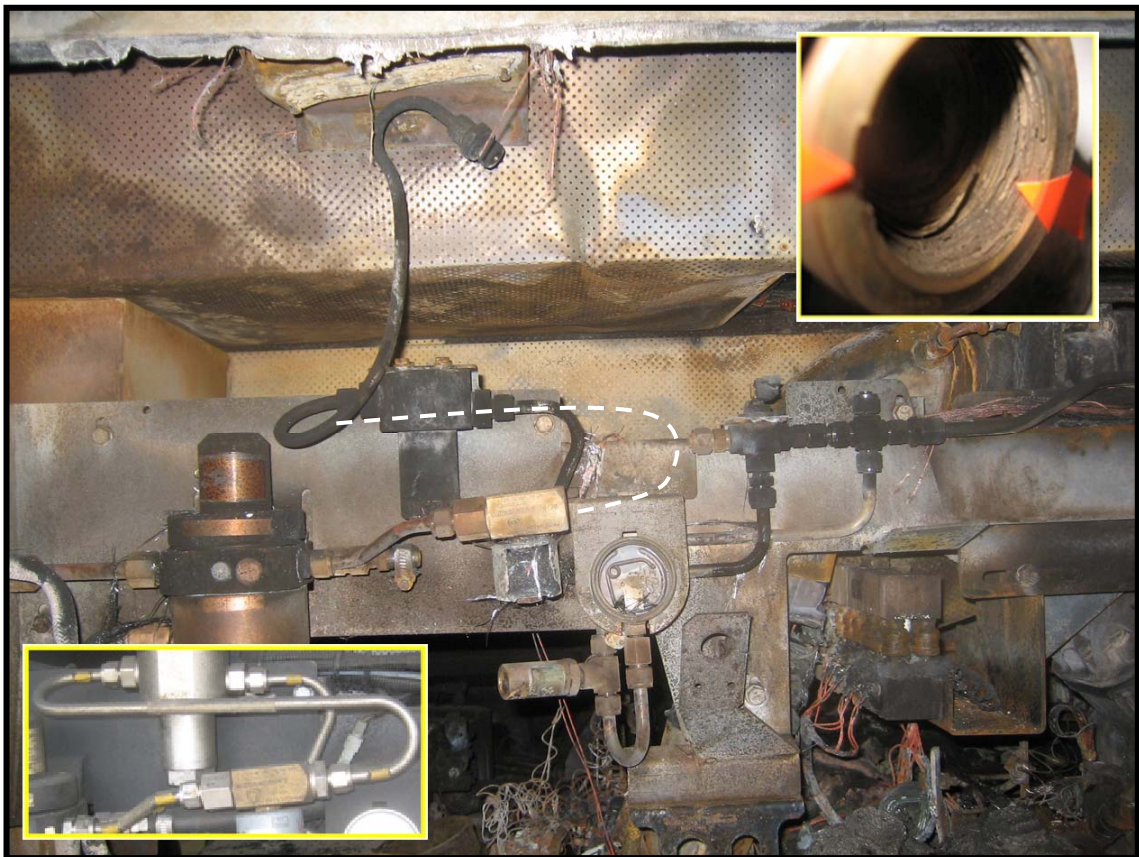
**Photograph 3: Ruptured CNG line-compared with an undamaged line**

- 2.13 Examination of the bus found that the CNG fuel line was intact between the supply cylinders and the engine high pressure solenoid valve where a male threaded fitting manufactured from stainless steel had been torn out of a brass female fitting, stripping the internal brass thread. This component failure can be attributed to the combined effect of pressure in the gas supply line and heat from the fire, given that brass has a higher coefficient of thermal expansion than stainless steel.<sup>10</sup> The fuel line, with the stainless steel fitting attached, was bent well away from the brass fitting indicating that the line had been under considerable pressure when the fitting failed (see *Photograph 3*).

- 2.14 When the fitting failed, CNG vented through the ruptured line and was ignited by the fire. This caused a jet of flame to shoot out from the bus and partially across the roadway. The event was captured on the video recorded by the driver on his mobile phone and similarly by nearby witnesses who subsequently posted their video footage on YouTube. All videos show the back of the bus alight along with the interior and engine bay before the gas ignited.

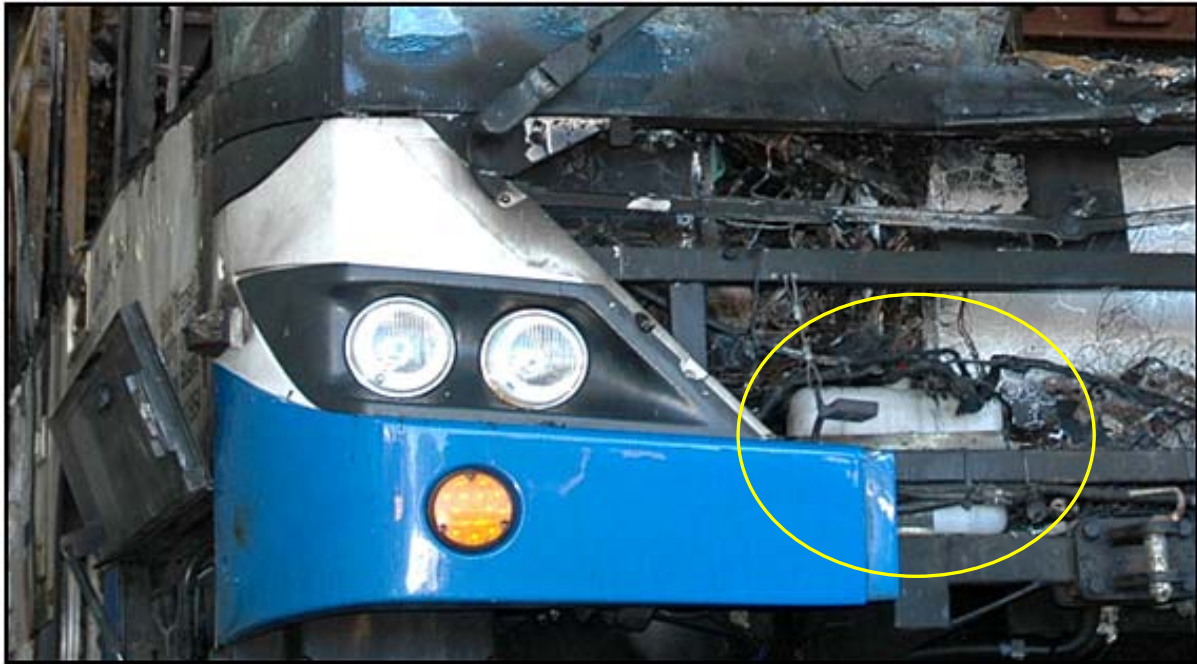
**Photograph 4: Windscreen washer bottle**

- 2.25 Examination of the interior section of the heat exchanger on the offside of the bus showed a clear line where the lower section had not melted, indicating that the coolant in the lower section had prevented it from melting. The coolant header tank mounted at the rear of the bus had completely melted indicating that the reservoir was empty prior to the fire. In contrast, the plastic windscreen washer bottle located in the front of the bus remained intact and was full of water, although all other components around it had been destroyed (see *Photograph 4*). The conditions as described are indicative of the possible loss of coolant in the heat exchanger and coolant reservoir before the fire commenced. A significant loss of coolant would result in a substantial rise in the operating temperature of the engine.

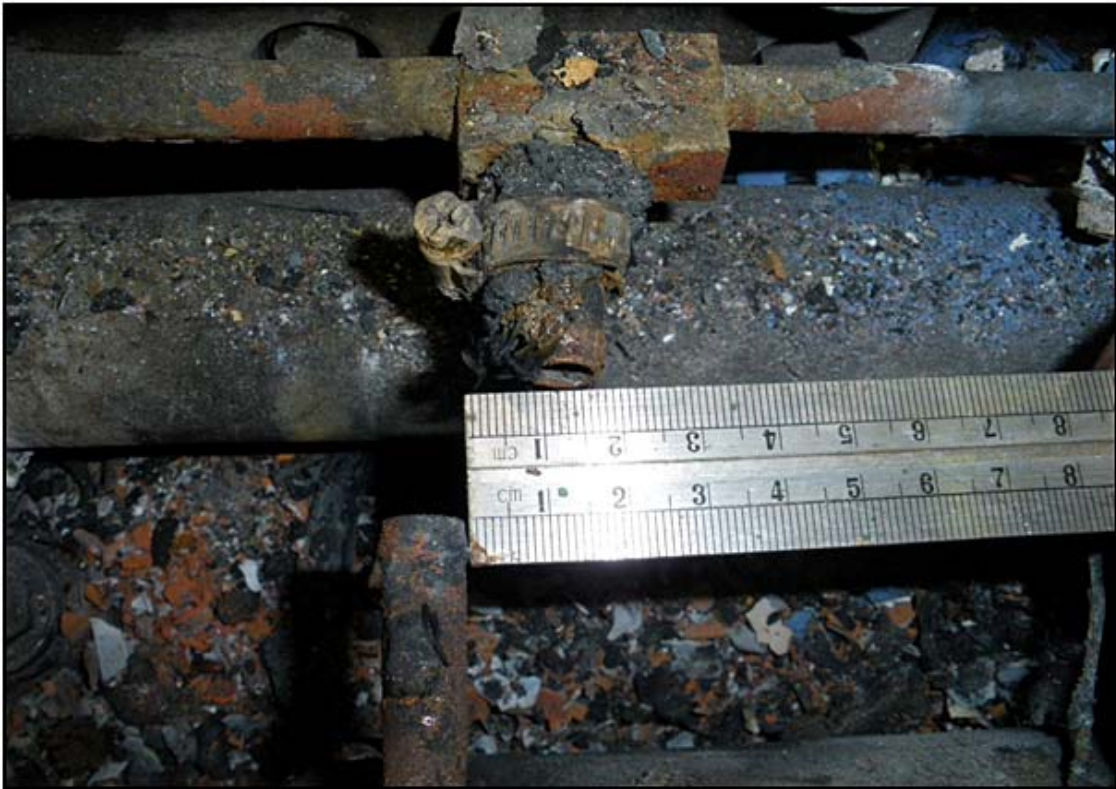
**Photograph 5: Coolant return hose fitting misalignment**

- 2.26 With the engine removed from the bus, a more detailed inspection was made to determine the cause of the fire. Examination of the coolant system showed the flexible rubber connection between the coolant return line from the turbocharger and a 'T' fitting was destroyed by the fire (see *Photograph 5*). The steel piping from the turbocharger was 18mm out of alignment with the 'T' fitting to which it was connected. This misalignment would have placed additional stress on the rubber hose, exacerbated by engine vibration. The coolant return line was supposed to have been replaced on 14 December 2010 but was not (see *Servicing and Maintenance*).

- 2.39 The turbocharger coolant return line connecting hose and connecting reduction hose on the main coolant line were located in the area immediately below the hatch. If a coolant leak were to occur in this area, the fluid could pool on top of the engine block as was the case with the bus that suffered a split connecting hose on 11 August 2011.

- the replacement of the return coolant line and connecting hose fitting on all their Mercedes Benz OC500 LE CNG model buses;
- the calling of tenders for the retrofitting of fire suppression systems on all their Mercedes Benz OC500 LE CNG model buses; and

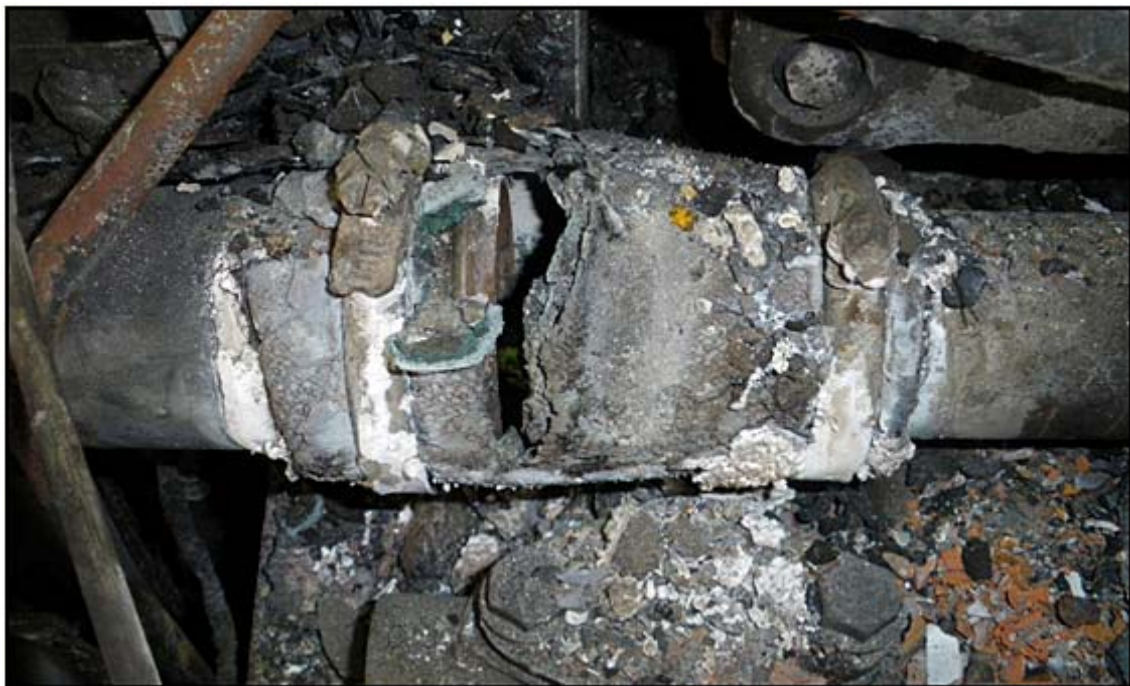
**Photograph 6: Main coolant line reduction hose**

- 2.27 There was also a split and fire damage to the flexible rubber reduction fitting on the main coolant supply pipe running along the top of the engine block, near the engine compressor (see *Photograph 6*). The main coolant reduction hose had also been severely damaged by fire on the top surface. It could not be determined if coolant leaking from the split in this hose was the cause of the fire or was a consequence of the fire.

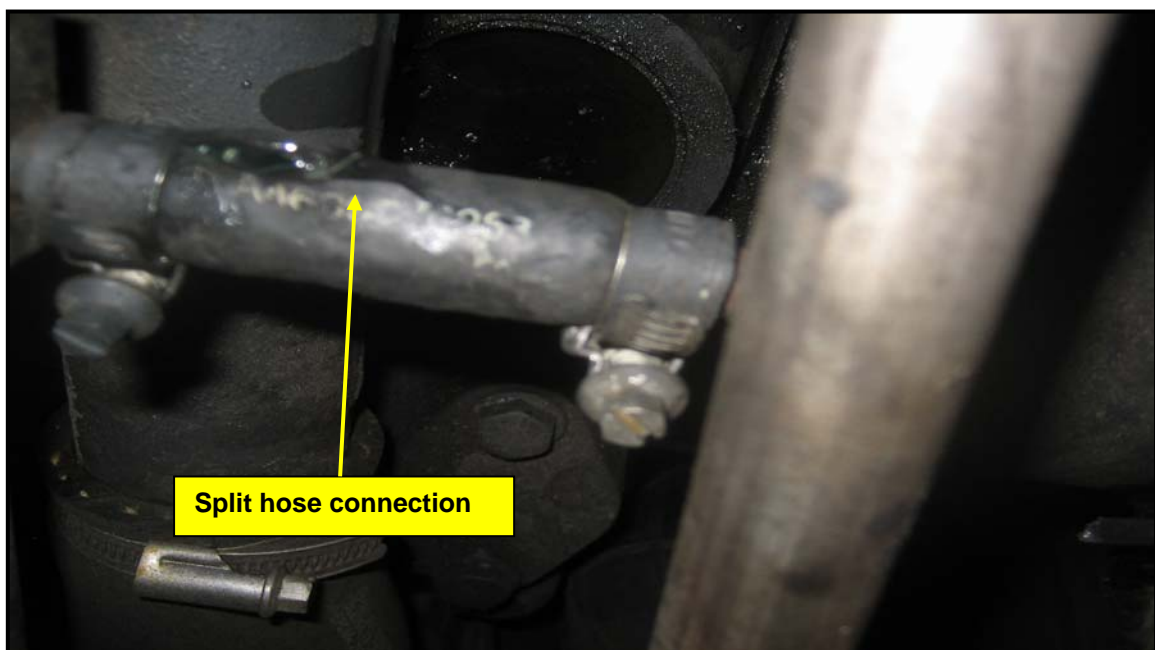
**Photograph 7: Split coolant return rubber connection**

2.28 On 11 August 2011, the flexible rubber connection between the coolant return line from the turbocharger and a 'T' fitting was found to have split on another OC500 LE CNG bus. This split in the hose resulted in a considerable amount of coolant being sprayed onto the engine (see *Photograph 7*). On this occasion the driver received a low coolant alarm and responded immediately by turning off the engine's ignition. He reported observing a large amount of steam emanating from the top of the engine. It is believed this steam was caused by the water content in the coolant boiling off on coming into contact with the hot surface of the engine.

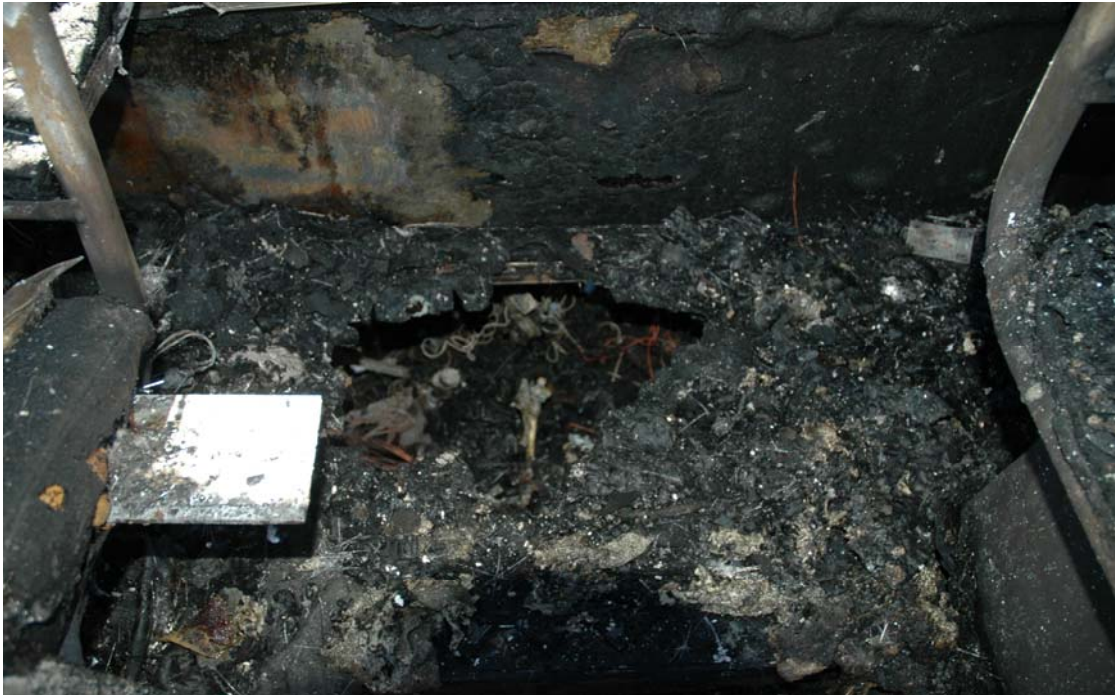
**Photograph 8: Rear floor hatches**

- 2.41 Analysis of the fire pattern on the underneath of the floor of the bus and on the engine indicated that the fire initially entered the inside of the bus through the small rearmost floor hatch which had completely burnt through (see *Photograph 8*). The second last floor hatch had also been severely damaged by fire although not burnt through completely. The hatch under the rear passenger bench seat was also severely damaged although there was a section of stainless steel shielding under the hatch.

- 2.42 As evidenced by the fire pattern radiating from the small hatch, the fire spread into the interior of the bus around the hatch then along both sides of the rear passenger seat, to both sides of the bus and towards the roof. This is consistent with the video evidence, the driver's statement and there being comparatively limited damage to fibreglass side panelling.

2.43 The floor hatches were not protected with stainless steel shielding like the other areas of the engine bay except for the rear seat hatch which, despite having some shielding, was still severely damaged. Also, the floor hatches are made of much thinner plywood than the rest of the floor; 12mm compared to 16.2mm. These bus floor hatches provided the area of least resistance to the fire and allowed the flames into the interior of the bus.
