BUS SAFETY INVESTIGATION REPORT

**FATAL BUS ACCIDENT - JUBO TRAVEL
JAMBEROO MOUNTAIN ROAD**

5 SEPTEMBER 2005

OTSI File Ref: 04190

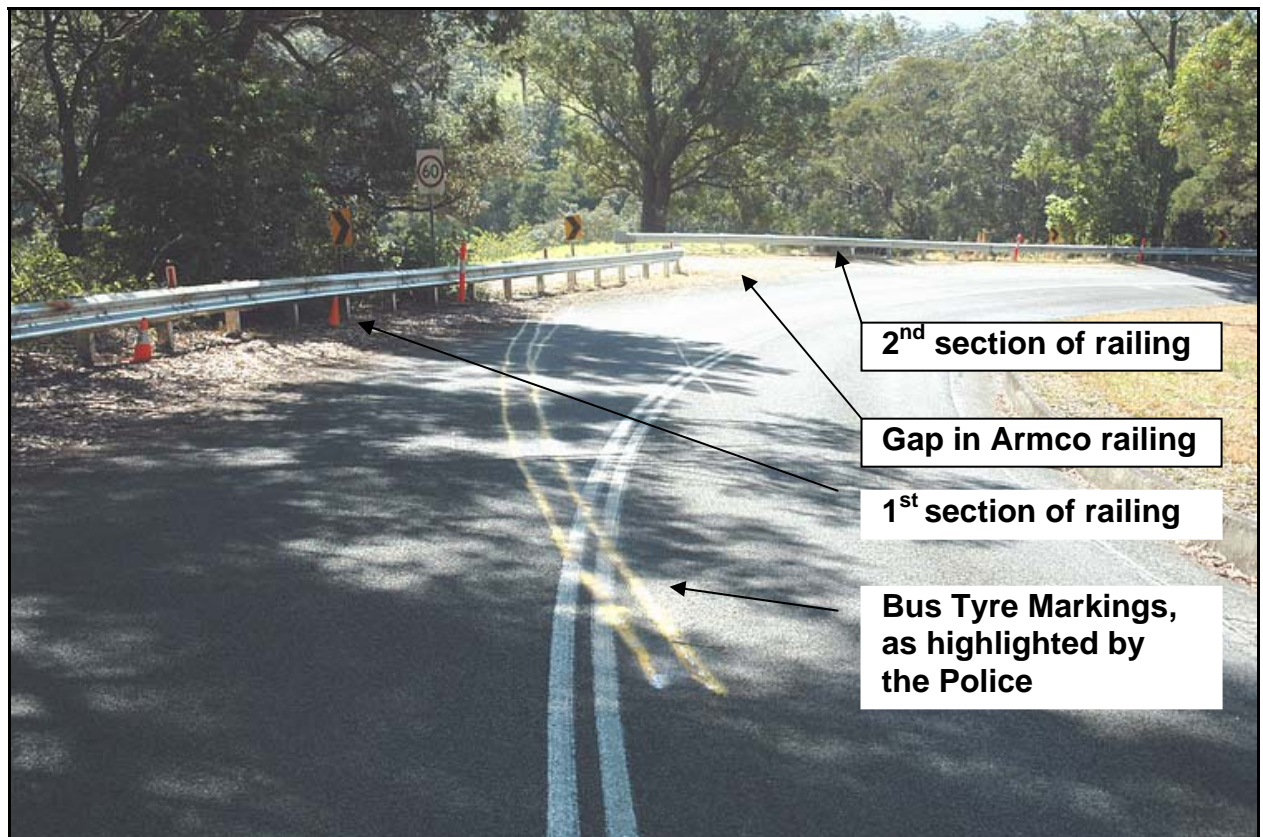
2.2 The Driver lost control of the bus as he approached a sharp right-hand bend at the end of a 7km section of steeply descending and winding road. The bus collided with a section of Armco guard railing and remained in contact with the railing for approximately 20m before rolling onto its left side and impacting with a second section of railing. It subsequently crushed the second portion of railing, slid over it and rolled onto its roof, coming to rest against a small tree. The immediate area of the accident is depicted in *Photograph 1*.

Photograph 1: Immediate area of the accident

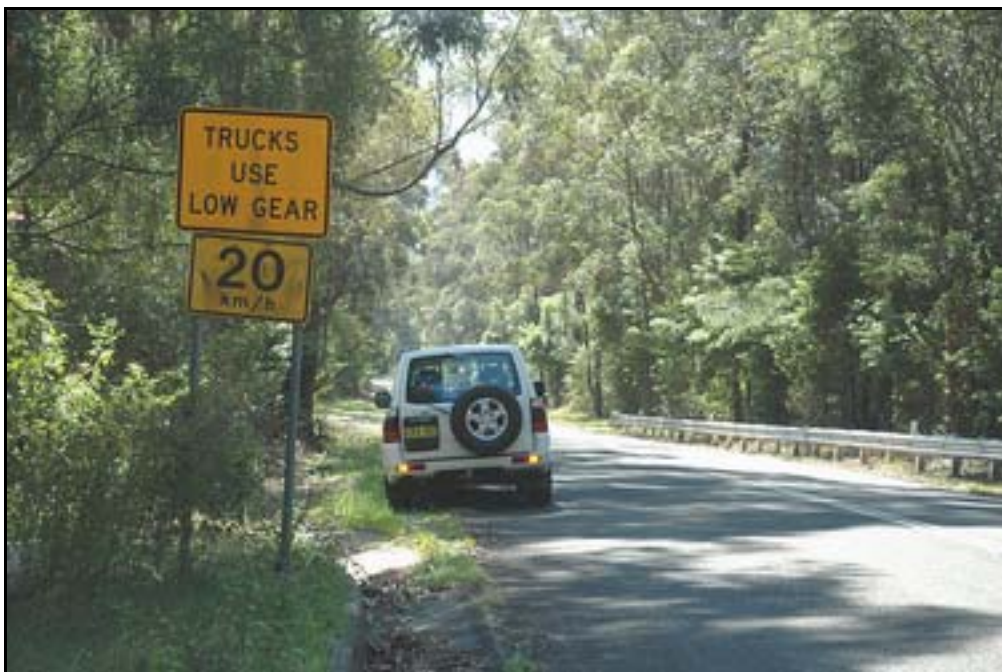
Photograph 5: Jamberoo Mountain Road location approximately 800m before the accident site.

3.4 Approximately 800m before the point of impact, there was a road sign advising "Trucks Use Low Gear", as previously indicated in *Photograph 5*. There were a number of other signs between this point and that of the accident indicating speed restrictions of 20km/h. Several days after the accident, OTSI observed buses and trucks travelling on this section and it was apparent from their engine noise that they were being driven in a low gear and with the benefit of exhaust brakes. However, as revealed by the tachograph, the bus was operated at speeds well in excess of 20km/h without the benefit of the exhaust brake and was found to be in 4th gear when examined immediately after the accident.

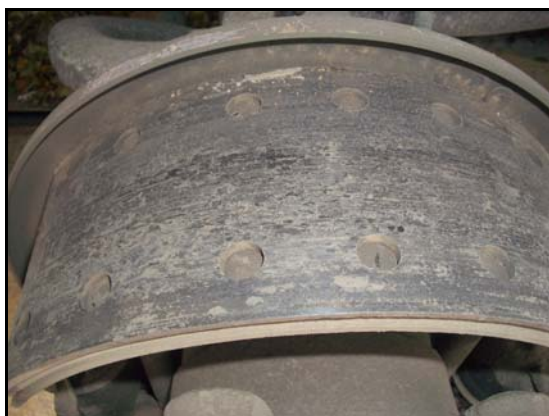
- 3.9 The operation of automotive brakes is dependent upon friction and the conversion of kinetic energy into heat energy in the process. Disc brakes, which are commonly fitted to modern passenger cars, dissipate generated heat efficiently; however, they require a high degree of force to operate. Drum brakes dissipate heat less efficiently but their stopping power and compact design make them more suitable for heavy vehicle applications. An examination of other elements of the bus's brake components established that that the brake linings were within the required specifications. However, there was evidence of discolouration of the outer brake drum and brake dust residue at the bottom of the drum as shown in *Photographs 6 and 7*.

Photograph 6: Glazed brake shoe

- 3.10 The discolouration is consistent with the brake operating at higher than normal temperatures, induced by frequent and rapid applications of the brake at speed. Furthermore, there was evidence of severe glazing on the transmission park brake hub, indicating that it had been used as a dynamic, rather than a static or 'park', brake.

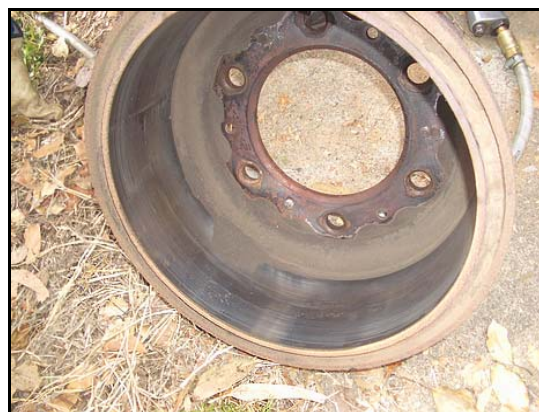
Photograph 7: Discoloured outer brake drum

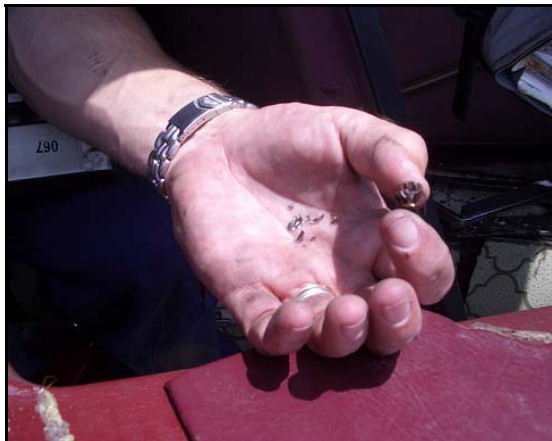
Photograph 8: Pieces of the broken light bulb.

- 3.16 During its examination of the bus, OTSI noted that the warning light and audible alarm on the dashboard, intended to alert a driver to low brake air pressure, was not functioning. *Photographs 8 and 9* depict what was revealed on closer inspection, that the light bulb for the

warning light was found to be inoperable and the circuit board within which it was located showed signs of discolouration and burnt circuitry.

- 3.17 Documentation revealed that this defect had been identified in Victoria by a coach repairer in 2004. Given that there was no record of the defect being rectified, OTSI could only conclude that this matter was not revealed during the certification and inspection processes that were required before the bus was first registered in NSW. This defect was not significant in the context of this accident as there was no indication that low brake pressure was at issue. However, the fact that Jubo Travel failed to detect this fault, or allowed the bus to operate with such an important safety device disabled, is indicative of poor defect identification.
- 3.18 Jubo Travel advised OTSI that following the accident, it suspended its use of the like bus and that when this bus's registration expired, it did not seek to re-register the bus.

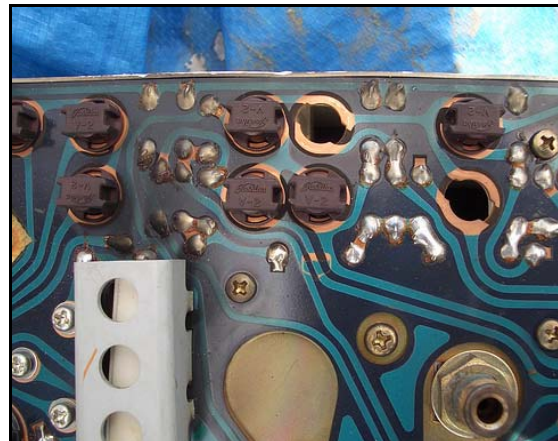
Photograph 9: Back of circuit board
