# **BUS SAFETY INVESTIGATION REPORT**

## **BUS WHEEL SEPARATION**

### **MEDOWIE**

**8 FEBRUARY 2010**

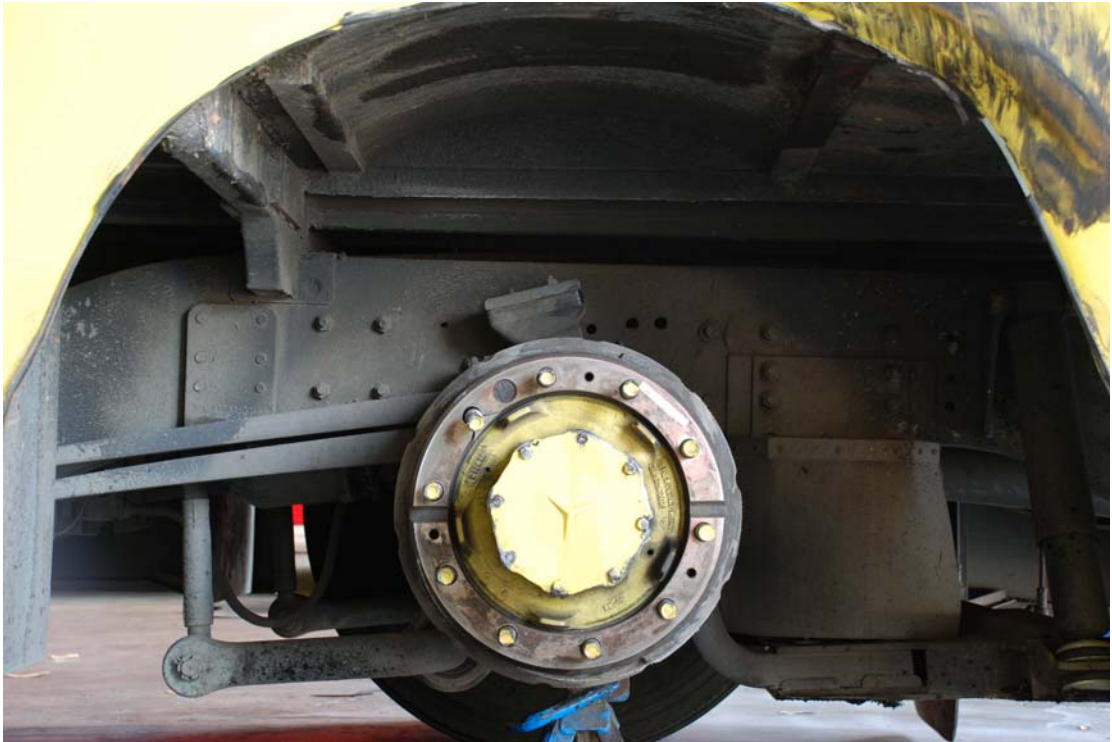
**Photograph 1: Nearside Rear Hub**

- 1.8 The bus was examined at the depot in an effort to determine how the wheels had come off. The evidence available included the bus, with the hub and all its studs attached, and the inner rear wheel which had been recovered after the incident. *Photograph 1* shows the hub involved.

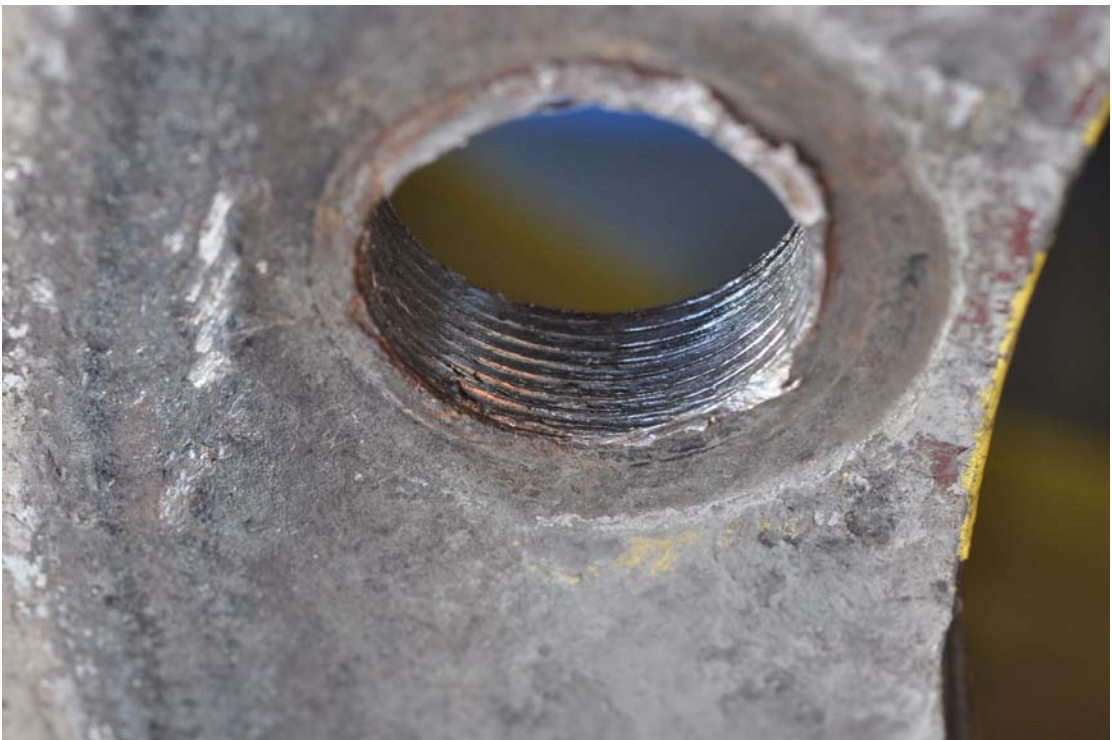
**Photograph 2: Damaged Inner Rim Stud Hole**

- 1.9 The inner rim showed evidence within the stud holes that most damage occurred to the rim during braking. *Photograph 2* is a close up of the marks left by one of the studs in the inner wheel.

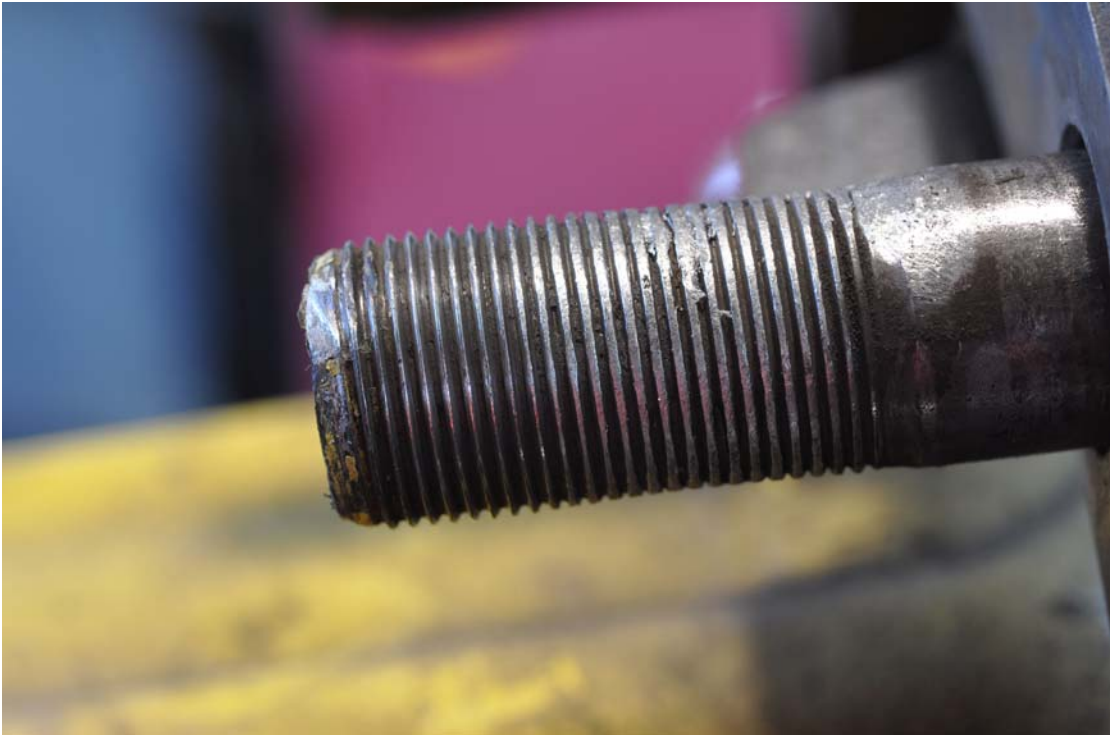
**Photograph 3: Example of Stud Damage**

- 1.10 Without the outer rear rim, it would have been impossible to determine how many nuts had been fitted to the wheel leading up to the separation. All studs displayed a generally clean thread surface, damaged only through contact with the loose rims (see *Photograph 3*). There was no evidence to show that nuts had been torn from studs. That being the case, sabotage through intentional removal or loosening of the wheel nuts could not be ruled out.

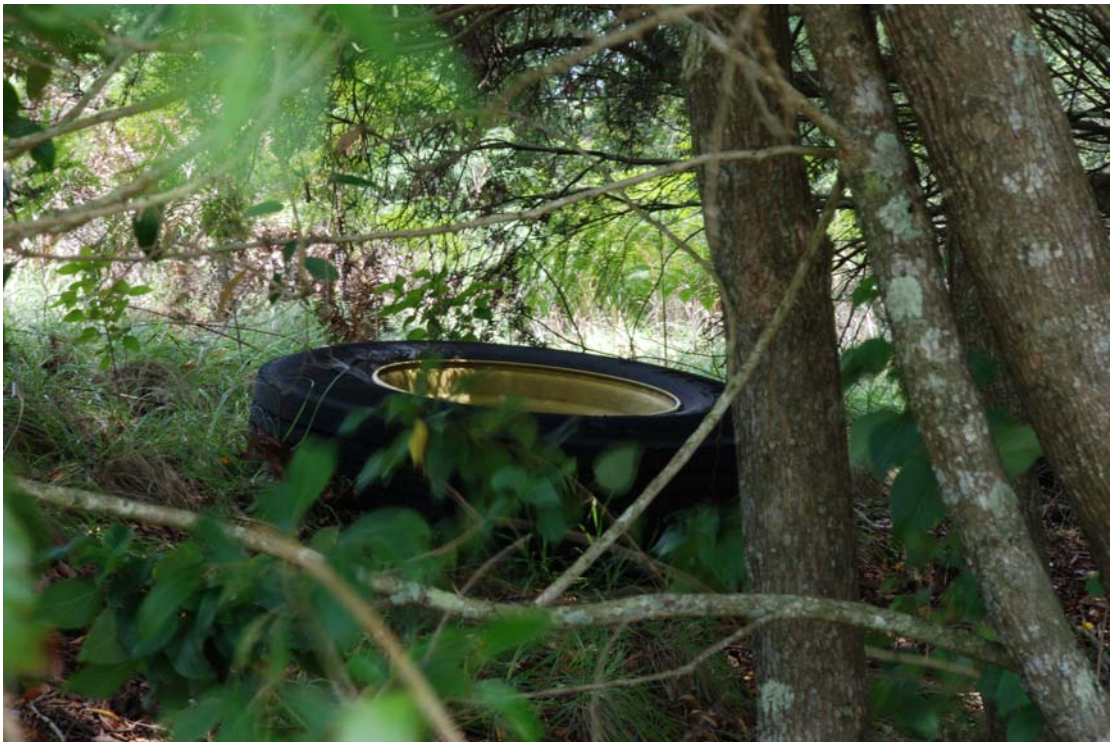
**Photograph 4: Outer Rear Wheel as Located**

- 1.13 Finding the outer rear wheel became crucial, as it would at least confirm the number of wheel nuts fitted because there would be evidence of the nuts fretting against the rim as they worked loose.
- 1.14 The route taken by the bus was retraced in an effort to locate any of the wheel nuts. No wheel nuts were located along the route or at the point where the wheels came off.
- 1.15 After a short search, the outer rear wheel was located lying under a tree (see *Photograph 4*) near the top of an embankment approximately 250 metres from where it came off the bus. The initial search had concentrated on an area closer to where the separation had occurred and it was only by chance that the wheel was spotted on the way to the search location.

- 1.16 The wheel was found lying at the base of a tree with its outside facing up. Initially it appeared that it must have been placed there by somebody, possibly in an effort to secrete it for later retrieval. There were no obvious tracks leading to its resting place and, complicating the find even more, was

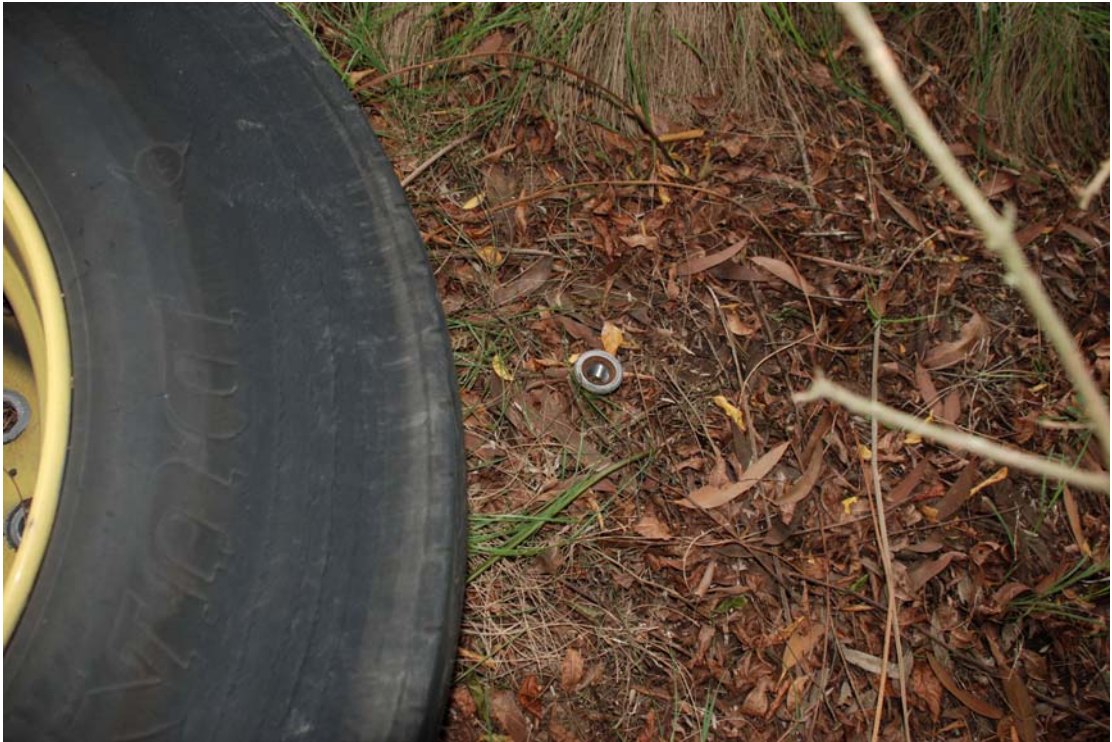
**Photograph 5: Wheel Nut Located Beside Wheel**

that fact that lying right next to the wheel was one of the wheel nuts (see *Photograph 5*). To have ended up where it was, the wheel had to have travelled from the bus, across the oncoming traffic lane, down the side of a slope, through a gully, up an embankment and rolled around the back of a tree.

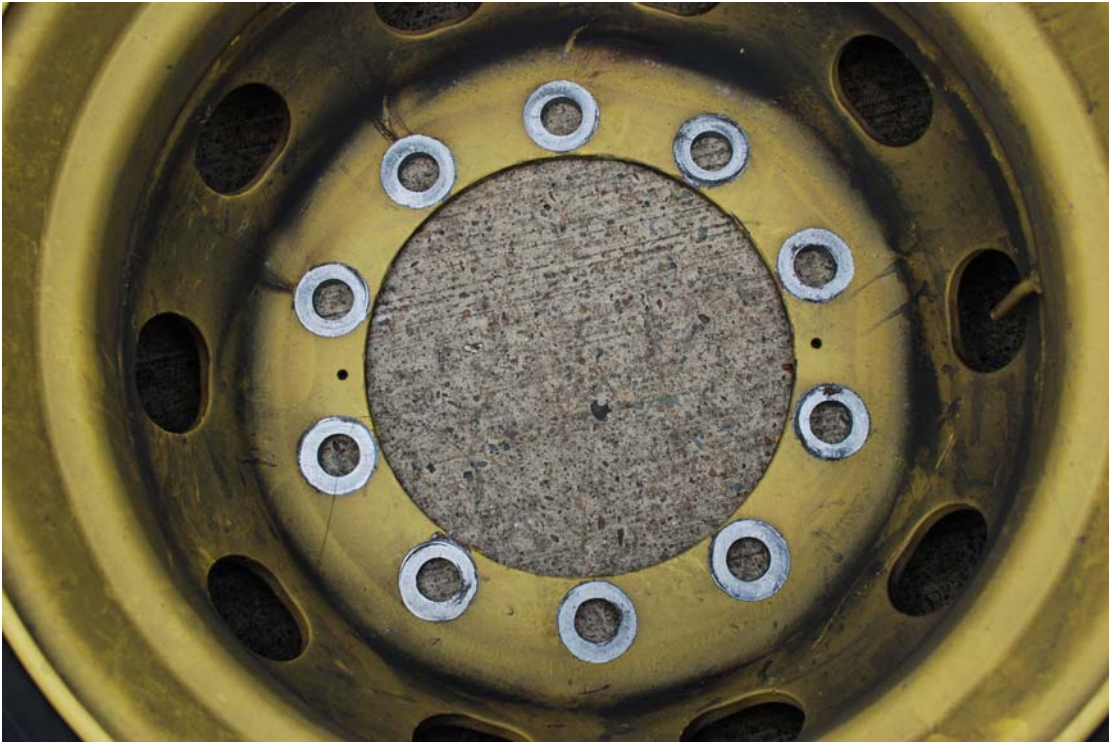
**Photograph 6: All Ten Nuts Marked Rim**

- 1.17 Vague impressions in the grass showed that a possible path of travel was to the top of the embankment, before hitting a post and wire fence and rolling back down to beneath the tree.
- 1.18 Investigators found a total of eight wheel nuts located within approximately two metres of where the wheel had come to rest. The two remaining nuts were not found and other search methods, such as using a metal detector, were not employed as the rim showed clear signs that ten nuts had been fitted to it (see *Photographs 6 and 7*). All stud holes showed bare metal and fretting where the nut flanges meet the rim.

- 1.19 Locating eight of the wheel nuts within close proximity to the outer rear wheel indicated they had all fallen off, rather than being ripped from the studs. This would indicate that all eight nuts must have come undone at approximately the same rate. Had that not been the case, some nuts would most likely have been torn from the studs during cornering, when the lateral loading on the rims was the highest.
- 1.20 The driver completed a pre-departure check of the bus as required during which he observed all wheel nuts fitted to the bus. Therefore, the nuts must have come undone over the short journey of approximately 25 kilometres.

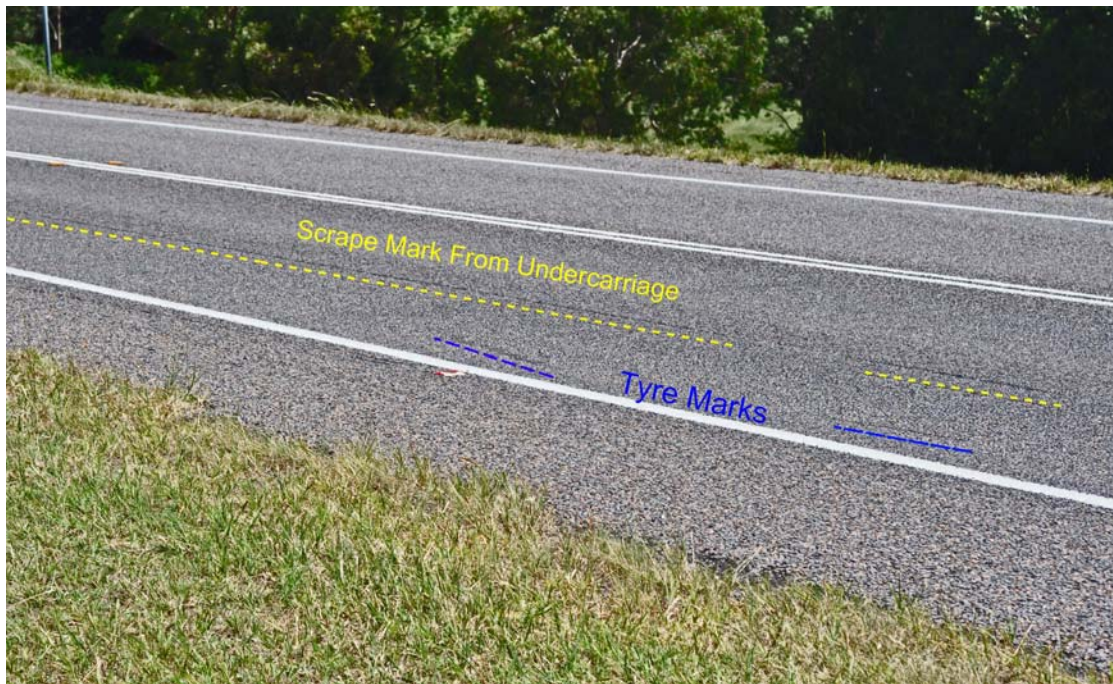
**Photograph 8: Scrape and Tyre Marks on Road**

- 1.23 The driver's actions in not using the brakes contributed to a controlled stop, with the scrape marks in the road depicting a course which confirmed the bus did not cross to the other side of the road (see *Photograph 8*).

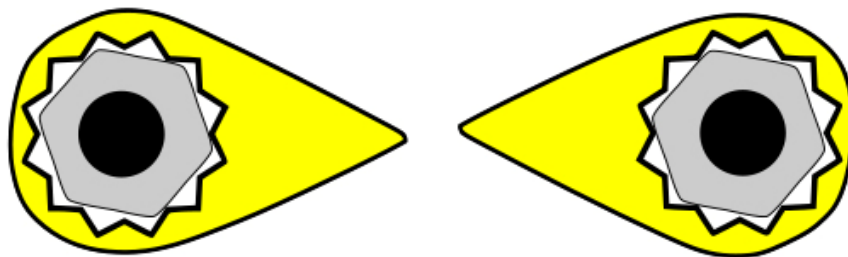
**Figure 2: Illustration of Wheel Nut Tags**

- 1.42 Since the Bossley Park incident, ComfortDelGro Cabcharge has implemented a trial of fitting plastic indicator tags to wheel nuts. The purpose of the tags is to provide a visual aid to determining if wheel nuts are coming loose. The tags are plastic arrows which fit over the wheel nuts and usually are fitted to pairs of nuts with the indicators facing each other (see *Figure 2*). In the event of nuts working loose, the indicator arrows will turn anti-clockwise, disrupting the pattern of original alignment (see *Figure 3*).

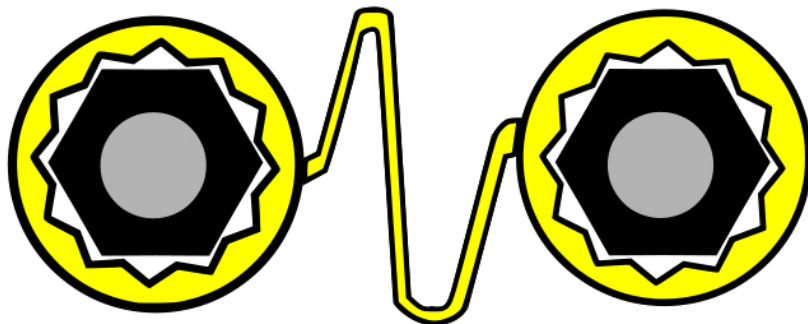
**Figure 4: Alternative System**

- 1.43 Another bus company has implemented an alternative to this type of indicator tag, whereby two pairs of wheel nuts are fitted with a plastic tag which effectively ties the nuts together (see *Figure 4*).

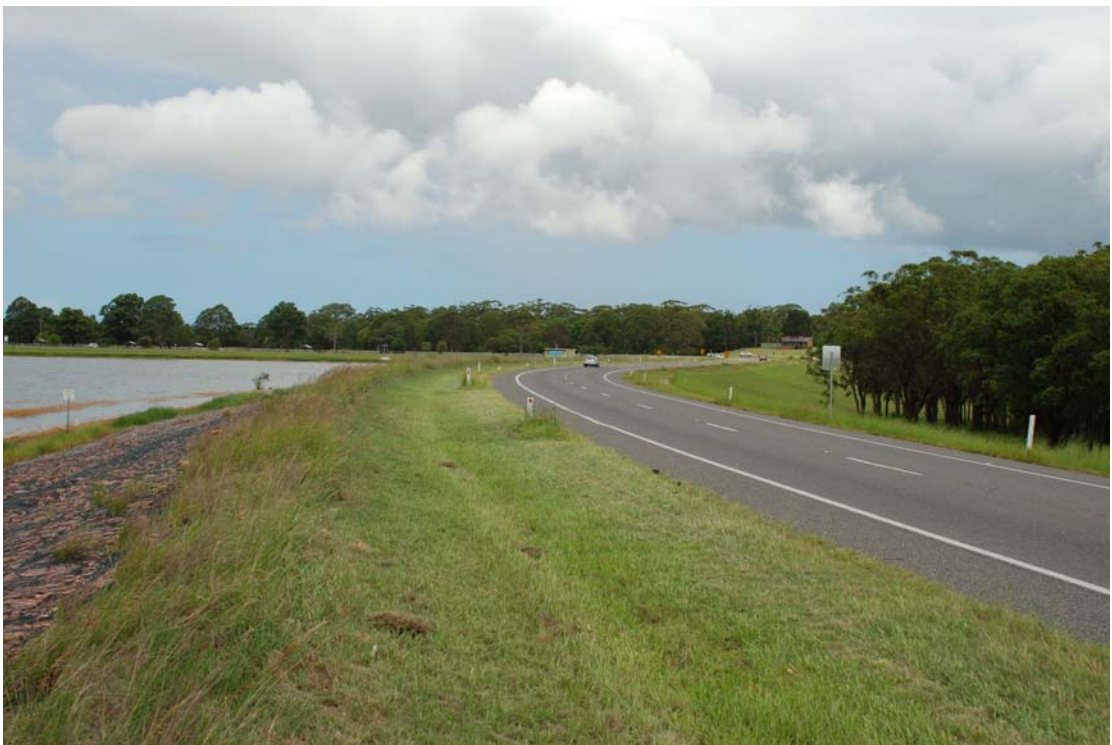
**Photograph 9: Richardson Road in the Direction of Travel**

- 1.51 There are no roadside crash barriers on Richardson Road. Had the driver lost control of the bus and travelled off either side of the road, the outcome may have been tragic. To the left, the bus would have travelled into Grahamstown Lake. Off to the right, the slope of the embankment could easily have caused a rollover (see *Photographs 9 and 10*). The presence of physical barriers for this section of Richardson Road would eliminate this potential risk.
