Office of Transport Safety Investigations

BUS SAFETY INVESTIGATION REPORT

STA BUS MO 1504 FIRE
SYDNEY HARBOUR BRIDGE
6 MAY 2016

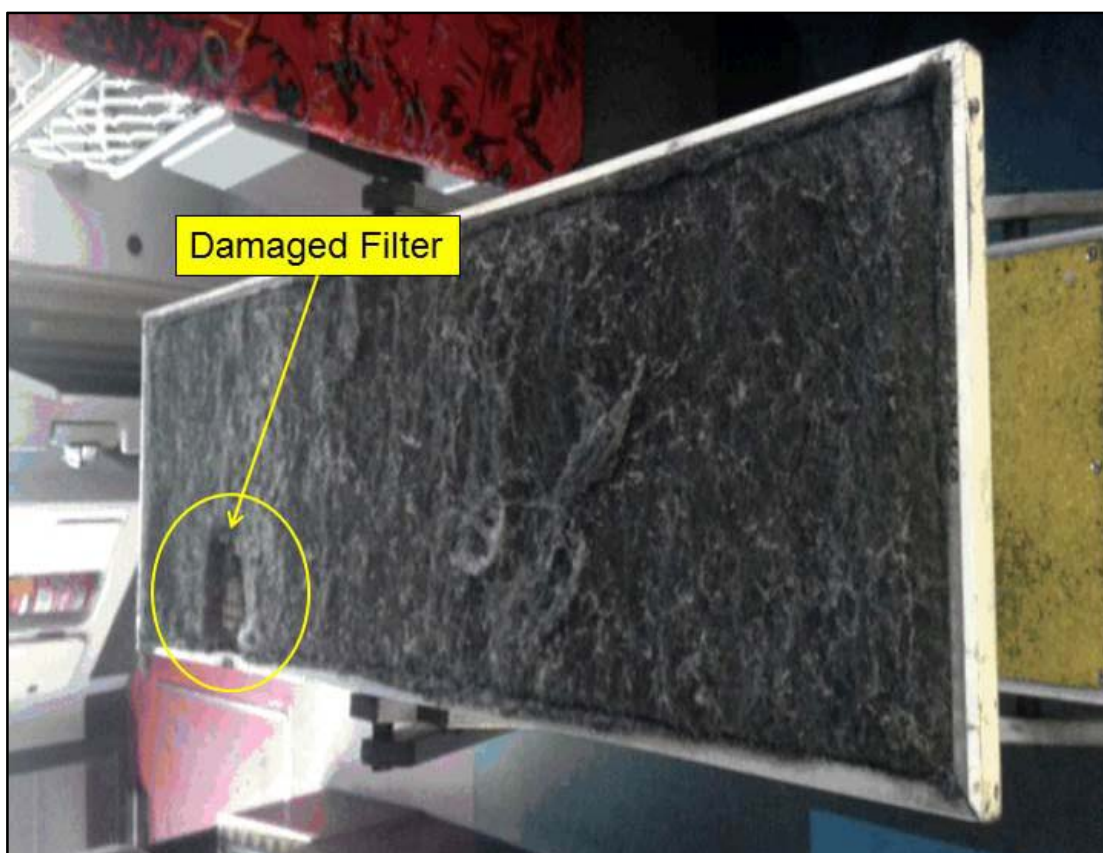
Figure 1: Fire damage to air conditioning filter

- 2.1 The air conditioning return air filter was removed to enable the examination of the electrical circuit boards. The air conditioning filter exhibited damage consistent with hot material falling from the circuit board mounted above the filter (refer *Photograph 1*). The heat-affected area was restricted to the air filter, circuit board and adjacent electrical wiring.

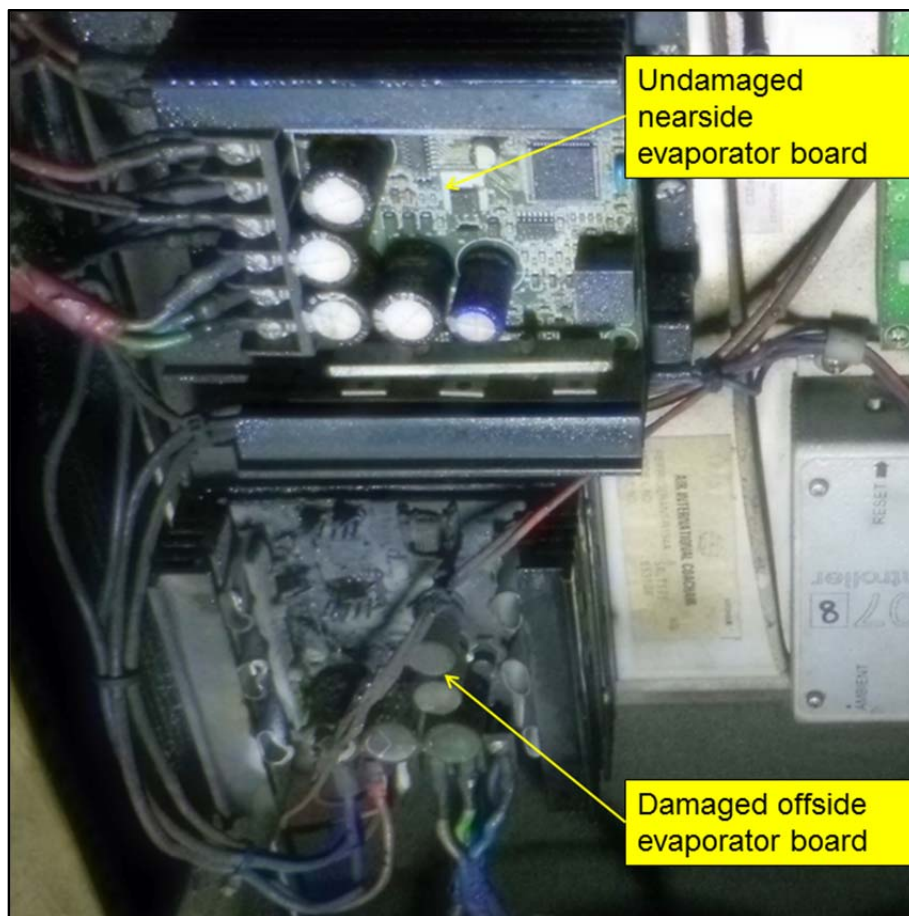
Figure 2: Roof mounted air conditioning circuit boards

- 2.2 With the filter removed, further examination revealed that the damage was confined to the offside² evaporator fan circuit board.

- 2.3 It was likely that the fire ignited in the offside fan circuit board. The fire most likely extinguished either when the circuit breaker 'tripped'³, or when the air conditioning power supply was switched off. It is likely that the circuit breaker tripped when the heat affected electrical components short-circuited the board's power supply.
- 2.4 The offside fan's control circuit board was fire damaged. Whilst the nearside fan's circuit board remained undamaged (See *Photograph 2*).

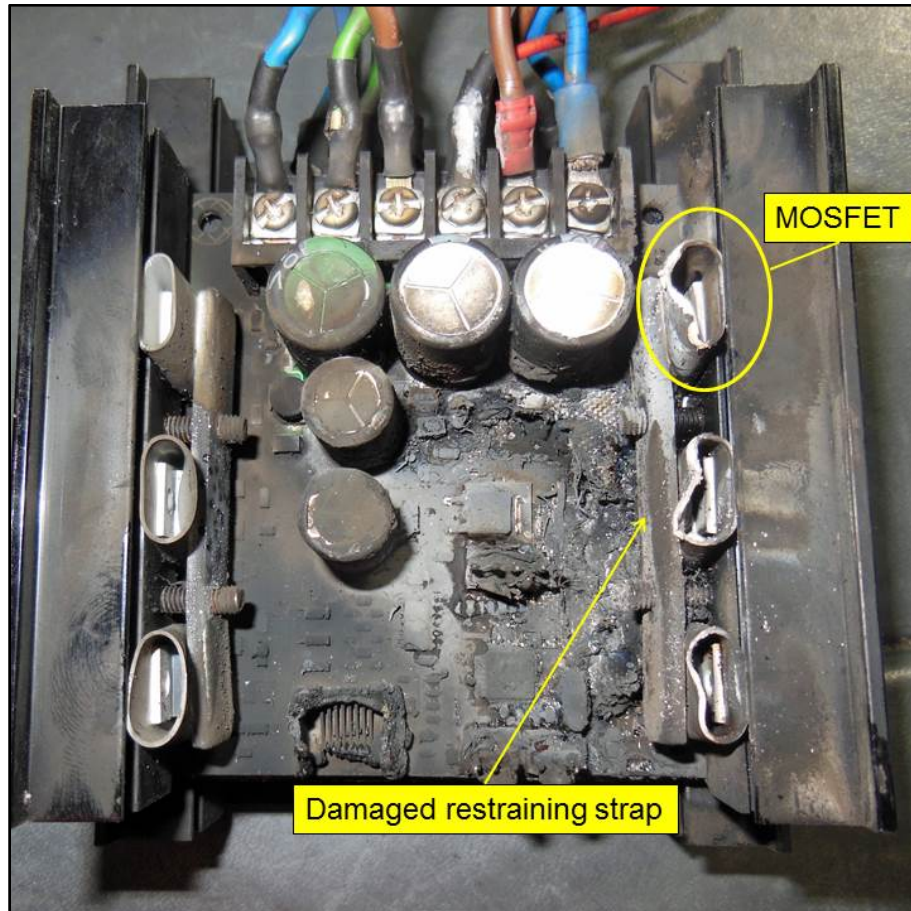
Figure 3: Damaged circuit board

2.5 The examination of the damaged circuit board revealed that a failed Metal–Oxide–Semiconductor Field-Effect Transistor (MOSFET) mounted on the circuit board was most likely the ignition source of the fire (see *Photograph 3*). These are two likely scenarios:

- The MOSFET was damaged during manufacture.
- The MOSFET was damaged when the unit was installed in the bus.

- 3.1 The ignition source of the fire was most likely a result of a short circuit of a MOSFET on the offside air conditioning circuit board.

- 3.2 It is possible the MOSFET was damaged during manufacture or when the control unit was installed in the bus.
- 3.3 Maintenance contractors may not have fully diagnosed and / or repaired faults as per the maintenance records as from the 3rd of January 2016 to March 2016 (see *Figure 4*).

- 4.1 All bus operators have an assurance process for work carried out by contractors, to ensure that work carried out complies with manufacturer's specifications and is conducted by competent personnel.
- 4.2 All bus operators provide bus drivers with robust emergency response procedures that include the isolation of electrical power supply.
