BUS SAFETY INVESTIGATION REPORT

PEDESTRIAN FATALITY

ULLADULLA NSW

1 JULY 2020

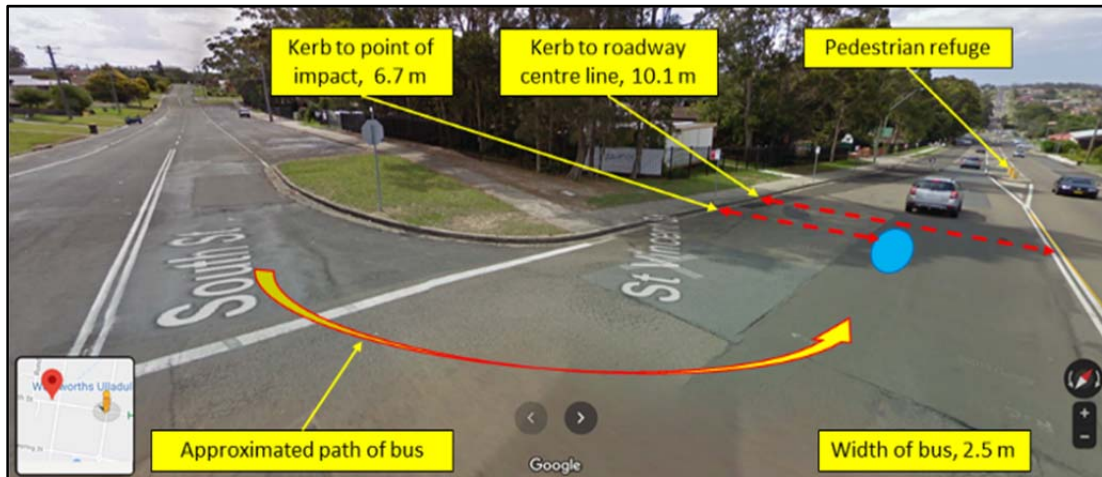
- 1.7 Witnesses recalled that the student was crossing St Vincent Street, from west to east, approximately 16 m north from the intersection with South Street (refer *Figure 1*).

- 1.8 CCTV footage from the bus showed the student approach the left hand side of the bus from the footpath area adjacent to the school. The student was observed moving towards the side of the bus, forward of the rear wheels. After impacting the bus, the student then fell to the roadway and was run over by the bus.

Figure 1: Street view of incident location

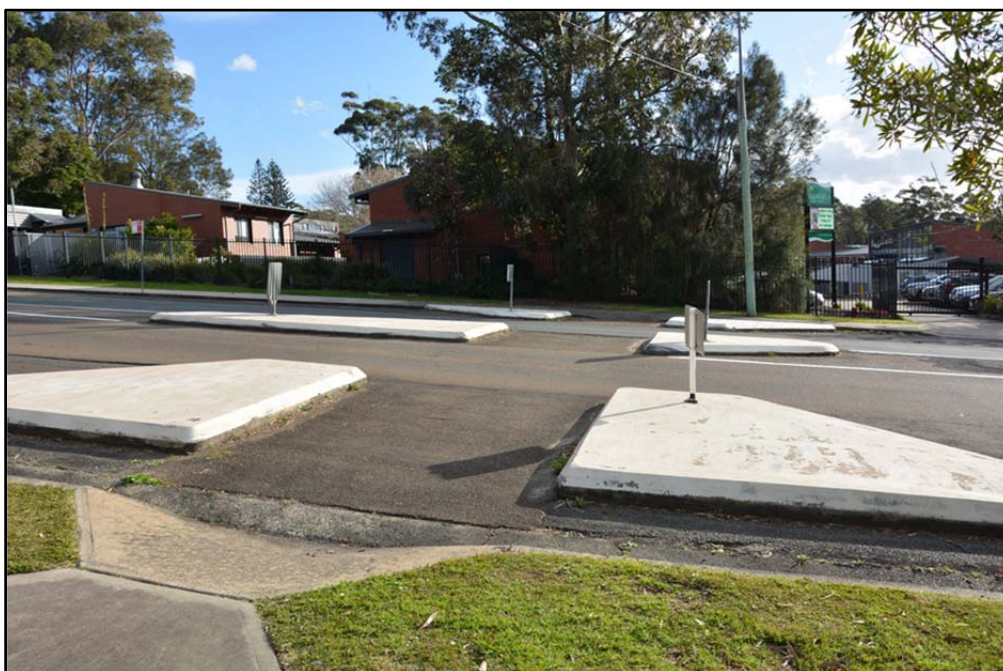
- 1.11 The student was not restricted from crossing at the location under NSW legislation. Regulation 234 of the NSW Road Rules 2014 stipulate that a pedestrian must not cross a road within 20 m of a crossing for pedestrians. There was a designated pedestrian refuge approximately 50 m from the incident location. The school administration encouraged students to cross at this pedestrian refuge. Additionally, it is not compulsory for drivers to stop for pedestrians crossing at pedestrian refuges, unlike marked pedestrian crossings, refuges place the obligation on the pedestrian to cross safely (refer *Figure 3*).

Figure 3: Pedestrian refuge - St Vincent Street

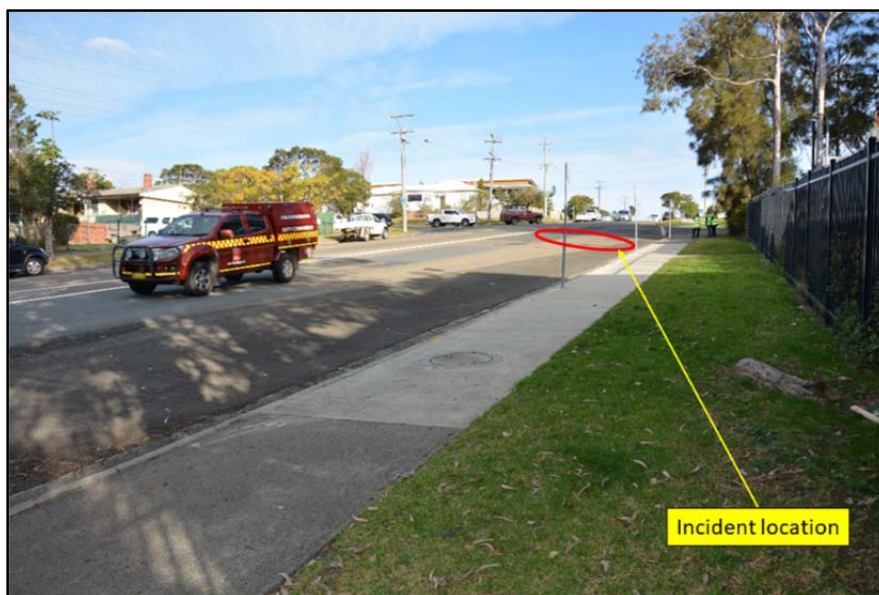
Figure 4: View of St Vincent Street facing south toward incident location

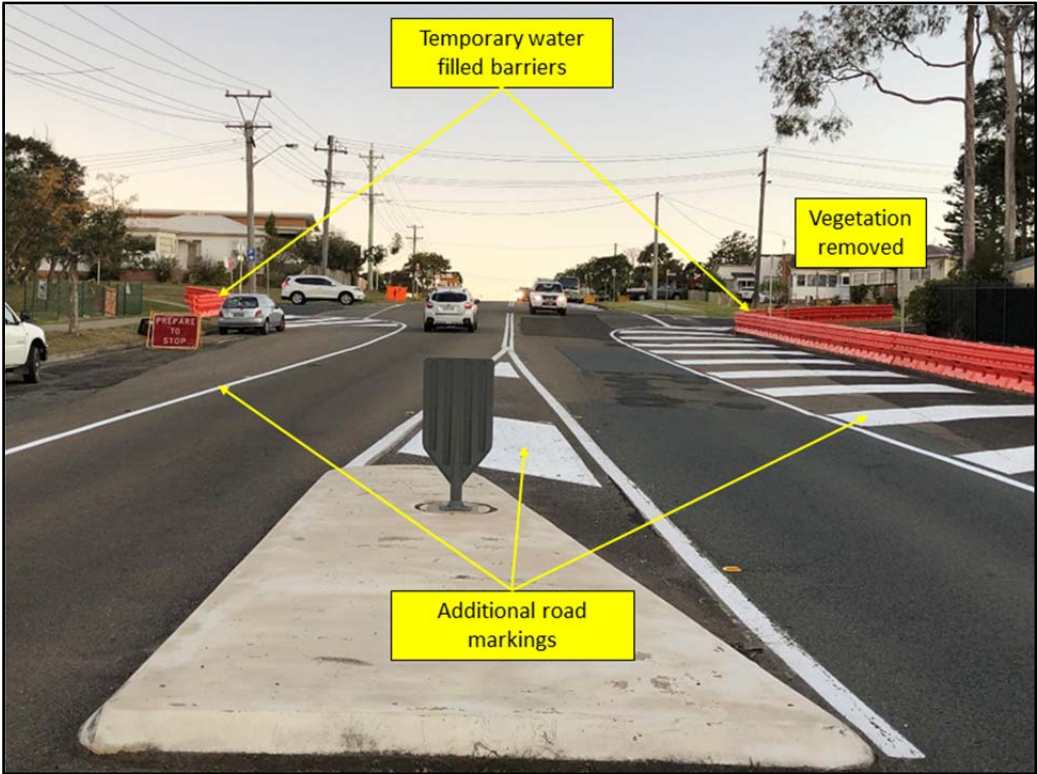
Figure 5: Incident site following additional work (facing south)

- Signposting, line marking, delineation and traffic/pedestrian control improvement recommendations as follows:
 1. Via a Traffic Control Plan, temporary water filled barriers to be installed as an interim pedestrian barrier, on the northwest and northeast corner of the intersection, to corral pedestrians toward the refuge facility.

2. Installation of edge lines, retro reflective pavement markers and chevron line marking along St Vincent Street from South Street to the pedestrian refuge.

3. Installation of additional stop signs, including on the central median. Installation of a stop template on the road surface adjacent to transverse stop line.

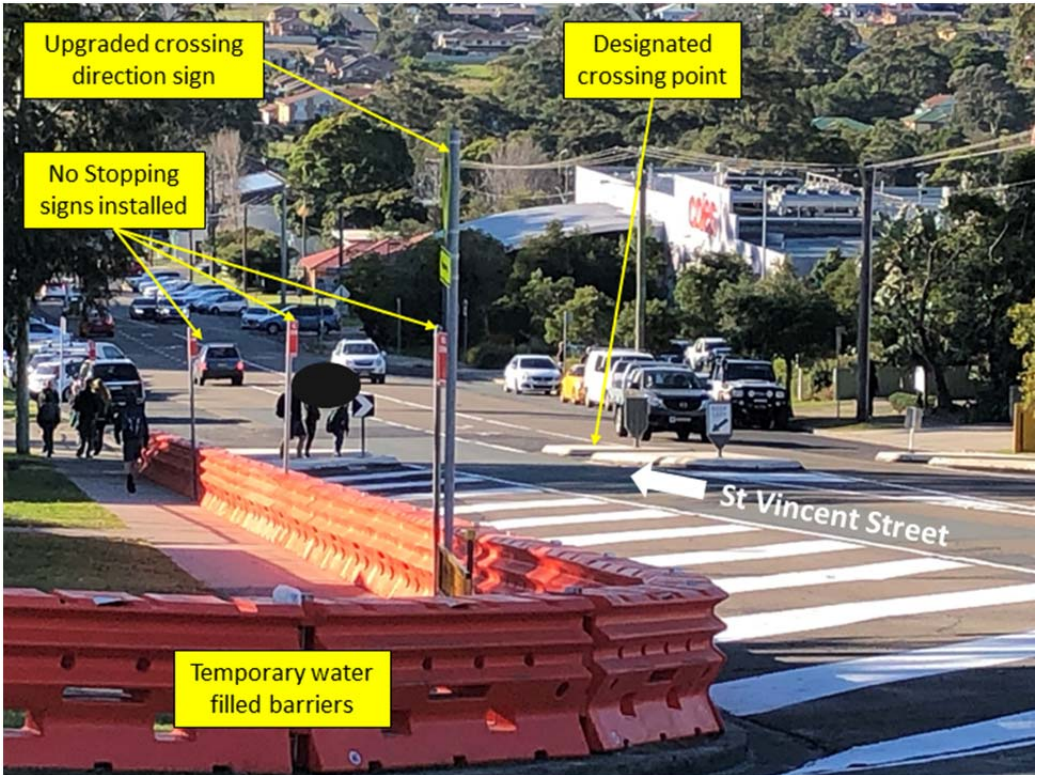
Figure 6: Incident site following additional work (facing north)

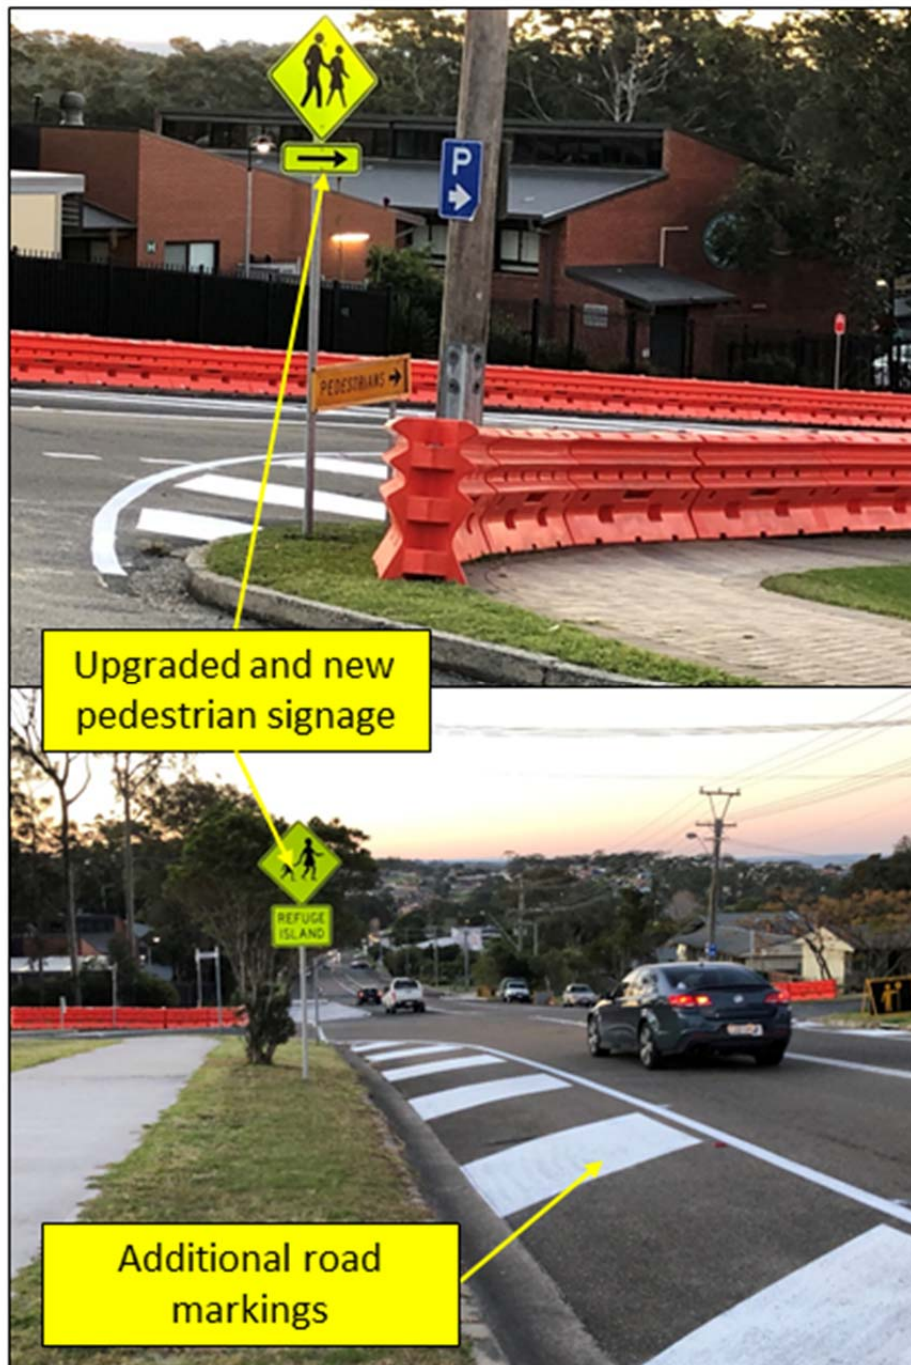
Figure 7: Additional work carried out at intersection

4. Update pedestrian refuge signs to fluorescent green standard.
 5. Removal of No Parking signs on the western side of St Vincent Street and replacement with No Stopping signs.
