BUS SAFETY INVESTIGATION REPORT

BUS FIRE

VALLEY HEIGHTS

30 JUNE 2017

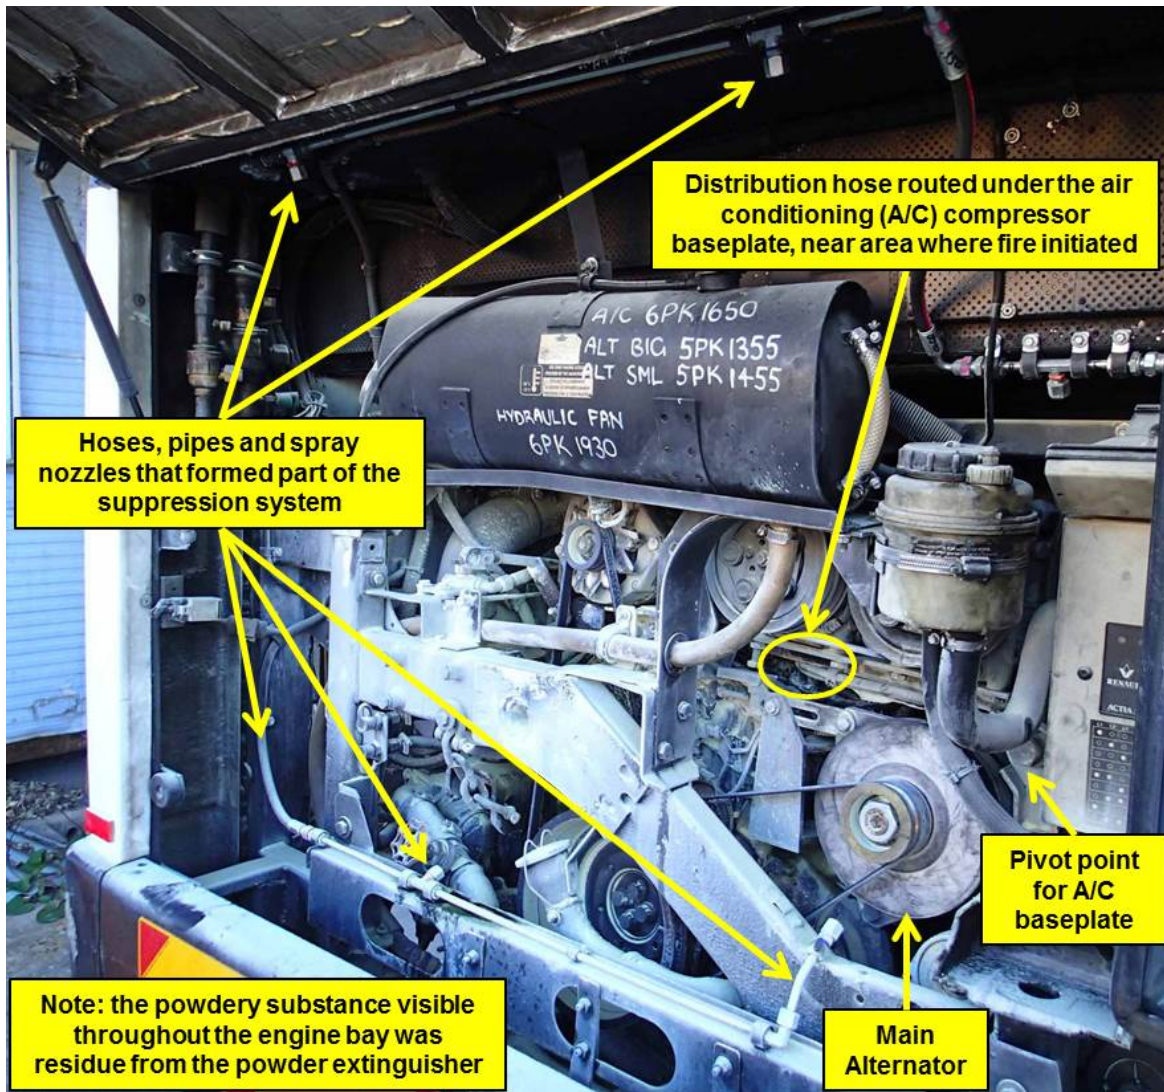
Figure 3: Engine bay showing part of the FSS network of hoses, pipes and nozzles

- 2.3 There was evidence of electrical arcing on both the join in the cable and alternator end casing. The main area of fire damage was concentrated on cabling near, and attached to, the alternator. A variety of cabling was located in this area. These included a pre-existing main chassis wiring harness and electrical cabling associated with the alternator. These were immediately adjacent to or in the vicinity of a newly installed distribution hose¹⁰ associated with the FSS network.

- 2.4 It was observed that the routing of this distribution hose transverses across the top of the main alternator cable, placing downward pressure on the cable. It was also intermingled amongst existing electrical cabling, static mechanical components and moveable components. Notably, it ran perpendicular to one end of the framework of the air conditioner (A/C) compressor baseplate (See *Figures 3 and 4*). It was noted that this baseplate pivoted on an axis point at the opposite end (See *Figure 3*). The routing of this hose restricted available

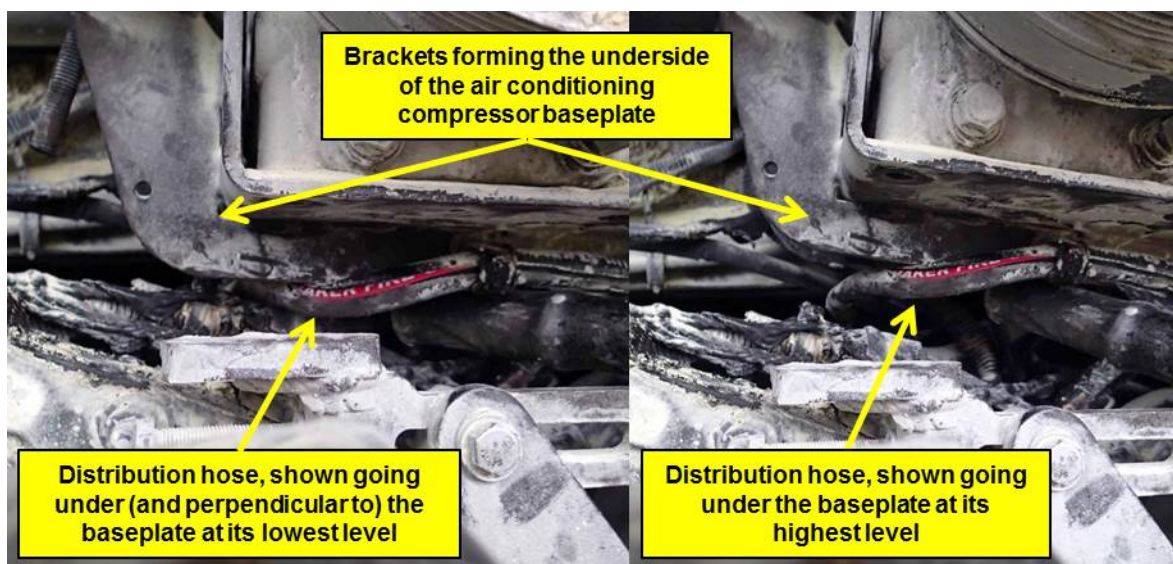
Figure 4: Distribution hose routed underneath the A/C compressor baseplate

clearance of the baseplate through its range of movement. When the baseplate was at its lowest point, it exerted increased pressure on the distribution hose, pushing it firmly against the underlying main chassis wiring harness containing the alternator cable (*See Figure 4 and 9*).

- 2.5 Inspection of this area indicated that the position of the distribution hose had probably disturbed the pre-existing position of the alternator loom. This equated to the joint in the alternator cable resting against the alternator end casing (*See Figure 9*). Closer examination of the joint in the cable and alternator end casing revealed evidence of arcing specific to the area where they now made contact.

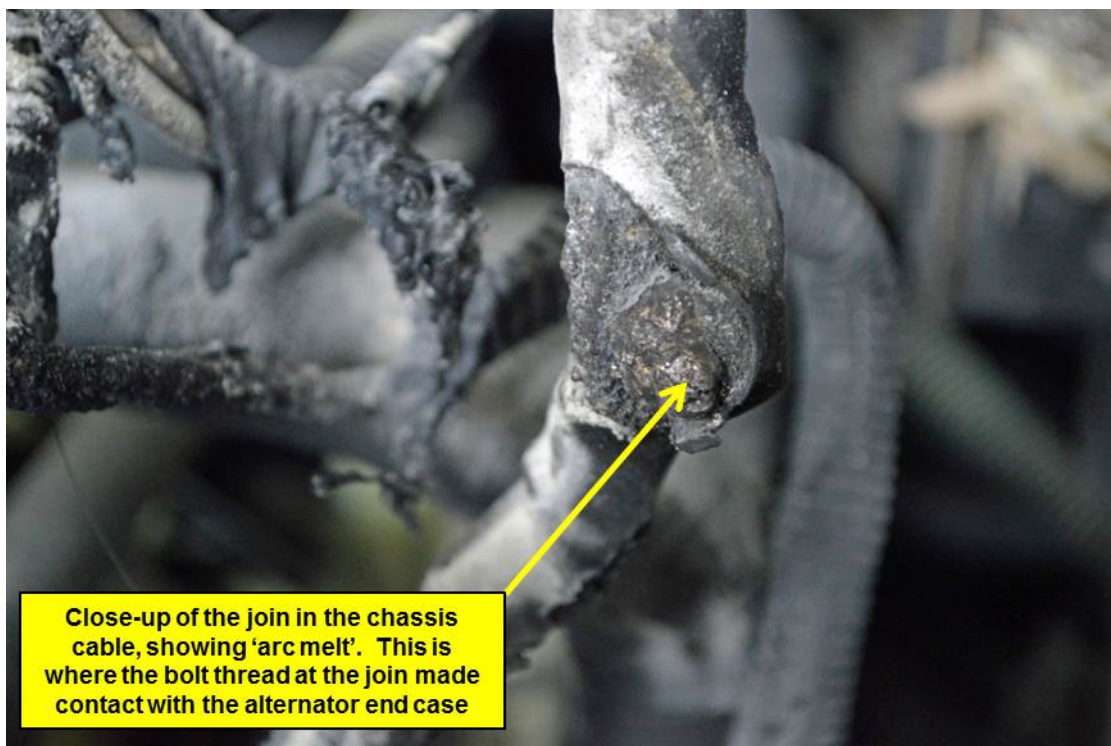
- 2.8 The TfNSW forensics report confirmed: *'Examination of the bolt clearly depicts copper deposition/fusion derived of the cable terminal..... The scanning revealed clear evidence of copper deposition fused to the aluminium alloy which is consistent with electrical arcing.'*¹² (*Refer to Figures 5 through to 8 which highlight the damage to the chassis cable and alternator end case*).

Figure 6: Cable showing close-up of the join and evidence of 'arc melt'

- 2.18 The TfNSW forensics report stated “*insulation was diminished due to abrasion*” in reference to the alternator end case (See Figure 6 and 7). Abrasion of this protective insulation would have diminished its effectiveness as a protective barrier. Ongoing abrasion would have increased the risk that the insulation would fail, leaving the internal conductive components exposed and prone to damage, failure, or in this case, damage from contact with other metallic components causing unwanted current flow, leading to short circuiting.

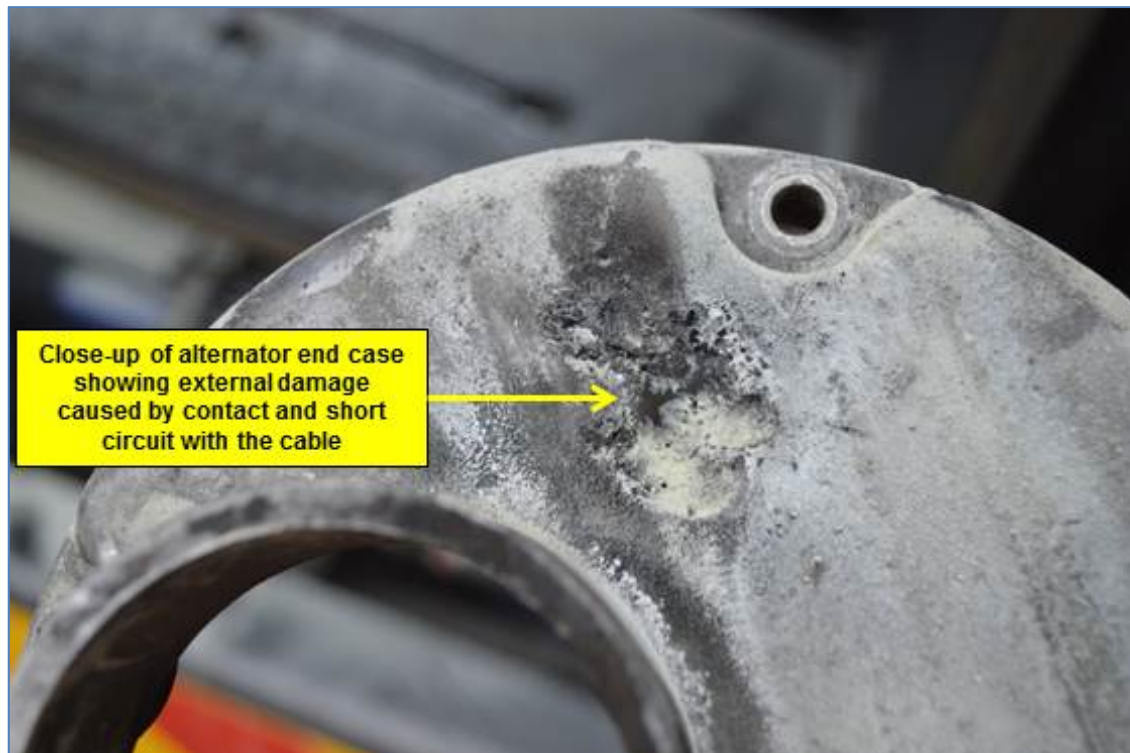
Figure 7: Exterior of the alloy alternator end case.

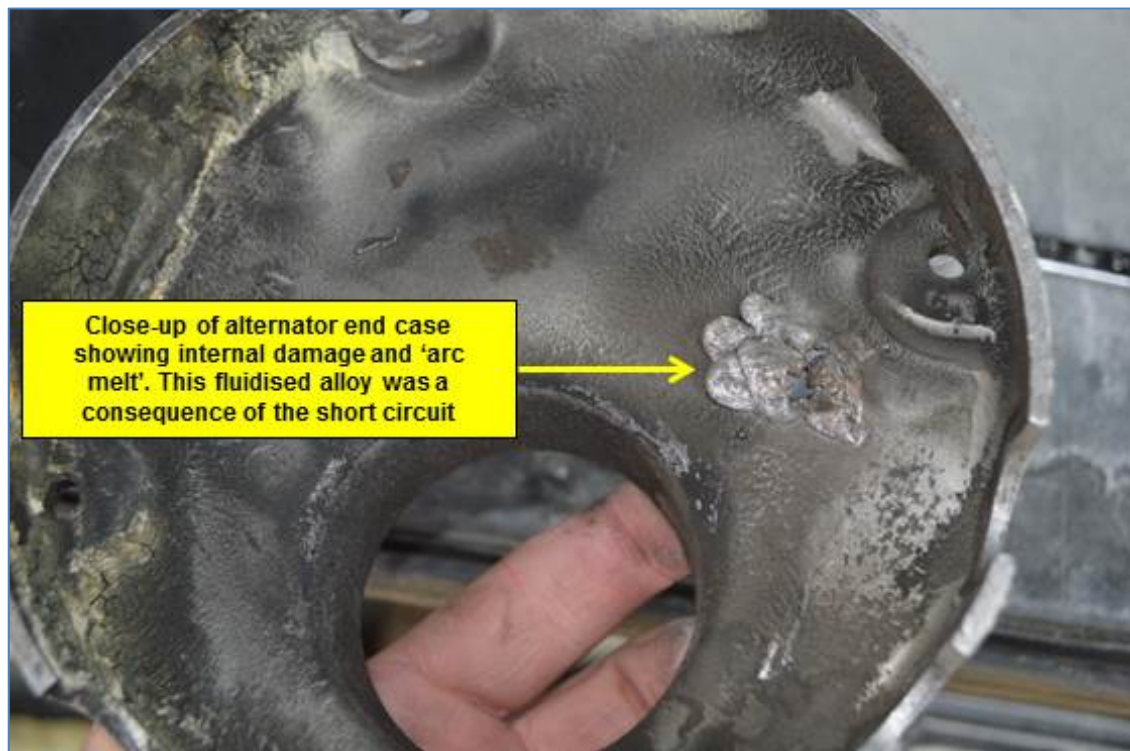
Figure 8: Interior of the alternator end case.
