Bus Safety Investigation Report

Woodpark

3 March 2004

Air brake failure on bus resulting in a collision.

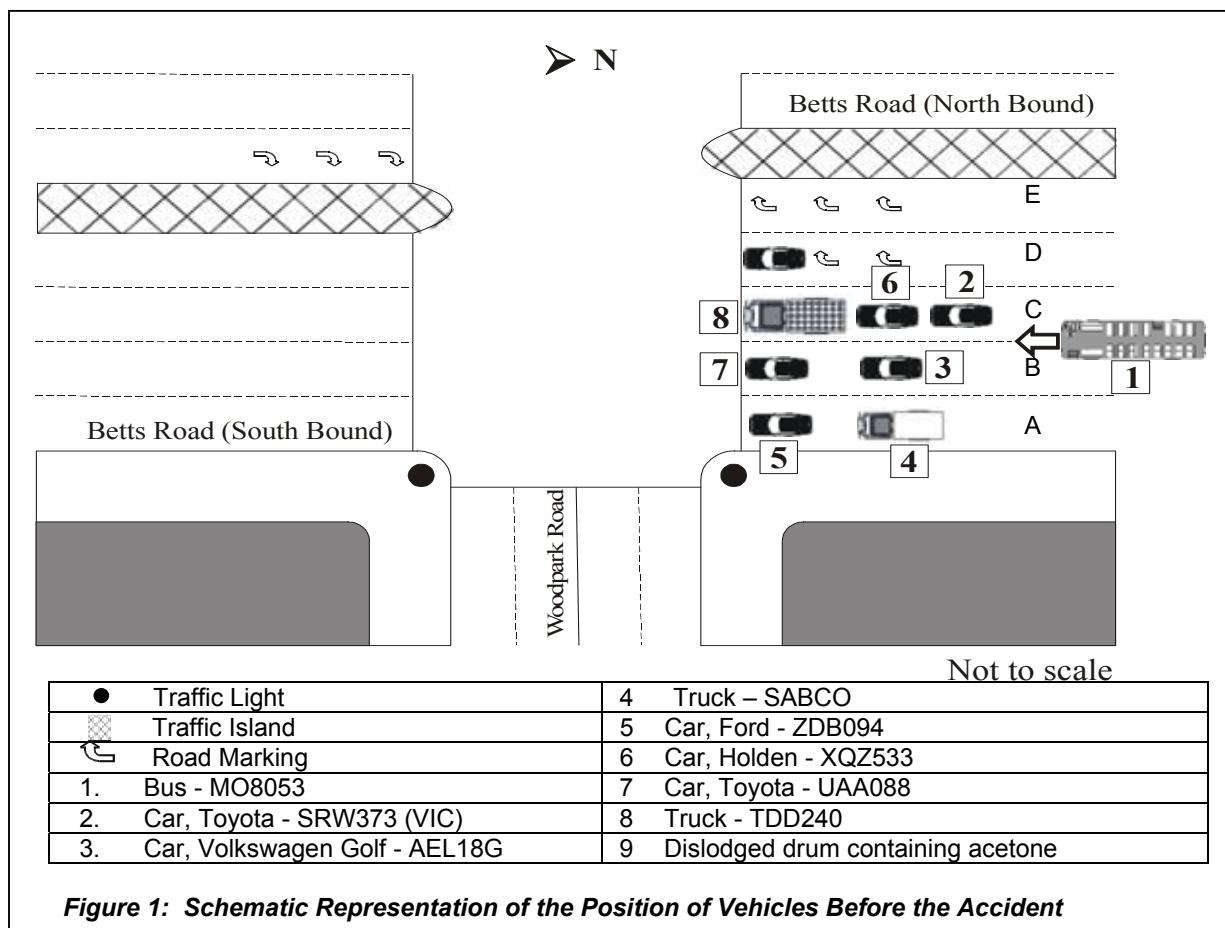
- 3.1 At approximately 12:30 hrs on 3 March 2004, a chartered bus operated by Bustrans, registration number MO8053, collided with five cars and a truck at Woodpark in NSW. The bus was returning 64 children and teachers to Fairvale High School following an official excursion. The truck, registration number TDD240, was transporting 40 drums of acetone, a highly flammable liquid. At the time of the incident, the bus was travelling in one of three southbound lanes and was approaching the intersection of Woodpark Road, on the Betts Road section of the Cumberland Highway, where the southbound traffic was stationary at the intersection's stop lights. In addition to the three southbound lanes, there were two dedicated lanes to facilitate traffic turning right/west into Woodpark Road. (Refer to *Figure 1*). The speed limit was, and is, 70km/h.

- 3.2 The bus (1) was travelling in the second of three southbound lanes (indicated as lane B in *Figure 1*). After cresting a hill approximately 600m before the intersection, the bus driver reported that he applied the brakes and that the application was effective. A few seconds later, he again applied the brakes but there was no deceleration. He also reported hearing a “strange” noise. He made a further application of the brakes but there was no brake pressure and the pedal travelled to the floor.

- 3.3 After warning the passengers of the loss of brakes, the driver considered applying the emergency brake but appreciated that he would be unable to both reach the brake handle and concentrate on steering¹. He therefore elected to steer the bus between stationary vehicles in the lanes indicated as B and C in *Figure 1*. In the process, the bus collided with a vehicle (indicated as 2) at approximately 70 km/h and subsequently with three other vehicles (indicated as 3, 6 and 7) before colliding with the rear of a truck (indicated as 8). The bus and truck came to rest on the island separating north and southbound lanes of Betts Road. (Refer to *Figure 2*).

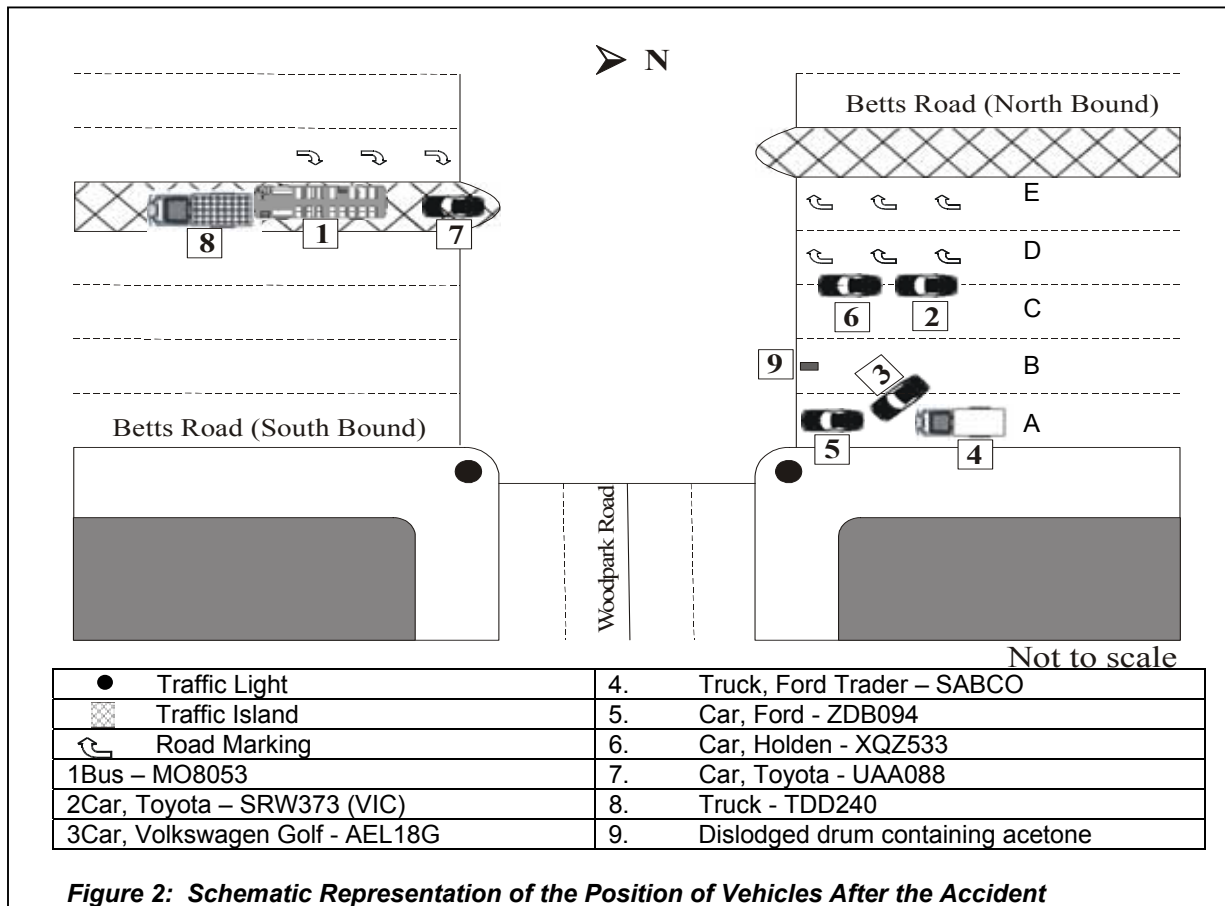
- 3.5 The sequence of events that followed the bus driver's decision to attempt to guide the bus between the second (B) and third lanes (C) in an attempt to avoid a major collision with vehicles in the first lane (A) and an adjacent residential wall was as follows:

- the bus scraped against the left side of vehicle 2;
 - the bus collided with the right rear bumper of vehicle 3;
 - vehicle 3 was rotated 90 degrees, counter-clockwise, and collided with the front of a truck (vehicle 4) positioned directly behind it and with the rear of vehicle 5;

- the bus scraped the left side of vehicle 6;
 - the bus scraped the right side of vehicle 7;
 - the bus driver attempted to direct the bus towards the island separating the north and southbound lanes of Betts Road and collided with vehicle 8 (a truck), and

- vehicles 1 and 8 came to rest on the island. A 167 litre drum (9) was dislodged from the truck, ending-up in the second lane from the left (B) on Betts Road.

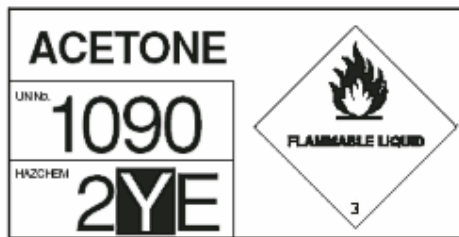
Figure 3: Acetone Warning Sign

- 3.17 MO8053 was authorised to carry 55 seated and 14 standing passengers and was therefore operating within limits at the time of the accident.
- 3.18 The truck (vehicle 8) was laden with 40 drums, each containing 167 litres of Acetone. Acetone is extremely toxic and highly flammable and is therefore classified under the Australian Dangerous Goods Code as a Class 3 flammable liquid³. Containers of Acetone must be labelled (refer to *Figure 3*) and any load of this type in excess of 1000 litres requires the consignor to display warning signage on the front and rear of the transporting vehicle/s.⁴ In this instance, the truck was not displaying the required signage; a matter under the jurisdiction of, and consideration by, the EPA.

- 3.19 In addition to the one drum that was dislodged, four drums were embedded into the side of the bus. Had any of these drums ruptured, the consequences might have been catastrophic. The RTA's Load Restraint Guide requires individual drums to be secured by lashings⁵. The rope webbing found at the rear of the truck may have allowed for easy access to the drums but it did not meet the RTA requirements designed to ensure that dangerous loads are isolated in the event of rear-end collisions. The restraining arrangements also failed to meet the requirements of the Dangerous Goods Code which requires that such loads be isolated by a secure gate on all sides.⁶ Again, these are matters for further consideration by the RTA and EPA.

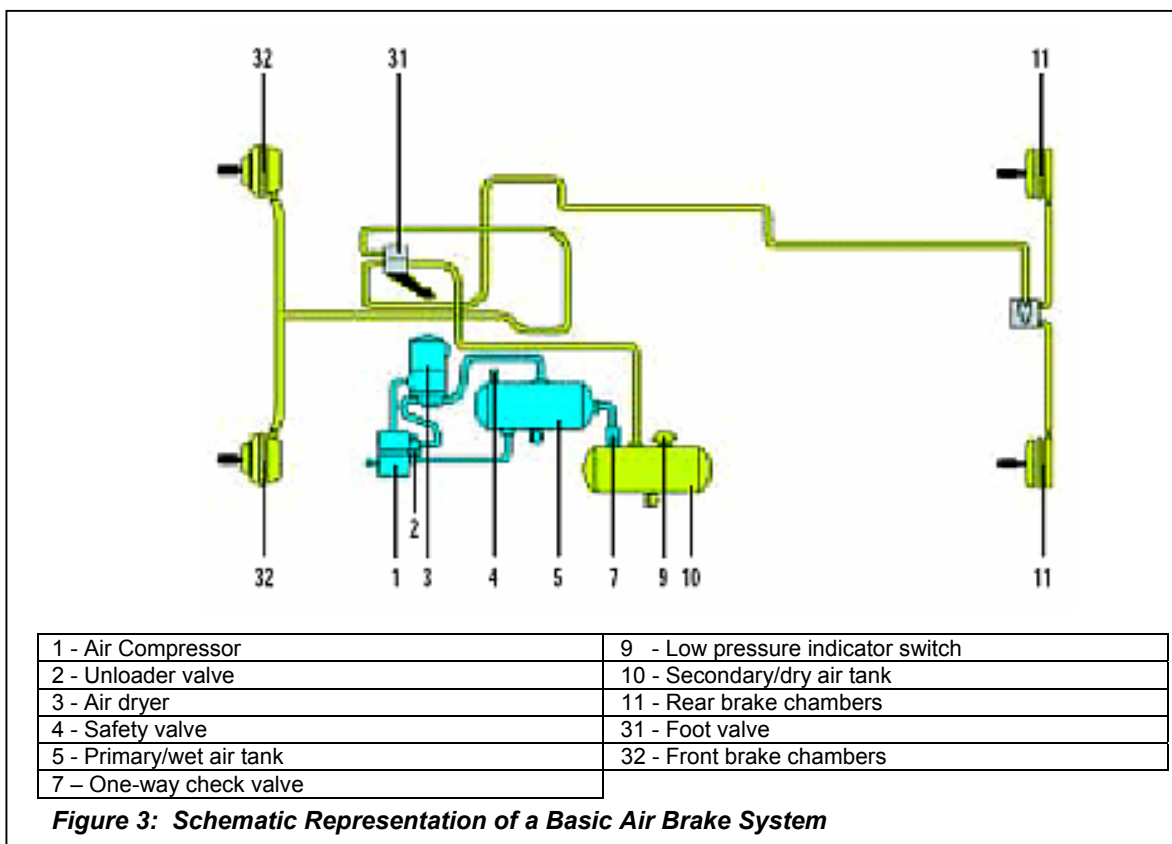
4.1 **Bus Braking System & Function.** *Figure 3* illustrates a braking configuration typical of that fitted to MO8053. It should be noted that such a system, whilst allowed, predates the requirement of Australian Design Rule 35 which requires a level of redundancy with respect to compressed air (braking) systems. The braking system of MO8053 requires a regulated flow of compressed air passing through an air compressor (indicated as 1) to brake chambers (11 & 32) which allow for the activation of brakes when applied. Enroute, air pressure is regulated by an unloader valve (2) and moisture is removed via an air dryer (3) and 'stored' in air tanks (5 & 10). These components make up the critical elements which need to be functioning correctly for proper brake function to occur.

- 4.2 Testing of MO8053's braking system at the RTA Heavy Vehicle Inspection Station immediately following the accident established that the vehicle's secondary air tank (10) and the air compressor (1) failed to supply air, but that the damage was a consequence, rather than the cause, of the accident. When the system was supplied with pressurised air from another vehicle, the air-brake test results were satisfactory. Each wheel brake (11, 32) and the park/emergency brake (a separate system not depicted) functioned satisfactorily when tested on a brake roller.

- 4.3 Examination of the air compressor (1) established that it was pumping a sufficient amount of air through the air line to the unloader valve.
- 4.4 During an inspection of the primary air tank (5), a considerable amount of oil and debris drained from the tank when the drain cock was opened.

- 4.6 Inspection of the air line and a one-way check valve (7) connected between the unloader valve (2) and the primary air tank (5) found that the air line and a one-way valve connected between the unloader valve and the primary air tank were also contaminated with engine oil and sludge.⁹ This contamination effectively blocked the flow of compressed air, preventing the activation of the brakes.

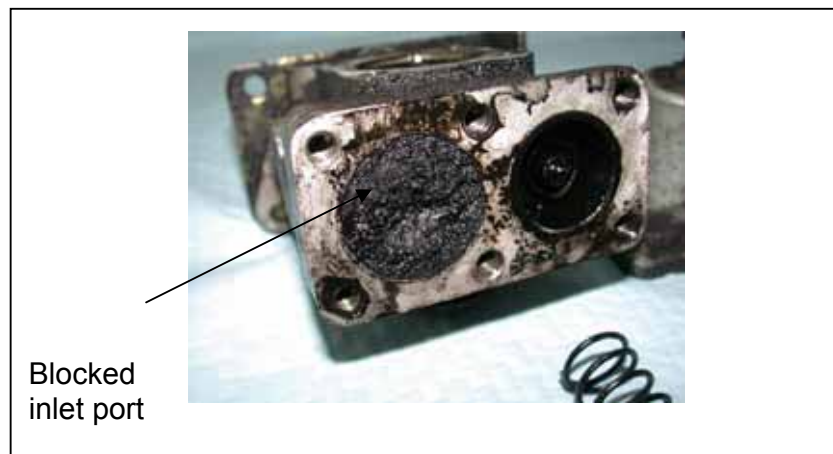
Figure 4: Photograph of Unloader Valve Removed From MO8053 on 17/03/2004

- 4.5 Shortly after the accident, testing of the unloader valve (2), which is designed to maintain constant air pressure in the braking system, found that a large amount of oil had dispersed from around the inlet side of the unloader valve and sprayed rearward onto the surrounding chassis rail and body. It was further established that with the engine idling, no air was detected coming out of the valve. The Police subsequently removed the unloader valve and in their report stated that "the entire inlet port was blocked with a build up of carbon and other debris, which had hardened."⁸ Further examination found that the inside of the valve assembly was coated with "sludge" and engine oil (refer Figure 4).

- 4.10 Police testing has established that MO8053's air system, upon which the brake system depended, was contaminated by water, grease and oil. This contamination was a consequence of poor maintenance.

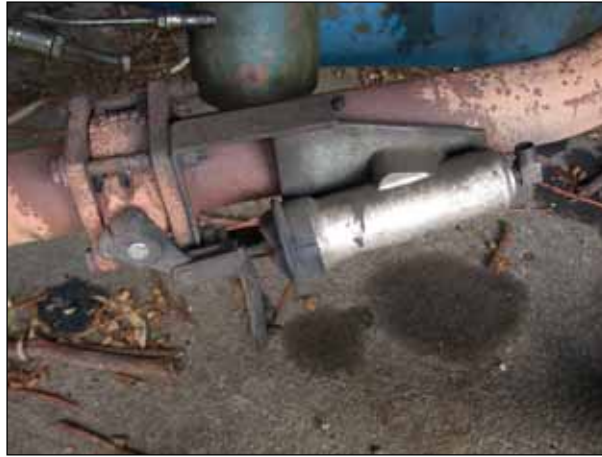
Figure 5: Photograph of Disconnected Exhaust Brake from MO8053 on 17/03/2004

- 4.7 The exhaust brake, an engine brake, is designed to slow rather than stop a vehicle. There is no legislative requirement to have an exhaust brake fitted on a passenger bus in NSW, however it is worth noting that in this instance the brake was disconnected. The NSW Police investigating officer is of the view that disconnection was not a consequence of the collision, i.e., disconnection had occurred before the collision.¹⁰
