## BUS SAFETY INVESTIGATION REPORT

SYSTEMIC INVESTIGATION INTO AN ALLEGED 'BLIND SPOT' ON MARK II AND MARK III MERCEDES-BADGED BUSES OPERATED BY THE STATE TRANSIT AUTHORITY.

**OTSI File Ref: 03004**

**27 September 2005**

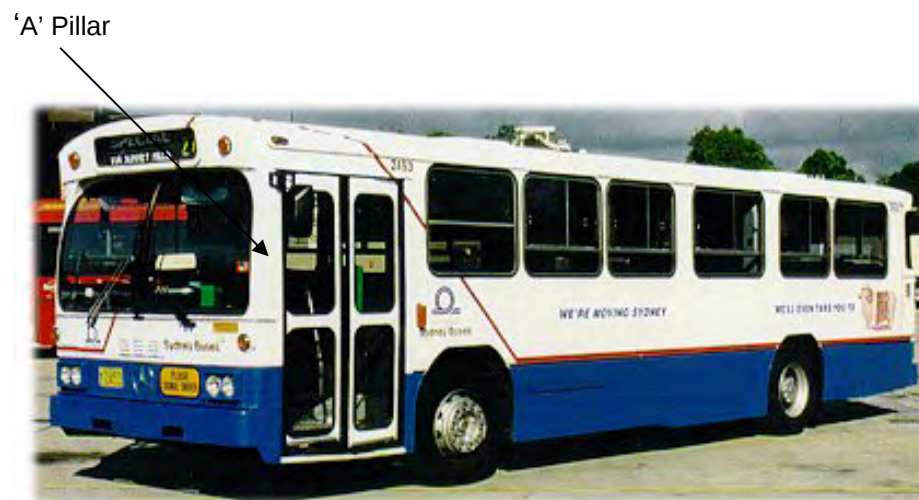
Photograph 1 - Mk II "Mercedes"

**4.3 Design.** STA introduced the Mk II Mercedes bus into service between 1978 and 1980 to satisfy an increasing demand for public transport at the time and to replace its aging fleet of Leyland Leopard buses. A Mk III was subsequently commissioned into service in the period 1981-1983. With the exception of subtle changes in step and ceiling heights, the two bus types are very similar in appearance. In respect of those matters that might affect the driver's visibility, STA's Mk II and Mk III Mercedes buses are, as can be seen in Photographs 1 and 2 below, almost identical. It is important to note that many buses are 'hybrids', with one manufacturer supplying the chassis, engine, transmission and other mechanical components, whilst another provides the coachwork. The Mk II Mercedes bus operated by STA is in fact a Mercedes chassis fitted with coachwork supplied by the Pressed Metal Corporation<sup>4</sup>. **Accordingly, OTSI's investigation has more properly focused on establishing the presence, or otherwise, of a blind spot on Mk II and Mk III 'Mercedes-badged' buses operated by STA.**

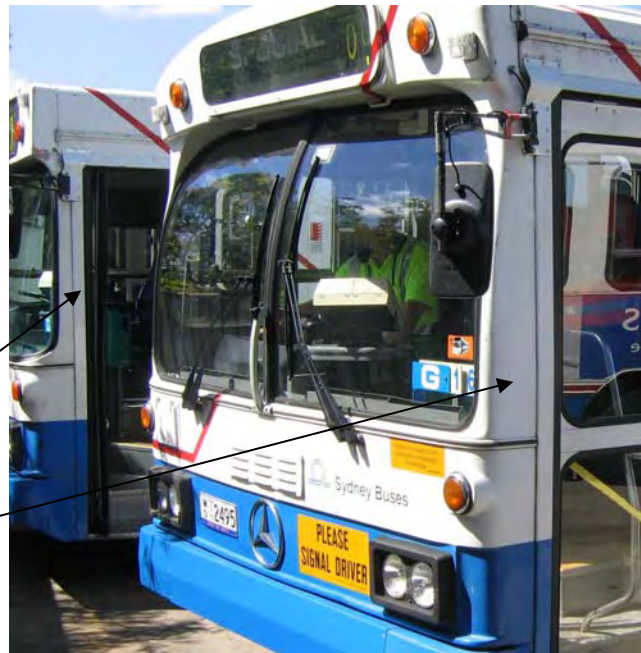
4.5 Notwithstanding improvements in design, all vehicles have, under certain circumstances, a 'blind spot'. The 'A' pillar on a truck or bus is vertically positioned to provide additional structural integrity. The pillar on buses typically also provides part of the housing for the front door frame. In contrast, the 'A' pillar on a standard family vehicle is oriented at approximately 45 degrees and is therefore less likely to obstruct a driver's view of a standing pedestrian in close proximity. OTSI noted that whilst the integrity of the 'A' pillar on the Mk II and Mk III Mercedes-badged buses operated by STA is not in question, 50% of the pillar is comprised of moulded fibreglass and contributes to design aesthetics, rather than structural integrity, i.e., the 'A' pillar on these models is 50% wider than need be. Indeed, much of this fibreglass was removed and replaced with glass in the Mk IV.

The difference in 'A' pillar width between STA's Mk IV and Mk II Mercedes-badged buses.

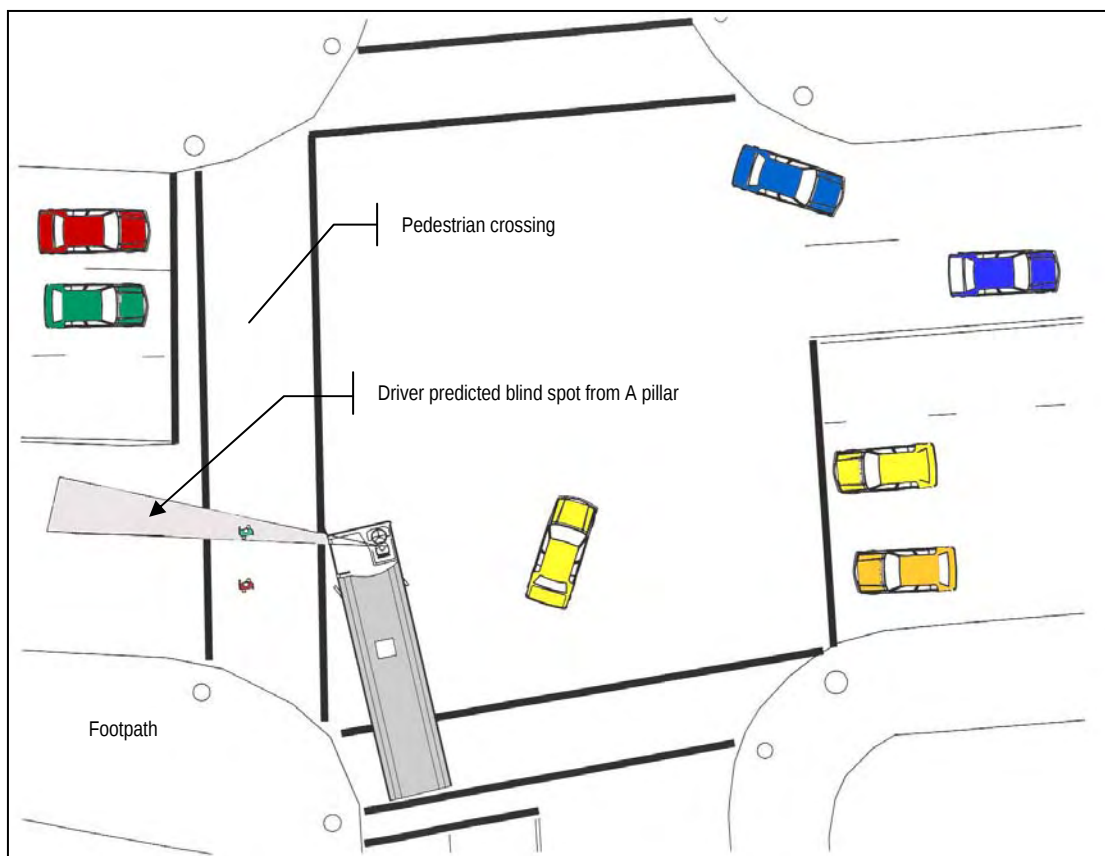
4.6 To define the magnitude of the blind spot effect, OTSI utilised a commercially available computer-aided design program and measurements taken from the driver's seat in a Mk II Mercedes-badged bus to produce the representative diagram below. OTSI calculated that the width of the 'A' pillar on STA's Mk II and Mk III Mercedes-badged buses produces a blind spot which, if the driver remains in his/her normal driving position, increases in width by approximately one metre in every four metres from the left hand front corner of the bus.

Driver's predicted blind spot for a Mercedes Mark II & III bus when turning left at an intersection

4.7 To overcome the blind spot on STA's Mk II and Mk III Mercedes-badged buses, a driver must either lean forward or backwards to see around the 'A' pillar.

4.16 OTSI considers that there may be further scope to improve visibility, by a combination of mirror positioning and mirror type, on STA's Mk II and Mk III Mercedes-badged buses. STA has advised OTSI that it will be engaging a consultant to complete a comparative study on the physical blind spots that exist on all of its bus types and that the results will be used to develop appropriate strategies to manage the risks associated with any identified blind spots<sup>9</sup>. This provides STA with an opportunity to examine the positioning and type of mirrors fitted to its Mk II and Mk III Mercedes-badged buses.

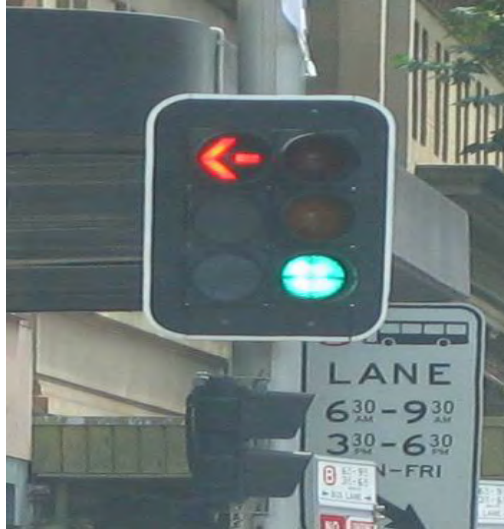
**4.17 Modification of Traffic Lights.** Had the flow of traffic at the crossings under review been regulated by arrow lights, as indicated below, vehicles

would have been prohibiting from entering the area where the pedestrians, with the benefit of a walk signal, were crossing.

4.18 The RTA has advised that the cost of replacing circle lights with lights also incorporating arrows and 'walk' illumination ranges between \$20,000 and \$120,000 per location, depending largely on the extent of re-cabling required.<sup>10</sup> Quite apart from the costs, the benefits of any program to upgrade a significant number of lights would also have to take into account the impact of reduced vehicular traffic flow. The limitations of this option should be readily apparent.
