Office of Transport Safety Investigations

BUS SAFETY REPORT

BUS FIRES IN NEW SOUTH WALES IN 2013

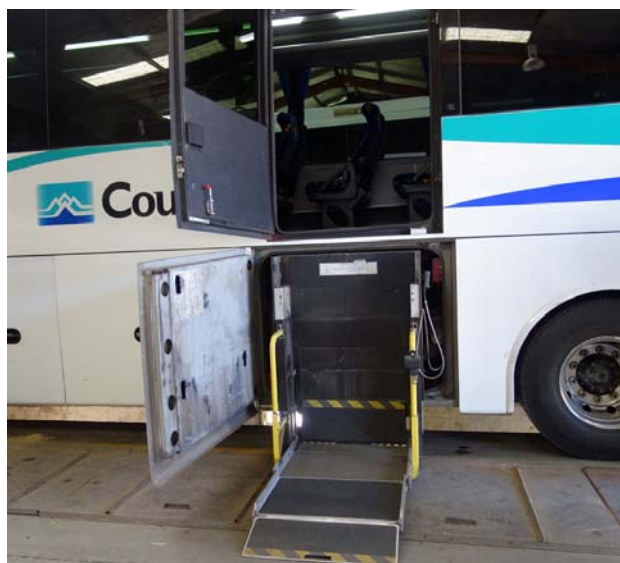
Photograph 1: Wheelchair lift deployed

During its investigations, OTSI encountered two coaches where disabled access was achieved through the use of a wheelchair lift installed in the rear of the underfloor luggage compartment on the nearside, just to the rear of the centre of the vehicles (see Photograph 1). While this might meet accessibility requirements, it is questionable if the arrangement would facilitate rapid evacuation in an emergency especially in the case of more than one wheelchair-bound passenger being involved.
