# FERRY SAFETY INVESTIGATION REPORT

**SINKING OF MV *VENTURE***

**CABARITA, PORT JACKSON**

**1 MARCH 2015**

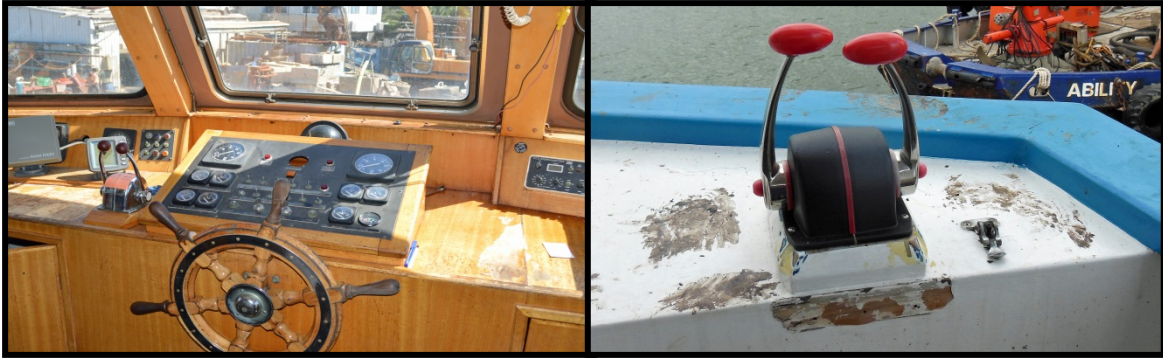
**Photograph 4: Wheelhouse and starboard wing controls**

- 1.29. The wheelhouse starboard control lever was placed in the astern position and the wing control was tested. The starboard engine gearbox remained in the astern position. However, the wing starboard control lever could be moved through both ahead and astern positions without changing the astern position at the gearbox. The operation of the starboard wing lever while the gearbox position was in astern was stiff, and firm resistance was noticeable. Full movement in both directions was accomplished. The movement of both levers in astern and ahead positions advanced the throttle the same amount. Although the levers on the wing position were longer than the levers in the wheelhouse, advancement of throttles was the same at the engine.

- 1.30. The examination determined that, providing there was no gear selected from the alternate position, both the wheelhouse and wing positions in both astern and ahead selections operated the gear selection at the gear box correctly. Also, the throttle advancement functions were functioning as intended.

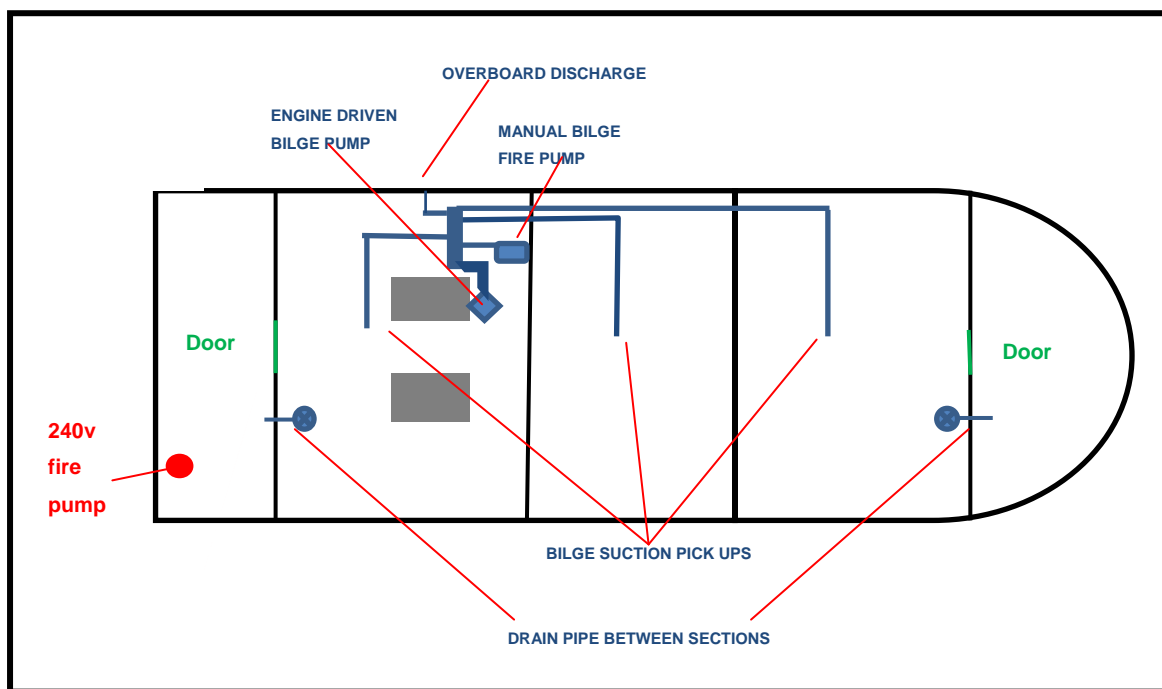
Diagram 2: Bilge pumping system

- 1.33. Accumulation of water in the bilges of the five sections of *Venture* was pumped out by a Jabsco® pump driven off the port engine (see *Diagram 2*). The bilge pump was connected to a valve chest and overboard discharge. The forward and aft voids bilges were not connected directly to the bilge system. They were connected by drain pipe fitted with a shut off gate valve. This allowed accumulated water to be drained into the adjacent compartment where bilge pickups were located.
- 1.34. An additional 240 volt electric fire pump located at the stern on the port side supplied water direct from outside the hull through the pump to the fire hydrants on the rear and upper deck. The pump plumbing did not allow

immediate conversion for use as a bilge pump without shutting off the intake valve, removing the line from the through hull fitting to the pump and placing the line into the bilge.
