# FERRY SAFETY INVESTIGATION REPORT

COLLISION OF THE MANLY FERRY *COLLAROY*  
NUMBER 3 WEST WHARF, CIRCULAR QUAY  
4 MARCH 2005

**OTSI File Ref: 03545**  
**25 November 2005**

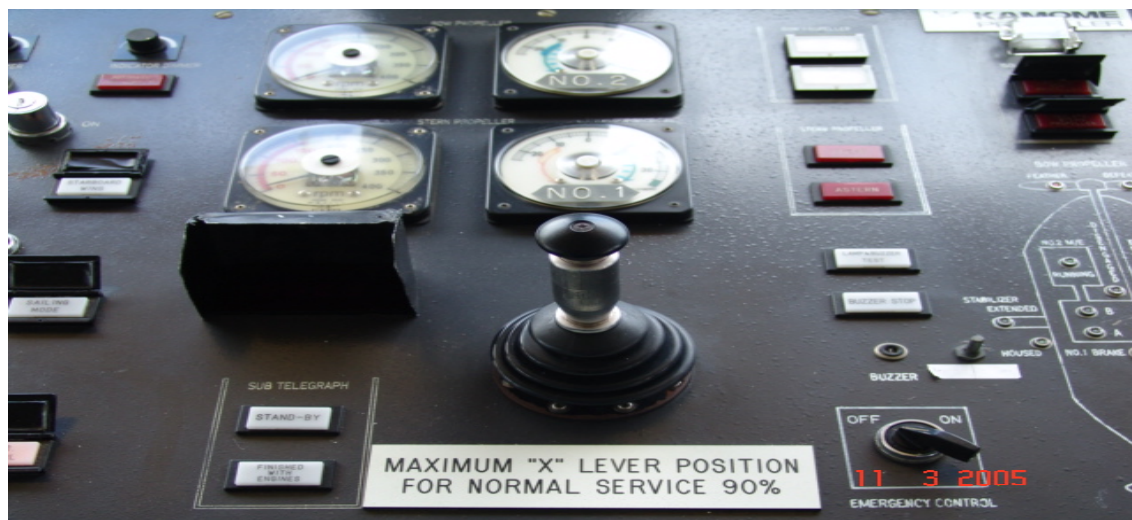
Figure 7: Showing the X-Y lever and Emergency Control Switch

- 3.4 The master advised that, on realising that he was gaining speed rather than slowing, he manipulated the X-Y control lever several times to regain control and obtain full astern propulsion. Approximately one minute elapsed between the onset of the failure he described and the subsequent collision, during which time he did not attempt to communicate with, or effect control through, the engineer located in the MCR. Nor did he attempt to utilise the alternative Emergency Control back-up propulsion system fitted to the vessel, activate a pre-recorded audio warning message or deploy an anchor, on the basis that there was insufficient time to do so. However, he did initiate a prolonged warning blast on the ferry's whistle to alert his crew and personnel ashore.

- 3.17 Confronted by a loss of control, the master responded by repeating his command instructions several times via the X-Y lever. This response action would have been conditioned by previous instances where loss of control had been known to self-correct, and by the fact that he had not been alerted to an alarm which was designed to inform him of a malfunctioning ProCon unit. However, OTSI notes that instrumentation on the control panel would have provided such an indication. The master would also have expected a standby ProCon unit to be automatically available to him. When this didn't happen, the master concluded that there was little he could do, other than to initiate a prolonged warning blast on the ferry's whistle to alert his crew and personnel ashore. The master advised that he did not consider it feasible to deploy an anchor or to use the separate Emergency Control system available to him on the *Collaroy*, believing that there was insufficient time for such manoeuvres to have the desired effect. OTSI notes that the process of deploying an anchor requires both time and space that were not available to the master in this instance.

- 3.18 While the emergency mode comes on-line immediately a master switches the Emergency Control Switch to 'on', the initial effect of such an action is to bring the on-line propulsion engine up to 600 rpm very quickly. However, propeller pitch settings remain as they were immediately prior to the selection of Emergency Control. This option would have had to have been exercised by the master almost immediately after the onset of the failure to have had the desired effect

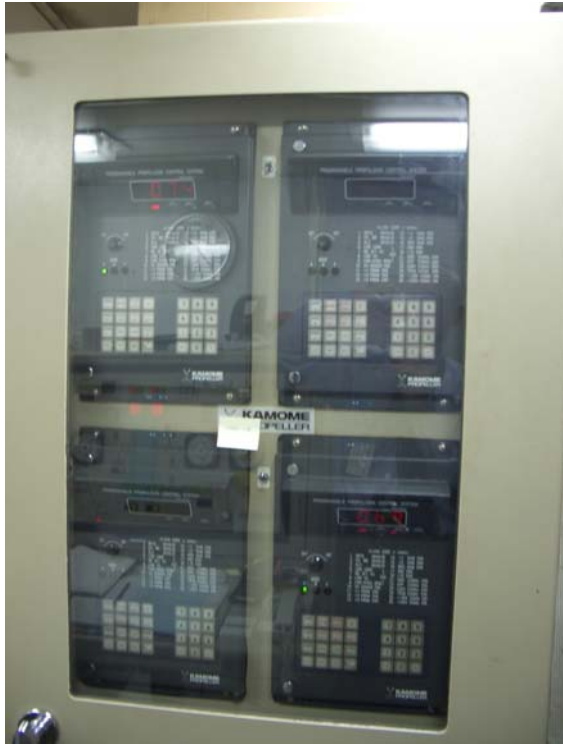
Figure 9: ProCon Cabinet

- 3.14 Eventually, a simulation which fed false inputs into the ProCon system, did replicate the 4 March failure and revealed that ProCon unit 1B had failed. The logic cards, in effect circuit boards, in the ProCon were subsequently replaced with new cards. *Collaroy* was then subjected to a series of sea trials which were completed without fault. Further analysis established that at the time of the malfunction, ProCon units 1B and 2A were being employed by the master, instead of the normally used 1A and 2A units. More significantly, it was also established that ProCon units 1A and 2B were not switched on. This meant that when unit 1B failed, there was no prospect of the master receiving an audible warning alarm, or of a back-up ProCon unit being automatically brought on-line.

- 3.15 Sydney Ferries advised OTSI that they had been experiencing thermally-induced faults in the ProCon's electronic logic-card circuitry over a period of several months and that Sydney Ferries' technical support staff were aware of the situation. The problem, believed to be caused by the ProCon units being subjected to repeated cycles of heating and cooling after being switched on and off on a daily basis, was usually only apparent during morning start-ups whilst the propulsion control system warmed-up. Loud warning alarms would sound in the vessel's MCR each time a unit malfunctioned. The problem would typically self-correct before vessels left the Balmain Yard. A senior engineer, on his own initiative, issued a Memo to guide fellow engineers in a modified start-up procedure which, amongst other things, was intended to compensate for the problems that were being experienced within the ProCon units during start-up. Part of the instructions read:
