FERRY SAFETY INVESTIGATION REPORT

FERRY *FRESHWATER* COLLISION

WHARVES 4 & 5 CIRCULAR QUAY, NSW

4 JANUARY 2018

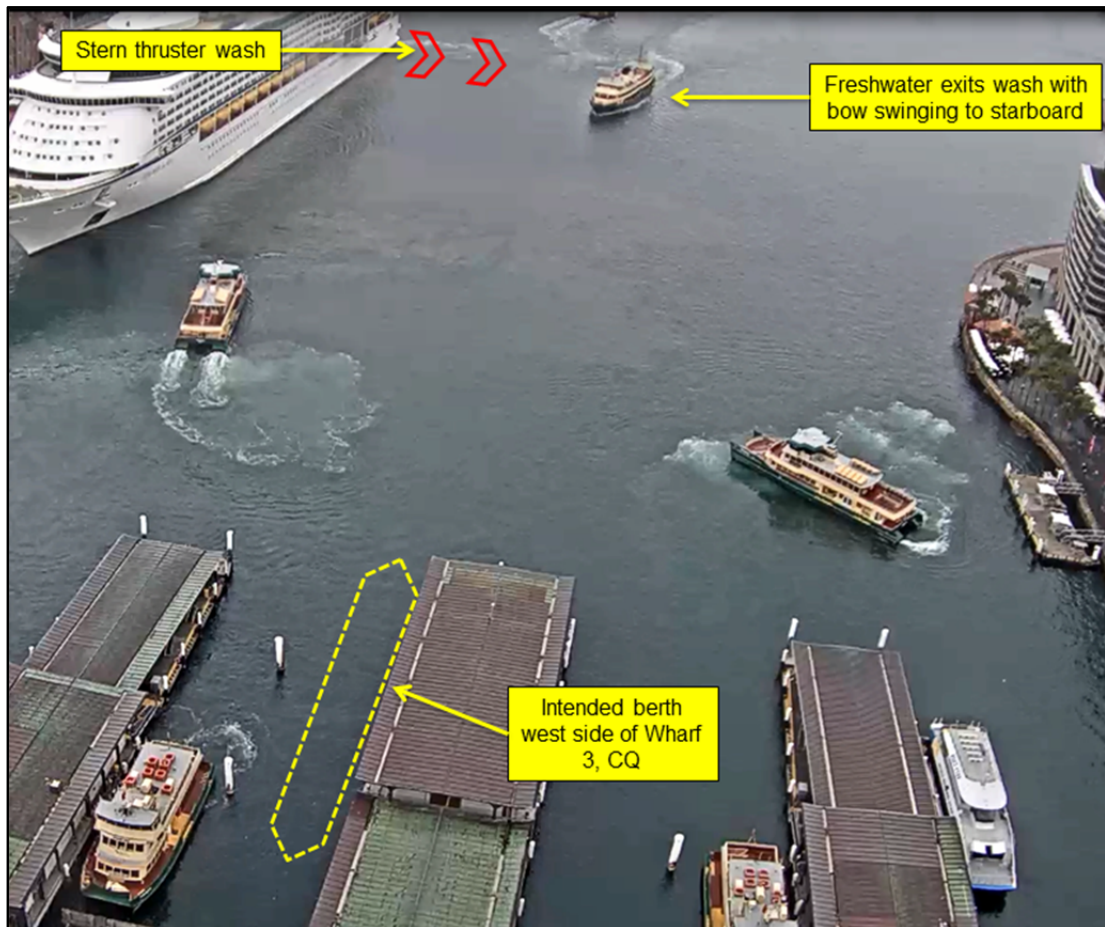
- 1.17 The master responded by turning the rudder to starboard, resulting in *Freshwater's* bow slowly swinging back to starboard. As *Freshwater* passed through the thruster wash, the wash began to apply force on *Freshwater's* stern. The force on *Freshwater's* stern resulted in the ferry's bow increasing

its rate of turn to starboard. The master slowed this rate of turn by entering a command for the rudder to turn to port (see *Figure 2*).

Figure 2: *Freshwater* exiting stern wash

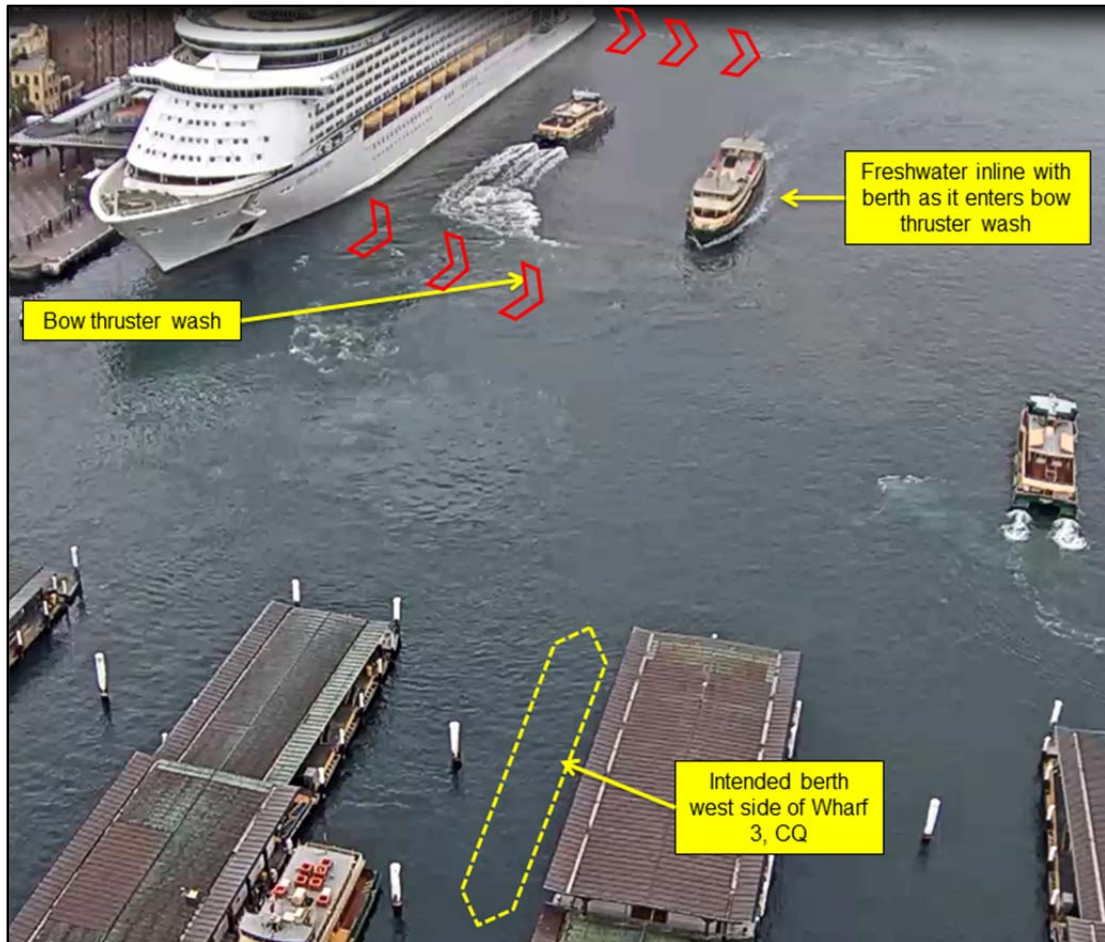
- 1.18 The master managed to realign *Freshwater*, now travelling at 8 knots, with Wharf 3 after passing through the stern thruster wash. *Freshwater* continued to slow as it moved forward. As *Freshwater* entered the liner's bow thruster wash, the ferry slowed to approximately 7.5 knots (see *Figure 3*). This wash, as before, turned *Freshwater* to port, then starboard.

Figure 3: *Freshwater* realigned with Wharf 3 prior to entering bow thruster wash

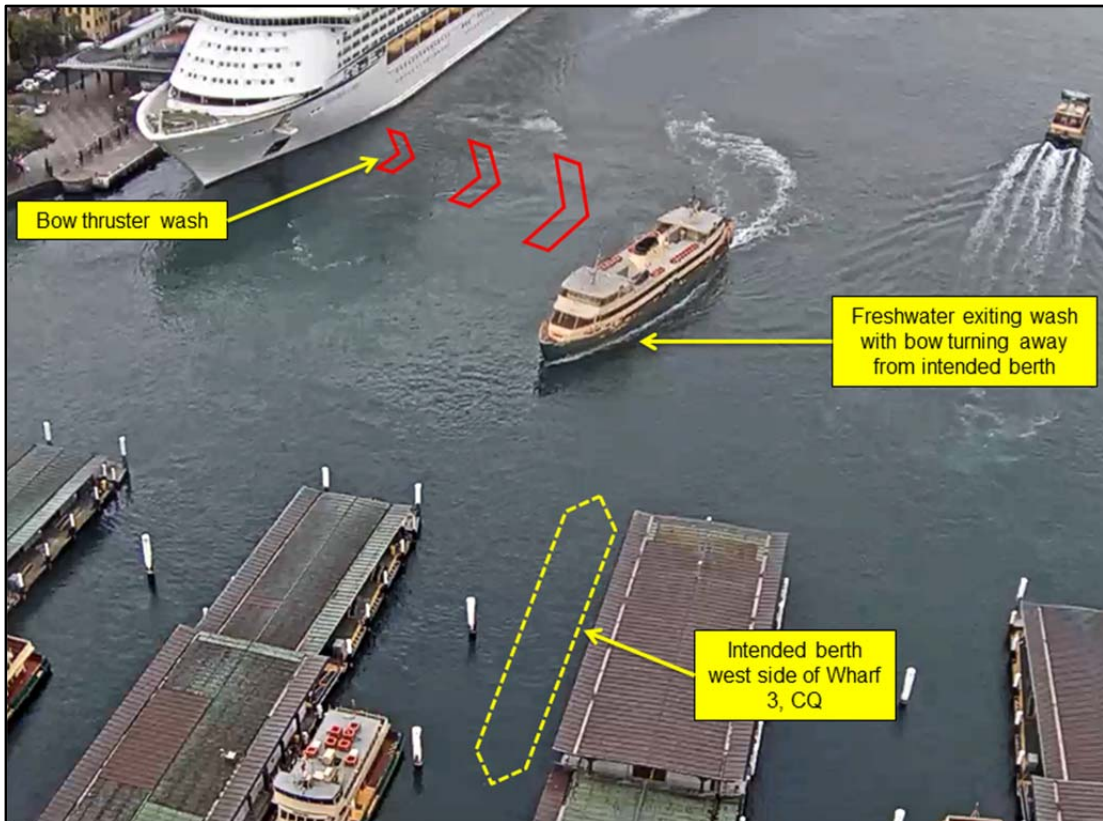
- 1.19 The master attempted to steer through the wash again, but this time was closer to the wharves with little room to manoeuvre (see *Figure 4*). The master recognised that a collision with the wharf was imminent. The ferry was travelling at 6.9 knots when the master selected full astern using the X-Y lever.

Figure 4: *Freshwater* exiting bow thruster wash turning to starboard

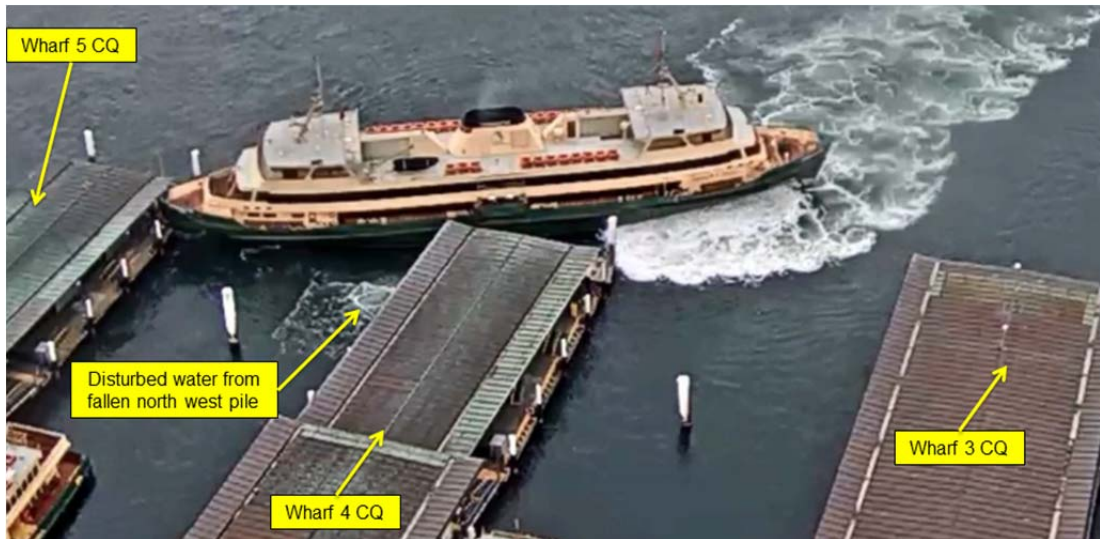
- 1.23 *Freshwater* slowed, to approximately 4.7 knots, swinging its bow further to starboard before striking Wharf 4 a glancing blow, knocking over the wharf's north-west pile. The ferry continued to slow, eventually contacting Wharf 5 at approximately 0.5 knots. *Freshwater* came to rest across the face of the Wharf 4 (see *Figure 5*). No injuries resulted from the incident.
- 1.24 The master did not activate the automatic public address message or sound the ferry's whistle to warn of an impending collision.

Figure 5: *Freshwater* makes contact with Wharf 5

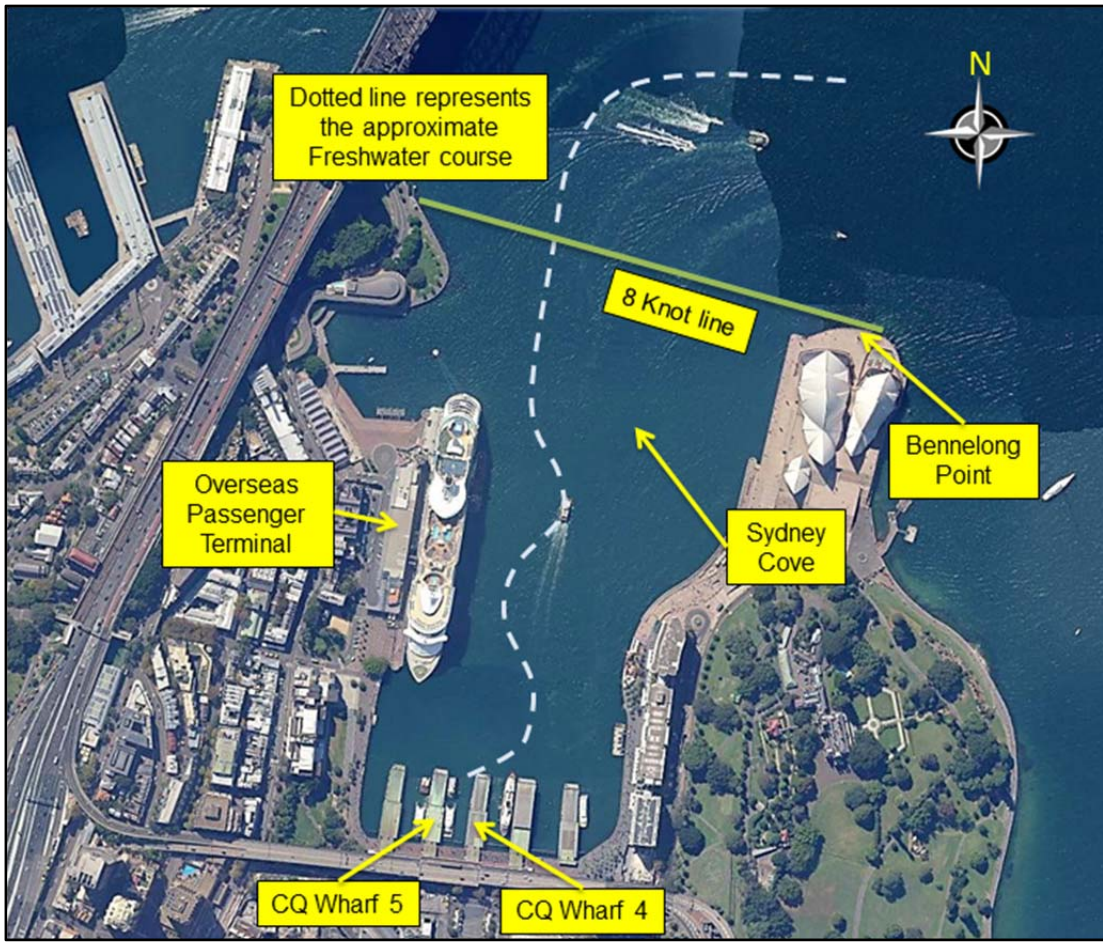
- 1.25 *Freshwater* suffered minor damage to hull and bulwark⁷ plating from the collision. For an overview of the *Freshwater*'s course in Sydney Cove see *Figure 6*.
- 1.26 Wharf 4 suffered damage to its crash barrier and to the north-western pile, which was knocked over. The loss of the pile allowed the crash barrier to float free.

Figure 6: *Freshwater* movements in Sydney Cove
