Office of Transport Safety Investigations

FERRY SAFETY INVESTIGATION REPORT

CLOSE QUARTERS

25 JULY 2012

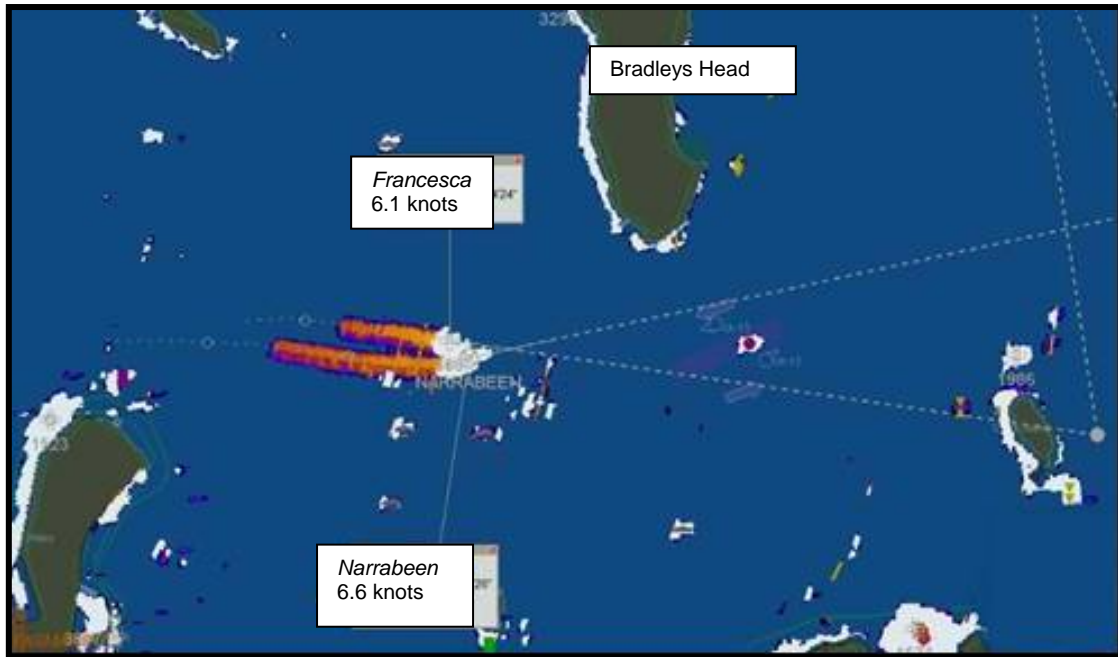
Radar Screenshot 1: *Narrabeen* altering course across *Francesca*

clearing distance estimated by *Francesca*'s Master to be only 10 to 15 metres. *Narrabeen* altered course slightly to port on a course of 077° travelling at 6.4 knots while *Francesca* was steady on a course of 096° travelling at 5.8 knots. The *Narrabeen* was now on a course which would pass on the wrong (north) side of the safe water buoy heading into the Western Channel.

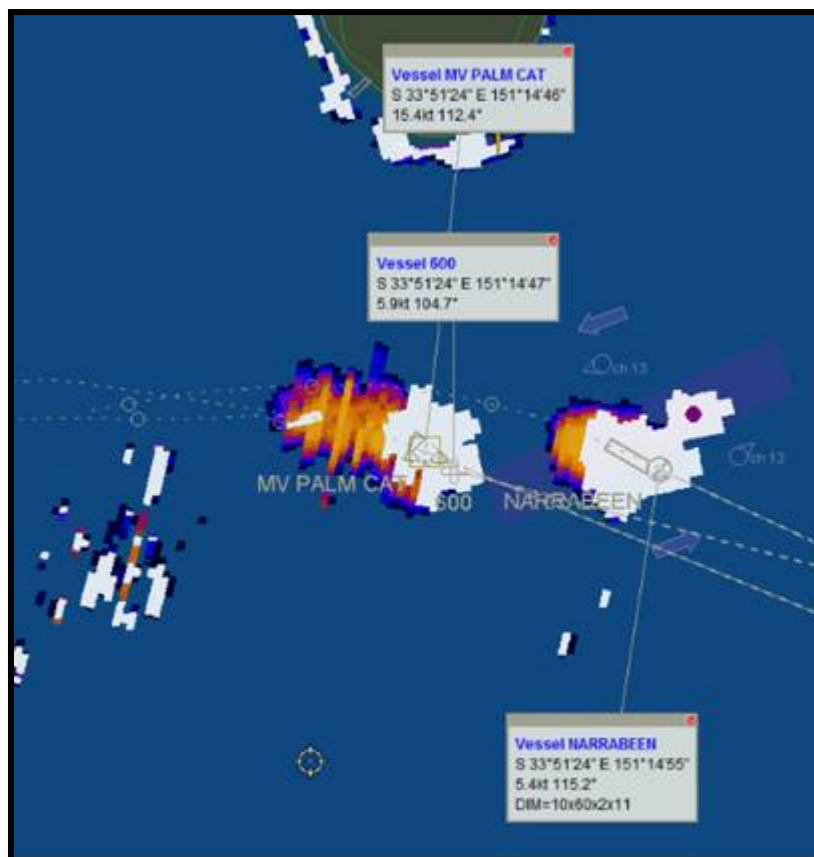
Radar Screenshot 2: *Palm Cat* close to *Francesca*'s port quarter¹²

- 1.40 At 6:06:56am *Narrabeen* altered course to 115° at 5.4 knots, *Francesca* was on a course of 104° maintaining 5.6 knots and *Palm Cat* was very close to the port quarter of *Francesca* on a heading of 112° but having just reduced its speed to 15.4 knots.
- 1.41 At 6:07:10am *Narrabeen* was south of the Bradleys Head safe water buoy on a course to 107° at 5.2 knots (see *Screenshot 2*). *Francesca* and *Palm Cat* were maintaining course and speed as *Palm Cat* overtook *Francesca* on its port side at a distance estimated by the Master of the *Francesca* to be no more than 5 to 10 metres. The crew of *Palm Cat* described the distance as close enough to call out to the crew on the aft deck of *Francesca*. Both the Master and Mate of *Francesca* reported hearing someone call out from *Palm Cat* at the time.

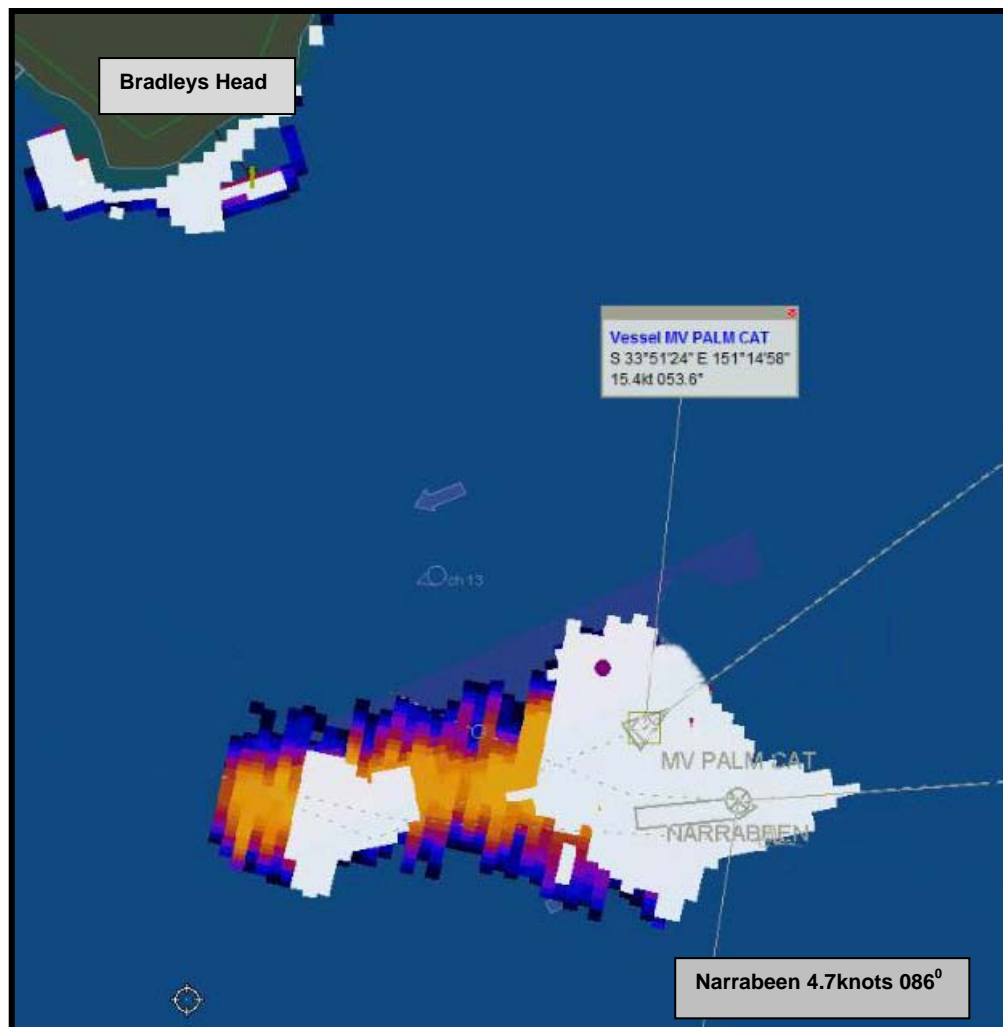
Radar Screenshot 3: *Palm Cat* after close quarter with *Narrabeen*

- 1.42 *Palm Cat* passed *Francesca* and continued on maintaining course and speed. At 6:07:43am *Palm Cat* altered course to 053° and overtook *Narrabeen* very close on the port side (see Screenshot 3). *Narrabeen* was then on a heading of 086° at 4.7 knots. The Master of *Francesca* stated that he slowed further expecting to hear the sound of a collision between *Palm Cat* and *Narrabeen*. He estimated the distance between *Palm Cat* and *Narrabeen* as “no more than 5 to 10 metres with the *Palm Cat* travelling far too fast”. The *Palm Cat* then continued south of the safe water mark and turned to port on a course of 014° heading towards the shore line at the north-eastern end of Chowder Bay at 14.5 knots.

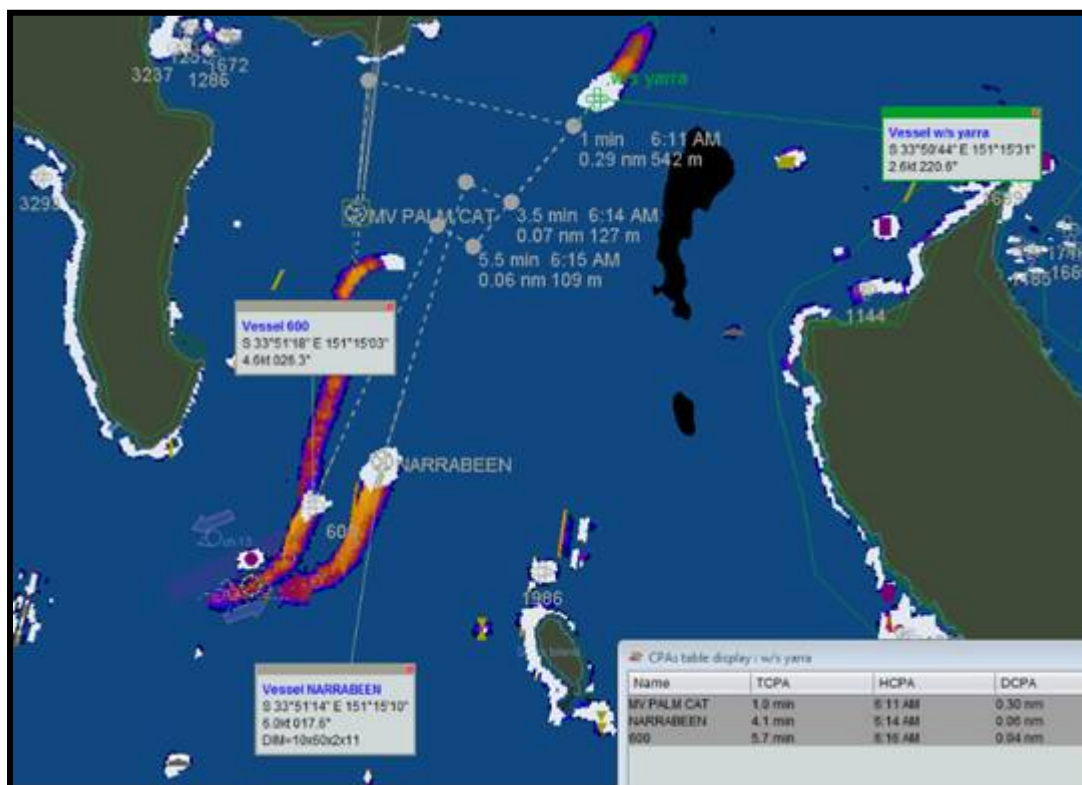
Radar Screenshot 4: *Palm Cat* commences 105° starboard turn

- 1.44 At 6:10:29am, in the words of the Master of *Palm Cat* at interview, “we altered course slightly to starboard”. However, the radar track showed this turn to be 105° (see Screenshot 4).

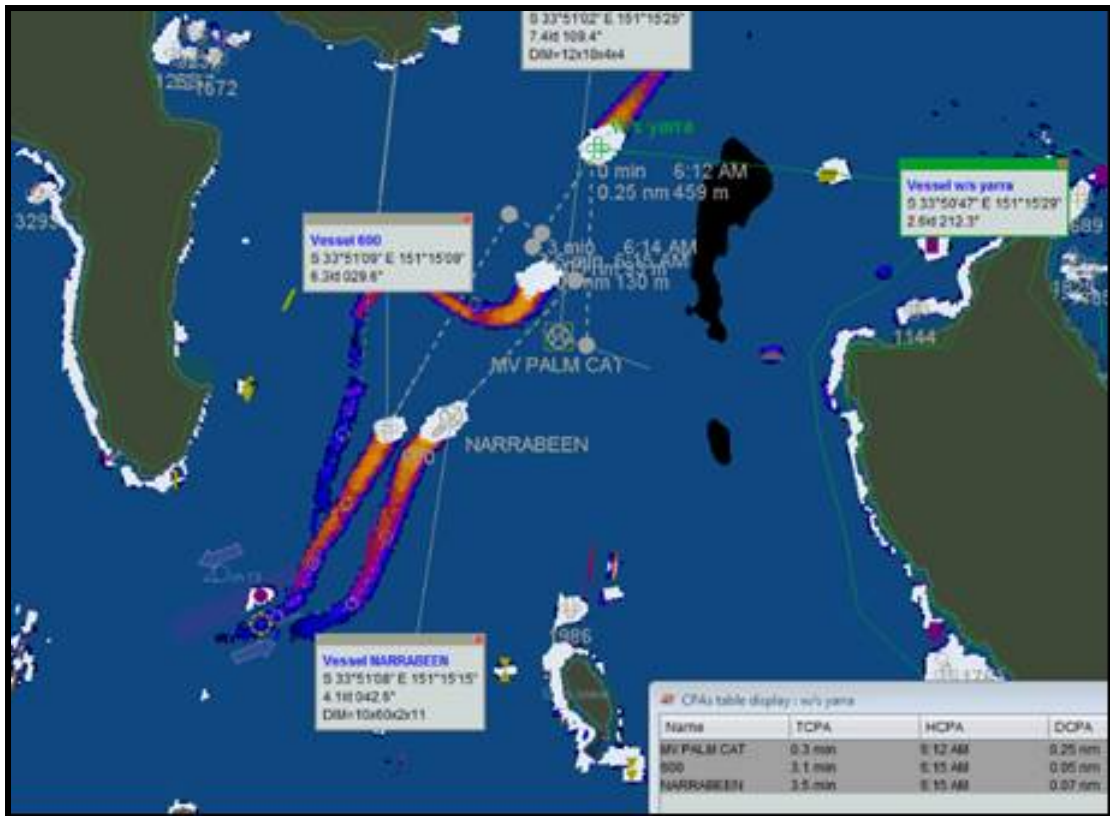
Radar Screenshot 5: *Palm Cat* turns towards *HMAS Yarra*

- 1.45 At 6:11:17am *Palm Cat* crossed the path of *HMAS Yarra* which was on a course of 215° at 2.2 knots. *Narrabeen* was on a course of 036° at 4.5 knots and *Francesca* was on a course of 029° at 6.1 knots.
- 1.46 At 6:11:35am *Palm Cat* altered course 85° to port towards *HMAS Yarra* which was keeping a steady course and speed. In this manoeuvre, *Palm Cat* had made a turn to port towards a vessel forward of her beam in restricted visibility. At this stage, *Narrabeen* was on a course of 043° at 4.3 knots and *Francesca* was on a course of 030° at 6.3 knots (see Screenshot 5). *Palm Cat* passed *HMAS Yarra* port to port then continued on to Manly.

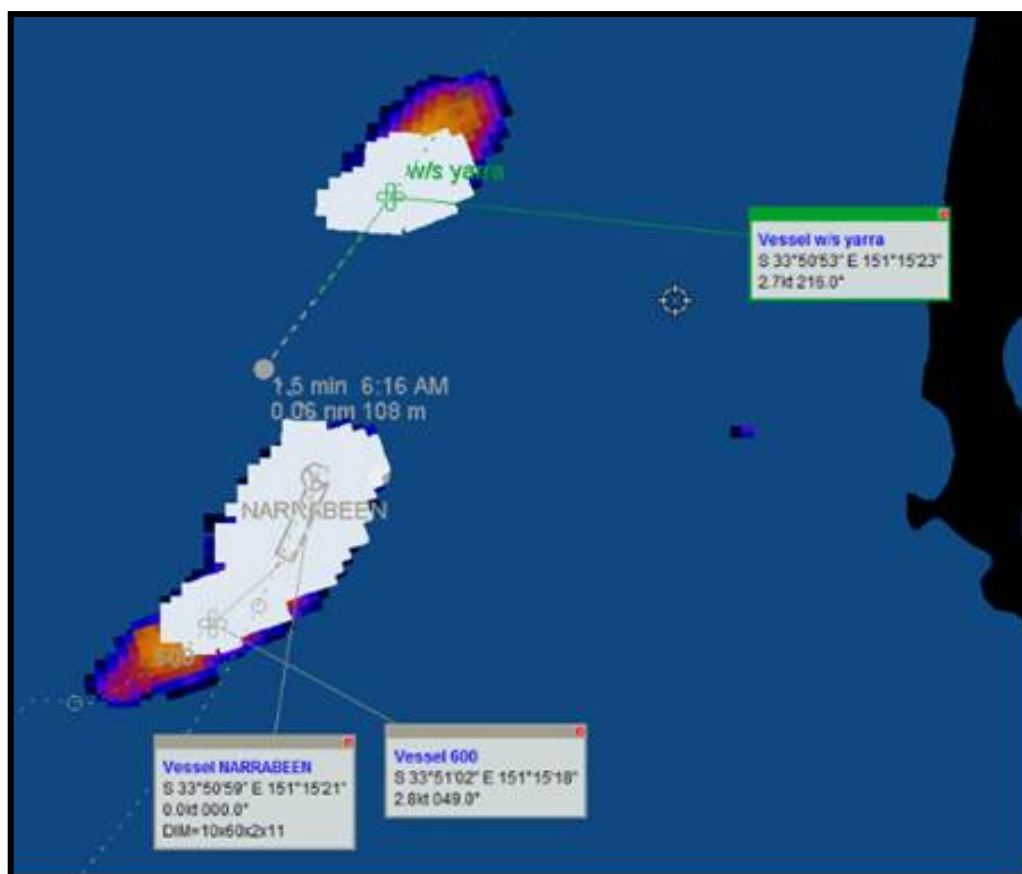
Radar Screenshot 6: *Narrabeen* stationary

- 1.50 At 6:14:50am *Narrabeen* was stationary, *Francesca* was astern of *Narrabeen* on a heading of 051° at 3.3 knots and *HMAS Yarra* was still closing *Narrabeen* and *Francesca* on a heading of 217° at 2.7 knots (see Screenshot 6).

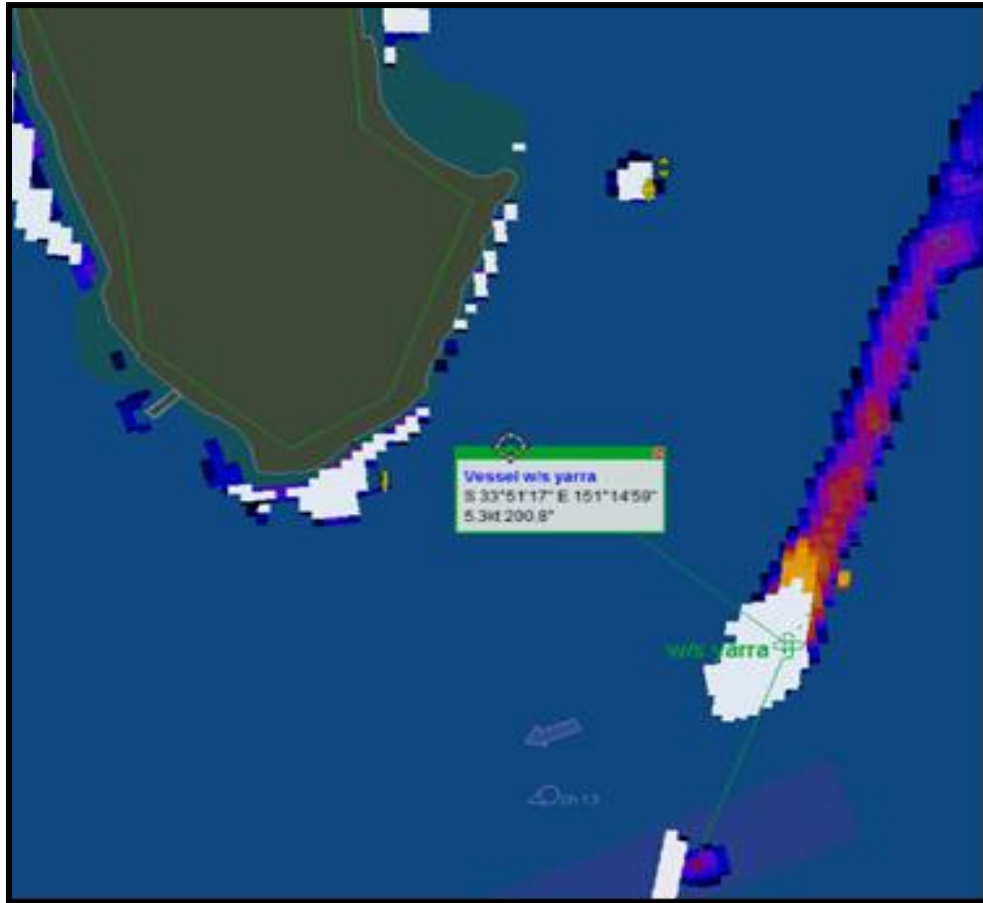
Radar Screenshot 7: VTS notifies *HMAS Yarra* of Safe Water Buoy

- 1.53 Bradleys Head Light is a major navigational mark for all vessels entering, leaving and navigating within Sydney Harbour, which makes the fog signal associated with it of particular importance. The fog signal sounds one long blast followed by two short blasts ('D' in Morse Code).
- 1.54 Due to an electrical power cut at 6:00pm on 24 July 2012, the light was operating at reduced power but the fog signal was not operating. The Harbour Master and VTS were unaware that the power had not been fully restored at 04:00am as expected, nor were they aware that the fog signal was not sounding due to the reduction in the power supply. Hence, there was no mention of the fog signal being inoperative in the VTS routine information broadcast at 6:07am.
