FERRY SAFETY INVESTIGATION REPORT

PASSENGER FATALITY – *MV LADY ROSE*

SYDNEY HARBOUR, NSW

2 FEBRUARY 2019

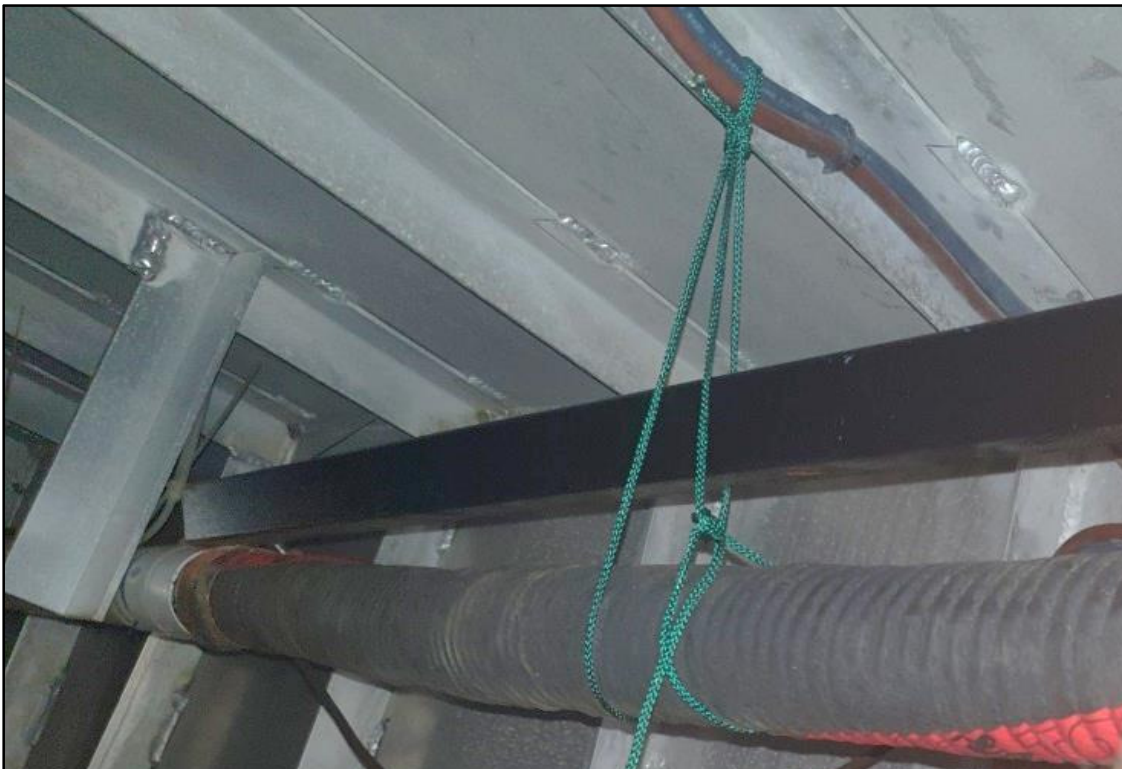
Figure 12: Chord securing rubber hose fitted to vent line

- 2.66 During an inspection of the sewage system, the contracted MAC plumber found that a flexible hose fitted to the horizontal sullage tank vent pipe had sagged approximately equivalent to the outer diameter of the hose. The hose was supported by a piece of cord tied to a bundle of electrical cables above it (refer to *Figure 12*).

- 2.67 The contracted MAC plumber disconnected this length of rubber hose from the vent pipe near the connection to the top of the starboard sullage tank. He noted that a large quantity of effluent was present inside the hose. He was of the opinion that the liquid trapped in the sag in the hose would form a vapour blockage that '*would stop the flow of air*' from the starboard tank, through the vent pipe and to the mast head vent to atmosphere.

fitted to the vent line were; *'Adequate clamping and support of flexible piping systems is required to prevent sagging of flexible piping elements and to ensure adequate fall is provided on the flexible piping, which may otherwise impede the proper operation of the sanitary plumbing system if adequate support is not provided'*.

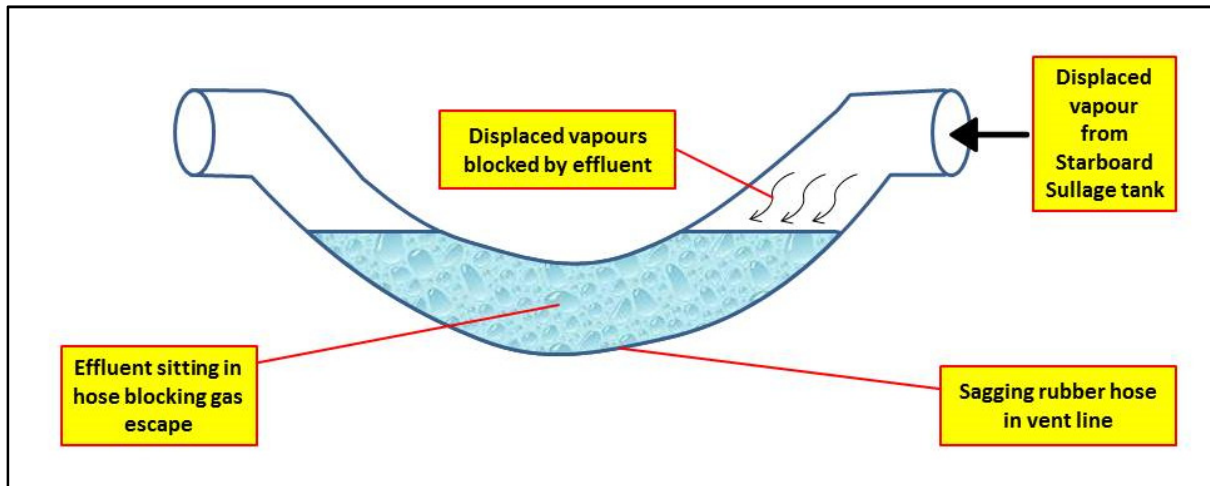
Figure 14: Vapour lock caused by sagging vent line

- 2.69 It is likely that the liquid observed within the rubber hose originated from the port sullage tank due to the tank overflowing from the faulty cistern valve. With the inflow of liquid from the port tank via the vent line and the starboard toilets and galley, it is likely that the available air space in the starboard tank was reduced. As the normal pathway for the sewer gases was impeded by the blocked tank vent line, it is likely that sewer gases from the tank were forced into the main starboard sewer network (refer to *Figures 13 and 14*).

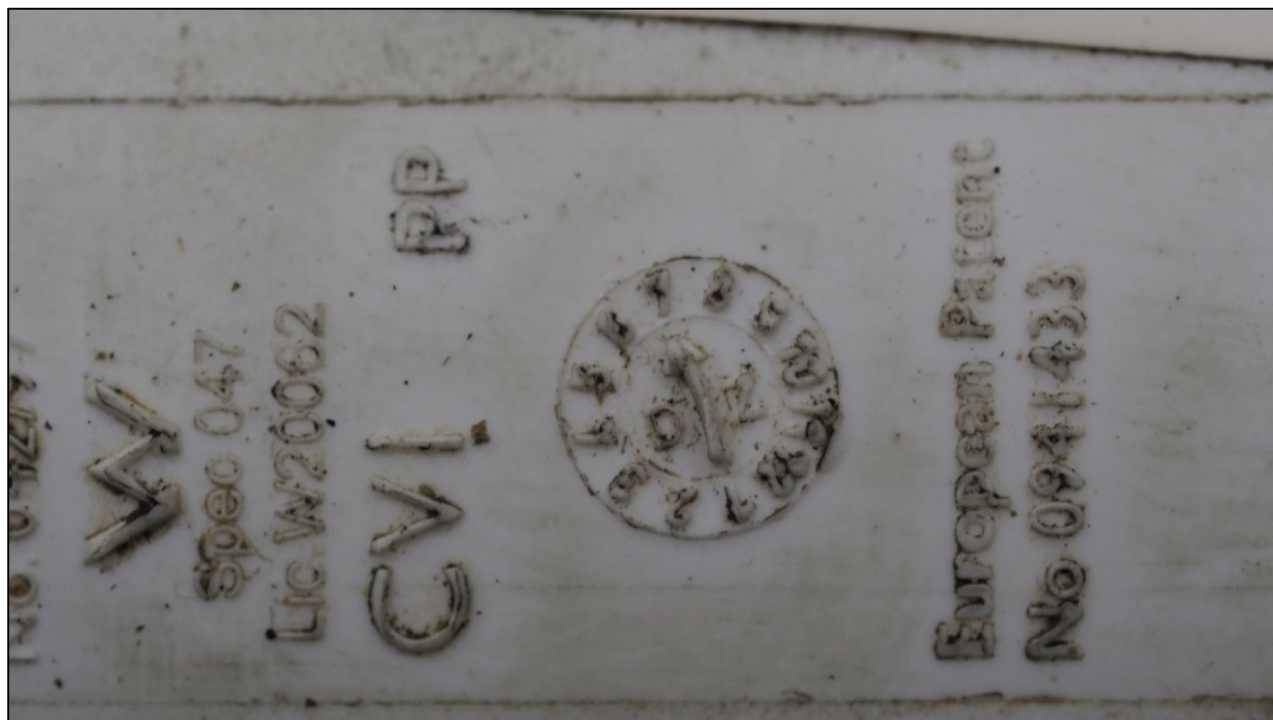
Figure 15: Manufacture date stamp on waterless valve

- 2.73 AOC stated that to the best of their recollection, the waterless trap in the subject cubicle was replaced in October or November of 2018. The date indicator on the waterless trap showed a manufacturing date identification of July 2010 as confirmed by the OEM (refer to *Figure 15*).

- 2.74 Service information from the manufacturer of the waterless trap specific to life expectancy states: *'Installed correctly can be expected to have a life expectancy at least equivalent to current water sealed traps. In addition, HepvO is guaranteed against defects in materials or manufacturing for a period of three years'*.

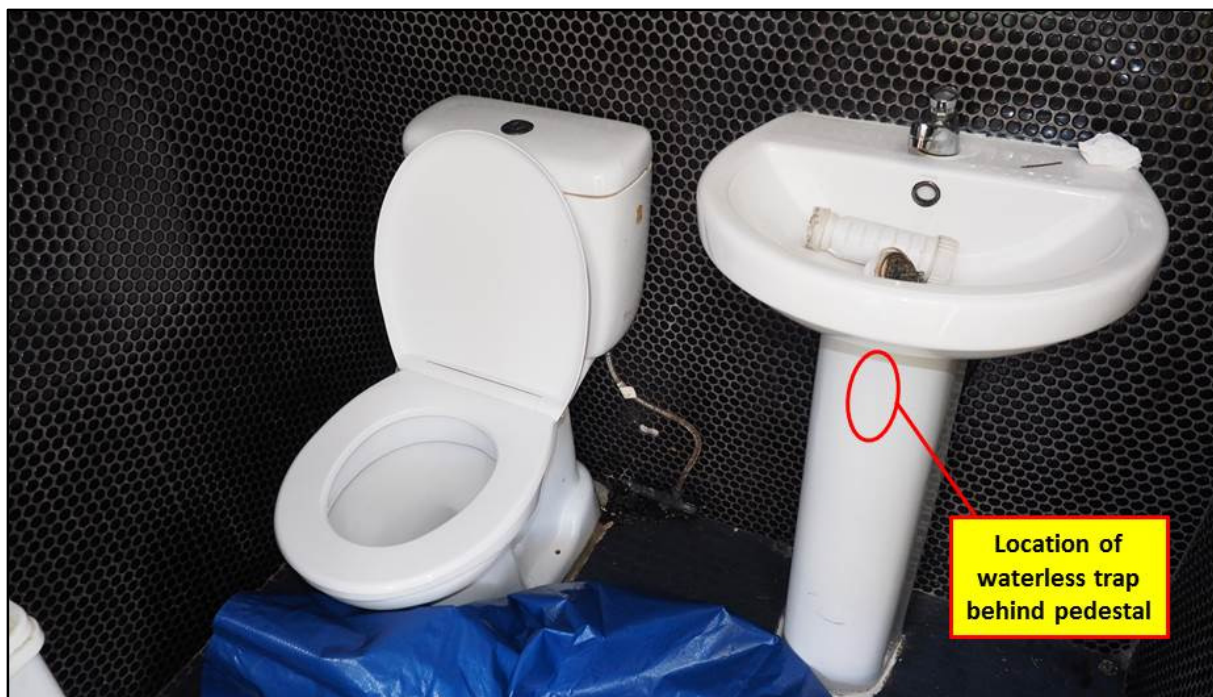
Figure 16: Location of waterless trap behind basin pedestal

- 2.71 Following the incident, the waterless trap fitted to the hand basin in the incident cubicle was removed for inspection by the contracted MAC plumber. It was found that the upper edge of the silicon membrane was damaged with a tear approximately 6mm in length. This tear would likely allow sewer gases to bypass the membrane and enter the cubicle (refer to *Figures 16, 17 and 18*).

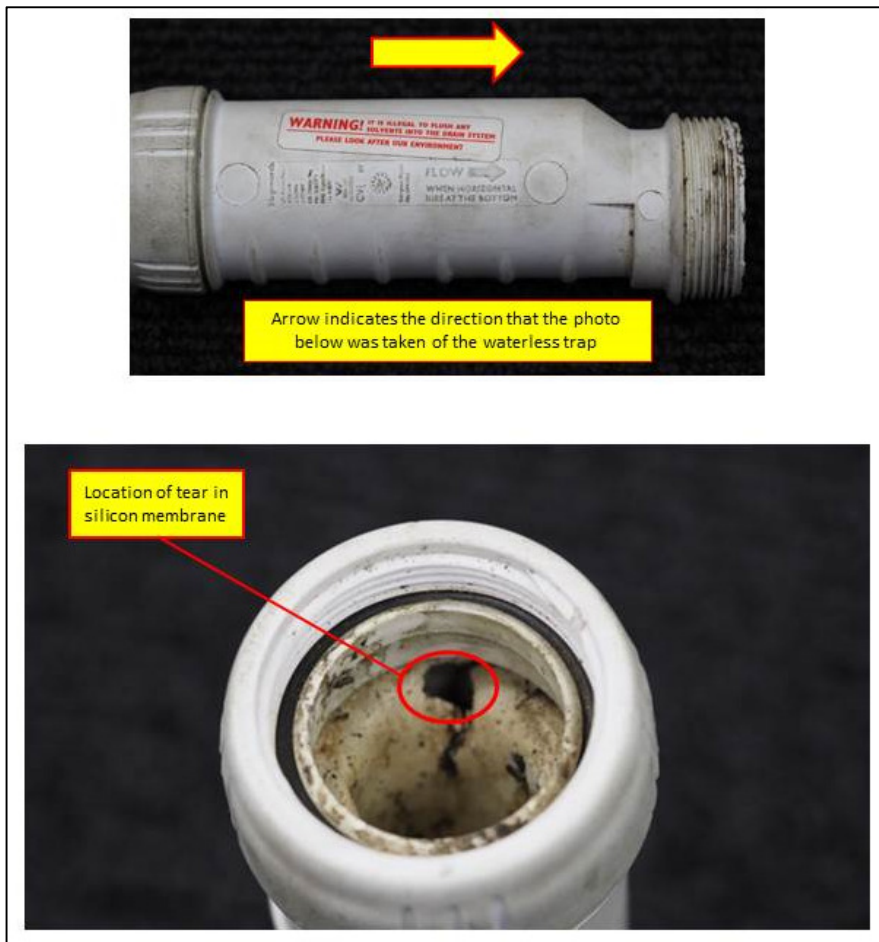
Figure 17: Tear in waterless trap sealing membrane

- 2.75 The contracted MAC plumber was of the opinion that the waterless trap was not fit for the application. He said; *'I would not use of this type of trap in a public facility or commercial survey vessel due to common instances of foreign articles placed down the drain'*. This was evident during the removal and inspection of the trap as he also states; *'when I removed the trap from the starboard inboard cubicle, I noticed it was a waterless trap. I immediately*

noticed it was partially blocked with debris and a hairpin. I also noted a ¼ inch tear in the silicon membrane’.

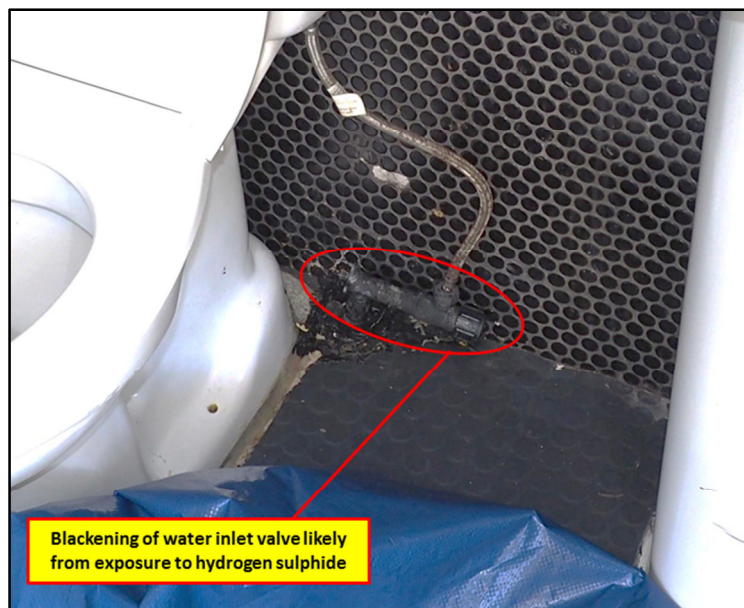
Figure 22: Water inlet valve showing blackening of chrome finish

2.118 *'In some investigation diagnoses, identifying the presence of hydrogen sulphide is made indirectly through identification of blackening of metal objects. The diagnosis is based on known sources of pollution or investigation of the accident site for blackened metals, a characteristic of exposure to hydrogen sulphide'*²⁶.

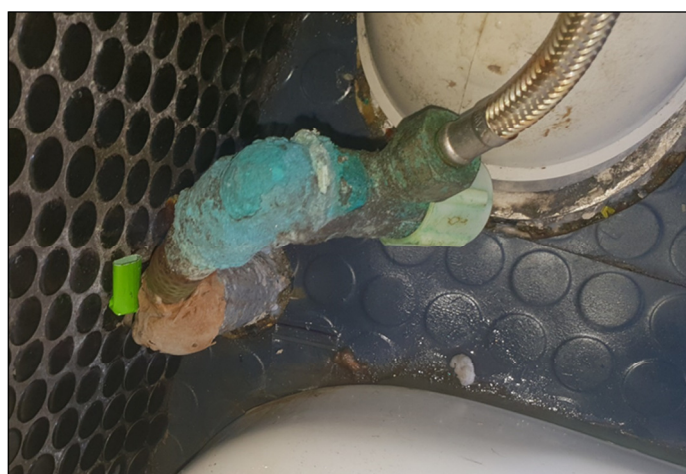
Figure 23: Comparison photo of similar water inlet valve

2.117 *Figure 23*, shows a sample of the corrosion observed in the remaining toilet cubicles. The corrosion in these cubicles is likely to have originated from exposure to salt water and or urine and is green / blue in colour.

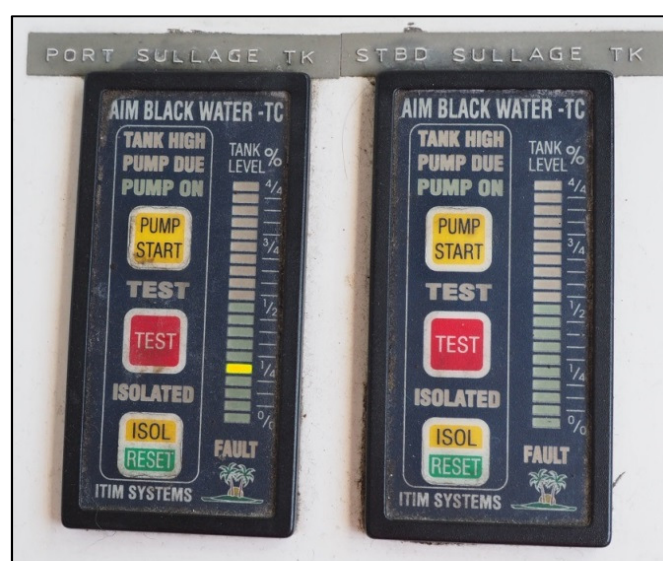
Figure 24: Sullage tank indicator panel with pump start switch

2.119 The two sullage tanks on *Lady Rose* were each fitted with a system known as a direct overboard discharge facility. The system was fitted with two electric pumps that allow untreated sewage to be drawn from the sullage tanks and discharged overboard via the engine exhaust outlets at the stern of the vessel. Power is supplied to these pumps through two circuit breakers marked 'sullage pump' located in the vessel's main circuit breaker panel. The sullage pumps are operated remotely via a switch on the sullage tank indicator panels located in the wheelhouse. The switches are labelled as 'pump start' (refer to *Figure 24*).

2.123 The fitment of the discharge facility was in contradiction with the conditions of Appendix A, section 6 of the Recognition Certificate issued against *Lady Rose* in 2001 (refer to *Figure 25*). Up until the removal of this condition in the National Certificate of Survey and Operation issued by RMS in December 2014, the condition was noted in no less than ten prior surveys carried out on the vessel.
