# **RAIL OCCURRENCE: FACTUAL STATEMENT**

## **LEVEL CROSSING COLLISION**

### **MOORLAND, NSW**

**21 APRIL 2016**

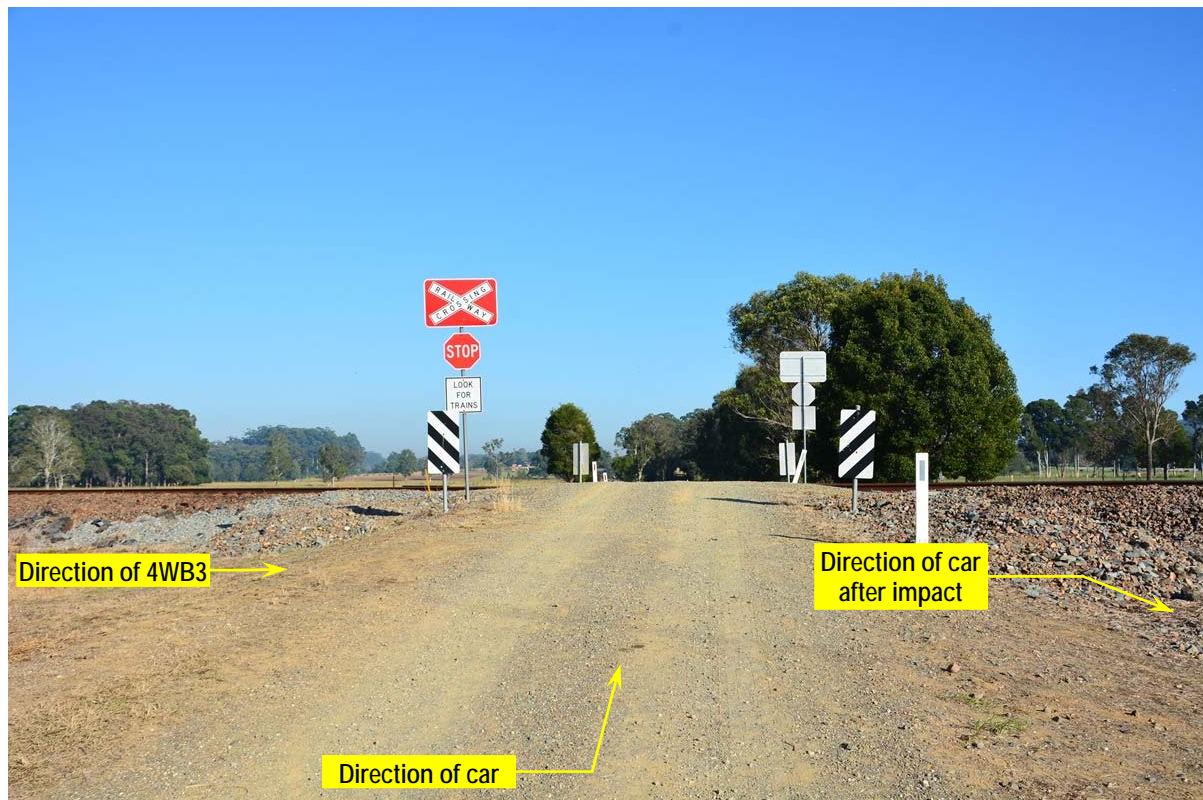
Photograph 1: Henrys Lane level crossing

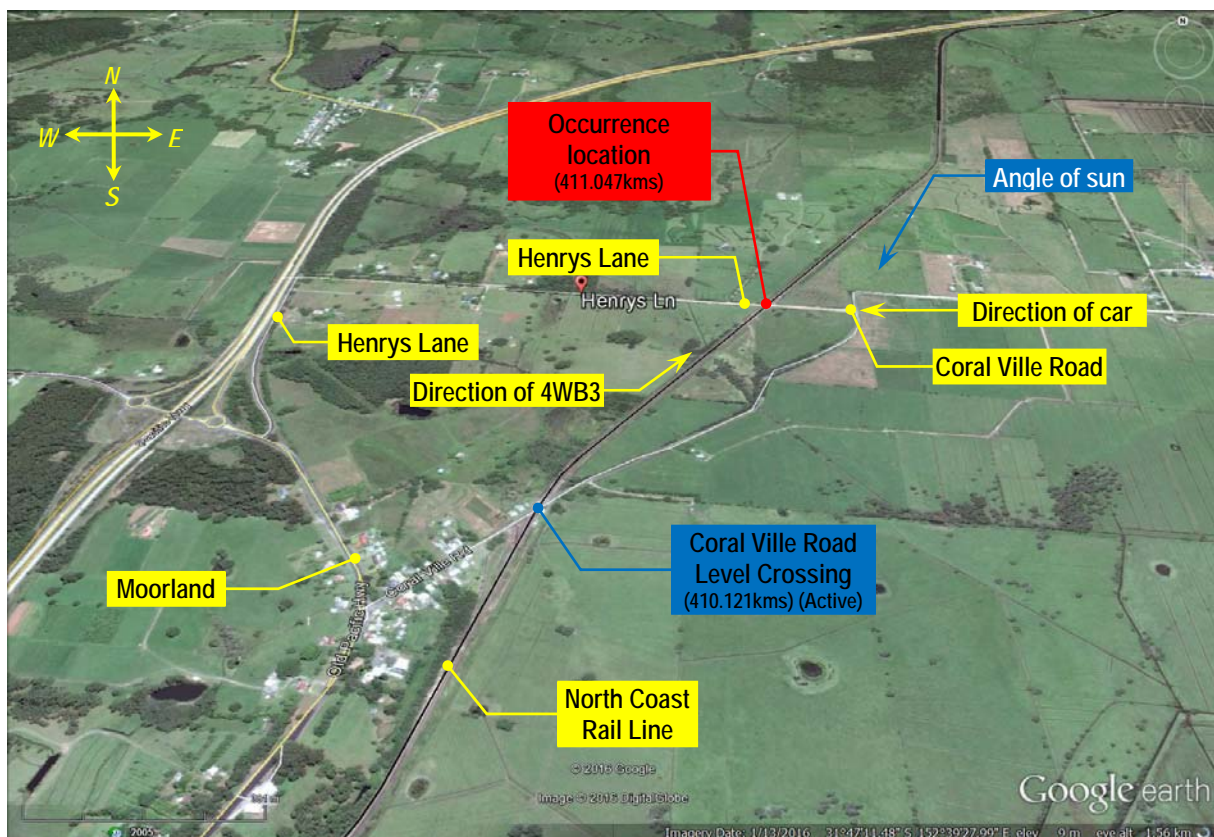
Photograph 2: Location of Henrys Lane level crossing

- 1.4 Henrys Lane is a thoroughfare servicing a small number of rural properties between Coral Ville Road and the Old Pacific Highway at Moorland. (*Figure 2*) An alternative level crossing was available on Coral Ville Road approximately two kilometres south of Henrys Lane. This crossing was protected with 'active' warning lights, bells and boom gates.
- 1.5 The train crew observed the car approaching the crossing 'at speed'. However, despite illuminated headlights on the leading locomotive and the

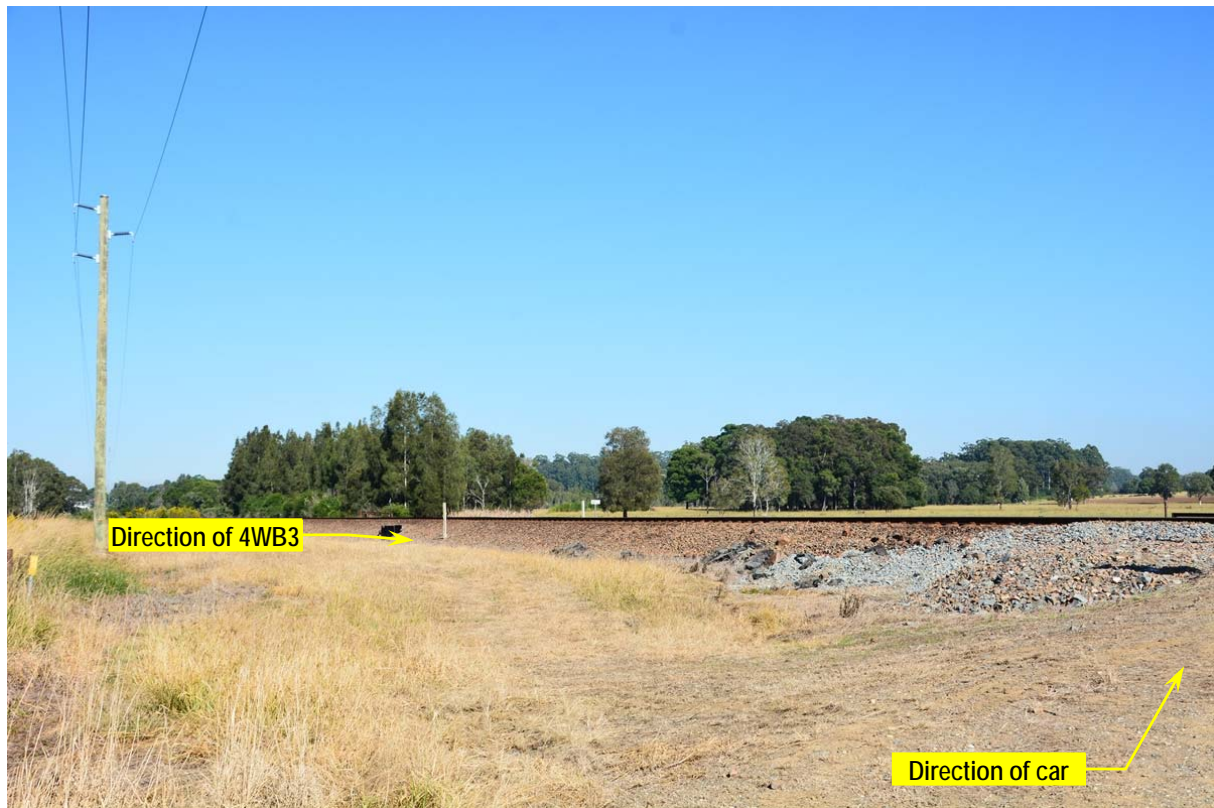
Photograph 3: Location of crossing – looking in direction of the approaching train
