# Locomotive fire

Awaba, New South Wales | 5 June 2014

## **ATSB Transport Safety Report**

RO-2014-010

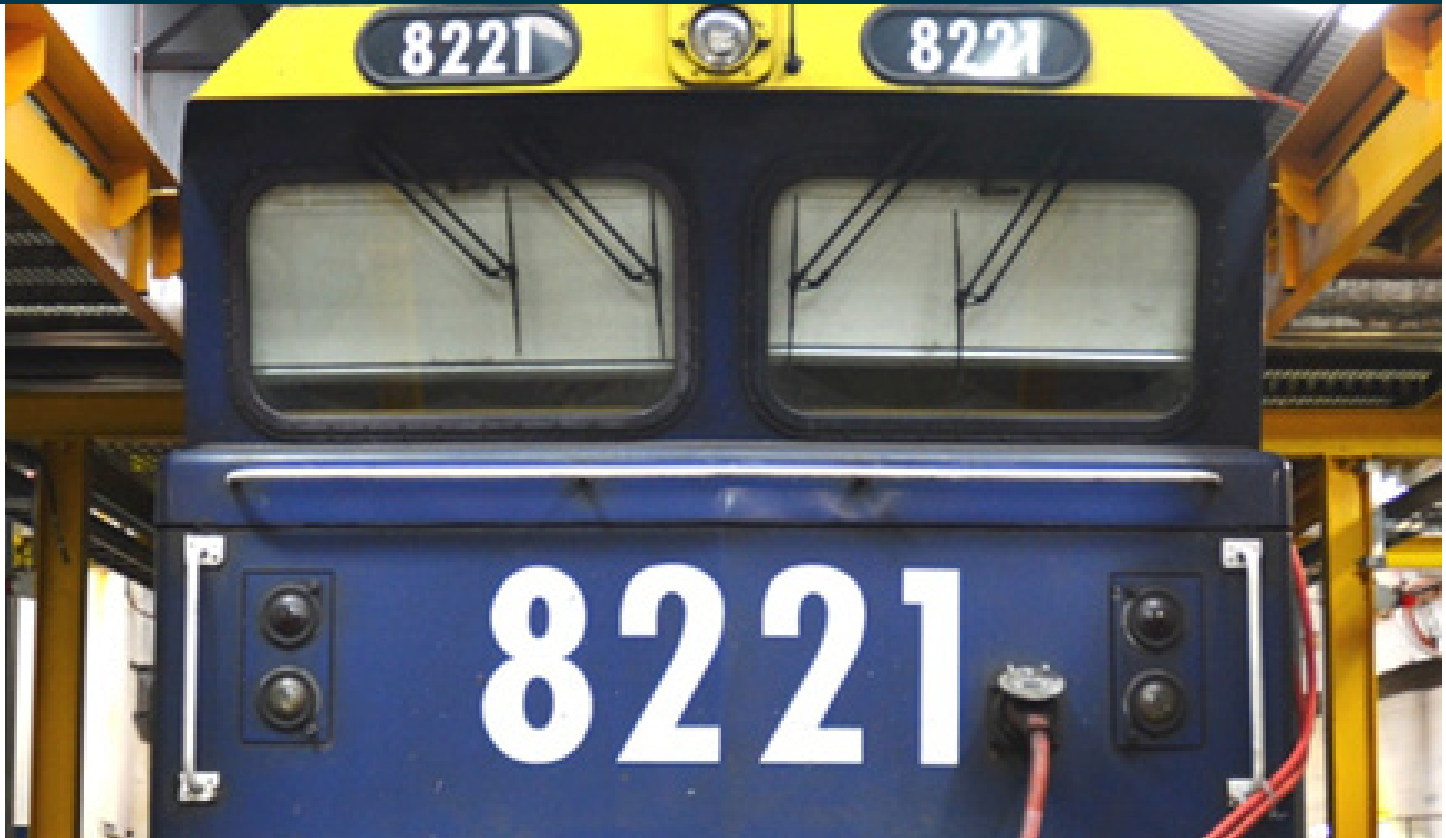
## 8221 Fire damage pattern

At 2245 on 5 June 2014, the crew on Pacific National (PN) coal service ER64 reported that flames were emanating from the top of the fourth locomotive, 8221, on their train. At the time, ER64 was near Awaba in New South Wales enroute to unload at the Eraring power station. The crew stopped the train and assessed the extent of the fire while also calling for fire brigade assistance. The fire was declared extinguished at 0139 on 6 June 2014. It caused substantial damage to the locomotive.

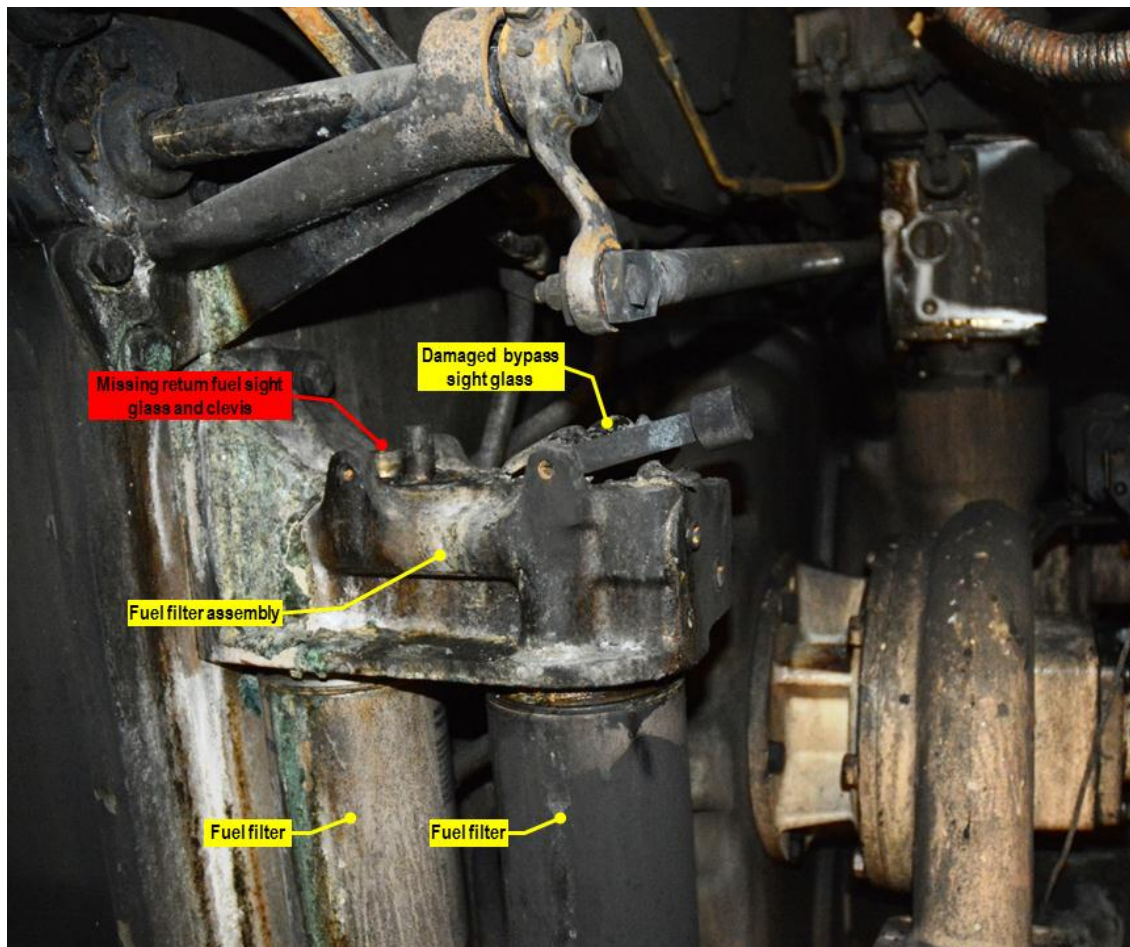
**Figure 3: Damaged fuel filter assembly including missing return fuel sight glass and clevis**

The inspection further determined that the fire had most likely originated at the return fuel sight glass which was missing from the top of the fuel filter assembly (Figure 3). Remnants of the return fuel sight glass, a sight glass seal and the sight glass clevis, which clamps the sight glass onto the filter assembly, were recovered from the sump floor unaffected by the fire (Figure 4). The clevis and remnants of the second (bypass) sight glass were observed still in position albeit fire affected.

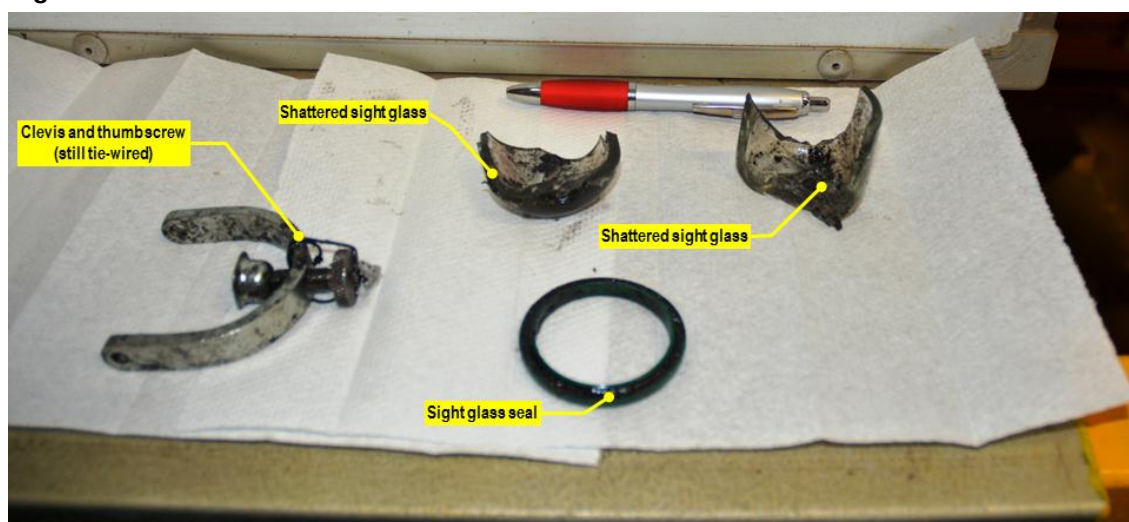
**Figure 4: Recovered items**

The absence of fire damage on the recovered items indicated that they had disengaged and fallen from the filter assembly prior to the fire igniting. This disengagement would have caused diesel fuel under pressure to leak and eventually spray throughout the engine bay starving the engine of fuel and causing it to lose power. The crew reported that the train had experienced a power loss as it passed through Newstan Colliery.

Initial inspection of the items recovered from the sump revealed the following:

- The clevis thumb screw was still tie-wired in position complete with clamp seat intact but not in accordance with current maintenance procedures. However, the second (bypass) sight glass was a Durox® ratcheting type which is currently being removed from service as its thumb screw cannot be tie-wired in accordance with these procedures

- The overall width of the clevis had compressed and bent inwards from 170 mm to 164.5 mm. This caused an excessive total gap of 5.5 mm when the clevis was fitted into position in the mating (170 mm) aperture on the fuel filter assembly

- The protrusion of the two clevis bolts, which measured 6 mm and 2.5 mm respectively, was not set correctly in the fuel filter aperture
- The thumb screw hole was not centrally located width-wise in the clevis

- The thread on the thumb screw exhibited considerable wear
- There were no part number or equipment manufacturer details marked on the clevis.

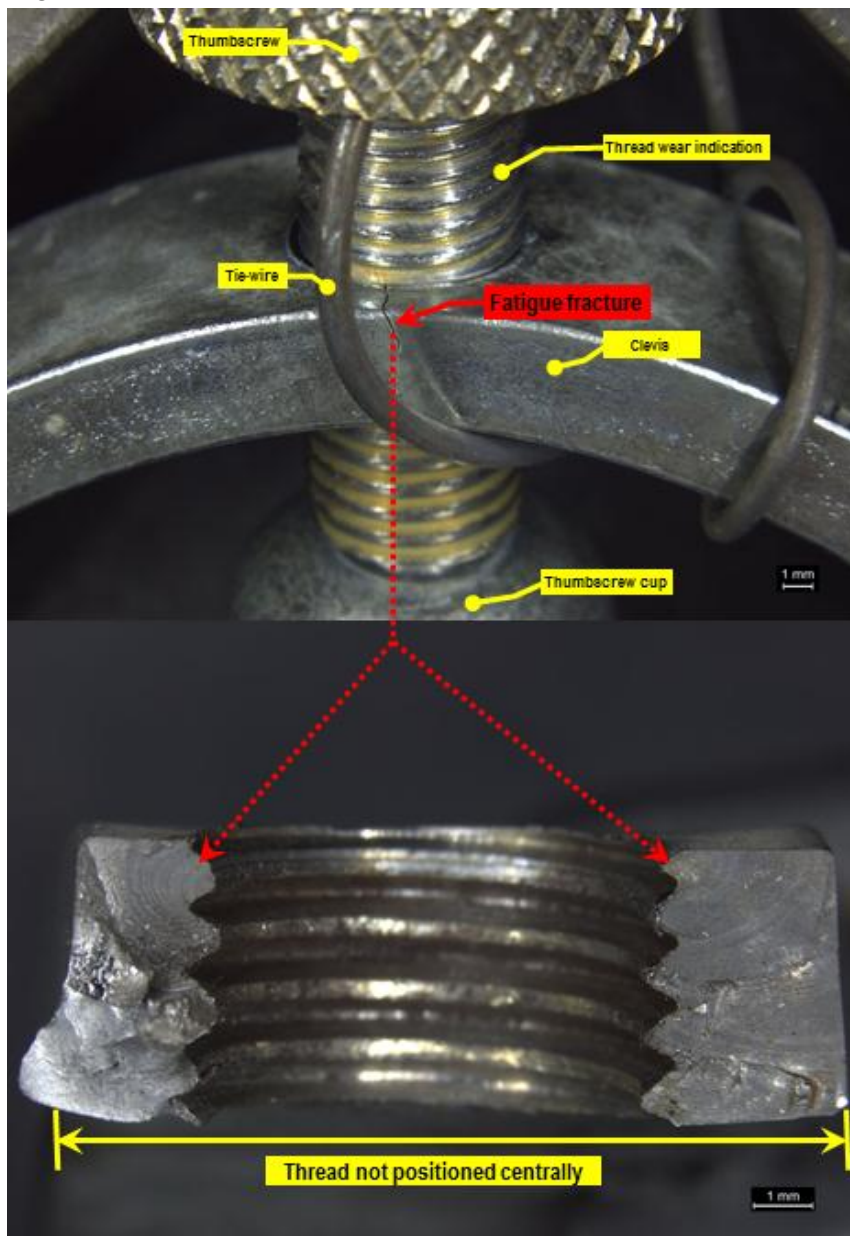
**Figure 6: Fatigue fracture**

- The presence of a fatigue fracture that had progressed through 75% of the cross sectional area at the thumb screw hole of the clevis (Figure 6)
- There were gas inclusions (bubbles) within the sight glass material
- The seal recovered was not made of the current specified material.

The compressing of the clevis was most likely the result of continual over-tightening. The continual over-tightening was evidenced by the wear on the upper surface of the thumb screw thread and the fatigue fracture which initiated at a stress point relative to the thread in the clevis.

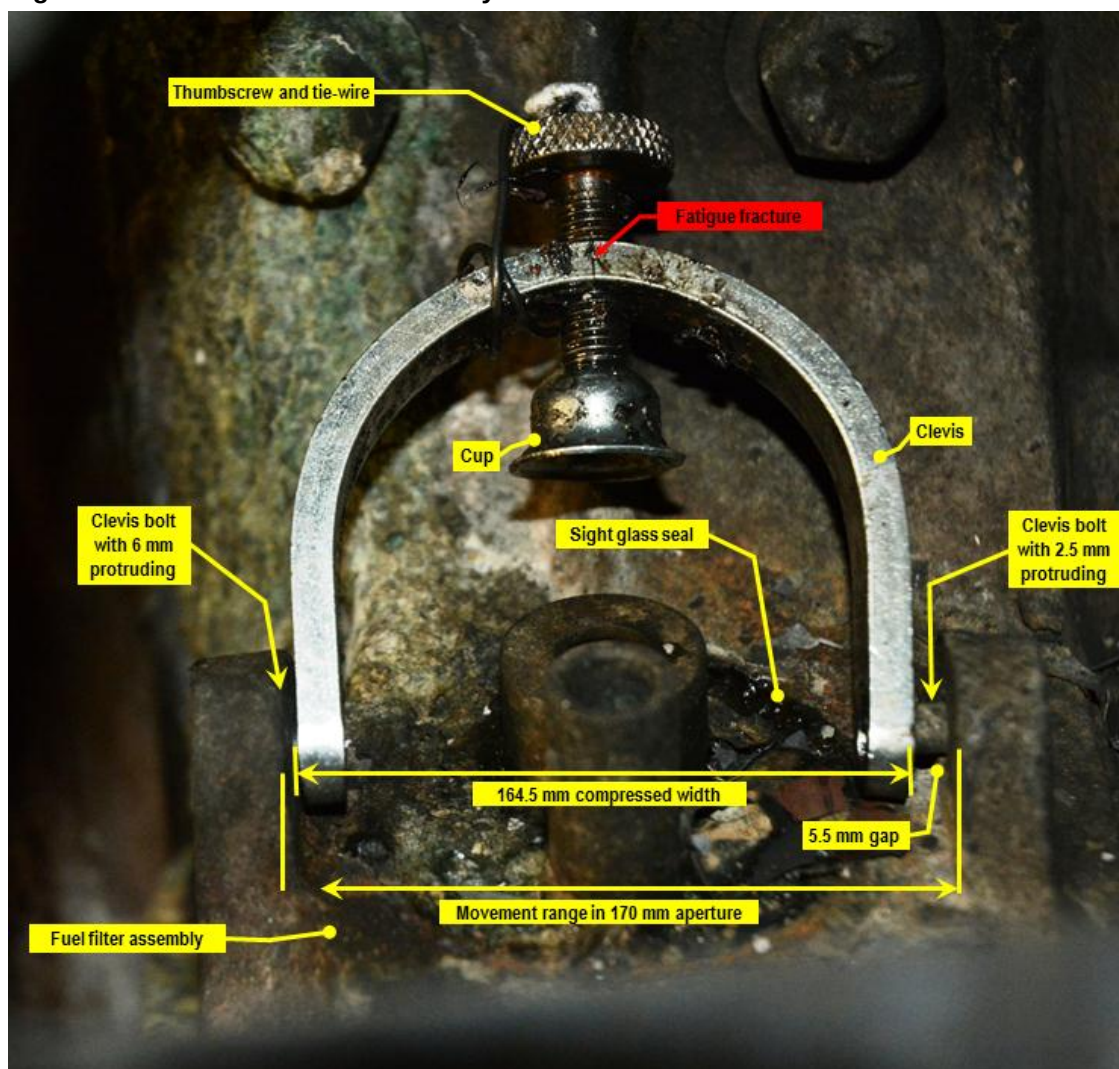
**Figure 7: Clevis on fuel filter assembly**

- The overall width of the clevis had compressed from a nominal width of 170 mm to 164.5 mm. This created a total gap of 5.5 mm for lateral movement between the clevis and the faces of the aperture in the fuel filter assembly (Figure 7)
- One of the clevis bolts protruded only 2.5 mm into the aperture. With the 5.5 mm gap in the aperture, the clevis only had to move laterally the length of the protruding pin (2.5 mm) before one side disengaged. Once disengaged, all clamping on the sight glass was released allowing fuel under pressure to escape into the engine bay.

In addition, subsequent dismantling of the fuel filter assembly by PN, in conjunction with Downer EDI Rail (DEDIR), identified that the short protruding clevis bolt was a non-OEM part with a differing thread which had misaligned upwards during replacement of the clevis on 27 April 2014.

The subsequent movement of the clevis was most likely caused by engine vibration under normal operating conditions.

- An immediate inspection of all locomotives fitted with the sight glass arrangement to ensure clevis assemblies conform with OEM specifications and requirements
- A best practice review and various amendments to the current maintenance procedures which have increased the inspection requirements for the clevis and clevis bolts. Included are additional requirements to inspect for the following:
  - Bending in at the base of the sight glass clevis
  - Worn clevis bolts
  - Elongation of clevis bolt locating holes
  - Fracture of sight glass clevis
  - Worn thread on the sight glass thumb screw
  - Correct alignment of the clevis bolts in the aperture of the fuel filter assembly
- An audit of its current stock of clevis bolts to ensure conformance to OEM specifications
- Improved sight glass clevis tightening procedures
