# Derailment and collision between coal trains

Ravenan (25km from Muswellbrook), New South Wales, on 26 September 2018

## **ATSB Transport Safety Report**

RO-2018-017

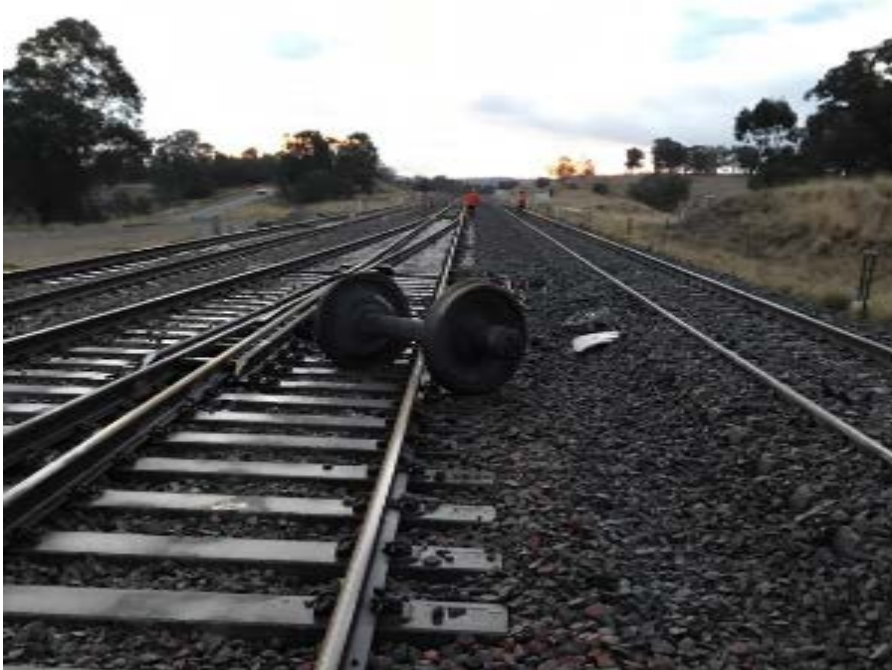
**Figure 1: Location of ejected wheelset**

Shortly after derailing, a wheelset ejected from its bogie and came to rest at 271.684 kms. The train continued to travel in a derailed state for approximately nine kilometres.

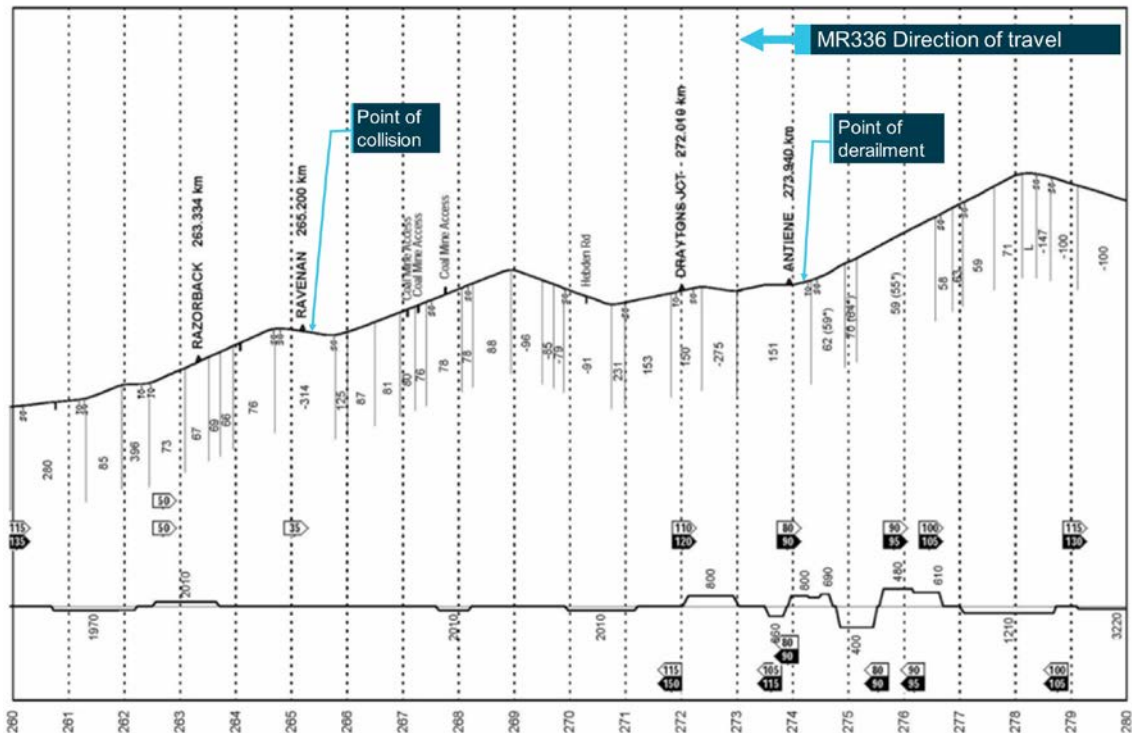
**Figure 2: Curve and gradient diagram indicating point of derailment and point of collision**

MR336 travelled approximately 160 km after departing Moolarben loading terminal before the train derailed on the up main line<sup>2</sup> at Antiene. The leading wheelset of the trailing bogie of the 25<sup>th</sup> wagon mounted the rail at kilometre mark 274.396 km.<sup>3</sup> The wheelset dropped off the rail in a derailed state at kilometre mark 274.394 km.

The trailing bogie on the 25th wagon on MR336 was dragging across the down track fouling the down main line. The lead locomotive of WC915 collided with the dragging bogie that had been partly dislodged from the wagon earlier. The collision between the lead locomotive of WC915 and the dragging bogie caused the wagon it was attached to (25th) and the seven following wagons on MR336 to derail and incur damage to varying degrees.

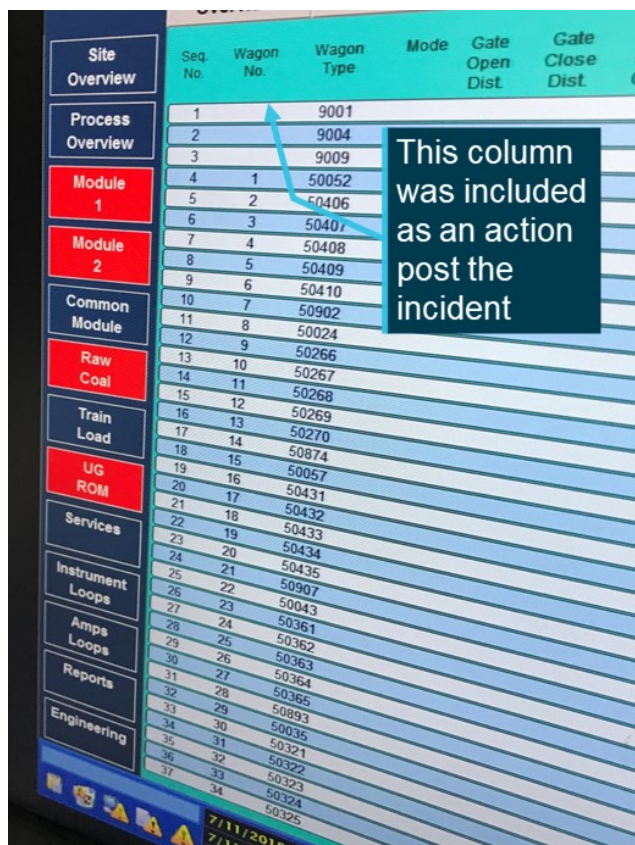
**Figure 3: Train loading display screen**

Prior to the occurrence (wagon not being loaded), the train loading display screen did not display the wagon number column.

Moolarben loading terminal corrected the malfunctioning sensor and implemented more detailed verification processes of the train load out summary. They reviewed their risk assessment for train loading and implemented a number of actions resulting from this review process. The details of these actions is presented in this report.

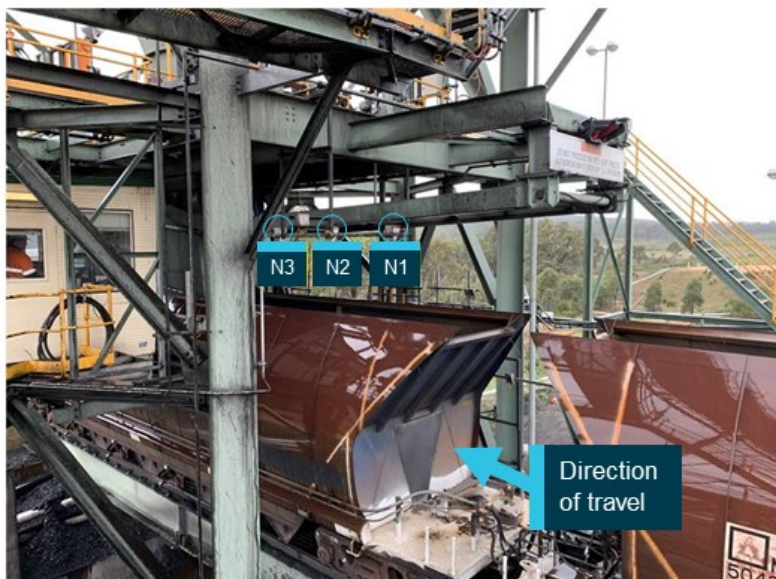
**Figure 6: N1, N2 and N3 sensors**

It was advised by Moolarben representatives that a redundant sensor N3A also existed at the time of the occurrence which was used to confirm what the N3 sensor was detecting. This redundant sensor has since been removed.

The loading system was set up with sensors to detect wagons and automatically load each wagon as it passed underneath the coal loading chute. As loading progressed on the morning of the incident, there was a fault in the system which stopped coal from being loaded into the 25th wagon. Moolarben's post incident analysis of the loading system found the stop loading sensor N3A had malfunctioned. Moolarben loading terminal decommissioned the N3A sensor shortly after.

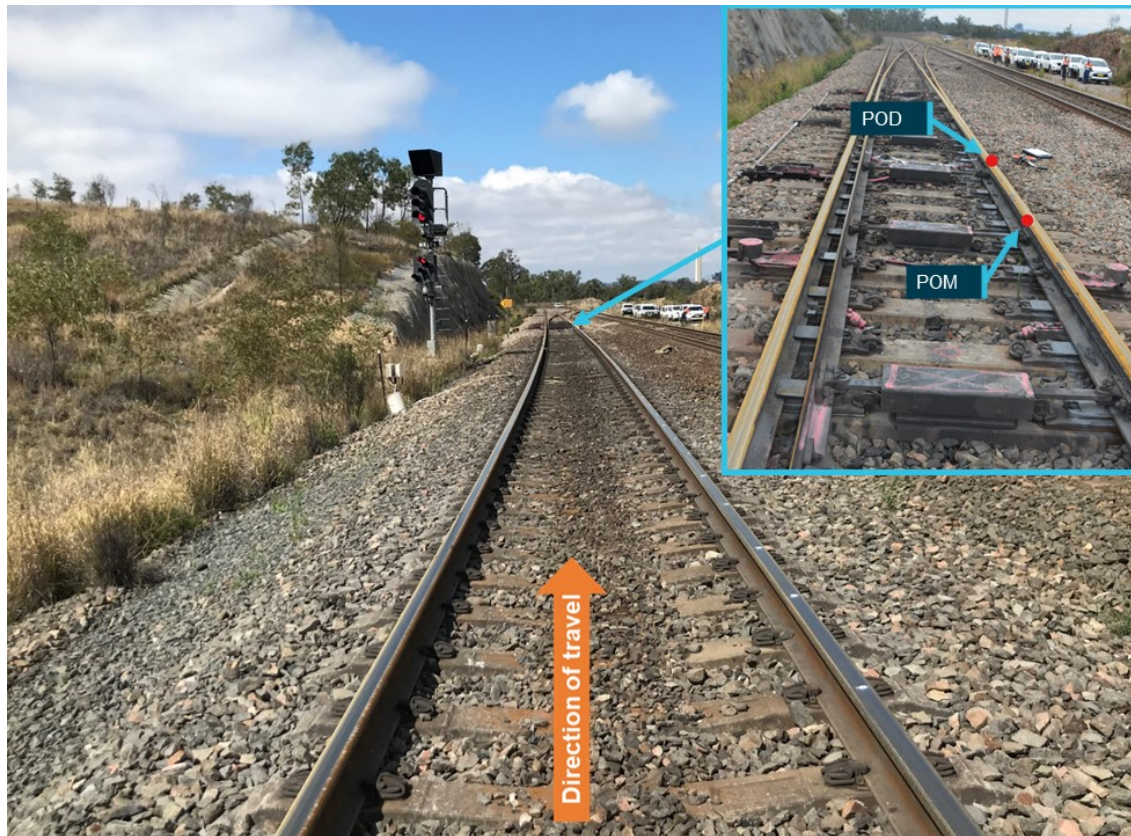
**Figure 7: Point of Mount (POM) and Point of Dismount (POD) – Antiene Up direction**

The 25th wagon was positioned between two loaded wagons, the front of the wagon was coupled to the 24th wagon and was attached to the 26th wagon by the solid drawbar connection.

Following the derailment the leading wheelset of the trailing bogie was ejected from the bogie and left on the track at kilometre mark 271.684 km. As the driver remained unaware of the derailment, the train continued with the bogie dragging on the down rail of the up main line within the six foot and foul of the down main line.

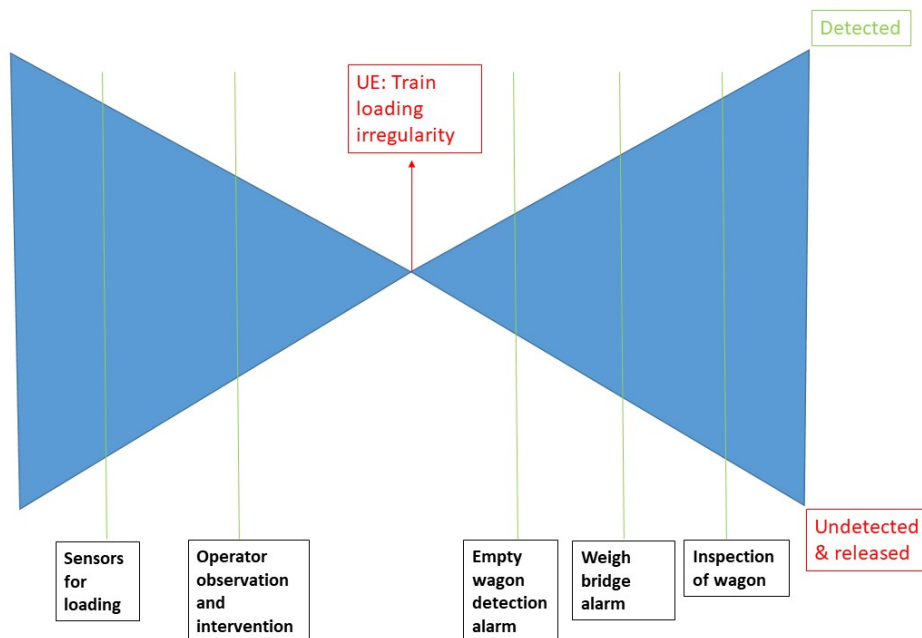
**Figure 9: Bow tie risk diagram depicting ineffective risk controls in this incident**

A summary of the risk controls that were ineffective which lead to the unwanted event of an empty wagon positioned between loaded wagons is depicted below (see Figure 9).

The layers of control (defences) in place failed to prevent and detect the loading irregularity. As a result, the loading terminal reviewed its risk assessment and controls to confirm the systems level of effectiveness. The outcomes from the review included implementation of additional controls, such as extra lighting on the outbound side of the loading chute, two independent mechanisms for detection of empty wagons and a process of verification of the train load out summary between the TLO and the Control Room Operators to ensure each train is loaded within required specification prior to advising the train operator that loading is complete.
