Runaway of grain train 8960

Dombarton to Unanderra, NSW | 22 April 2017

ATSB Transport Safety Report
Rail Occurrence Investigation
RO-2017-001
Final – 5 December 2018

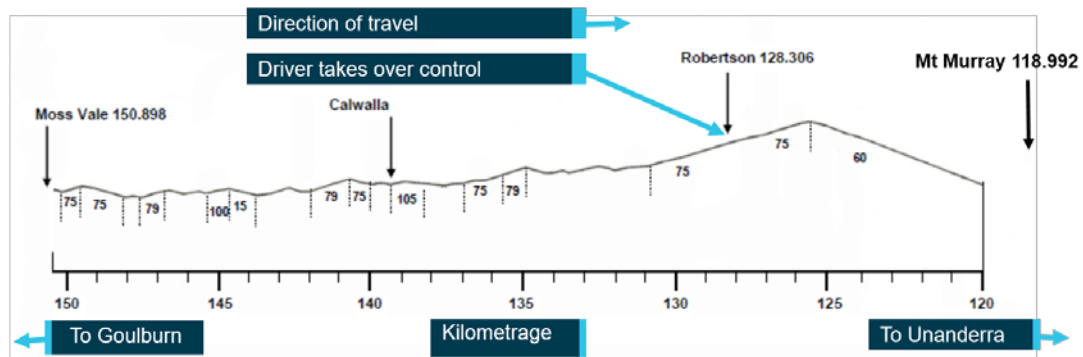
Figure 1: Gradient diagram Moss Vale to Robertson

Between Goulburn and Mt Murray, the driver made a number of running brake applications using the train's air brake system to gauge the train's braking capability. There were no issues found with the train's braking capability. This is known as a running brake test and it is a standard driving practice that train crews conduct this test.

The train passed Mt Murray and then, at 1216, it was brought to a stand just past Summit Tank, as required by a Qube work instruction.³ Here, the driver conducted a performance test of the brakes. The driver was satisfied with the braking performance and resumed the journey.

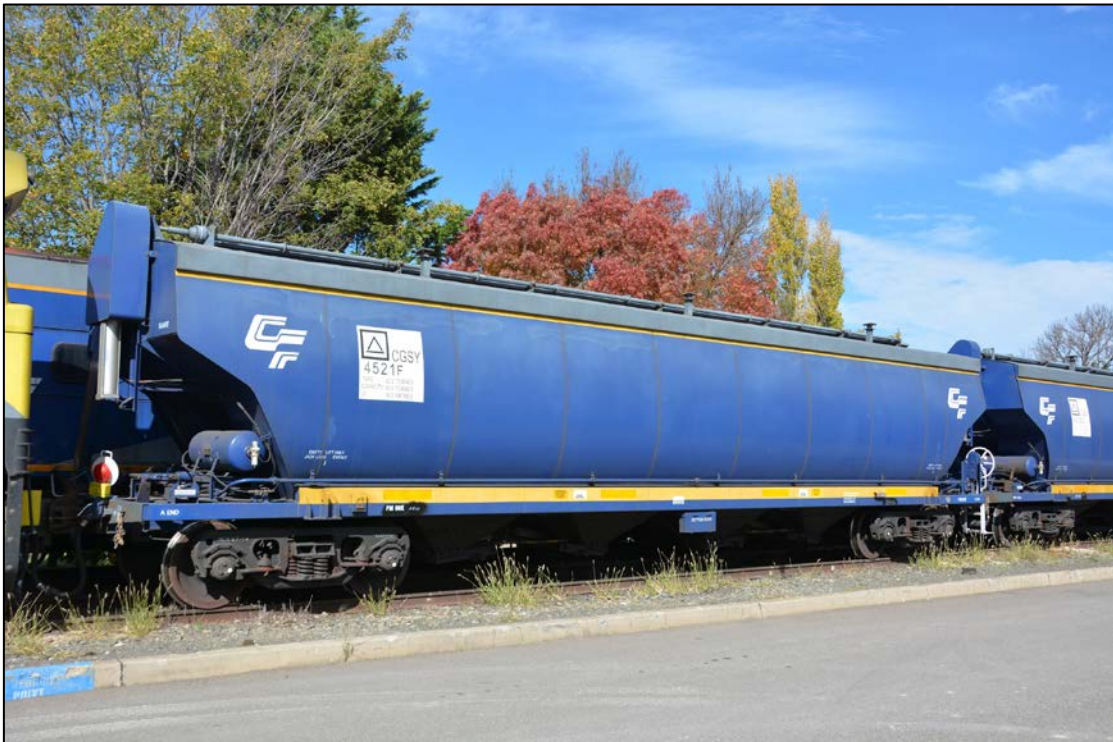
Figure 7: CGSY wagon

- As well as testing the train's brakes, the brake cylinder piston travel lengths were measured on all 40 CGSY wagons. It found that seven piston lengths exceeded the Asset Standard Authority (ASA) criteria relating to piston travel. Qube stated in their report that as the train had been manually regulated the piston travel was not considered a contributing issue.

- On 1 May 2017, a single car air test (SCAT) was carried out on three randomly chosen wagons: CGSY 4502, CGSY 4507 and CGSY 4510. This test was conducted by an independent contractor. The tests found that the slack adjusters were ineffective. This can cause irregular braking forces if the piston lengths increase outside tolerances and they fail to take up or let out the slack. The issue with the slack adjusters was known to the operator and 'due to their design have never been effective.'¹¹ The slack adjusters have since been re-engineered but at the time they were manually inspected and regulated prior to every train journey between Goulburn and Unanderra.
