RAIL SAFETY INVESTIGATION REPORT

SAFEWORKING BREACH

GLENLEE

28 OCTOBER 2009

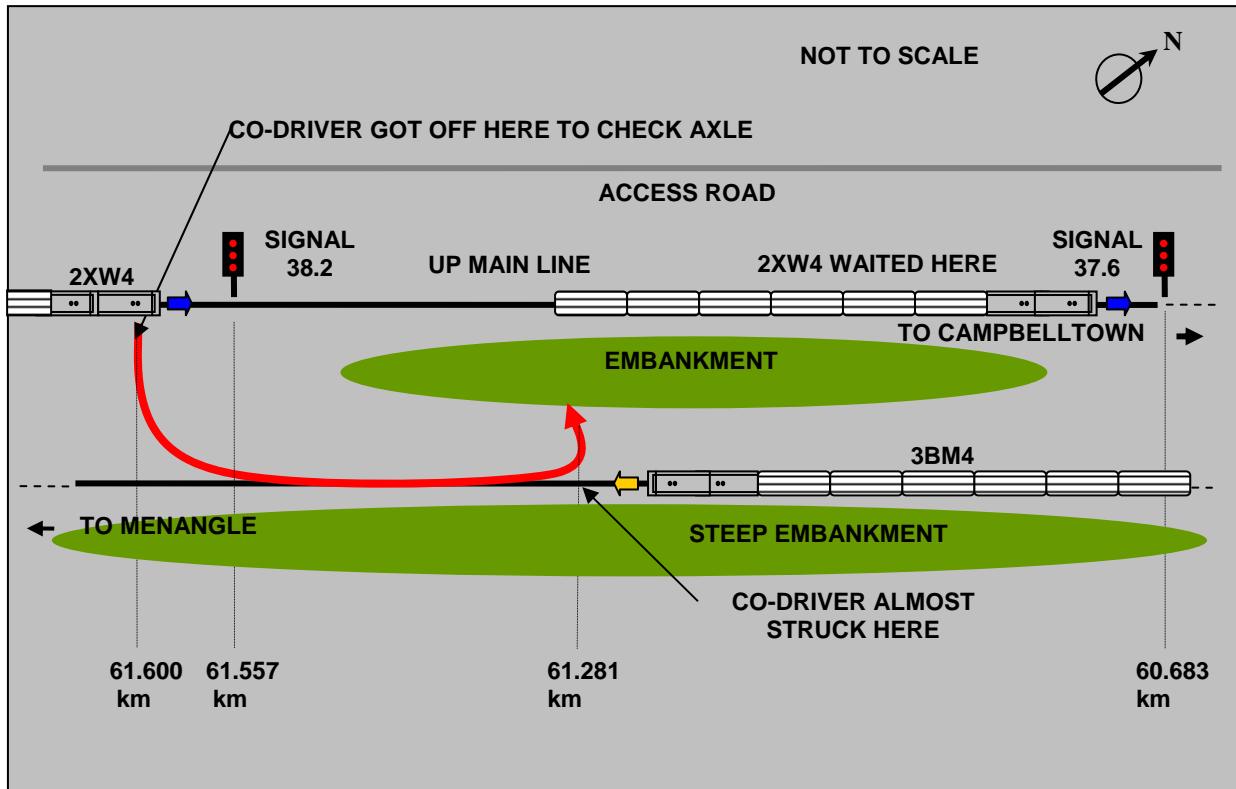
Figure 2: Track layout with path of Co-driver shown in red

- 1.10 In order to return to the cab of 2XW4, the Co-driver walked towards Campbelltown along the 'Down Main' line (see *Figure 2*), in the 'four foot', believing that a blocking facility had been applied to this line. The PN freight

- 1.27 The incident happened after the axle bearing inspection was finished and when the Co-driver was returning to the cab. In order to return to the cab of the leading locomotive after conducting the axle bearing inspection the Co-driver of 2XW4 made the decision to walk along the 'Down Main' line believing that this line had blocking facilities applied. He thought that signals would prevent any train from entering the section from either direction (see *Figure 2*).

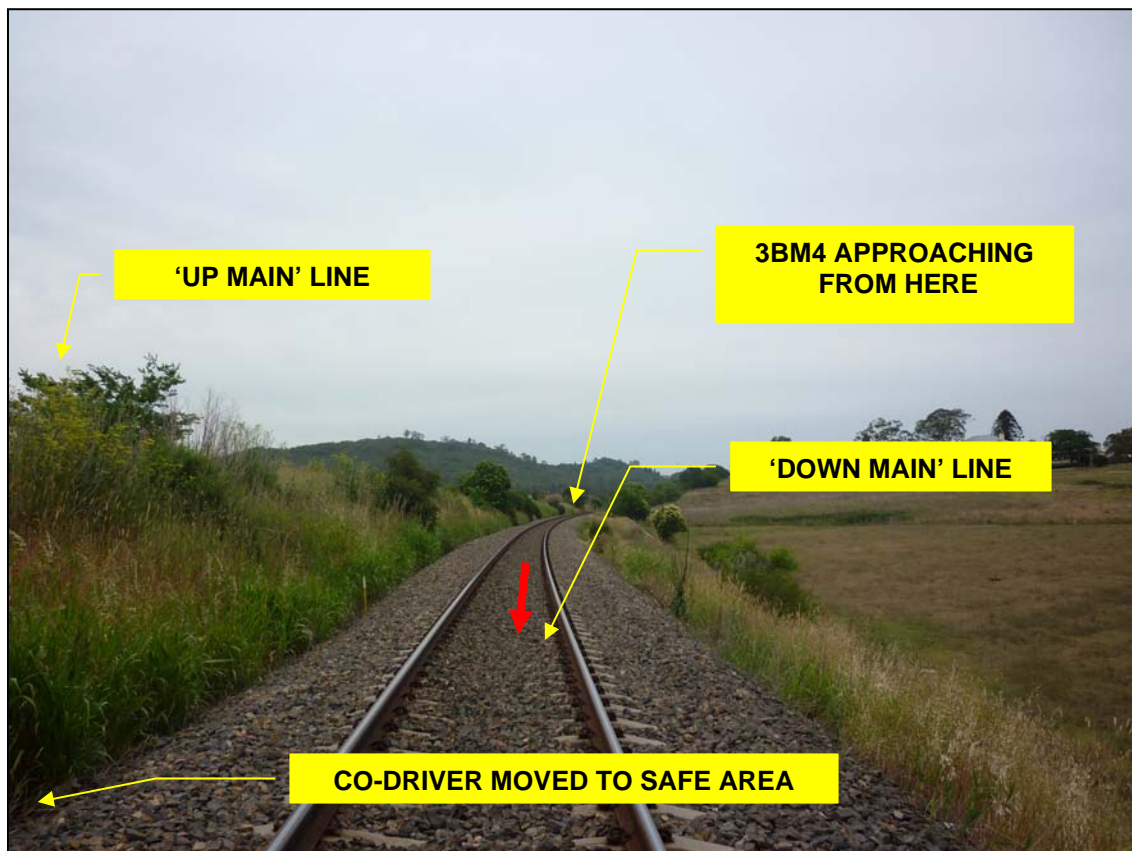
**Photo 1: Looking North along ‘Down Main’ line, the Co-driver’s view of approaching train
(Red arrow indicates direction 3BM4 was travelling.)**

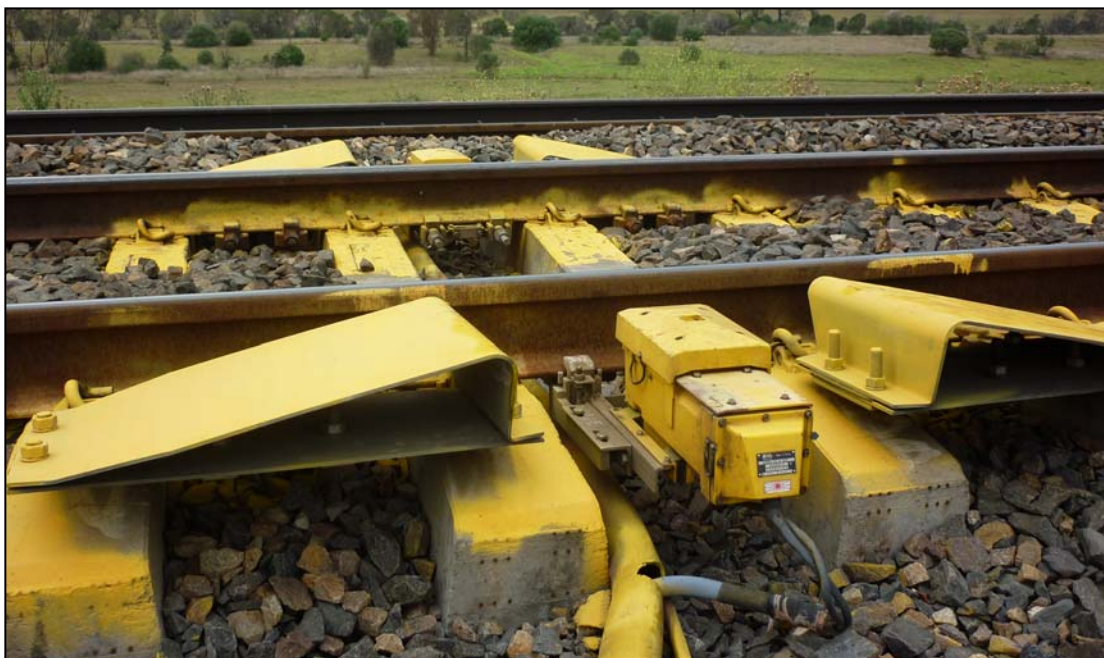
Photo 3: Hot box detector at Menangle

- 1.21 The Menangle hot box detector is located at kilometrage 67.255 (see *Photo 3*) and is operated and maintained by ARTC. It is a device that measures the temperature of passing axle journal bearings and automatically sends an alert to the NCCS if the temperature exceeds a certain level. The network controller is alerted by a flashing light on his panel and an audible alarm.

- 1.22 The hot box detector at Menangle had identified axle 162 as having an elevated journal bearing temperature which can be an indicator of a potential bearing failure. Extensive delays will result if a bearing failure occurs and a train is disabled when it is in the Sydney metropolitan rail network. A more serious consequence is the potential for a derailment. This is why it is preferable to conduct an inspection before the train reaches the metropolitan network. The distance between the Menangle hot box detector and the start of the metropolitan network at Macarthur is approximately 10km.

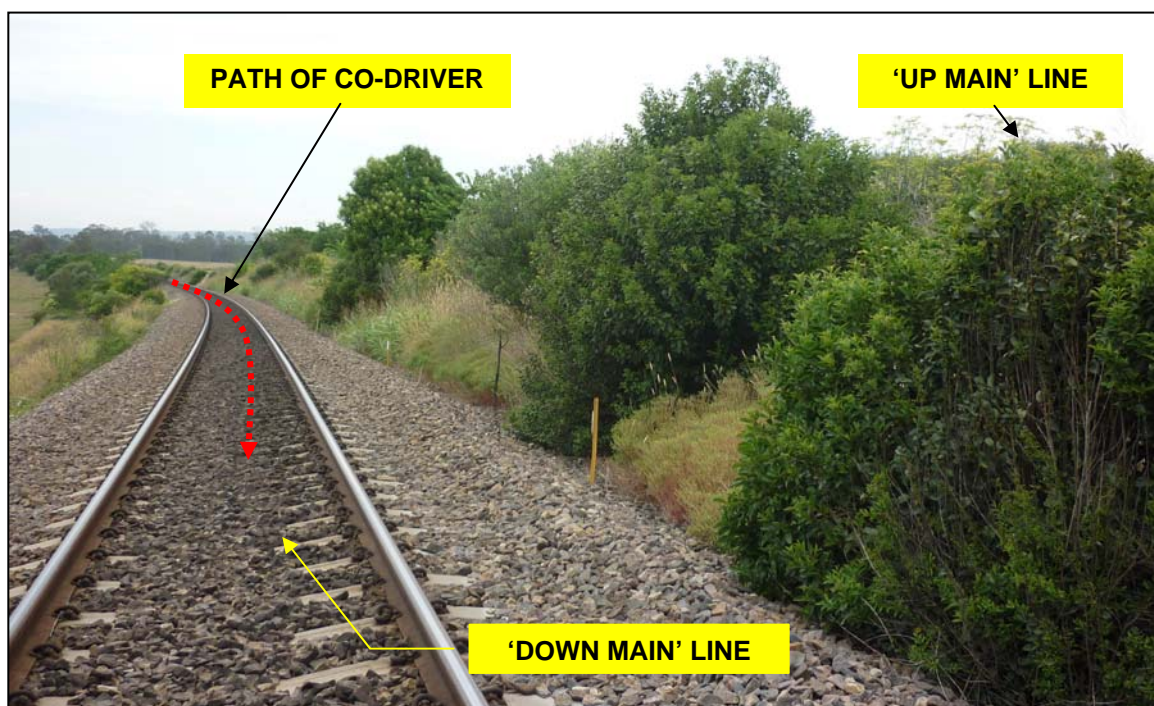
- 1.28 He was walking in an area where the 'Up Main' line was higher than the 'Down Main' line by about one metre. Between the two tracks is a barrier of dense vegetation (see *Photo 4*).

Photo 4: Vegetation between tracks, looking South

- 1.29 The vegetation and the difference in track height restrict access to the 'Up' side. On the 'Down' side there is a steep embankment making the area where the incident occurred particularly hazardous.

- 1.33 It is noted that the 2010 Federal Budget announced funding for crossing loops to be implemented at a number of locations including Glenlee. It may be an opportune time to incorporate the systems needed for a safe inspection area into any changes to the infrastructure. At Menangle, the location should take into account the desirability of the network controller having direct panel operability for the area under control rather than having to contact another signal box.

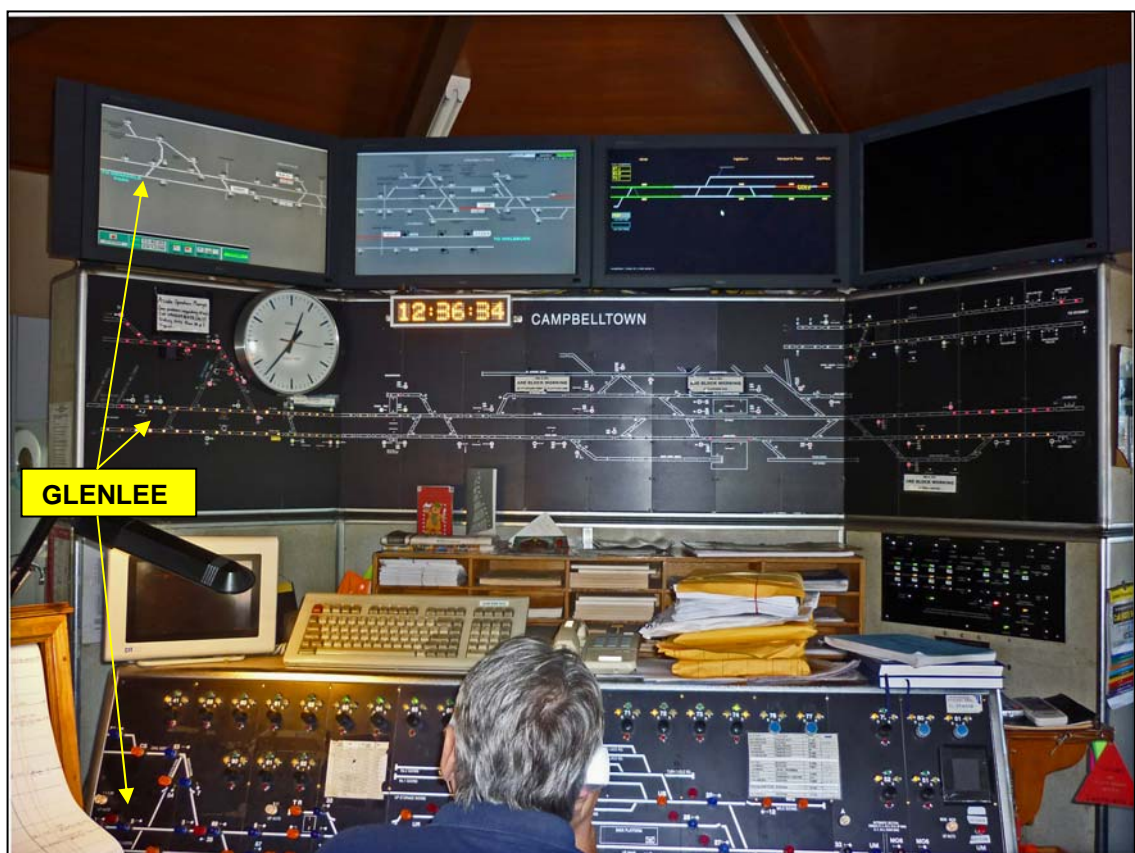
Photo 5: Control panel at Campbelltown Signal Box

- 1.49 Campbelltown Signal Box operates the signals around Glenlee. The Campbelltown panel detects train movements in this area and the position of trains is shown on the control panel (see *Photo 5*). If NCCS needs to apply blocking facilities to the 'Down Main' line in the vicinity of Glenlee then they need to contact Campbelltown Signal Box and request them to operate the signals.

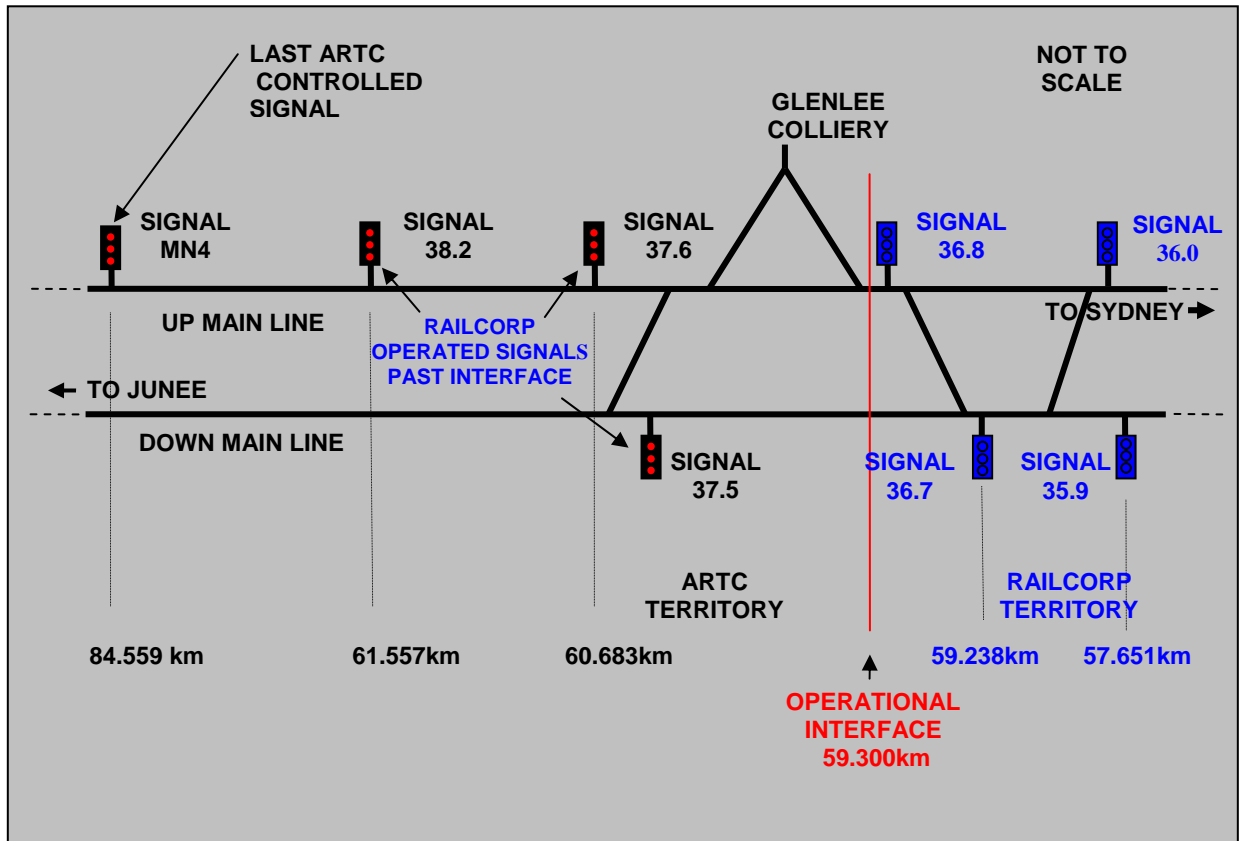
Figure 3: Track layout showing operational interface at time of incident

- 1.50 Though not a causal or contributory factor in this incident, it became apparent during the investigation that the location of the operational interface between ARTC and RailCorp was not clear. When questioned about the location of the operational interface, three controllers were unable to specify the location. This was also the case with several drivers and track maintenance staff with

- 1.51 The Co-driver was unaware of which rail control centre was applying blocking facilities which were protecting him while he was on the tracks. As he was called by a Network Controller from NCCS, and thought that they were applying blocking facilities, he did not think it necessary to contact RailCorp’s Campbelltown Signal Box as well.

- 1.52 The network controllers at Junee and the area controllers at Campbelltown understand which signals they control around Glenlee, and the trains are operated effectively in this area despite the existence of a number of documents concerning the operational interface which differ. In practice, on the ‘Up Main’ line all the signals on the ‘Up’ side of kilometrage 61.557 are operated by RailCorp under the control of ARTC (see Figure 3). This includes Signal 38.2 and Signal 37.6 which are operated by Campbelltown Signal Box, under direction from NCCS, to allow trains to exit the Glenlee South Fork (from Glenlee Colliery). On the ‘Down Main’ line it includes Signal 37.5 (kilometrage

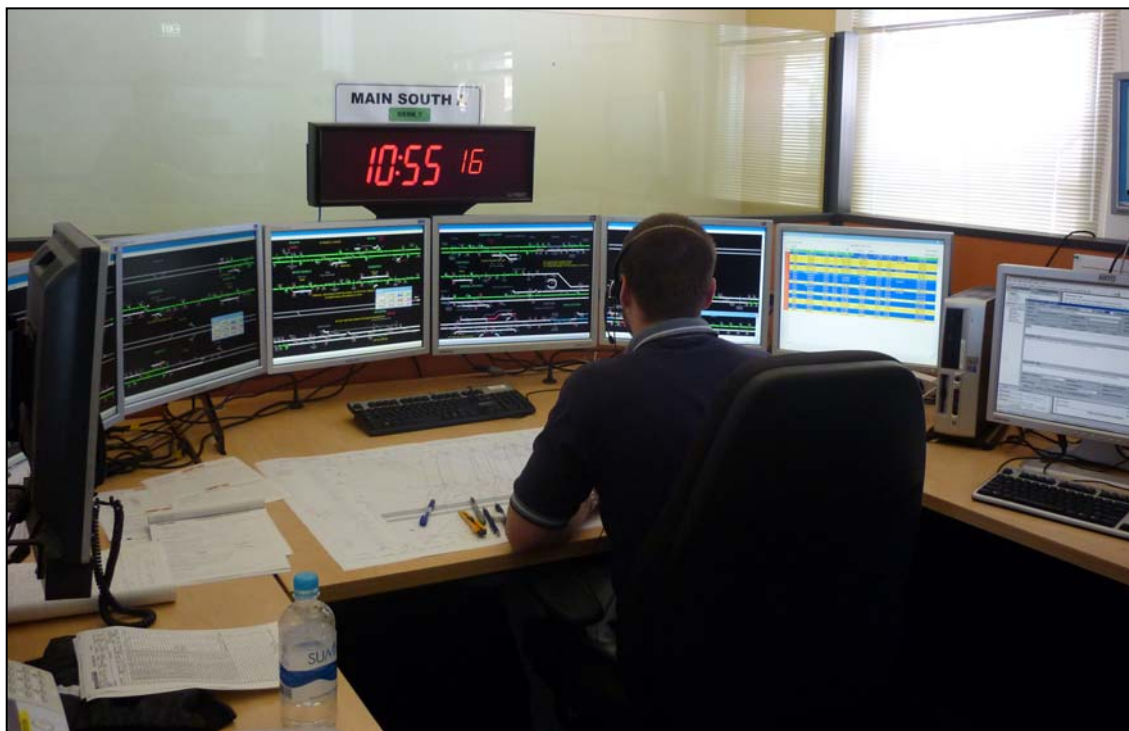
Photo 6: Main South 'A' Panel at Junee

- 1.63 The Main South 'A' Panel is an active operational panel and is a challenging environment when it is busy or there are network problems, such as train delays or breakdowns. On the day of the incident there were a number of network delays in the morning which increased the workload for the network controllers on the Main South 'A' Panel. By the time of the hot box detector alert at 1:32pm, both the trainee and supervising network controllers had not had any break since 7:00am. The investigation found that this was normal practice and that rest breaks were taken at times of low activity when a network controller in an adjoining work area could take over. Often meals were eaten while sitting at the panel. There was no scheduled break roster nor were there any relief controllers rostered.

- 3.6 Revise the work roster as it applies to network controllers to ensure that it specifies adequate meal, rest and convenience breaks and makes provision for relief arrangements at peak workload occasions, and amend rostering practices accordingly.
