## RAIL SAFETY INVESTIGATION REPORT

### DERAILMENT OF 4BM7 LIDCOMBE

4 NOVEMBER 2005

15 December 2006

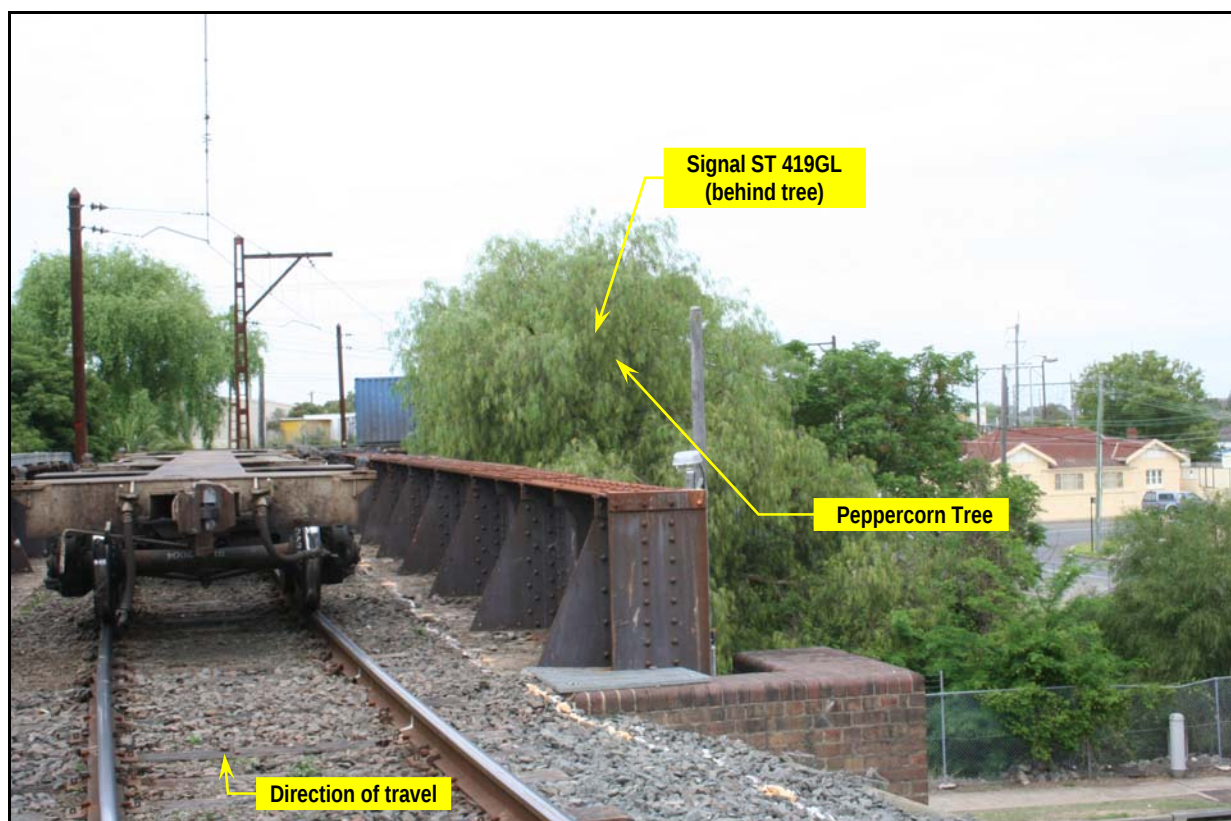
Photo 1 Looking towards Signal ST 419GL, with sighting obstructed by a peppercorn tree

- 3.5 While at the incident site, and in the light of day, OTSI noted that a large peppercorn tree, on the Western side of the embankment, obstructed visibility of signal ST 419GL up to a point 93 metres from it (See *Photo 6*).

- 3.6 The tree also obstructed the sighting of Signal ST 429GL. Given the size of the tree, it had clearly been obscuring Signals ST 419GL and ST 429GL for a long time. However, OTSI noted that this had not been the subject of reporting by drivers or by those responsible for inspecting and maintaining the

- iii. RailCorp has a program to check on matters that might impact on the operation or visibility of signals, but this program failed to detect what was an obvious and long-standing obstruction, caused by a large peppercorn tree on the Western side of the track, 93 metres from Signal ST 419GL.

- d. rectify the deficiencies previously identified with No. 717 catch points, and
- e. review the effectiveness of the methods employed in signal sighting inspections.

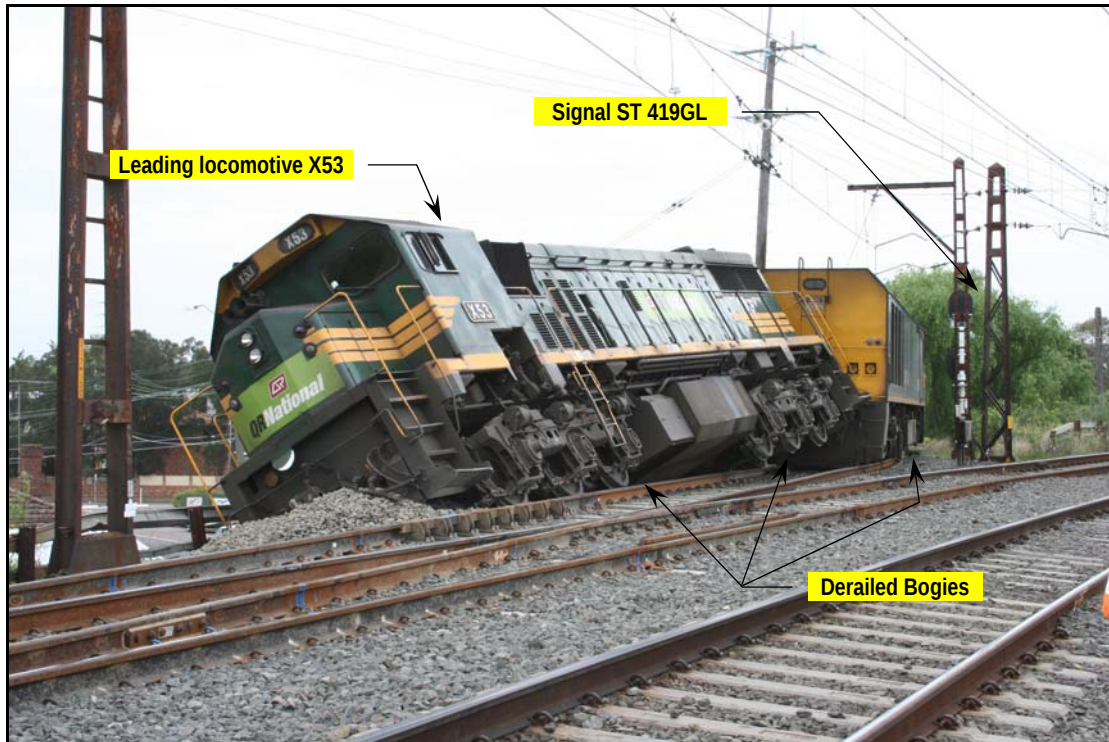
- 2.6 Upon sighting Signal ST 419GL at 'Stop', the driver immediately applied the emergency brakes. However, he was unable to stop 4BM7 and its leading locomotive (X53) travelled over the open set of catch points (No. 717) and

derailed. Both of the locomotive's bogies derailed and the locomotive came to rest in loose ballast on top of an eight metre-high embankment approximately 40 metres beyond Signal ST 419GL (see *Photo 2*). The leading bogie on the trailing locomotive (EL58) also derailed.

Photo 2 Derailed locomotives of 4BM7 at daylight on day of incident

- 2.20 Both of 4BM7's locomotives suffered minor damage. Six concrete sleepers and various components within No. 717 catch points were crushed during the derailment. A short section of signal troughing and a timber retaining wall also suffered impact damage, but the integrity of the signalling and track systems was not affected. Fire crews remained on-site to respond to any fluid that might have leaked from the derailed locomotives.
- 2.21 Concerns over the stability of the derailed locomotives and the security of the train's load, resulted in the site of the derailment being cordoned-off to prevent the access of other than response personnel.

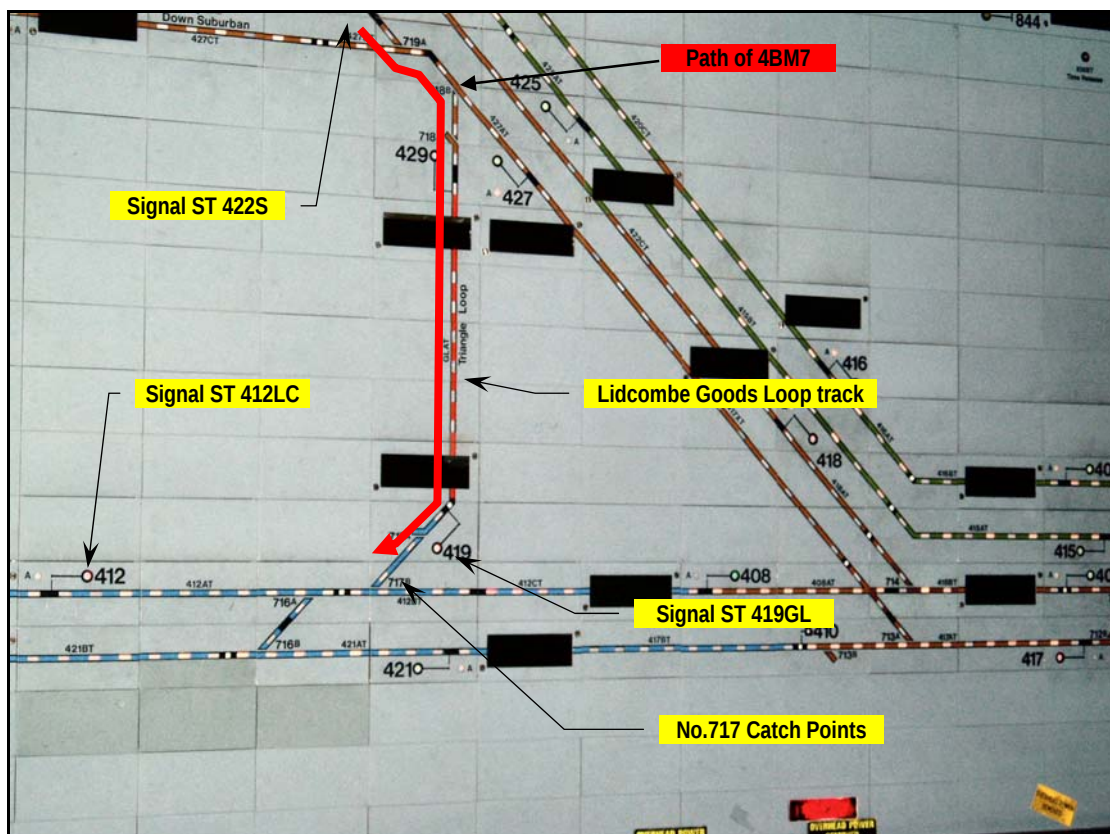
Photo 3 The Area Controller's Track Indication Panel, with the Lidcombe Goods Loop indicated

- 2.9 In the absence of a means for a SPAD to be displayed on his indication panel, the Area Controller believed that a technical fault existed with track-side equipment and advised the driver of 53-U that a problem existed with the signalling. He then authorised the driver of 53-U to pass Signal ST 412LC at 'Stop' but report any problems encountered. The driver of 53-U proceeded past Signal ST 412LC with an appropriate degree of caution.
- 2.10 Having passed Signal ST 412LC, the driver of 53-U saw what appeared to be two white lights, 4BM7's marker lights, as he approached the Lidcombe Goods Loop but assumed them to be street lights because of the odd angle at

- vii. the design of the Track Indication Panel which failed to provide an alarm to alert the Area Controller that Signal ST 419GL had been passed at 'Stop' without authority;

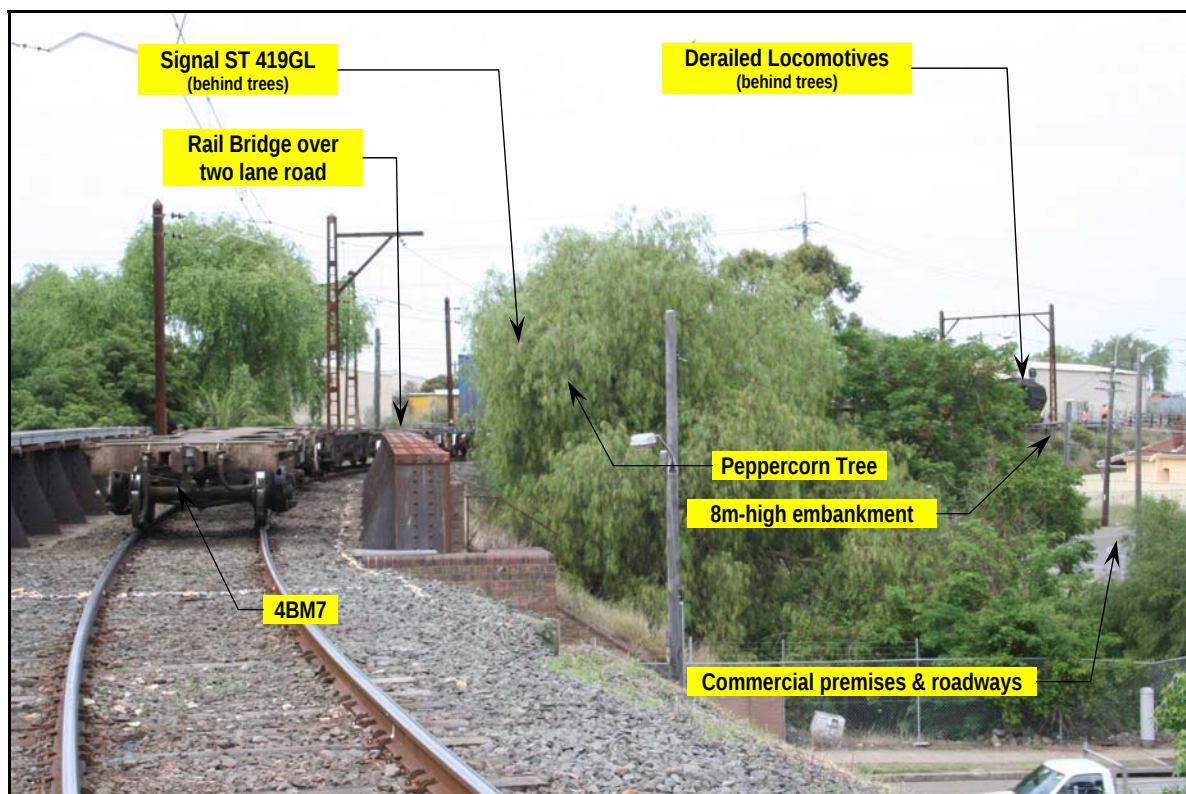
- 2.17 The proximity of the loop line to roads, commercial premises and facilities is depicted in *Photos 4 and 5* (over page).

Photo 4 Lidcombe Goods Loop Line, approaching Signal ST 419GL, showing roads and commercial premises

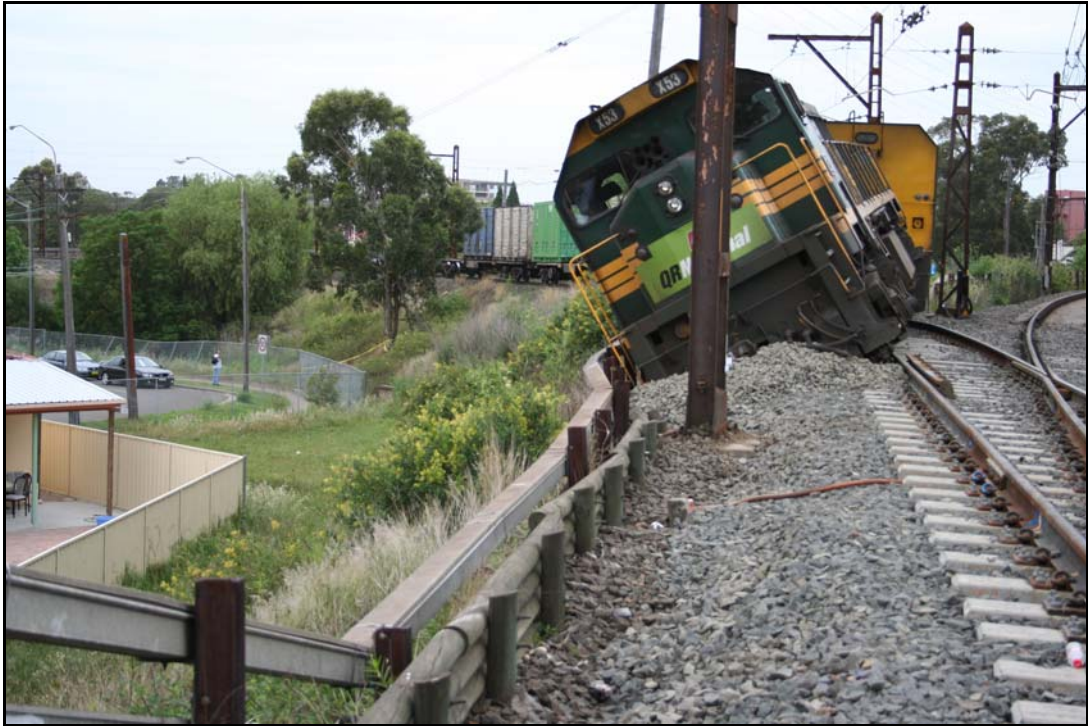
Photo 5 Locomotive X53 at rest, on top of 8m-high embankment, and its proximity to commercial premises and roads

- 3.8 OTSI noted that the positioning of No. 717 catch points presented a number of risks. Whilst the points functioned as intended, by derailing 4BM7 when it passed Signal ST 419GL without authority, the run-off rail and ramp<sup>9</sup> at No.717 catch points directed it towards the edge of an eight metre-high

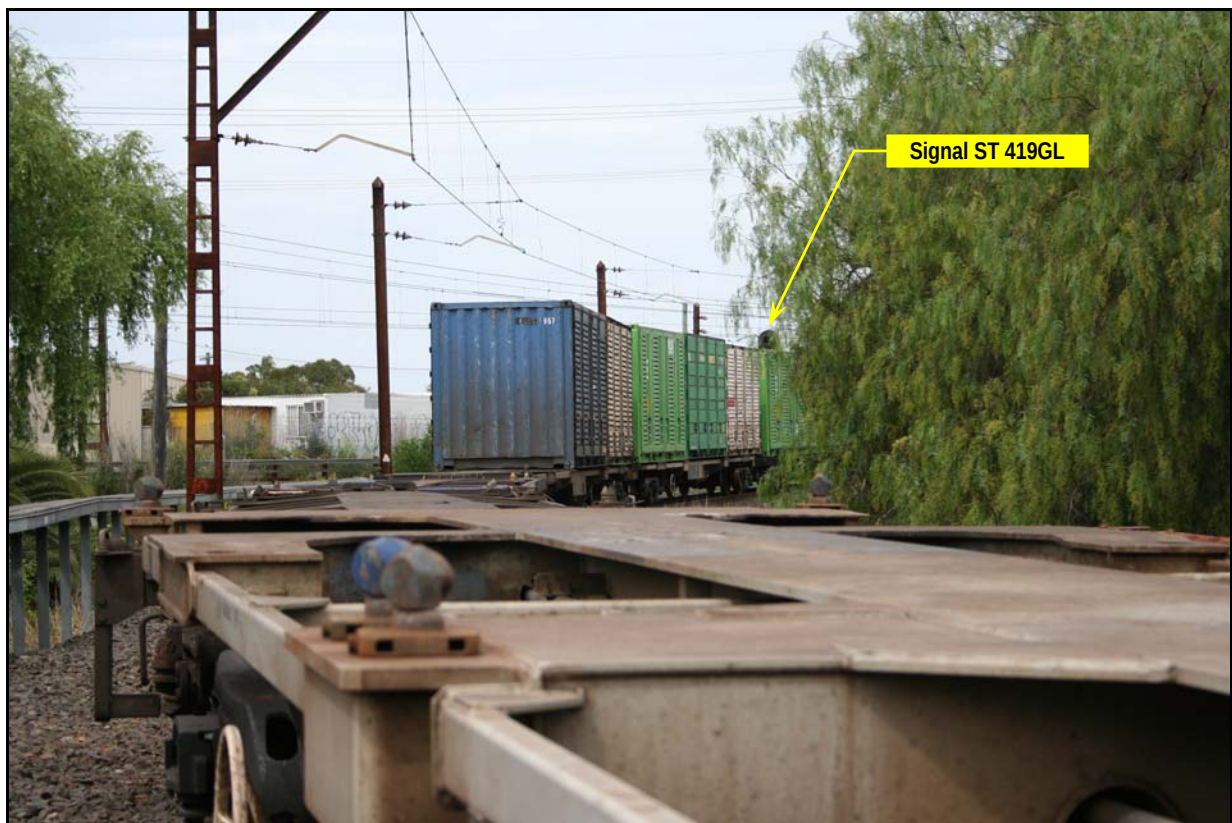
Photo 6 Point 93m from Signal ST 419GL, at which sighting first becomes unobstructed

- 3.7 RailCorp's "Signals Engineering Standard Construction Specification" SC-00-47-00-00-SP requires a signal to be visible for a minimum of six seconds at line speed. The specification also states *"running signals shall be located to provide so far as practical, the longest, most continuous sighting of the signal after passing the signal in the rear"* and *"preferably, a minimum of 200 metres sighting distance for speeds to 100 kph and 300 metres for speeds over 100 kph wherever the environment permits"*. As previously noted, Signal ST 419GL first becomes visible at a distance of 93 metres which is at the point where the locomotive driver passes the peppercorn tree (as depicted in *Photo 6*). At 28km/h, OTSI calculated that Signal ST 419GL would have remained visible to the driver for approximately 11.9 seconds. At the maximum permitted speed of 25km/h while 4BM7 was still clearing points on the West Suburban lines, this signal would have been visible for approximately 14.1 seconds. Calculations on rates of braking estimated that, at full service braking<sup>8</sup>, a freight train similar to 4BM7 requires a minimum of 86 metres to stop when travelling at the speed of 28km/h. The implication is that at the point at which Signal ST 419GL first became visible, the driver had sufficient time and distance to have maintained proper control of 4BM7 had he been sufficiently alert. A sufficiently alert driver would have slowed 4BM7 down to below 25km/h on the basis of the 'calling on' indication at the preceding signal (ST 422S) because this indicated to the driver that he needed to be prepared to stop at any time before ST 419GL if the line was obstructed.
