Office of Transport Safety Investigations

RAIL SAFETY INVESTIGATION REPORT

FATAL LEVEL CROSSING COLLISION

NUNDAH

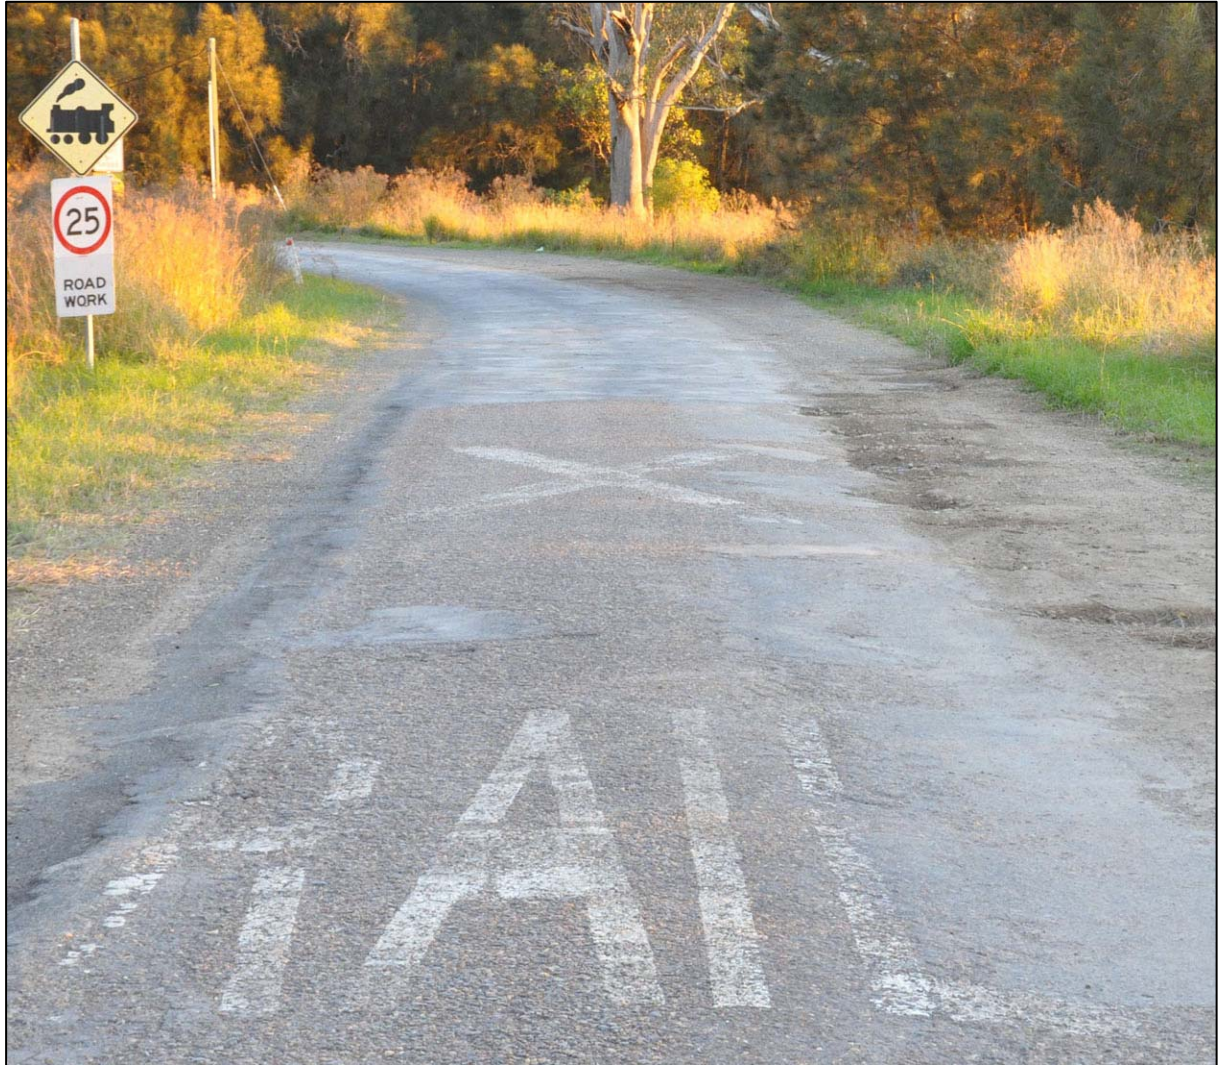
- 1.26 On the approach by road from the north (i.e., the path of the utility) the first indication of the crossing was the pavement marking shown in *Photograph 1*, located approximately 220 metres from the crossing. Although visible at the time of the collision, the marking was well-worn and inconspicuous on a poor road surface. More conspicuous at this point was a "Railway Ahead" warning in the form of a black steam locomotive silhouetted on a yellow background with which the previously mentioned Road Work sign had been co-located. This sign is described in *Australian Standard 1742.7—2007*² as an advance

Photograph 1: Road work sign, pavement marking and early warning sign

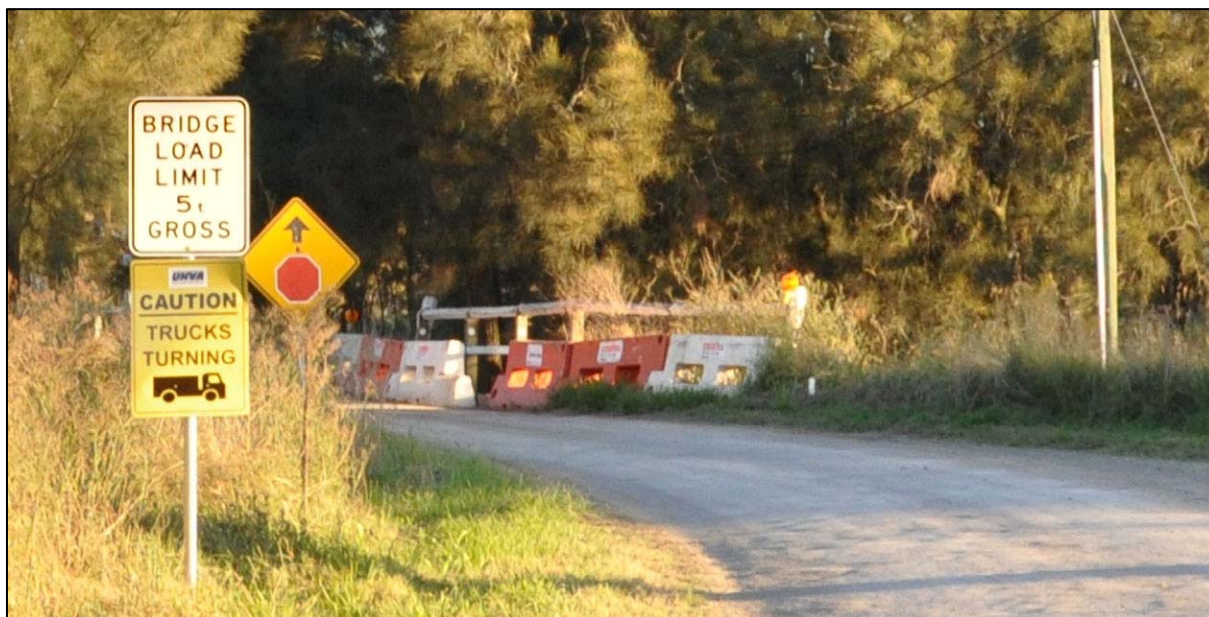
- 1.27 A “Bridge Load Limit” sign and a “Caution Trucks Turning” sign were co-located 50 metres further on, followed after a further 12 metres by a “Stop Sign Ahead” warning, as seen in *Photograph 2*. As these signs came into view, a bridge with safety barriers placed alongside its railings could also be seen.

Photograph 2: View on approach to bridge

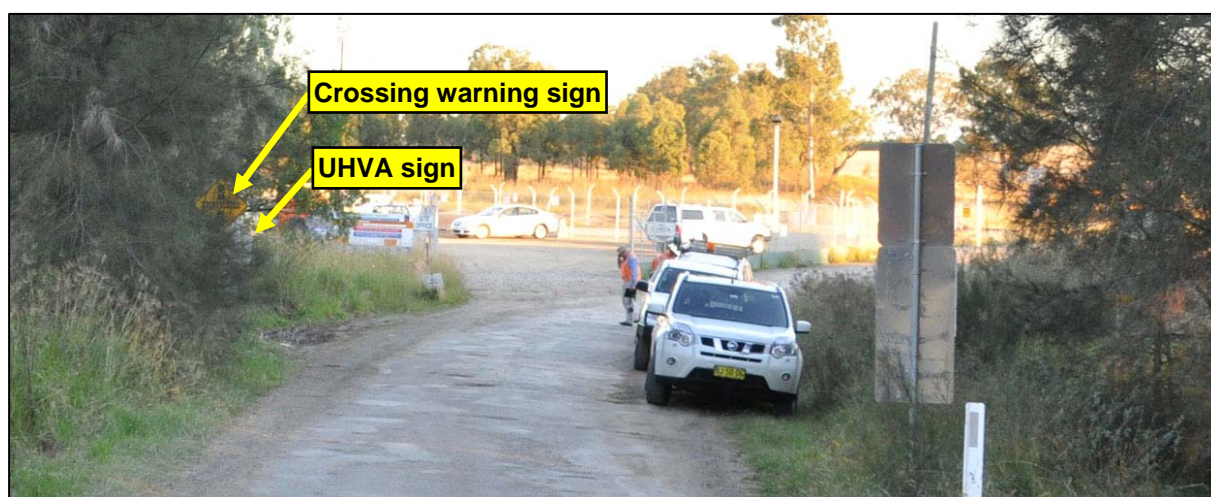
- 1.28 Once across the bridge and approximately 100 metres from the crossing, the road could be seen curving to the right. The crossing was not yet visible, concealed by the foliage of trees growing beside the bridge, as seen in *Photograph 3*. However, an additional warning sign, as specified in the *Australian Standard* for use with a give way sign, was visible on the left of the roadway although partly obscured by foliage. An Upper Hunter Valley Alliance (UHVA)³ sign had been co-located with it.

Photograph 3: Looking towards the crossing from the bridge

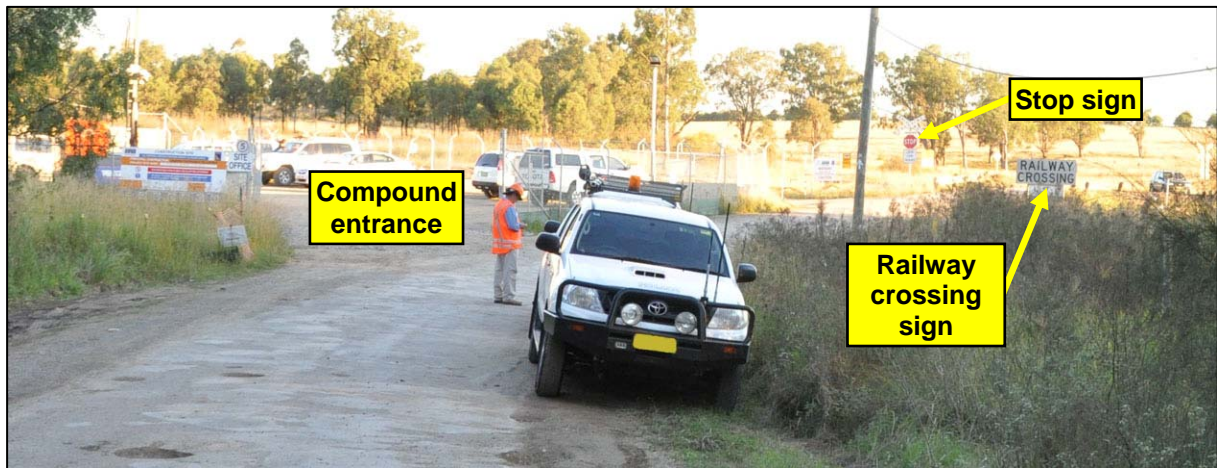
- 1.29 On the left of the road immediately before the crossing, a UHVA compound containing a parking area and site office had been constructed. When viewed from the bridge, the entrance to the compound was directly ahead with the road curving to the right. From 20 metres further on, a stop sign and a railway crossing sign could be seen but the track and crossing were obscured by fencing around the UHVA compound and undergrowth to the right of the roadway (*Photograph 4*).

Photograph 4: Railway crossing and stop signs

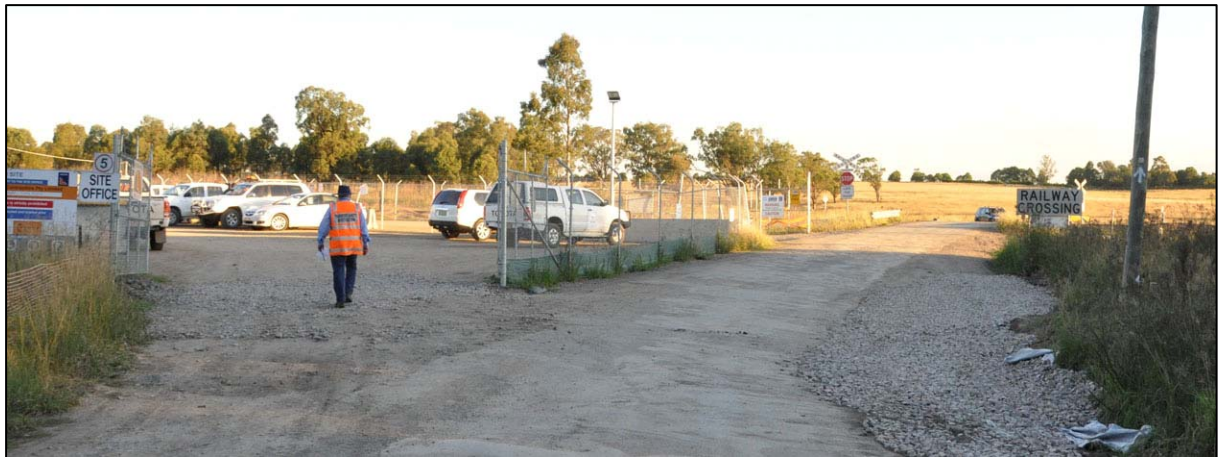
- 1.30 After a further 30 metres, the crossing could be seen (*Photograph 5*) and was clearly visible from that point onwards. However, the railway track to the left remained hidden by the UHVA compound and car park and by long grass. At the time of the collision, the vehicles in the car park included a mid-sized bus and a pantechicon parked nose-in against the south western fence which would have further obstructed the utility driver's view of any train approaching from the left as he drove towards the crossing.

Photograph 5: Crossing in sight, track obscured

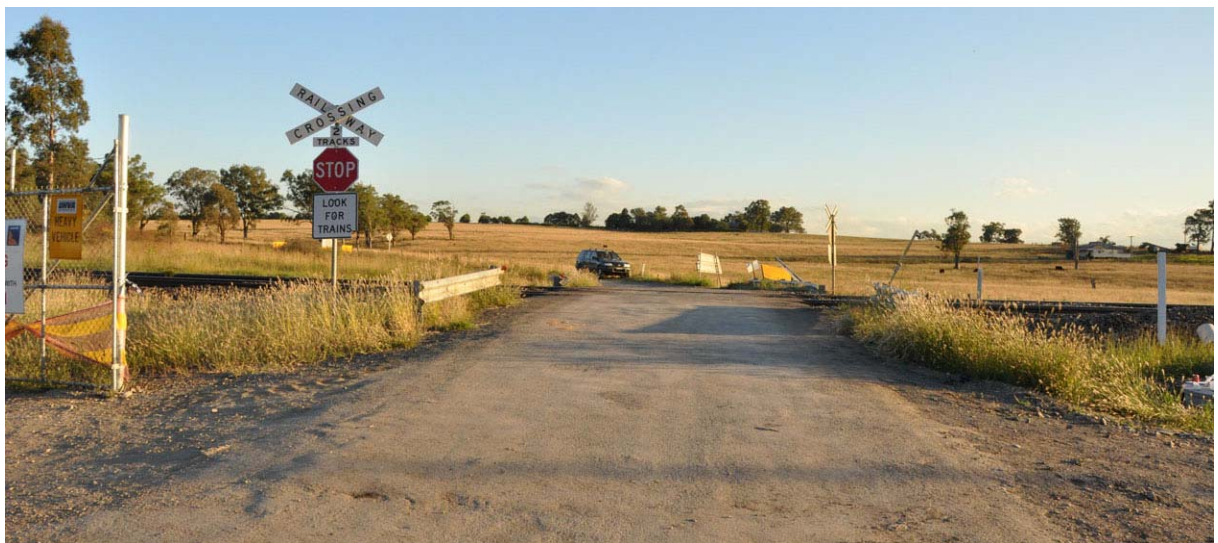
- 1.31 The road pavement on the approach to the crossing was in a poor state of repair, as can be seen in *Photograph 6*. The surface was of broken and potholed asphalt interspersed with dirt and there was no stop line visible.

Photograph 6: Road surface on approach to crossing

- 2.10 Although the stop sign was clearly visible and in good condition, the required stop line was not visible, possibly due to the poor condition of the pavement.
- 2.11 Except for the stop line, the usual signs warning of the railway crossing were in good condition. One sign, which was additional to the requirements of the *Standard*, was slightly obscured by foliage, while the others were readily visible. *Figure 3* illustrates the signage seen by a road vehicle driver approaching the rail crossing from the north.

- 3.2 The requirements for the use of stop signs include the marking of a stop line on the pavement at least 3.5 metres back from the rail at its nearest point. Although no stop line was visible at the time of the collision, this could have been due to the poorly maintained condition of the pavement.

- 5.1 Upgrade or repair the surface of each approach to the railway crossing and place a visible and durable stop line in a position such that approaching trains are clearly visible to the driver of a road vehicle stopped at the line.

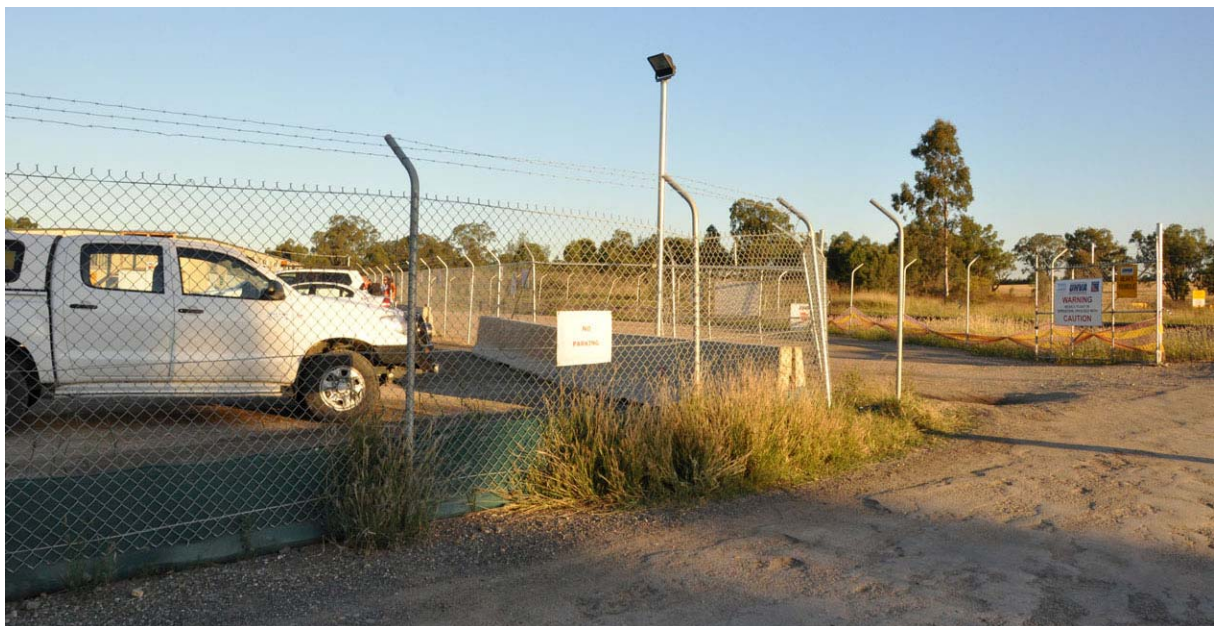
- 1.32 The car park and compound fencing continued to present an obstruction to the driver's view to the left approaching the crossing, as seen in *Photograph 7*.

Photograph 7: Visual obstruction due to compound

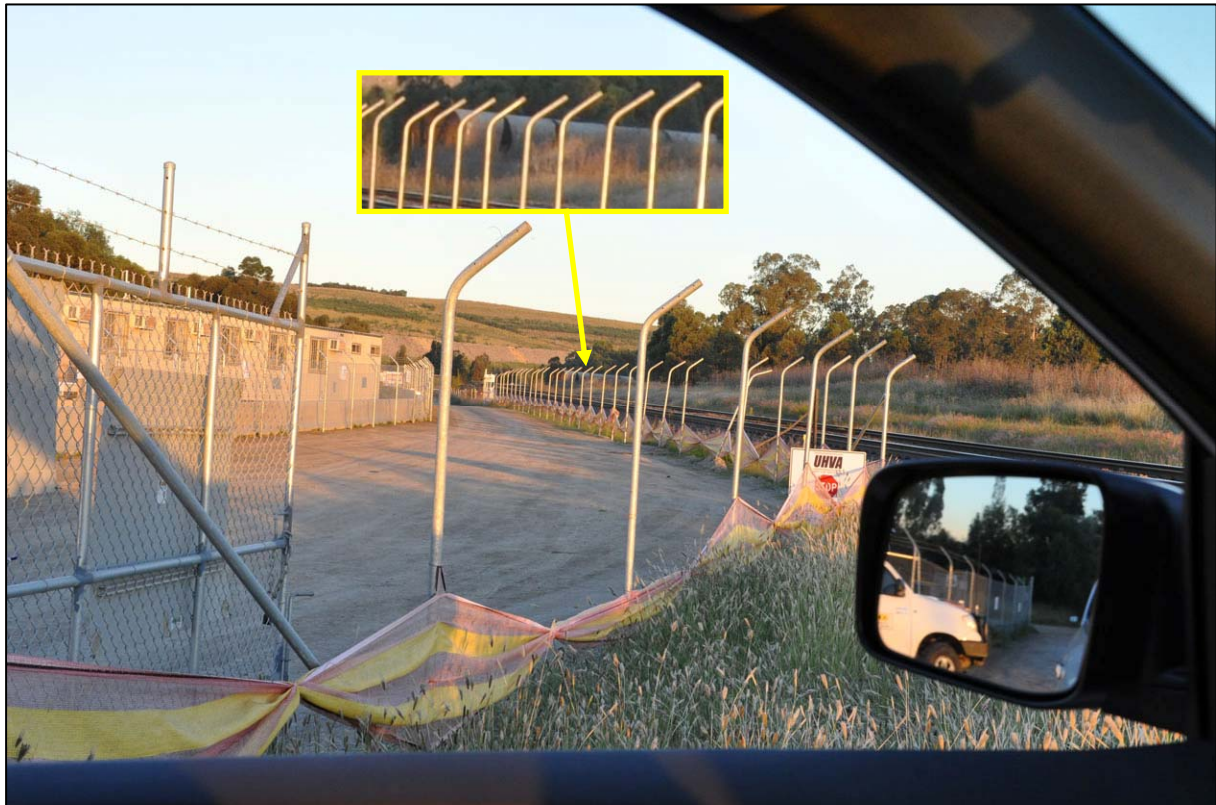
- 1.33 Had the driver stopped at the stop sign, which was 7.5 metres from the nearest rail, his view would have been as seen in *Photograph 8*. Note the rear of a train on the bend, obscured by the fence posts. At the time the utility passed the stop sign without stopping, the train would have been approximately 50 metres, or 2.5 seconds, from the point of impact.

Photograph 8: View to the left when stopped at stop sign

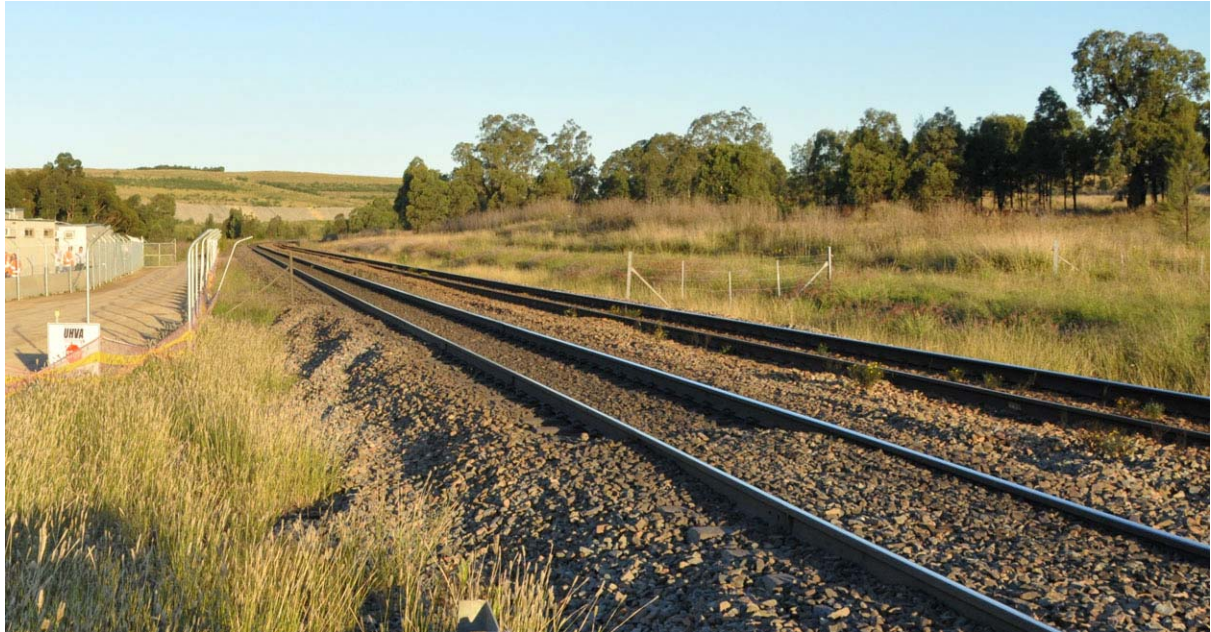
- 1.34 A clear view of the track to the left was not available to the driver until the vehicle had passed the stop sign and was no more than 3.5 metres from the nearest rail (*Photograph 9*).
- 1.35 In contrast, the view to the right (*Photograph 10*), although partially obstructed by a signal hut, was otherwise clear and a train standing approximately 800 metres away which was present at the time of the incident, was clearly visible. Note that the glare from the afternoon sun seen in this photograph would not have been a factor at the time of the collision.

Photograph 9: Clear view taken 3 metres from nearest rail

- 2.9 From the utility driver's perspective, the compound and fencing were major obstructions to the extent that a clear view of the track to the left, and of any train approaching from that direction, was not available when approaching or stopped at the stop sign. If the driver had stopped at the stop sign, he would have had to move forward a further 4 metres in order to obtain a clear view. The front of the utility would then have been no more than 3.5 metres from the track and the driver's view would have been similar to that shown previously in *Photograph 9*.

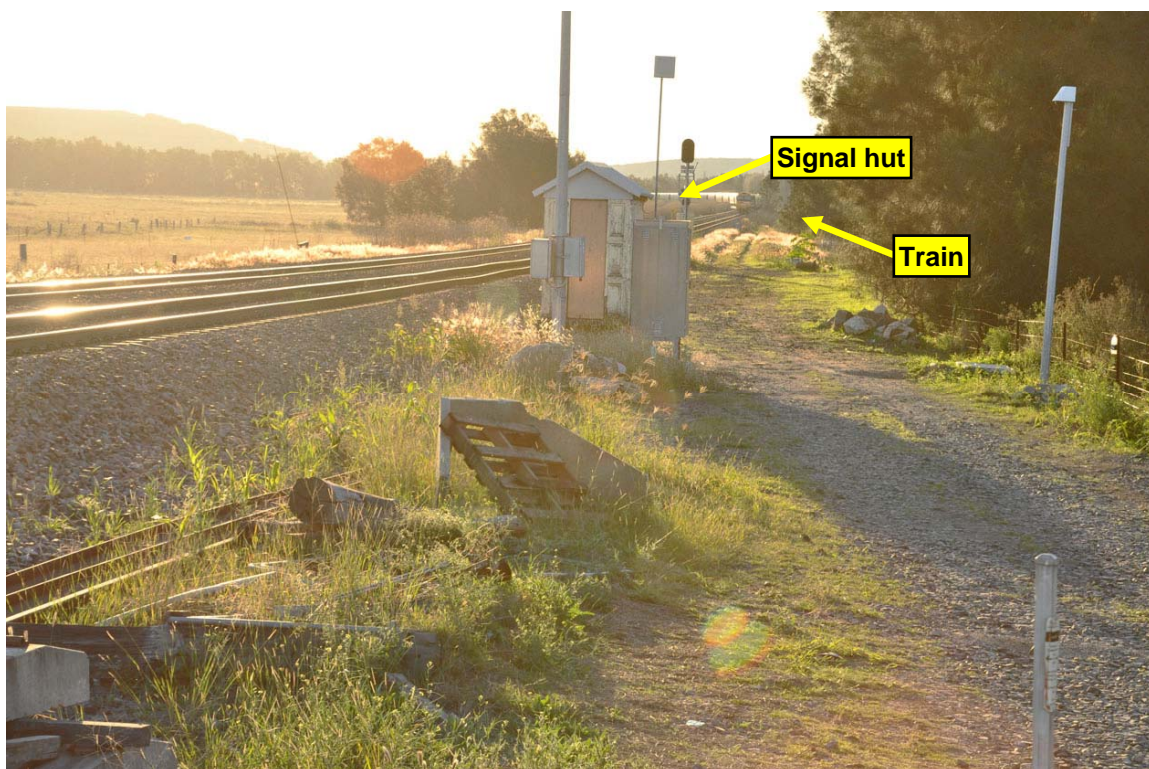
Photograph 10: View to the right when stopped at stop sign

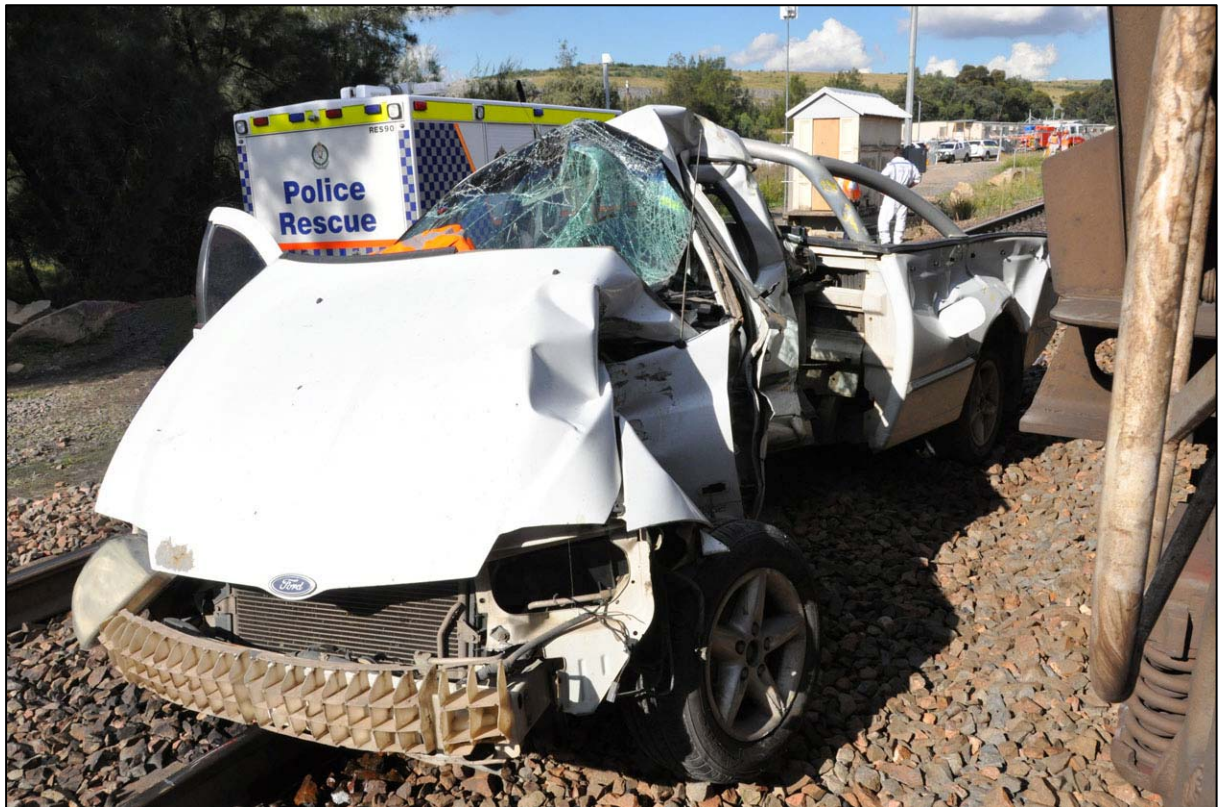
Photograph 11: Extent of damage to the utility

- 1.38 Damage to the utility was extreme, with its width reduced by approximately 50% at the seating position (*Photograph 11*).
- 1.39 As the QR train was approaching the crossing, Pacific National coal train NB914 was standing on the adjacent track approximately 800 metres north-west of the crossing and the crew, on seeing the collision, secured their train and hurried up the track to render assistance.

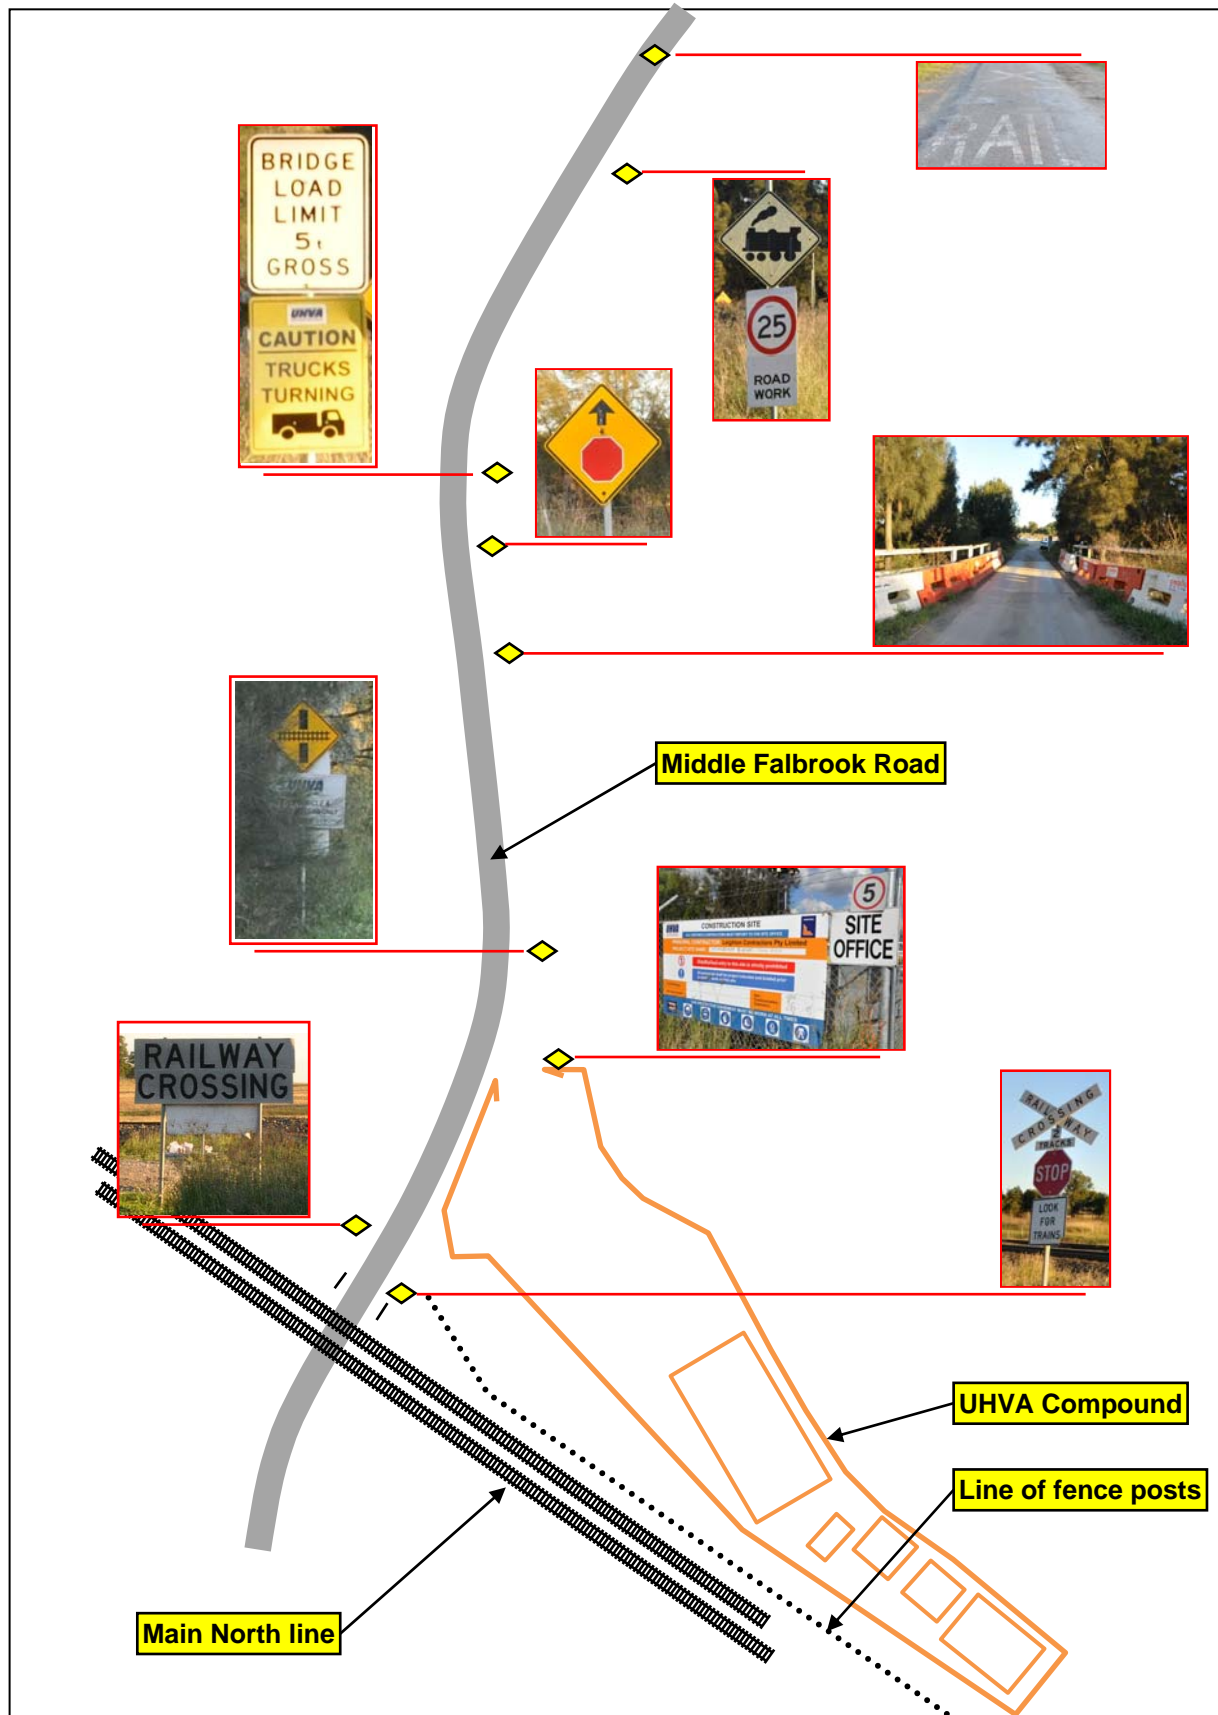
Figure 3: Location of road signs on approach from the north

- 2.12 The final 220 metres leading up to the crossing from the north presented a very busy visual environment. The presence of signs and barriers for roadworks, a speed restriction sign, the UHVA compound fencing and signage and the poor condition of the road were all potential detractors from the effective conspicuity of the railway crossing signage.
- 2.13 The utility driver may also have been aware of the presence of the train standing 800 metres away to his right. However this would not have been visible to him until he reached the stop sign, leaving insufficient distance to stop before reaching the tracks, and consequently having no influence on his decision not to stop.

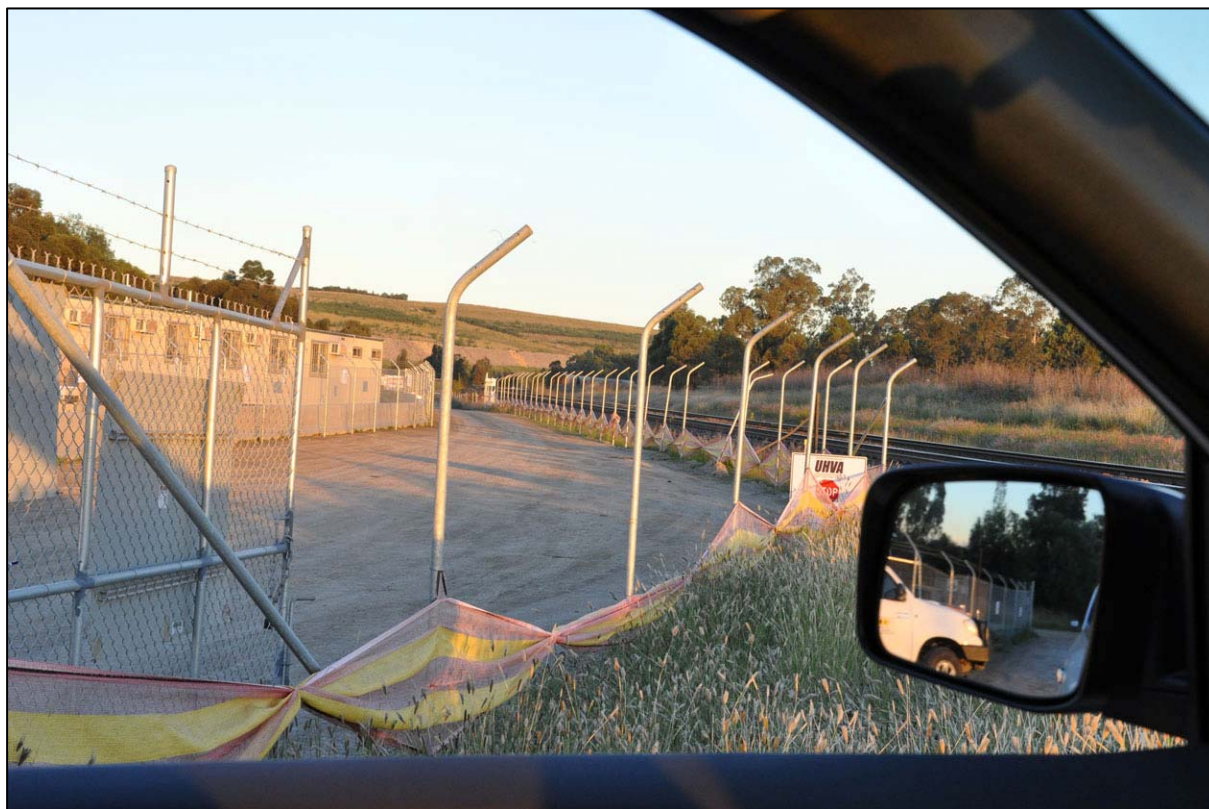
posts erected along the rail corridor was in a road vehicle driver's line of sight when stopped at the stop sign, 7.5 metres from the nearest rail as seen in *Photograph 12*. Movement forward from the stop sign to a position 3.5 metres from the nearest rail would give the driver a clear view of trains approaching from either direction and would decrease the required clearance time for a semi-trailer to 13.1 seconds from 13.9 seconds.

Photograph 12: View to the left when stopped at stop sign
