Office of Transport Safety Investigations

RAIL SAFETY INVESTIGATION REPORT

DERAILMENT OF CITYRAIL SERVICE 312A

11 SEPTEMBER 2006

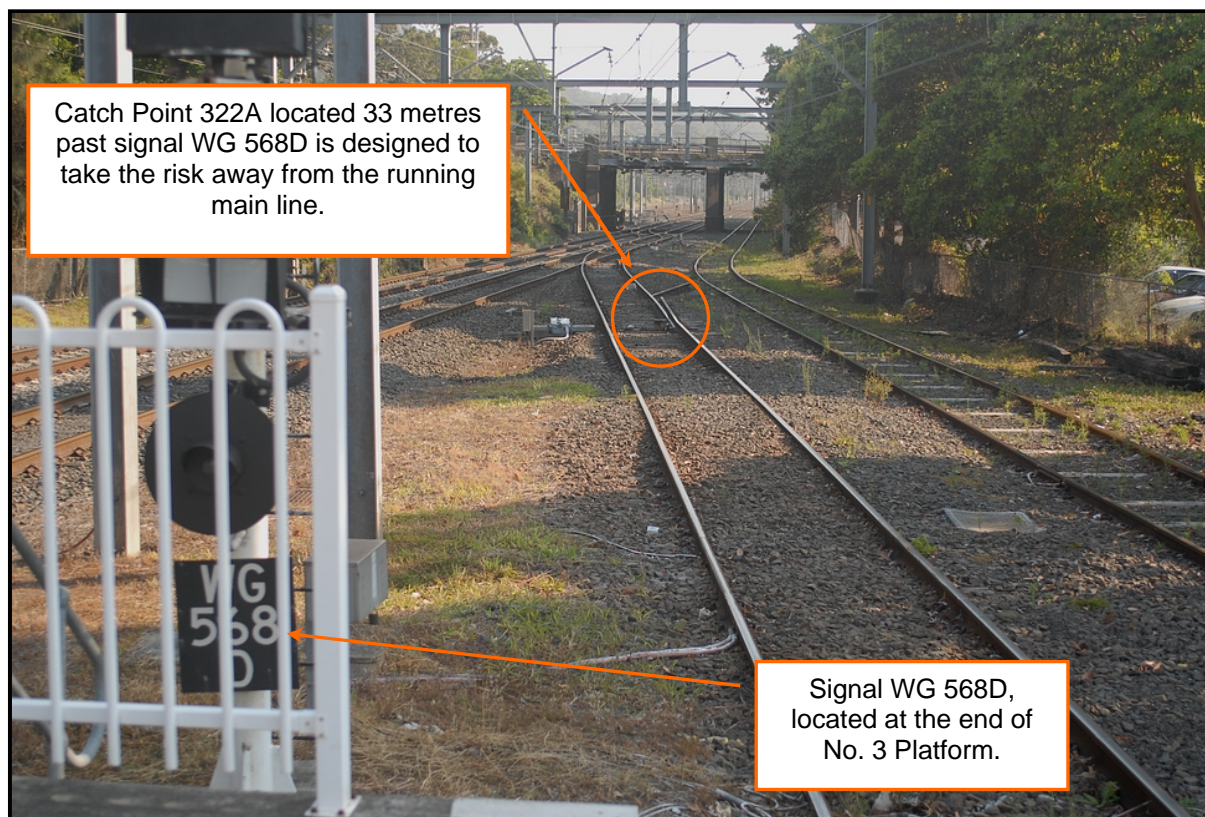
- 1.16 The train subsequently skidded past Signal WG 568D and then encountered the 322A catch-points positioned 33 metres beyond. This caused the four leading wheels of the leading car to derail, after which the train continued for a further 13 metres in the track's substructure (see *Photo 5*).

Photo 5: Signal WG 568D and catch-points.

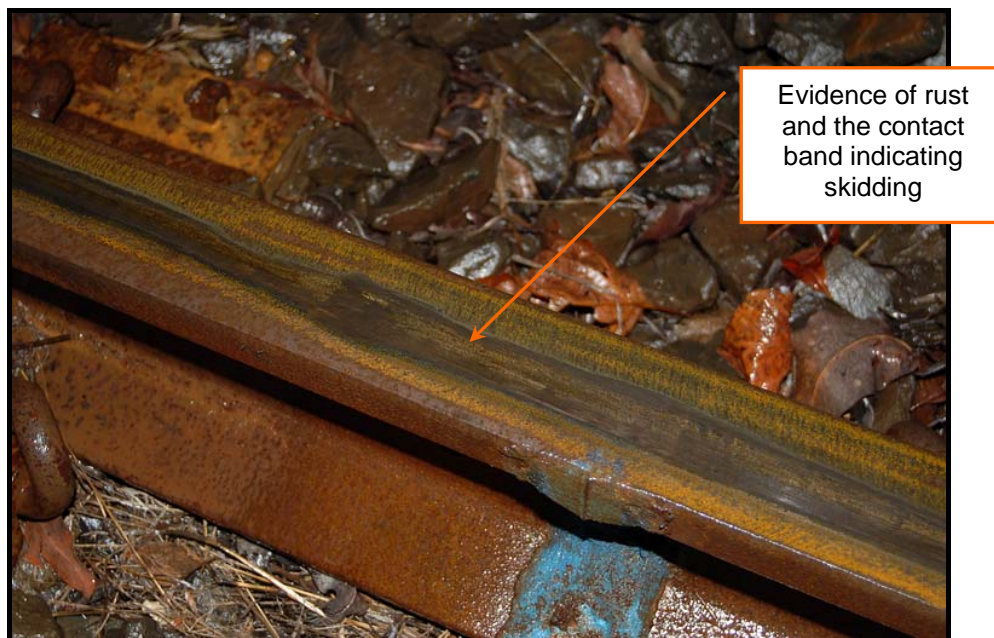
- 2.11. The track on which the derailment occurred had not had a train pass over it in the preceding 58 hours during which time strong southerly winds and wet conditions had prevailed. It is considered highly likely that these conditions, in combination with salt spray generated by the extreme surf conditions at nearby beaches, would have promoted the superficial rust that was apparent on the No. 3 Platform track. There was clear evidence of skid marks over a distance of 46 metres under the Tangara (see *Photos 7 and 8*).

Evidence of rust
and the contact
band indicating
skidding

Photo 7: Evidence of rust emulsion and skid marks on the railhead.
