## **TECHNICAL INSPECTION FINDINGS**

**FIRE INVOLVING STATE TRANSIT BUS MO 3422**

**DARLINGHURST, NSW**

**16 OCTOBER 2012**

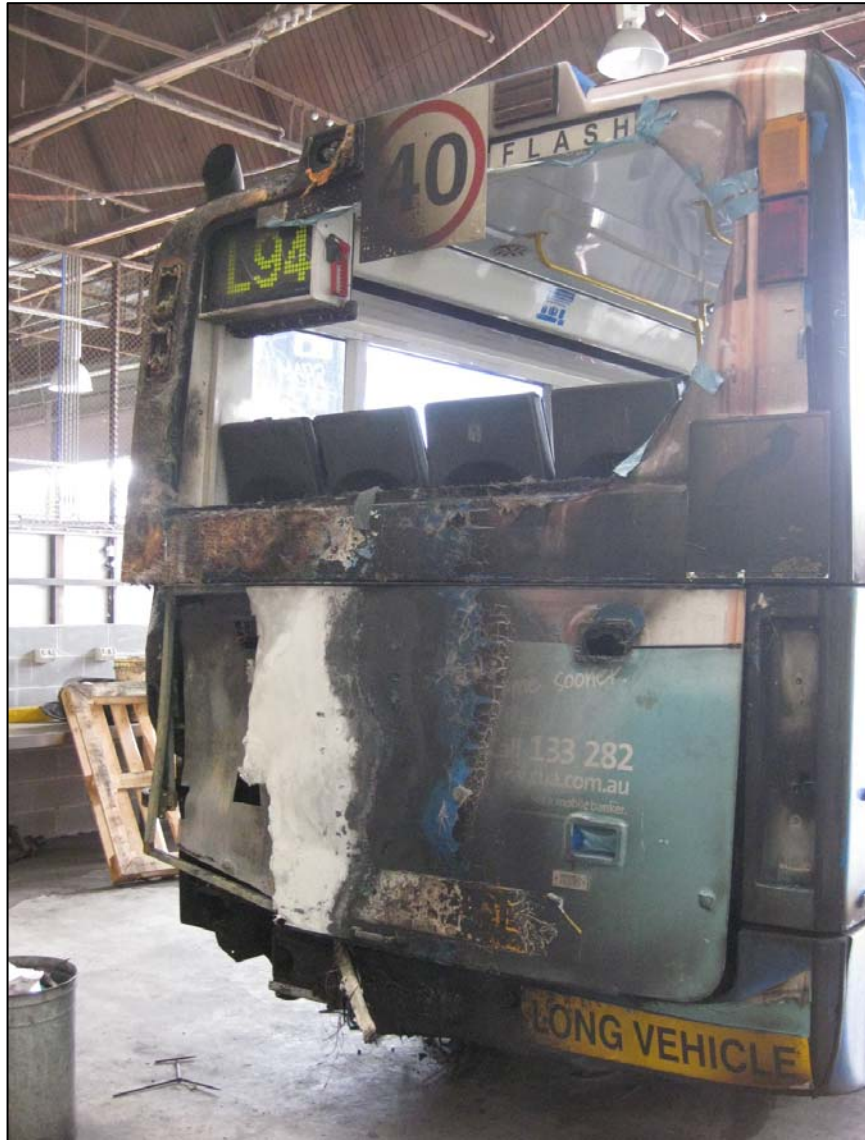
Examination of the bus established that there was a concentrated pattern of fire damage around a particular area within the engine compartment on the near side between the turbocharger, exhaust manifold and auxiliary alternator. Damage to the exterior of the bus was confined to the aluminium engine compartment hatch, the fibreglass body panels to the side and above the hatch, the rear window, the reversing camera housing and centre 'wig wag' lights (visible in *Photograph 1*). There were signs of minor heat and fire damage within the rear interior of the bus.

**Photograph 1: Overview of fire damage to the rear of the bus**

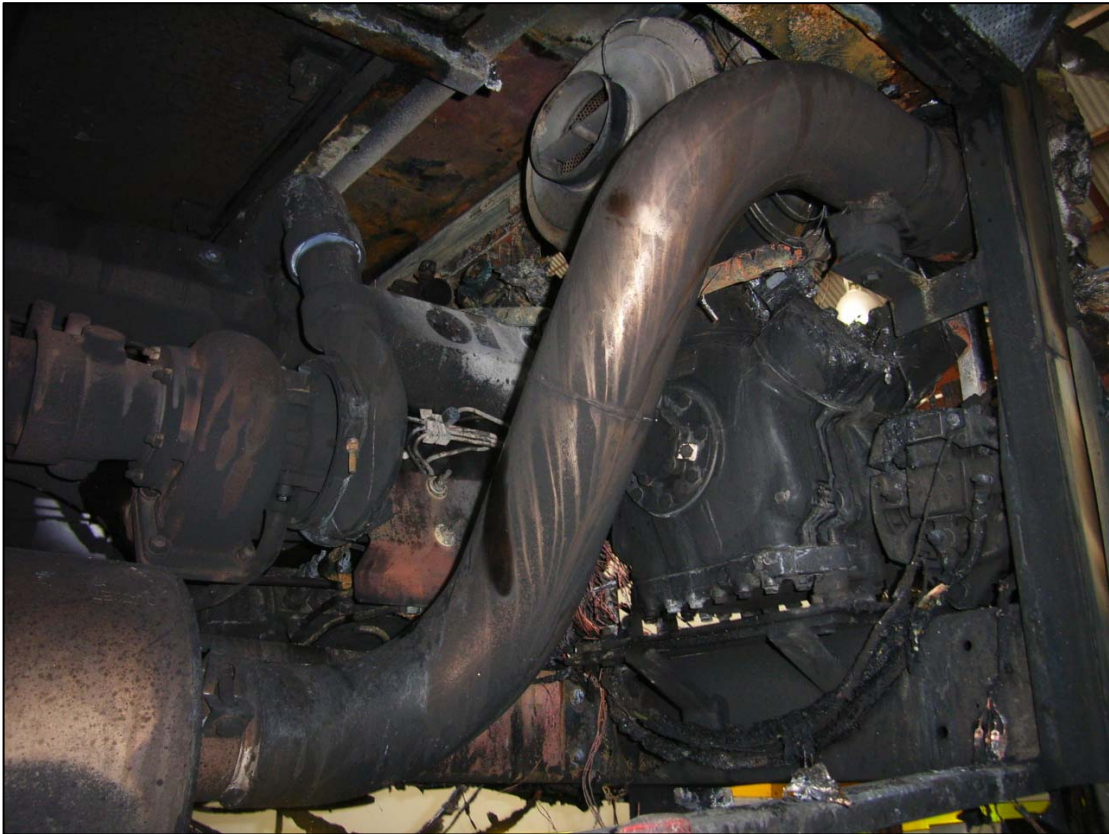
Witness observations, corroborated by the location of the greatest concentration of fire damage, indicated the likely source of the fire was on the near side of the engine (see *Photographs 1 to 3*). The turbocharger, air filter, auxiliary alternator and some nearby engine components were removed to allow for more detailed examination of those components, and to allow better access to that general area of the engine compartment. Other components in that area of the engine compartment included the exhaust manifold and several fuel injector delivery lines ('delivery pipes') which ran from the fuel pump to the fuel injector near the top of the engine. Amongst these delivery pipes was a low pressure fuel injector return line ('return line'). All components were checked for irregularities.

**Photograph 2: Damage within engine compartment (near side)**

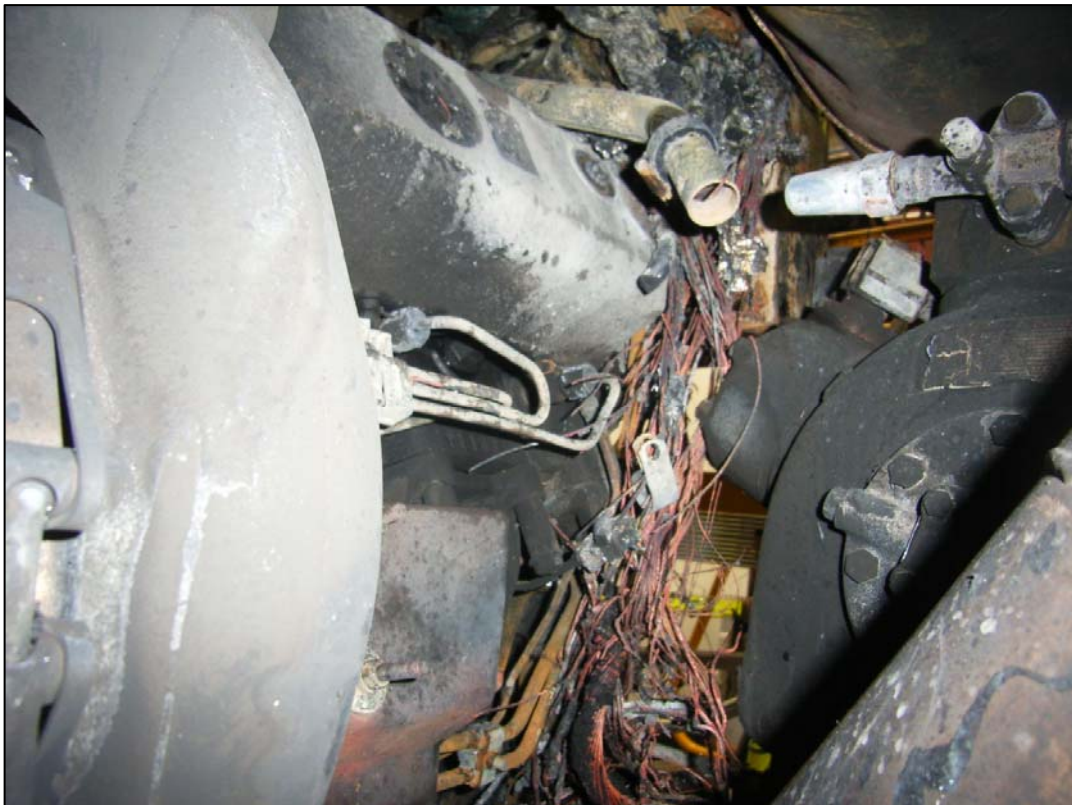
**Photograph 3: Component damage adjacent to fuel return line**

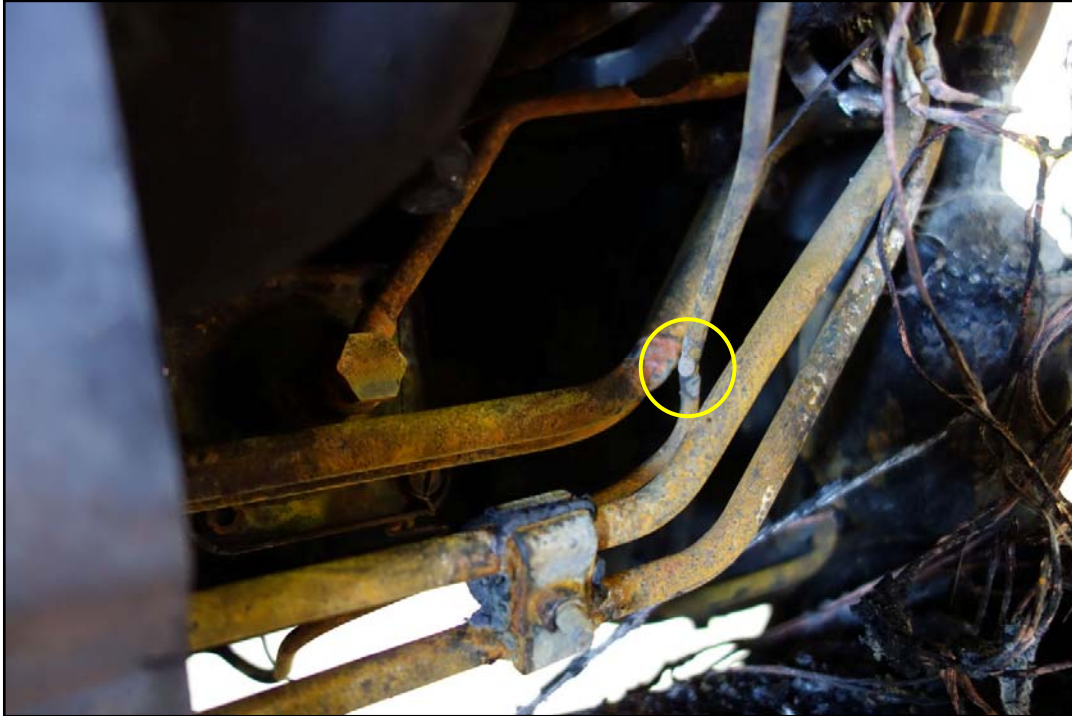
The delivery pipes appeared intact and properly clamped, however the return line was bent, unclamped, loose at one connection point and showed evidence of a previous repair (see *Photographs 4 and 5*). When removed for closer examination, the movement at the connection point was found to be due to a crack near a junction in the return line (see *Photograph 6*).

**Photograph 4: Fuel return line in situ, showing previous repair**

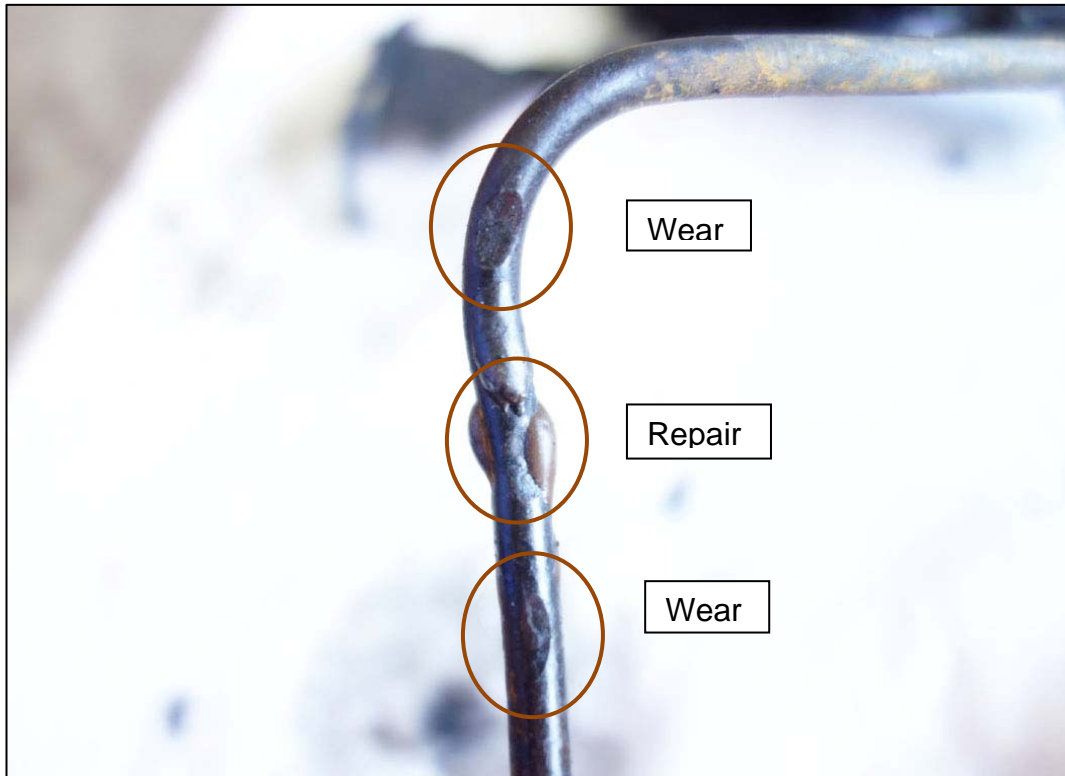
The return line was bent from its normal alignment, had evidence of a previous repair and showed wear marks from rubbing against adjacent pipes (see *Photograph 5*). This damage was unlikely to have been caused by the fire. It was more likely to

have occurred from a combination of normal operation/vibration, maintenance intervention and/or reinstallation activity. In this condition, the return line was more susceptible to failure from vibration and stresses under normal operating conditions.

**Photograph 5: Wear damage and previous repair on the return line**

- *“There were two visible areas of mechanical or wear type damage adjacent to the repair.”* (See Photograph 5) *“This type of damage is probably the type of damage that had previously been repaired.”*

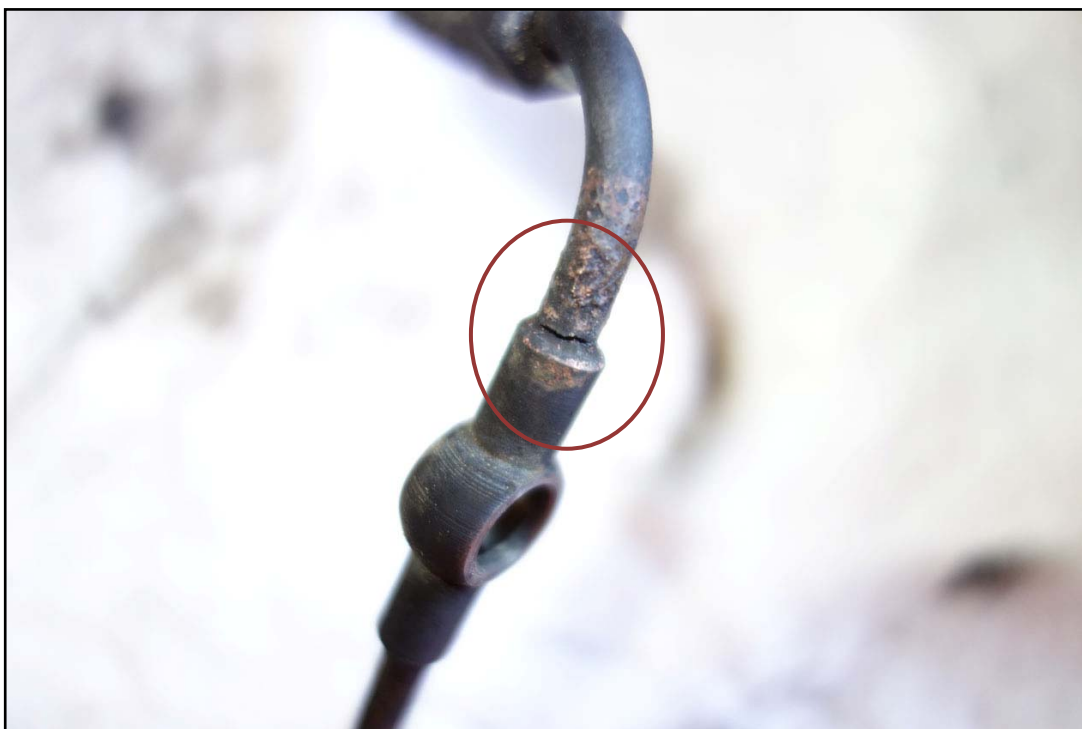
**Photograph 6: The crack in the return line**

- A fatigue crack had initiated at one end of the return line and grown in size over a period of time prior to the fire. The metallurgical investigation report states: *“A pre-existing crack of this size will have acted as a significant stress concentrator such that further crack propagation would have been likely to develop over a relatively short period of time, even under nominally normal operating conditions”*. Further: *“The presence of a crack at one end of the return line ... indicate that the return line provided the fuel source for the initiation of the fire in question”*.

- There were no witness marks along the length of the return line to indicate the presence of any supporting rubber sleeved “P” clamps. These clamps have an important role in improving rigidity against vibration, preventing chaffing against adjacent pipes and minimising the likelihood of undue stresses at the connection points. Importantly: *“The absence of a supporting “P” clamp will have greatly increased any movement of the return line associated with engine vibration etc. and therefore greatly increased the bending movement on the end of the return line where it fractured”*.

As a result of this incident, State Transit immediately inspected the remaining 48 buses of the same model in the fleet. They subsequently issued a maintenance alert covering vehicles of a similar configuration in the fleet (totalling 204 Scania buses). The alert focuses on the correct removal, repair and installation procedures relating to fuel lines.
