**Office of Transport Safety Investigations**

## **TECHNICAL INSPECTION FINDINGS**

**FIRE INVOLVING CYC TOURS BUS TV 4153**

**8 FEBRUARY 2010**

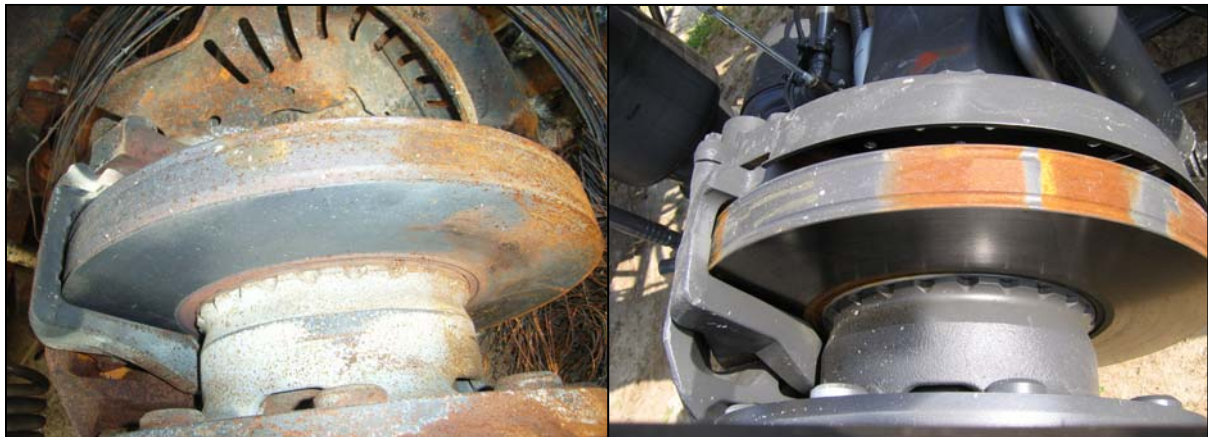
The brake shield located inboard of the brake disc was severely deformed, as can be seen in *Photograph 6* where it is compared with a similar undamaged shield. There was an impact mark, evidenced by visible burring, on the edge of the shield (*Photograph 7*) and, although the shield remained secured to the brake calliper mounting bracket by a bolt at each end, it had separated from a third bolt approximately mid-way between the other two.

**Photograph 6: Comparison of the damaged shield (left) with an undamaged shield (right)**

The damaged brake shield was examined and compared with an undamaged shield on another bus of the same model. It was considered that the damage to the shield was unlikely to have been caused by the tyre cord after the tyre disintegrated, as the cord was found to be lying loosely around the shield rather than caught and tangled on it.
