Office of Transport Safety Investigations

TECHNICAL INSPECTION FINDINGS

CITY SIGHTSEEING TOURS BUS FIRE

7 SEPTEMBER 2012

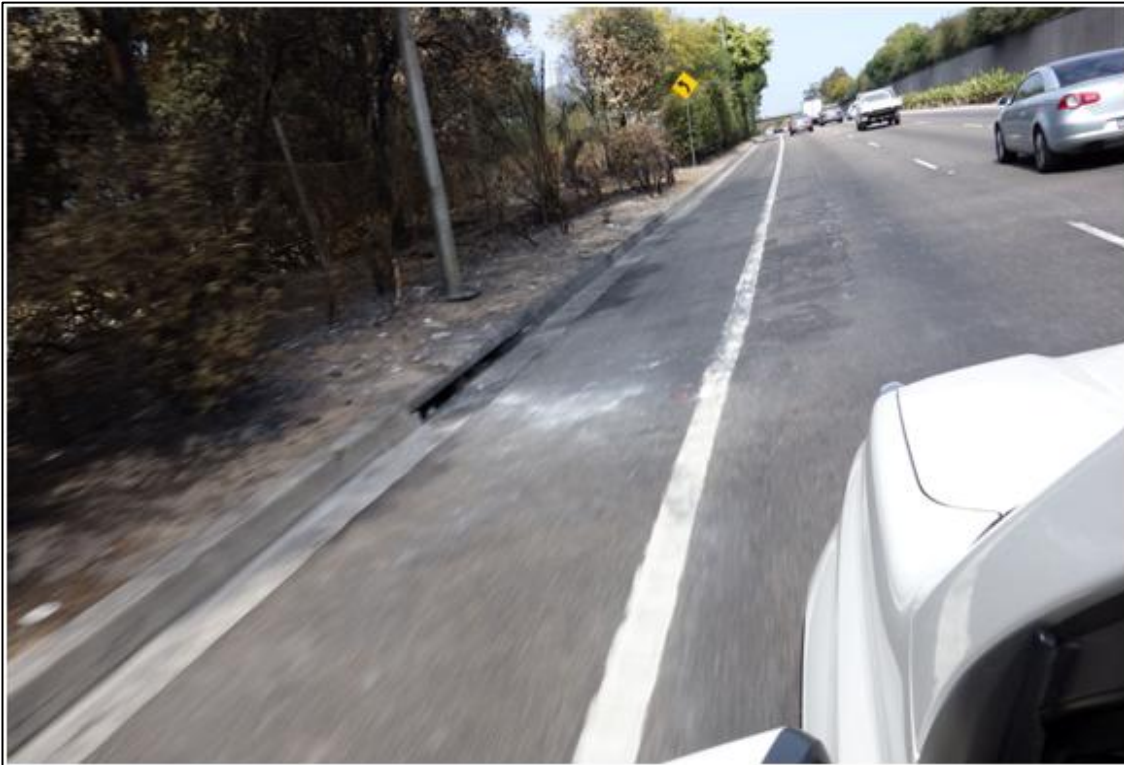
Photograph 1: Southern Cross Drive incident location

He continued driving for one to two minutes until he found a safe place to park in the breakdown lane of Southern Cross Drive adjacent to the Australian Golf Club (see

Photograph 1) where he pulled over, turned off the engine and called the Depot on his two-way radio to inform them of the situation.

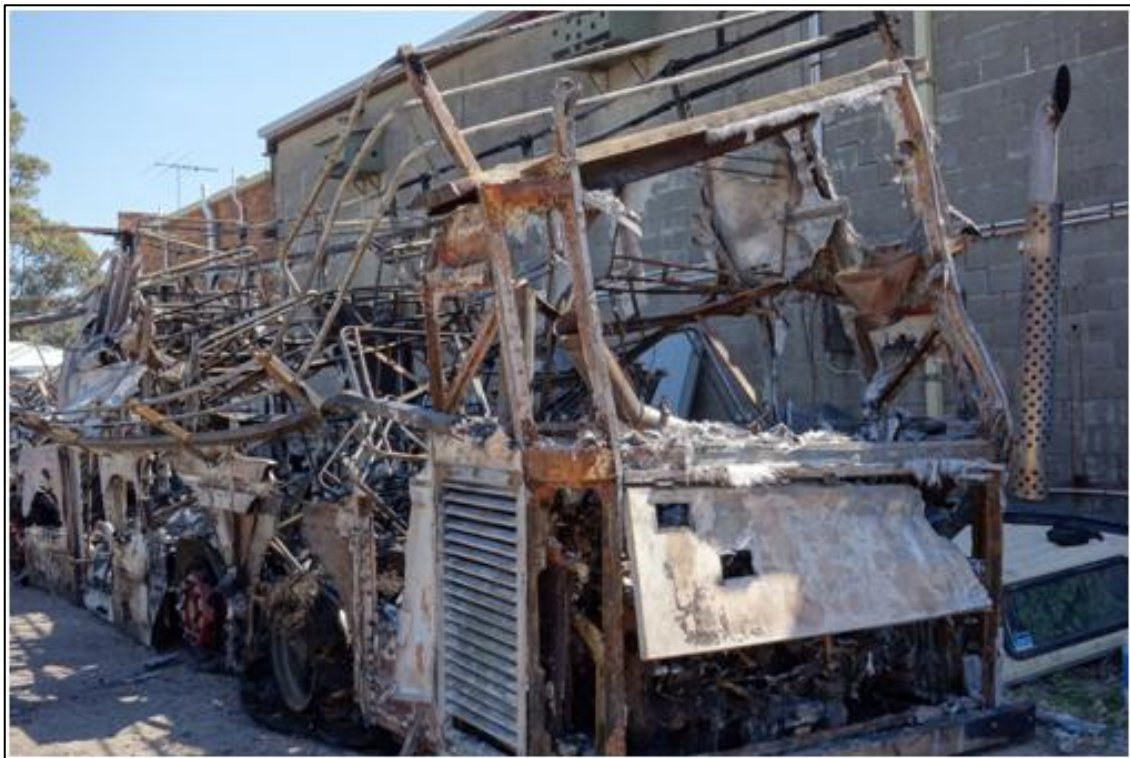
Photograph 2: Post-fire condition of bus

The extent of damage to the bus can be seen in *Photograph 2*.

The intensity of the fire was such that all that remained was the steel framework of the bus, some sections of body panels and various parts of the engine and drive train. The only area that remained relatively untouched was the front driver's side wheel (see *Photograph 3*). Nobody was injured as a result of the fire.

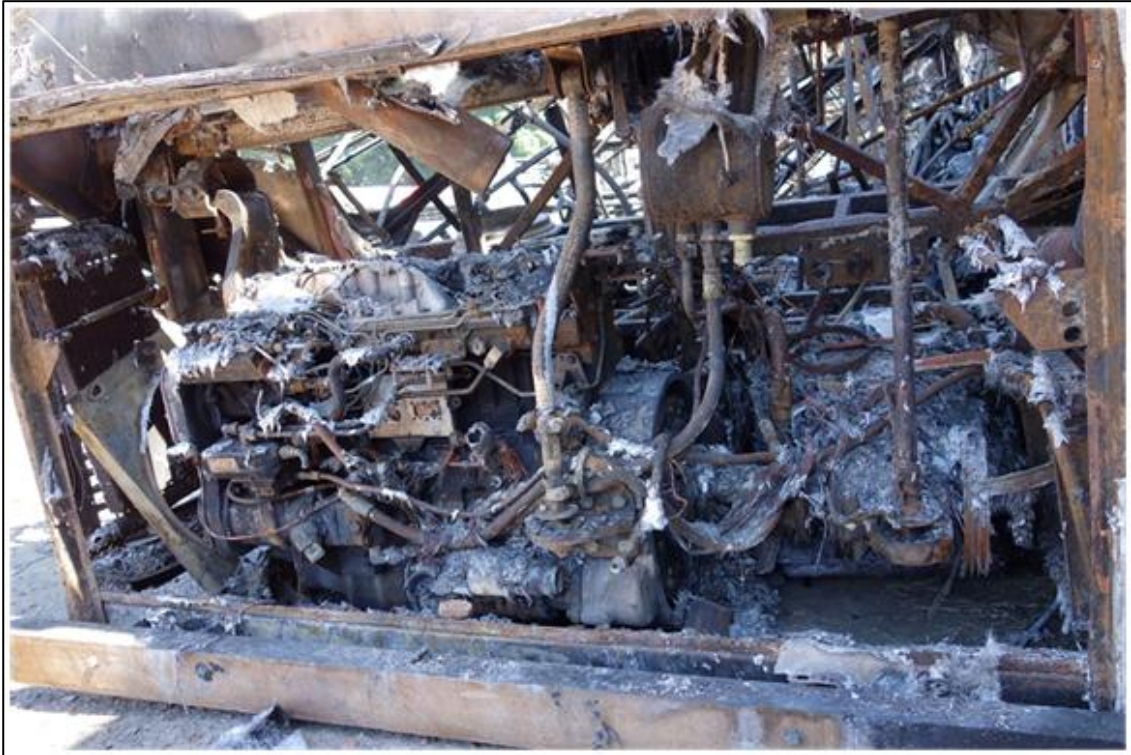
Photograph 5: Engine compartment

General damage to engine. The engine was substantially damaged with many engine parts partially or completely melted (see *Photograph 5*).

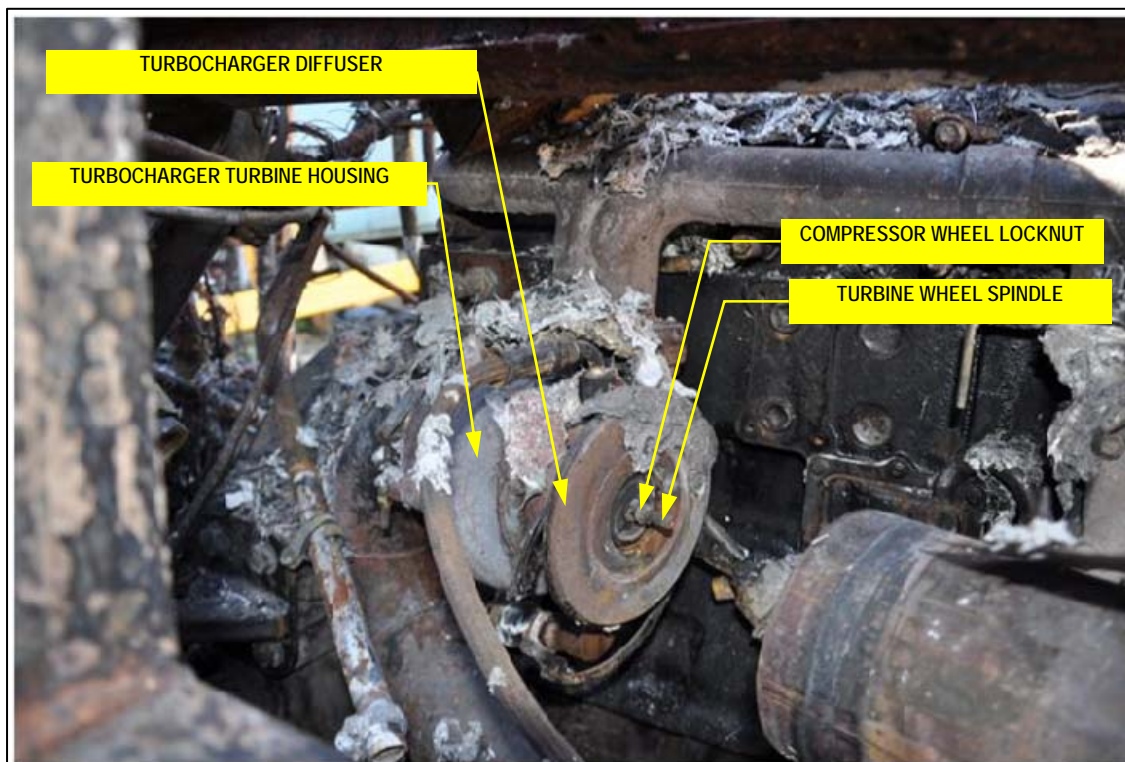
Photograph 7: Fire damaged turbocharger

An inspection of the turbocharger revealed that the compressor housing had completely melted with the remains still visible on and below the diffuser. The turbine wheel spindle was still in-situ with the compressor wheel locknut still in place; however, the compressor wheel was missing (see *Photograph 7*). It was noted that the turbine wheel spindle could still be easily rotated by hand, indicating that the oil flow to the turbocharger did not fail, since otherwise, the bearings would have seized.

There is no evidence of a bearing failure initiating this fire. Instead, it is probable that the compressor wheel disintegrated causing damage to the casing with consequent oil leakage from the turbocharger.

When the bus was inspected after the incident, it was found that the turbocharger compressor wheel and the surrounding casing were missing. On the basis of this evidence, it is considered most probable that the loss of power was the result of disintegration of the compressor wheel. This would have been followed by oil leakage due to consequent damage to the housing. The turbocharger would have been operating at a temperature sufficiently high to ignite the oil.

It is probable that the fire was caused by the turbocharger compressor wheel initially disintegrating, causing damage to the turbocharger casing with consequent oil leakage from the turbocharger. Oil then contacted a hot engine part and ignited. As the engine continued to run, oil was pumped out at a high rate to fuel the fire, which ultimately engulfed the entire bus.

If the bus had been equipped with effective fire detection and suppression systems, it is probable that early detection and suppression of the initial fire would have prevented the development of the fire.
