Office of Transport Safety Investigations

TECHNICAL INSPECTION FINDINGS

FIRE INVOLVING TRANSDEV SHORELINK BUS MO1970

16 DECEMBER 2011

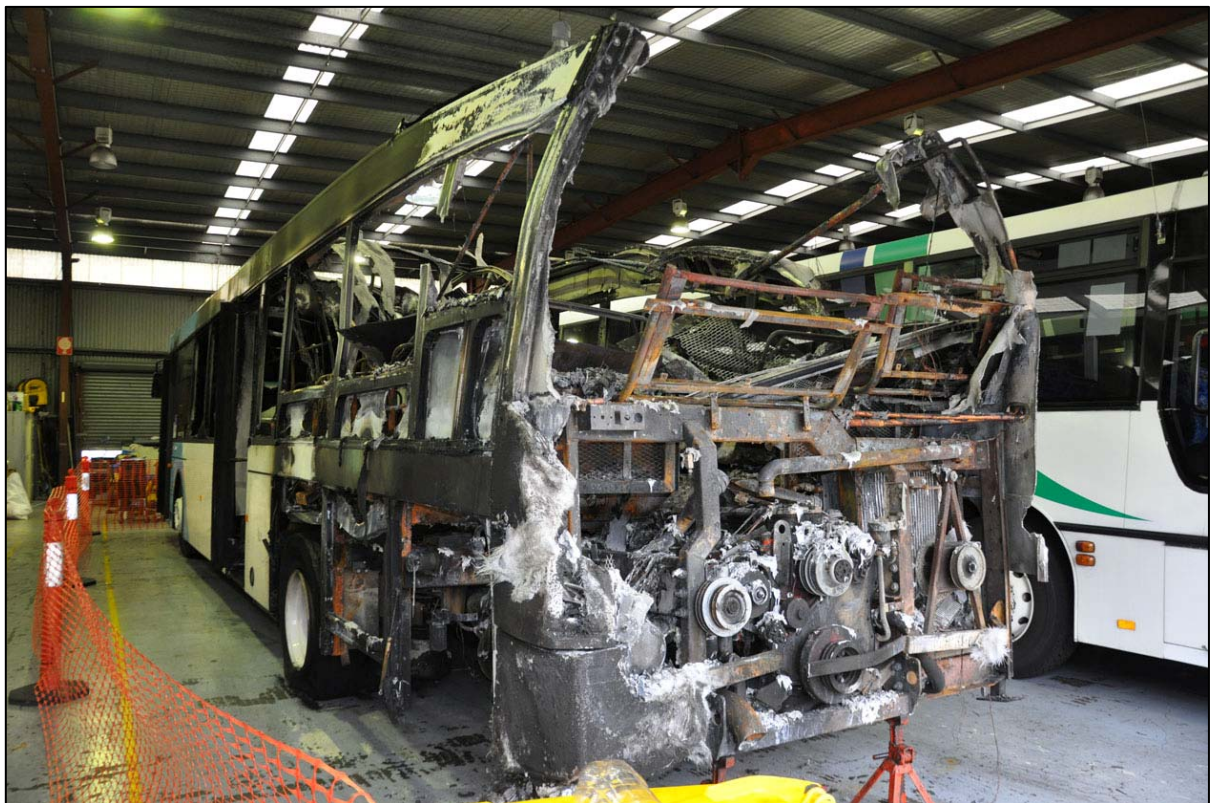
OTSI's Duty Officer was notified of the incident at 10:00pm on Friday 16 December 2011 by the Transdev depot. An initial inspection of the bus and the site of the fire took place on Monday 19 December 2011. The extent of damage to the bus can be seen in *Photograph 1*.

Photograph 1: Post-fire condition of bus

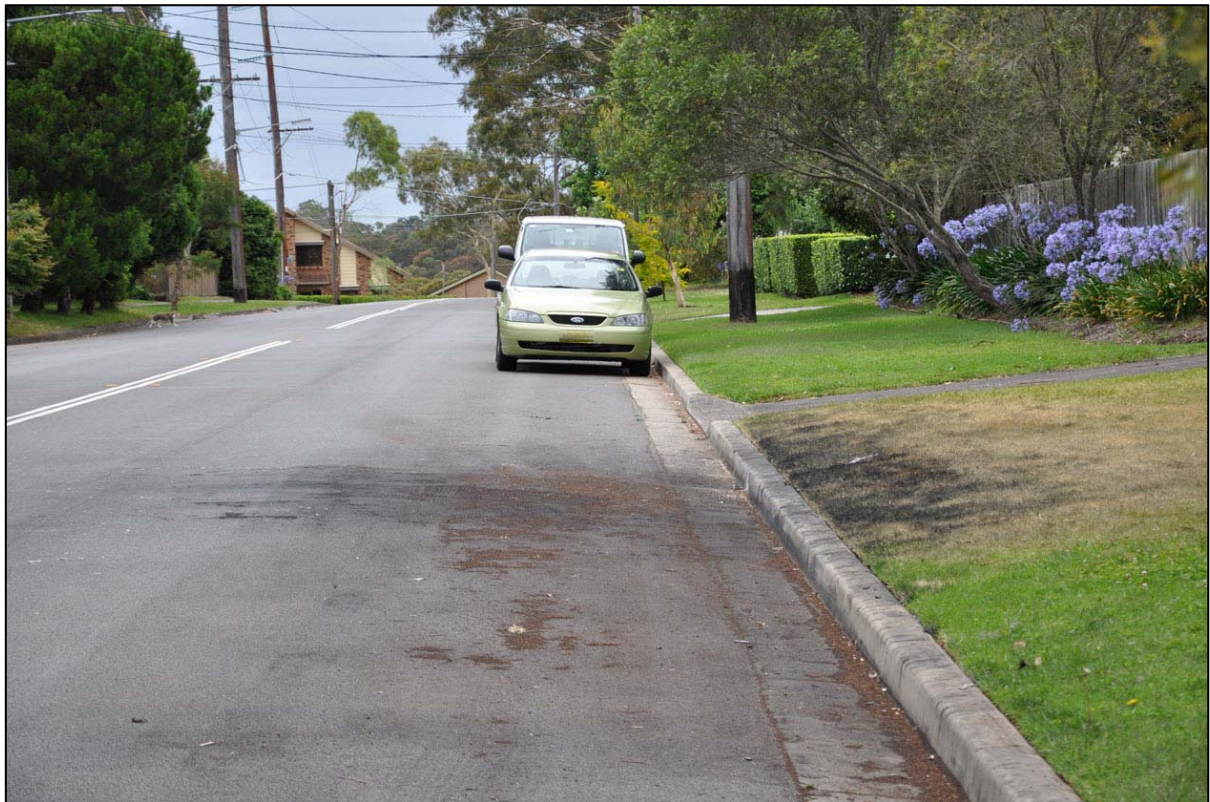
The location at which the bus stopped after the fire was detected was readily identifiable by a large scorched area of grass beside the roadway and a discoloured area on the road surface that had been covered with sawdust to soak up residual fluid, as seen in *Photograph 2*.

Photograph 2: Scorching on road surface and grass

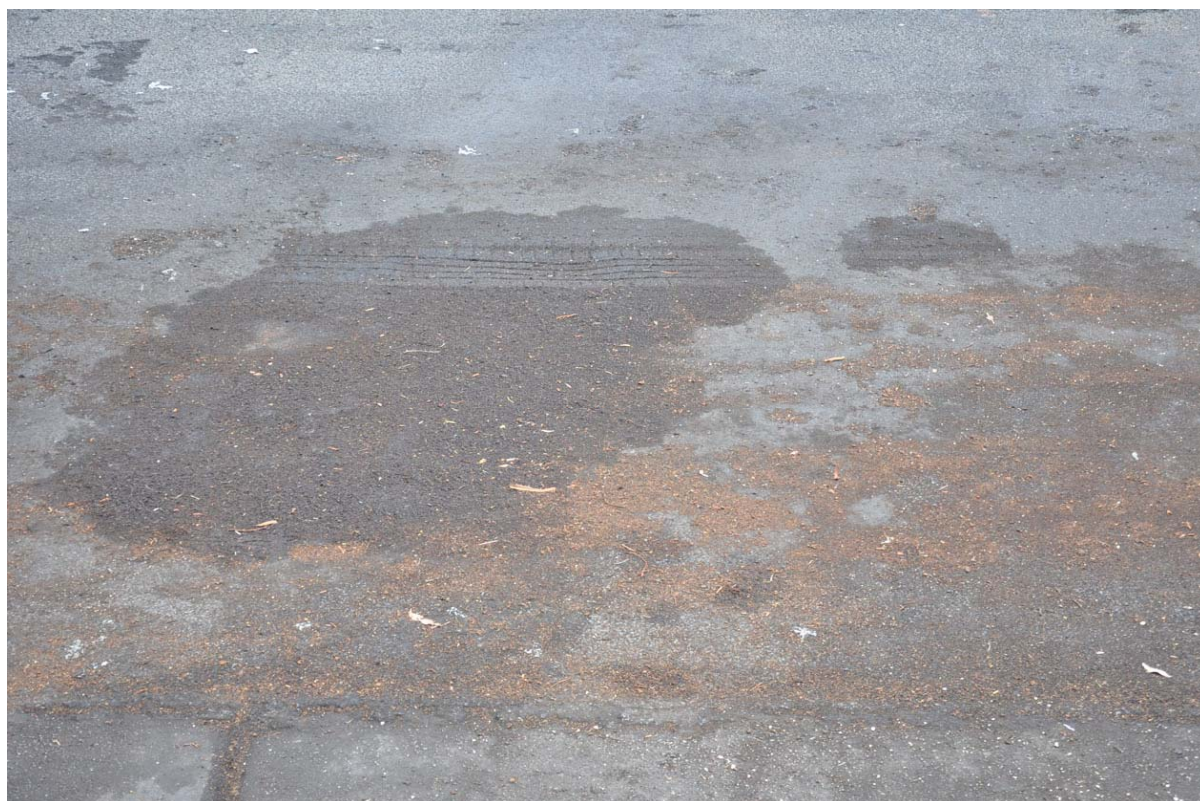
The substance causing the discolouration had soaked into and softened the surface of the roadway to such a degree that a tyre mark passing through it left a distinct impression, as visible in *Photograph 3*.

Photograph 3: Tyre mark in softened surface

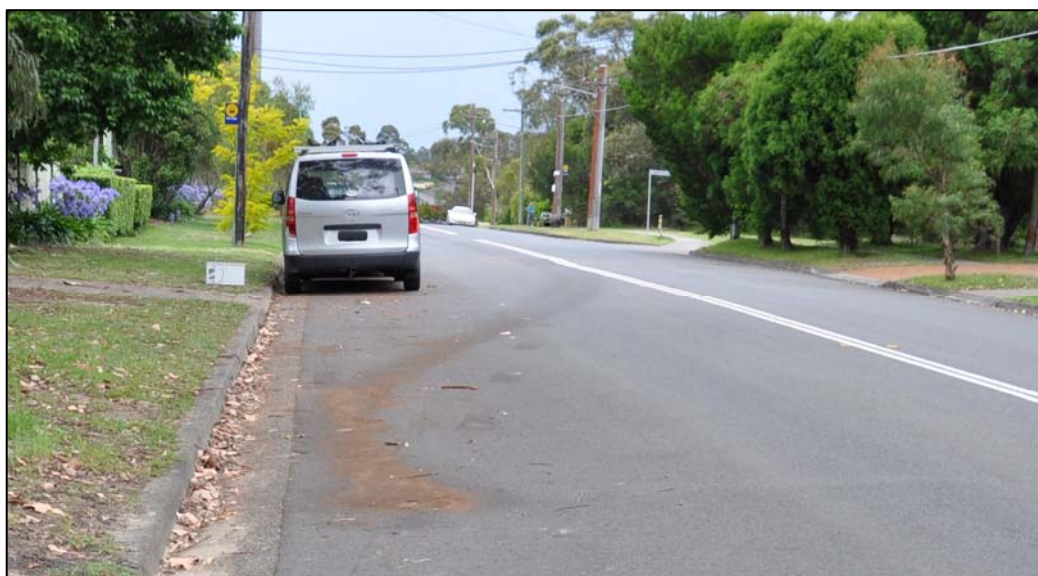
Leading up to the discolouration on the road surface was a trail following the path of the vehicle. This trail, which can be seen in *Photograph 4*, was approximately 100 metres long and started around 1 metre from the kerb, at the location at which the bus had stopped to set down the last passenger.

Photograph 4: Trail left by bus

There was no trail leading up to this point, and the greater width of the discolouration at its start suggests that it commenced while the bus was either stationary or moving at a low speed. The fact that the trail can be seen to initially track closer to the kerb suggests that it originated from a source substantially behind the rear axle, thus having been affected by the tendency of the rear of the bus to swing in as the front moved away from the kerb.

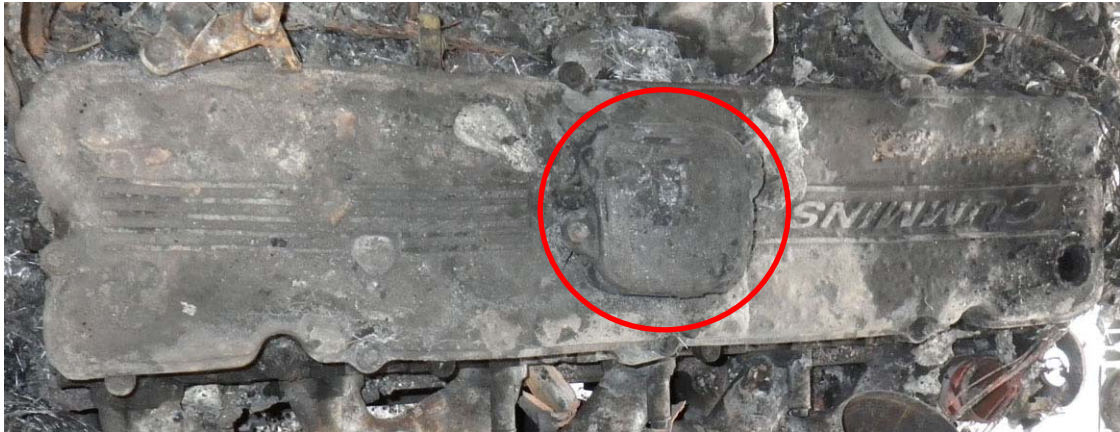
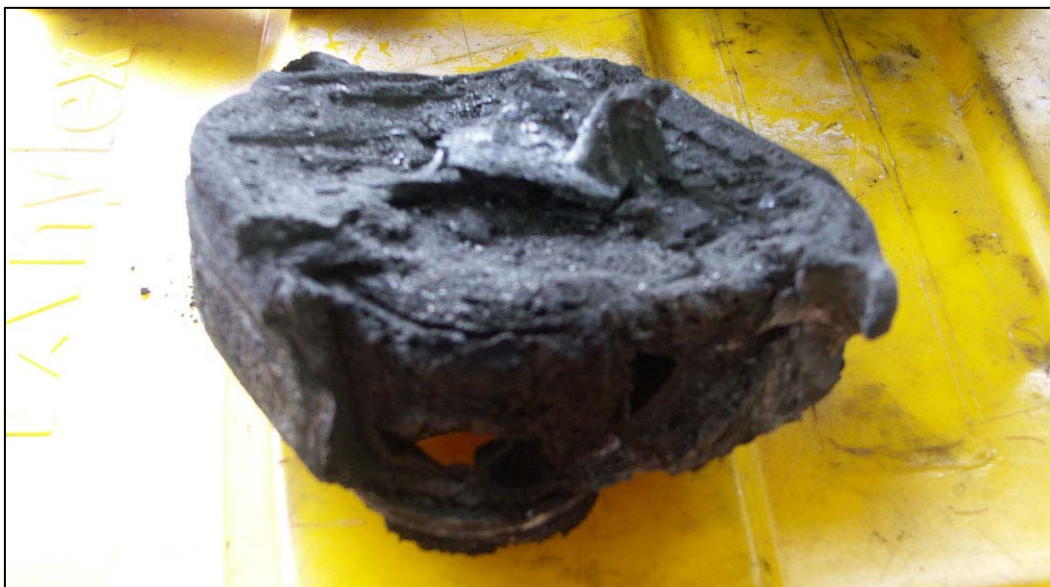
During the second inspection the engine control module (ECM) was removed for examination. ECMs store engine operating data to aid in service operations but, due to the extreme damage as seen in *Photographs 5 and 6*, it was impossible to obtain any data from it.

Photograph 5: Damaged engine control module

Photograph 6: Damaged engine control module after removal

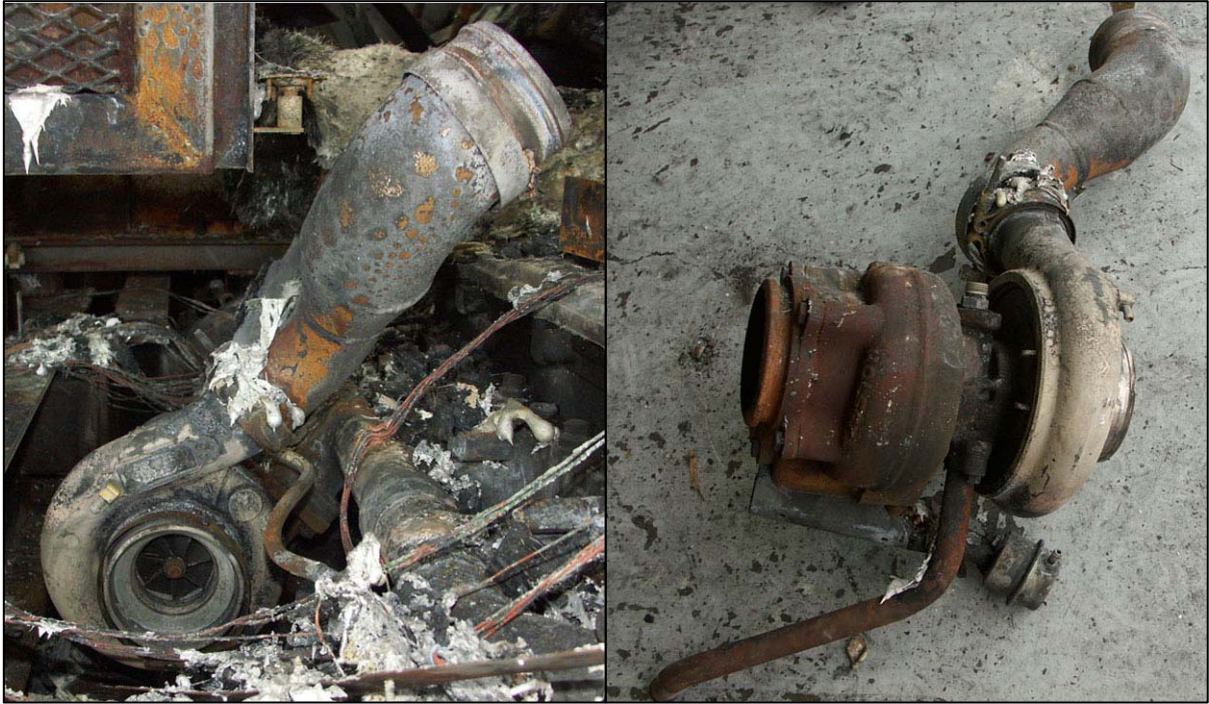
Photograph 7: Turbocharger before and after removal

- a. Once the compressor housing had been removed the turbine and compressor wheels were free to rotate.
- b. The turbocharger shaft exhibited some evidence of heat discolouration but no significant mechanical damage.
- c. The two floating bearings exhibited some heat/burnt oil discolouration but no evidence of any significant mechanical damage.

The consultant's opinion in conclusion was that there was no evidence to indicate that the fire was caused by overheating of the turbocharger in association with a lubrication failure.

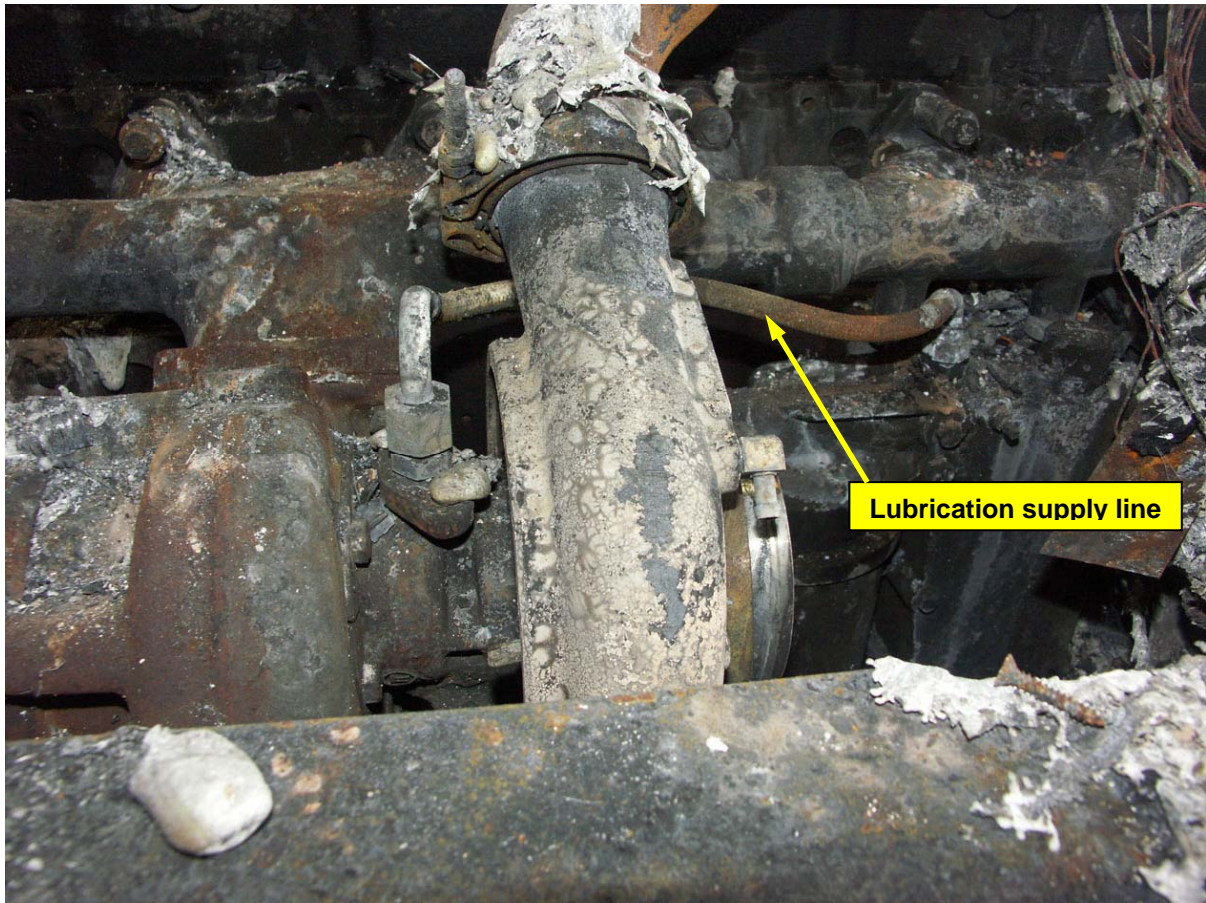
Photograph 8: Turbocharger lubrication oil supply line

The line was intact, and the union securing it to the turbocharger housing was tight. However, the union at the oil filter end was only a little more than finger tight.

It is possible that oil leaked from this union and contaminated the area around the turbocharger, ultimately igniting when the bus's operating conditions resulted in an elevated turbocharger temperature.

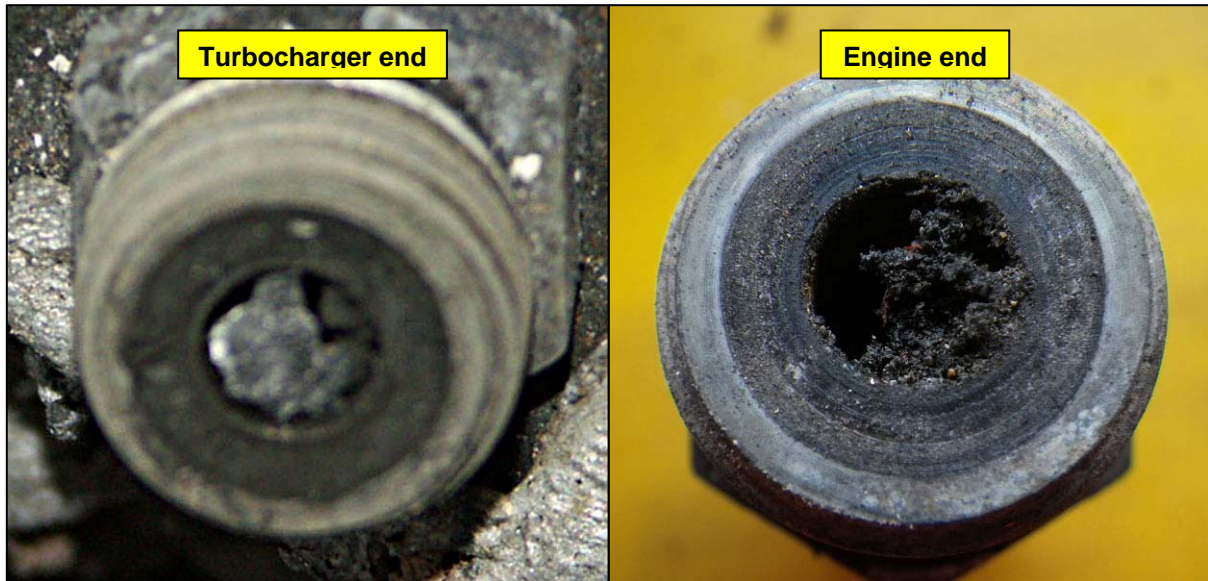
The engine end of the line and the union at the turbocharger end of the line were found to contain hard deposits partially blocking the bore, as shown in *Photograph 9*.

Photograph 9: Deposits in union and line

It is likely that these deposits formed during the fire after the engine stopped, as otherwise they would most likely have been carried into the turbocharger by the flow of lubricant, resulting in failure of the turbocharger bearings.

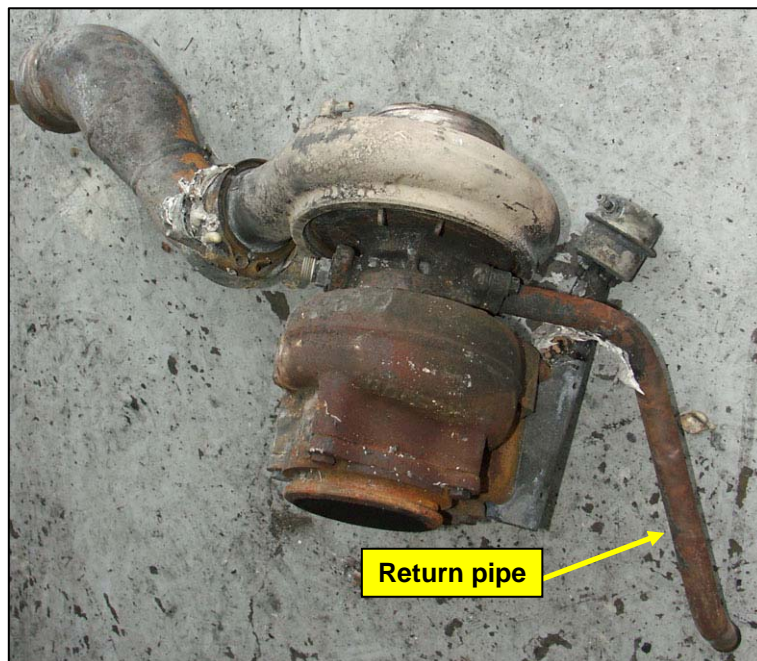
The flexible hose between the return pipe and the engine had been completely burned away, and the hose clamps were no longer in place. The condition of the return pipe can be seen in Photograph 11.

Photograph 11: Turbocharger lubricant return line

If the flexible hose had been burned away while the engine was running oil would have been pumped out at the delivery rate of the oil pump, until the oil supply was exhausted or the engine stopped.

Once the fire had started, it is likely that it burned through the flexible connection from the oil return to the sump, thus providing a high volume supply of oil to feed the fire. As an oil trail was found leading from the bus's last passenger stop but no trail was found leading up to this stop, it is probable that the fire commenced before this stop and burned through the return pipe's flexible connection while the bus was at the stop.

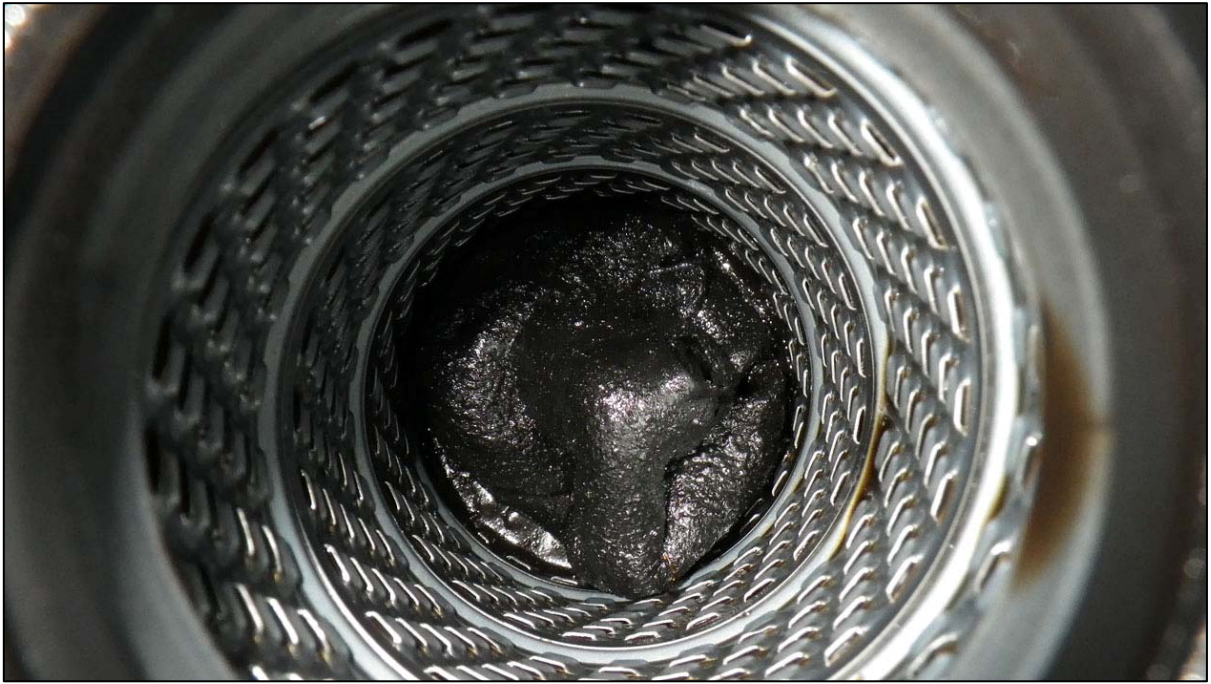
The oil filter was drained and on examination was found to have an irregularly shaped black mass firmly adhered to the bottom, as can be seen in *Photograph 13*.

Photograph 13: View inside oil filter

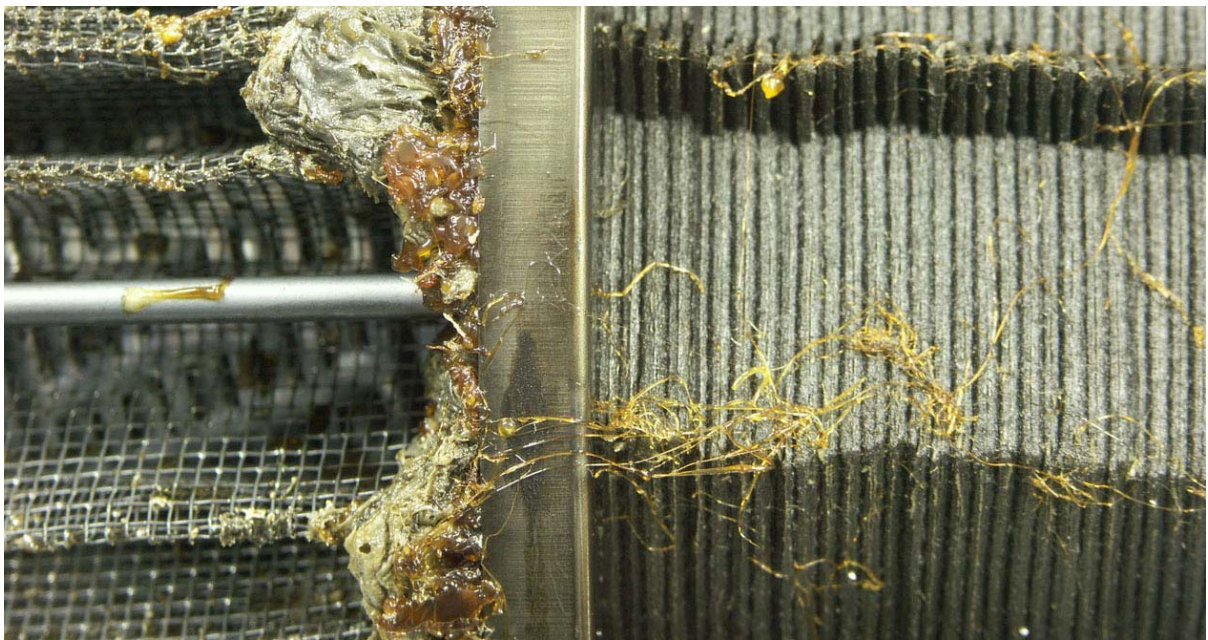
A variety of substances as seen in *Photograph 16* had been trapped by the filter. However, the quantities were small and there was no evidence that the filter had been blocked to such a degree that oil flow would have been significantly impeded.

Photograph 16: Deposits in filter

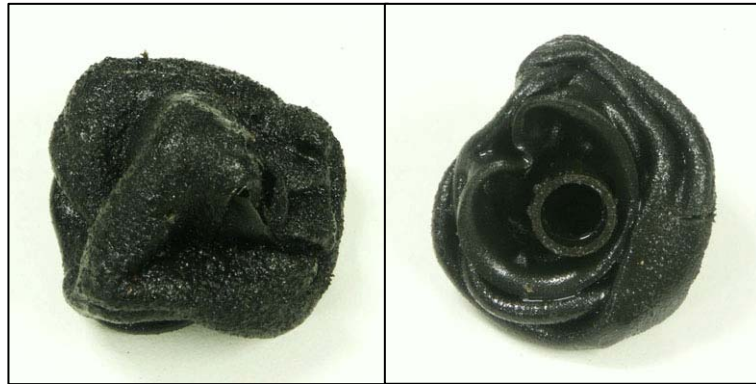
The mass seen at the bottom of the filter in *Photograph 13* was removed and is shown in *Photograph 17*. Its shape confirmed that it was a grossly distorted plastic venturi, indicating that it had been subjected to a temperature well beyond normal.

Photograph 17: Heat distorted oil filter venturi

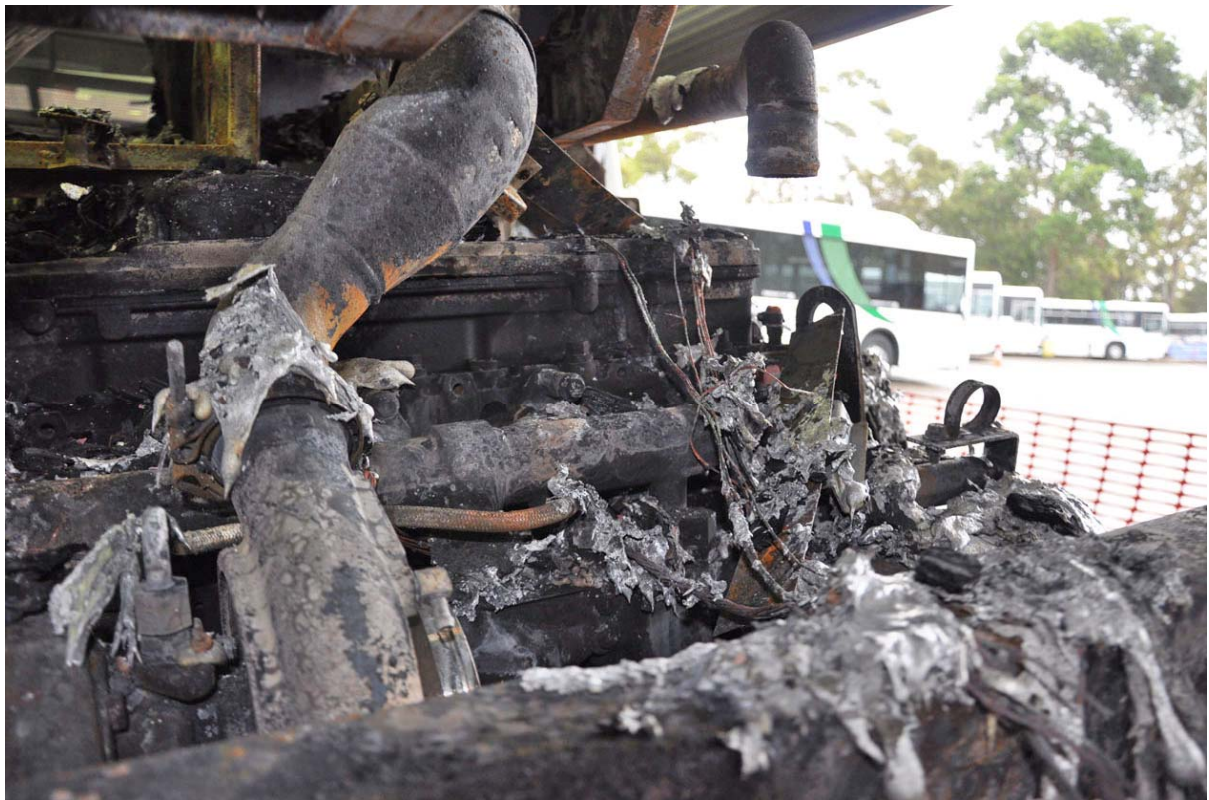
Although the fire damage to the engine was widespread, there were two areas where the damage appeared greater than elsewhere. These were in the vicinity of the turbocharger as can be seen in *Photograph 18*, and the engine's cam cover as seen in *Photograph 19*.

Photograph 18: Damage near turbocharger

Consideration was given to the possible sources of fuel for the fire in these areas. The main potential source of fuel in the vicinity of the turbocharger was the lubrication system, and in particular the supply and return lines connected to the turbocharger. In the case of the cam cover, the nearest potential fuel source was the diesel fuel supply associated with the engine's fuel injection system.

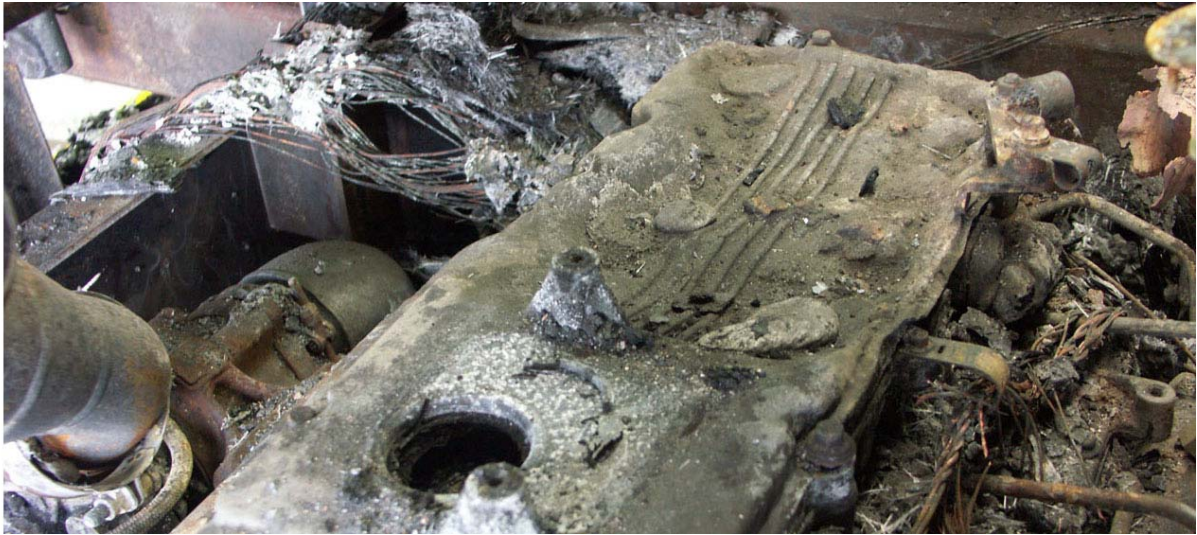
Photograph 19: Heat damage to the cam cover
