Office of Transport Safety Investigations

TECHNICAL INSPECTION FINDINGS

MAKEHAM'S COACHES BUS FIRE

4 JANUARY 2013

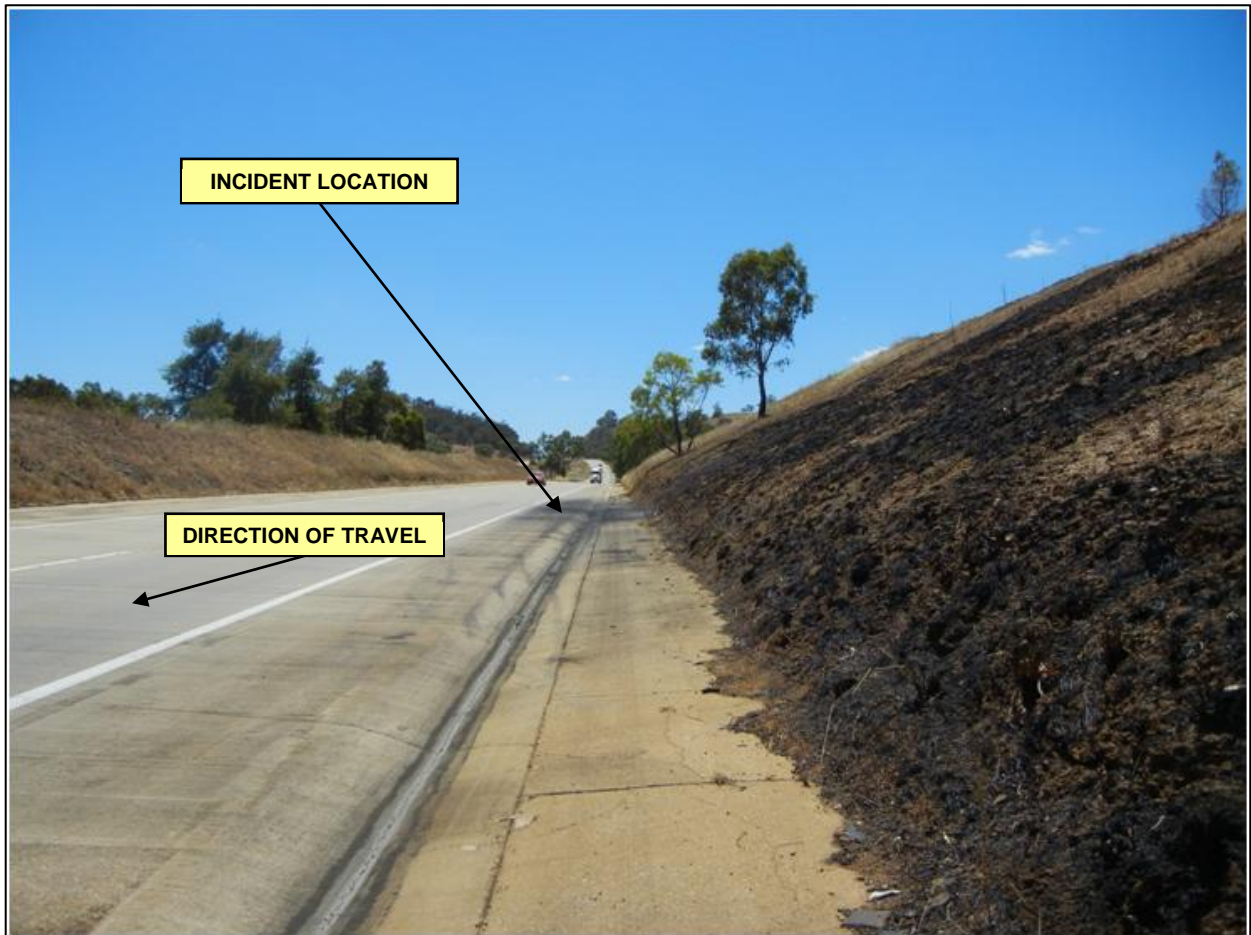
Photograph 1: Hume Highway incident location

The driver said he slowed the bus as quickly and safely as possible, decided on a suitable place to pull over, and pulled to the side of the Hume Highway where it was a lot wider and safer (see *Photograph 1*). He shut the engine down and noticed a fire alarm warning light illuminated on the dashboard.

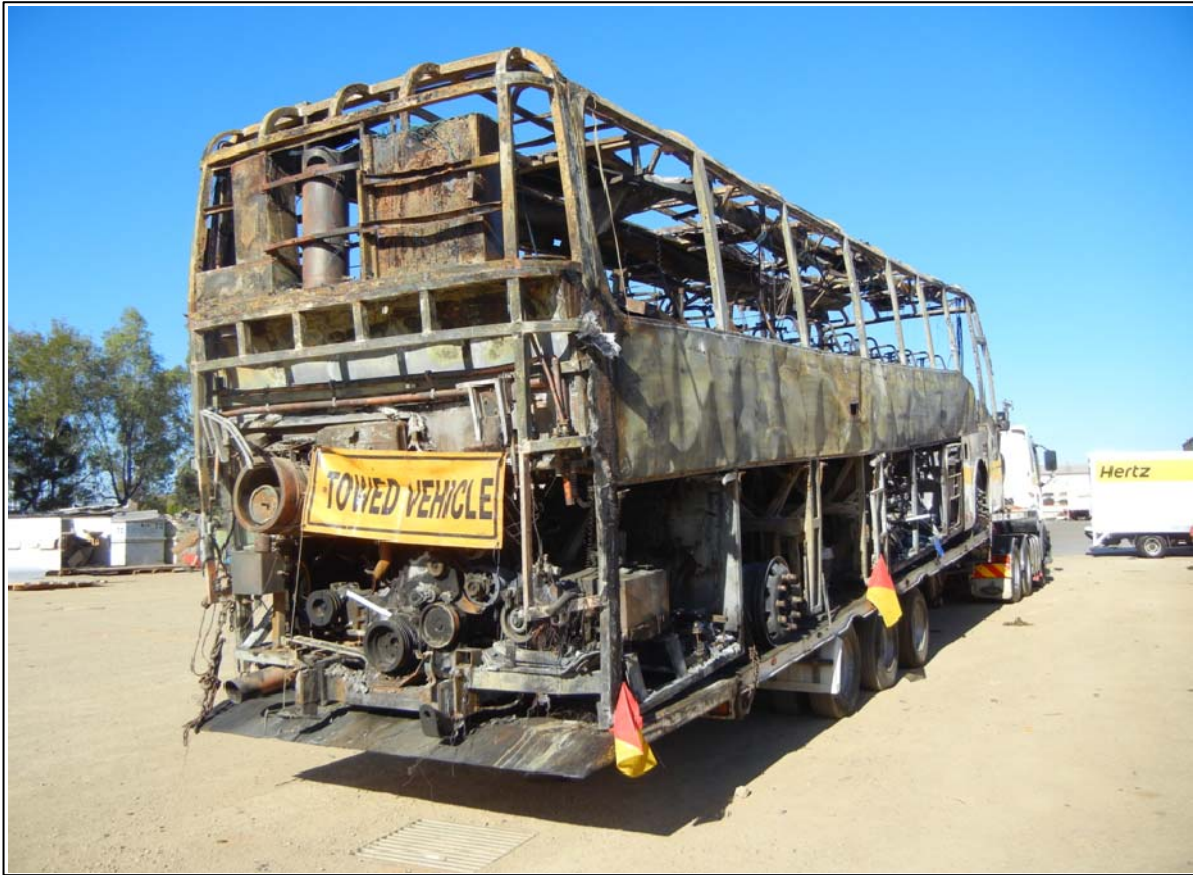
Photograph 2: Post-fire condition of bus

The extent of damage to the bus can be seen in *Photograph 2*.

The fire intensity was such that most of the combustible components of the bus were damaged beyond repair. The front right tyre and wheel, and some surrounding panels, were the only areas that remained relatively intact.

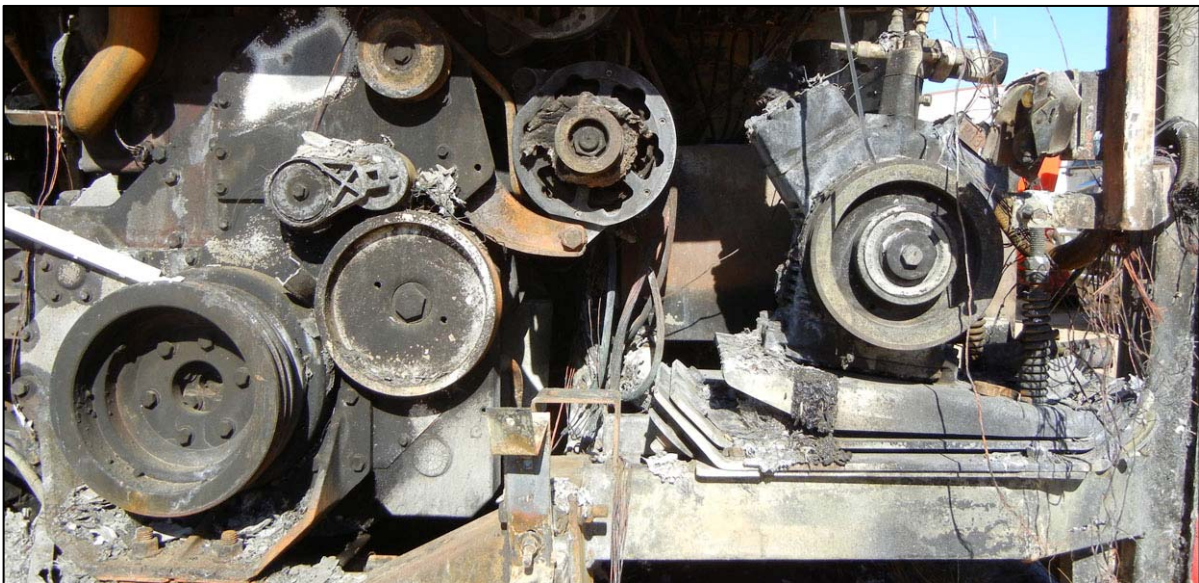
Photograph 3: Engine compartment

General damage to engine. The engine was substantially damaged with many parts partially or completely burnt or melted (see *Photograph 3*). The insulation was burnt off the electrical wiring and the batteries were burnt and melted. All plastic and rubberised material and some alloy parts were also completely or partially melted.

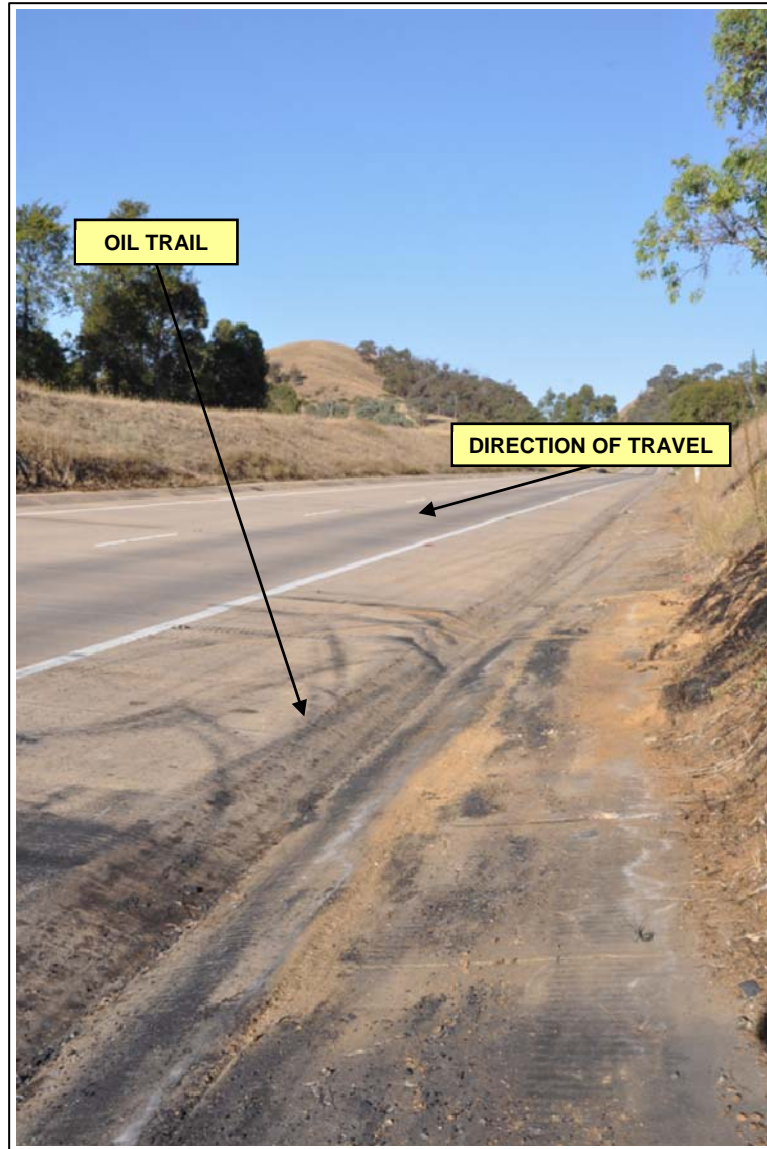
Photograph 4: Oil trail

A site inspection on the Hume Highway two days after the fire showed an oil trail for at least 100 metres leading to where the bus eventually stopped (see *Photograph 4*). The oil trail was in three separate lines of a continuous series of droplets, increasing in size as the bus slowed and eventually stopped. The oil trail ended at the centre rear of the engine compartment and followed the probable line of motion as the bus moved from the left lane into the breakdown lane of the highway. It is likely that this oil was leaking from an oil supply line, but not at such a rate as to cause engine failure, since the engine continued to run even as fire was consuming the flammable materials of the engine compartment.

The evidence above indicates the probability that the fire was initiated by leaking oil coming into contact with a hot surface in the engine compartment.

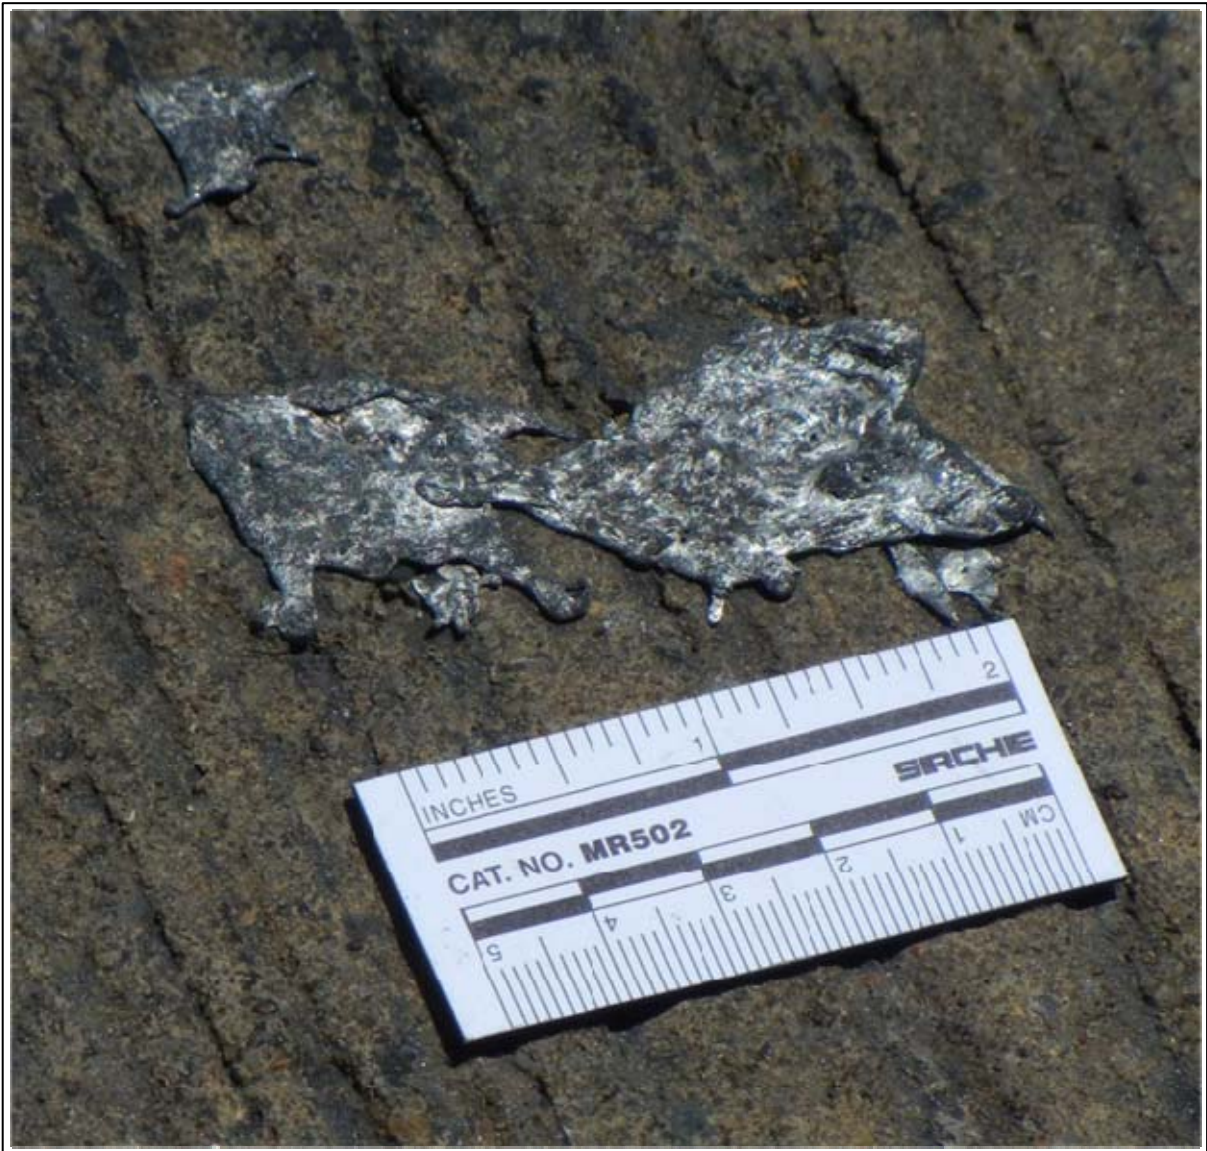
Photograph 5: Solidified molten alloy on road

Also noticeable along the path of the bus was a trail of solidified melted alloy (see *Photograph 5*). These drips were visible for over 300 metres leading to where the bus eventually stopped. At the site where the bus stopped were larger amounts of the solidified melted alloy which came from alloy engine parts (see *Photograph 6*). This confirms that the temperature in the engine compartment was high for a considerable time before the bus stopped and that the fire had initiated well before the start of the alloy trail.

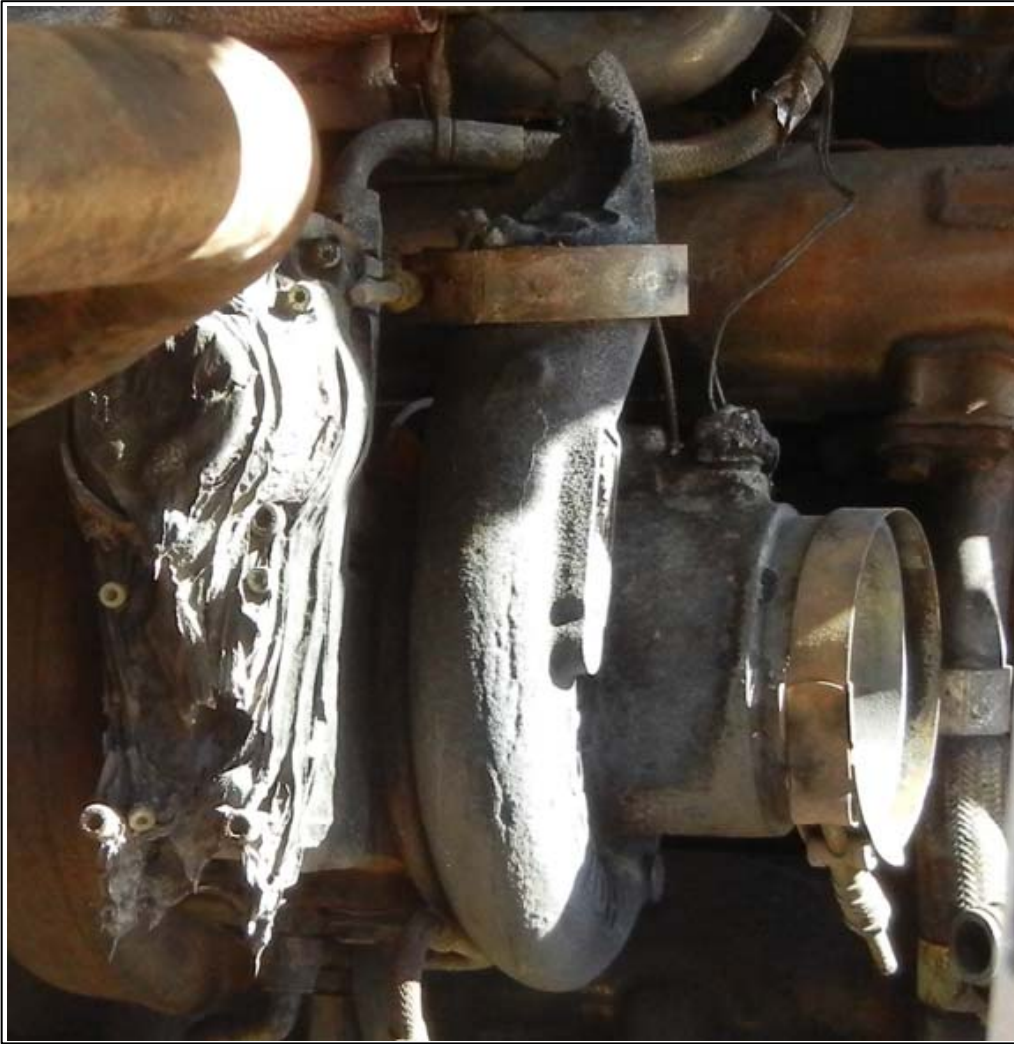
The turbocharger was another area which was closely examined. There was no visible evidence that the turbocharger was damaged before the fire.

Photograph 6: Heat damaged alloy turbocharger
