Office of Transport Safety Investigations

TECHNICAL INSPECTION FINDINGS

LODGES BUS SERVICE COACH FIRE

WODONGA, VICTORIA

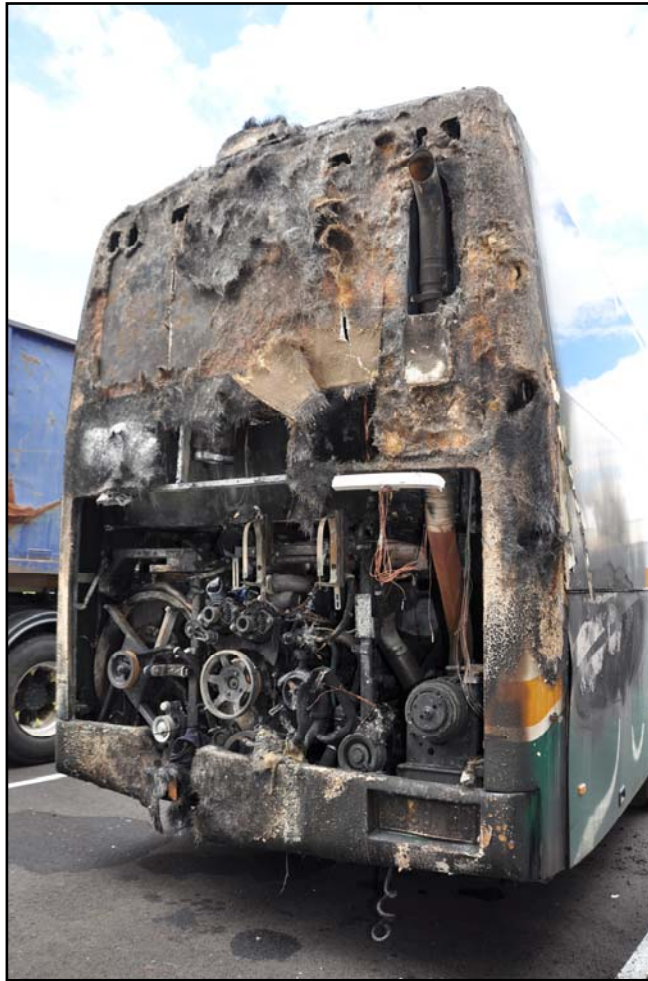
All components in the engine bay, particularly in the vicinity of the turbocharger, were damaged, as were the covering hatch of the engine bay and the body panels above and to the sides of the hatch (see *Photographs 1 and 2*). The rear window was shattered in the process of extinguishing the fire.

Photograph 1: Fire damage

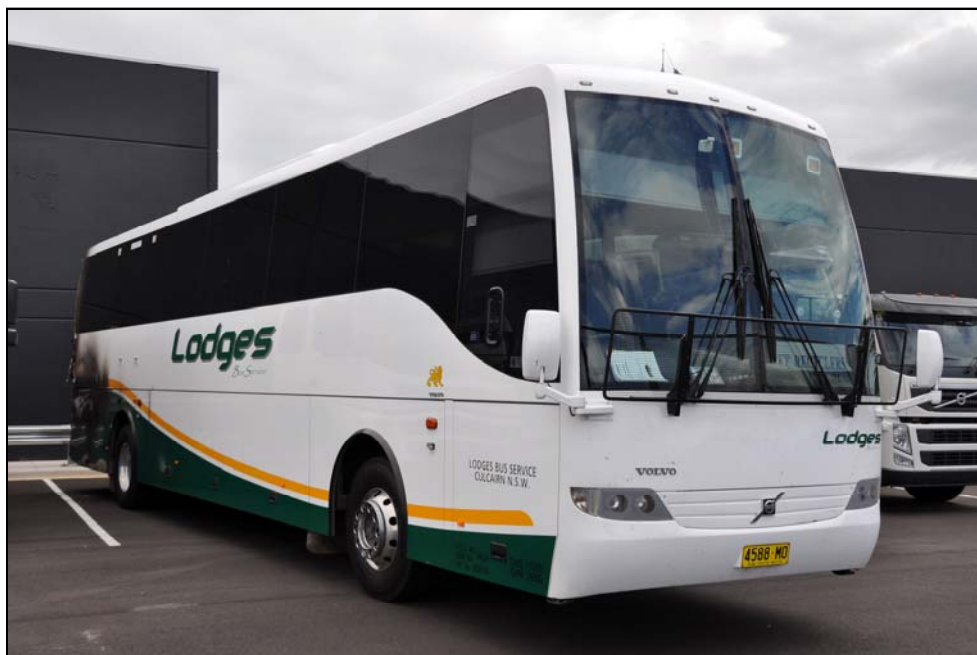
Photograph 2: Rest of coach in good condition

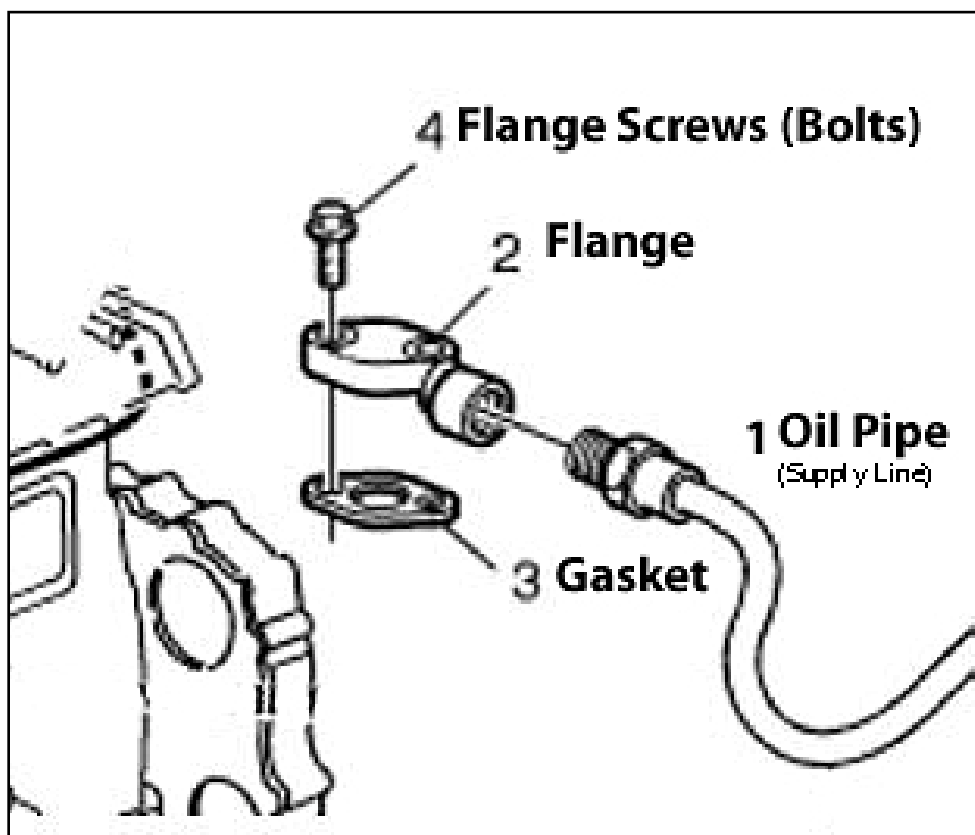
Figure1: Oil System Function Group

Turbocharger and associated piping. The engine is fitted with a Holset HX40W turbocharger. The turbocharger is lubricated and cooled by the engine oil and is additionally water cooled. As oil flow is critical for its operation, it is very important that inspection, servicing and maintenance of the engine lubrication system are conducted thoroughly. The oil pipe from the engine enters the turbocharger via a brass block called a flange, which belongs to the 'oil system function group' (see *Figure 1*). The flange is fastened to the top of the turbocharger and its purpose is to secure the oil supply pipe to the turbocharger. Oil from the engine sump supplies oil via the oil pipe and flange unit to the turbocharger at 300 to 550 kPa.

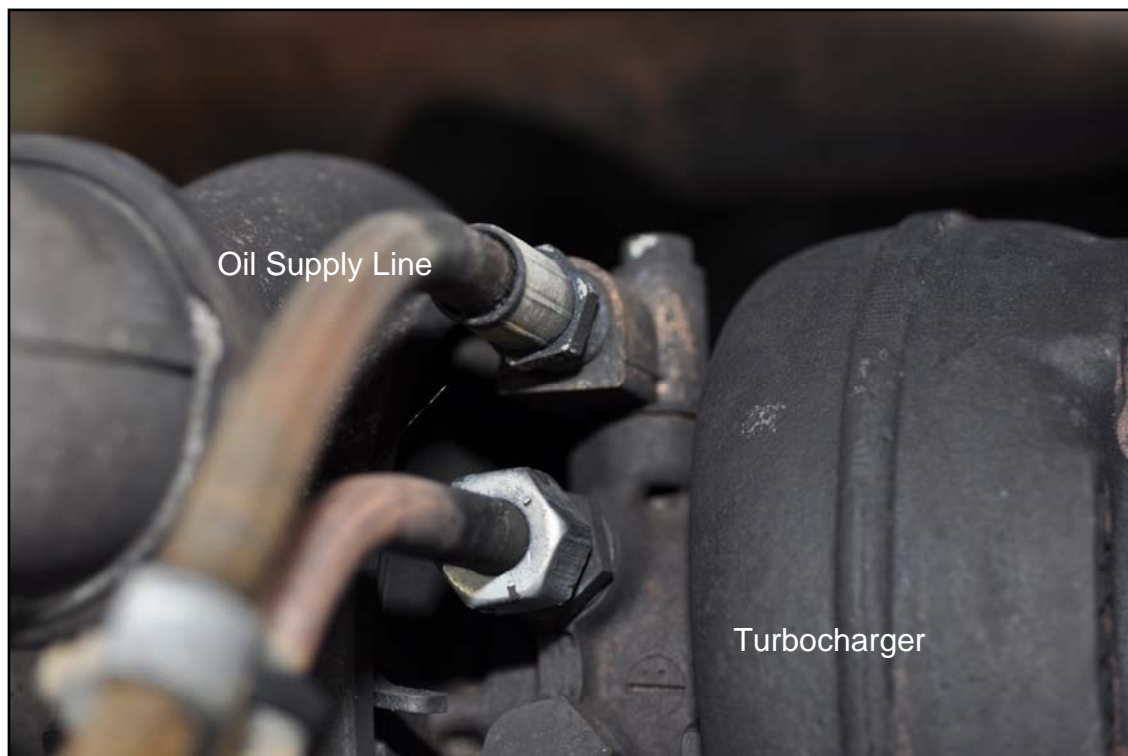
Inspection of the turbocharger revealed that the oil pipe was sitting loosely within the flange housing but was not fastened (see *Photographs 3 and 4*). This situation is likely to have caused the fire by permitting oil being supplied to the turbocharger under high pressure to spray over the hot turbocharger surface and ignite.

Photograph 3: Main oil supply oil line sitting within flange unit but not secured

The fire was caused by the main oil supply line to the turbocharger becoming loose, allowing oil to escape under high pressure and spray over the hot turbocharger and exhaust components of the engine.

Checking the integrity of the turbocharger and oil supply line during routine servicing, together with utilisation of a thread locking system, would constitute appropriate remedial action to prevent a recurrence of this type of engine fire.

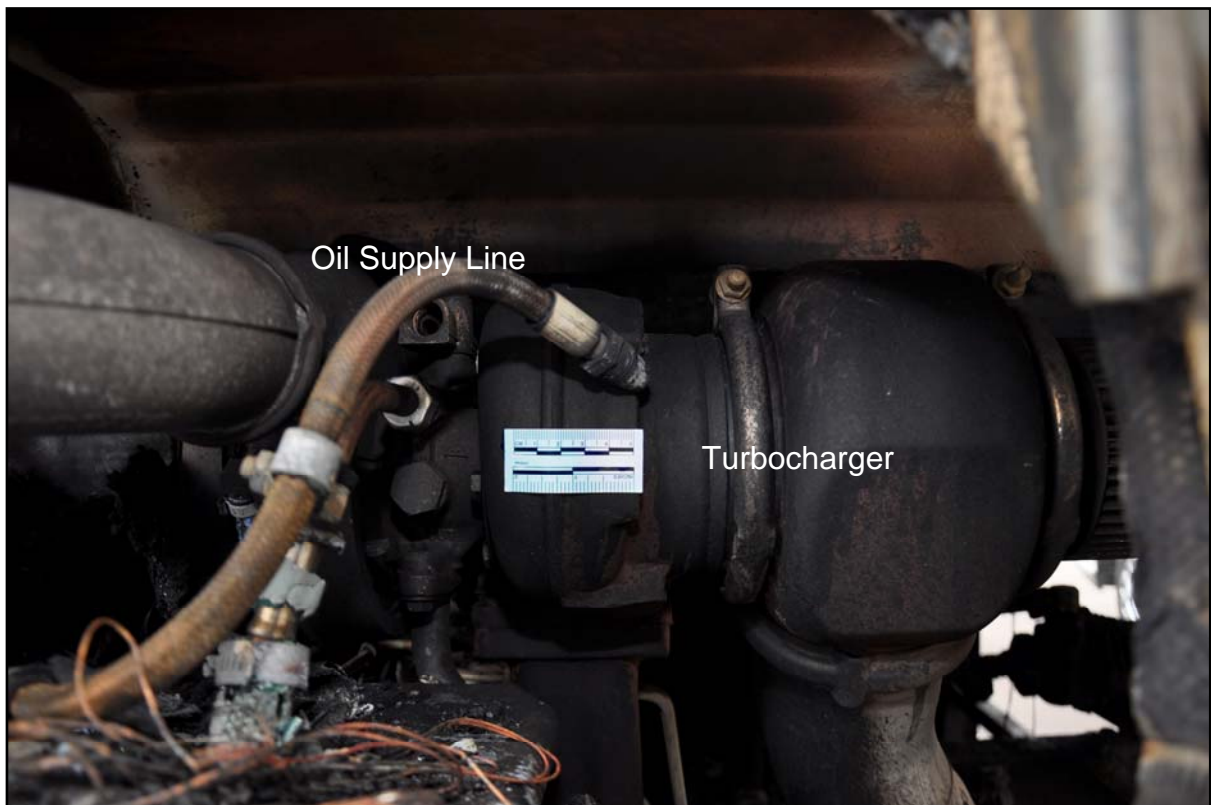
Photograph 4: Oil supply line sitting in front of turbocharger

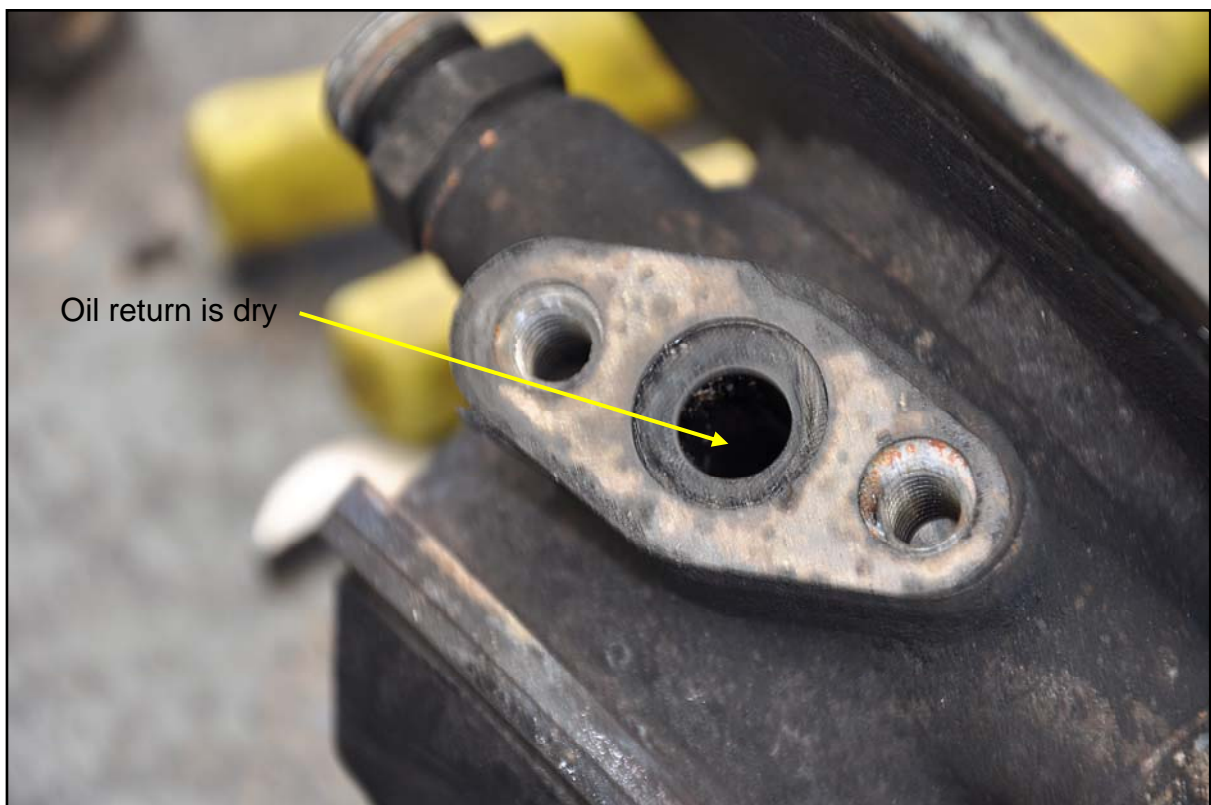
Other areas. On examination, the oil return housing and piping that fixes to the underside of the turbocharger were found to be dry (see *Photograph 5*), indicating that the turbocharger had been starved of oil as, normally, the oil return pipe would be saturated with oil.

Photograph 5: Oil return housing.

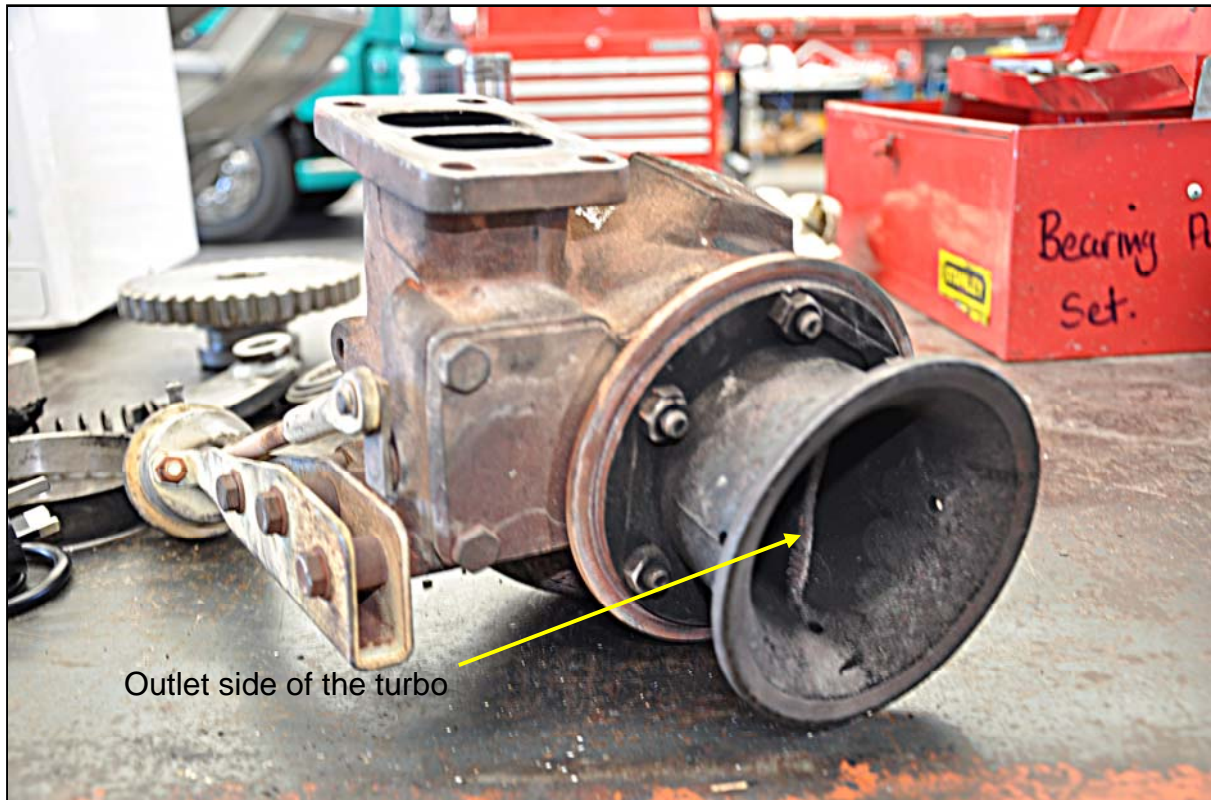
An examination of the exhaust system found it to be dry indicating that a faulty turbocharger seal or bearing was not the cause of the fire. Normally, when turbocharger seals and bearing become worn, the exhaust system is saturated with oil as oil bypasses the system. When the exhaust system was dismantled it appeared dry and normal in colour (see *Photograph 6*).

Photograph 6: Exhaust portion of the turbocharger dry and normal in colour

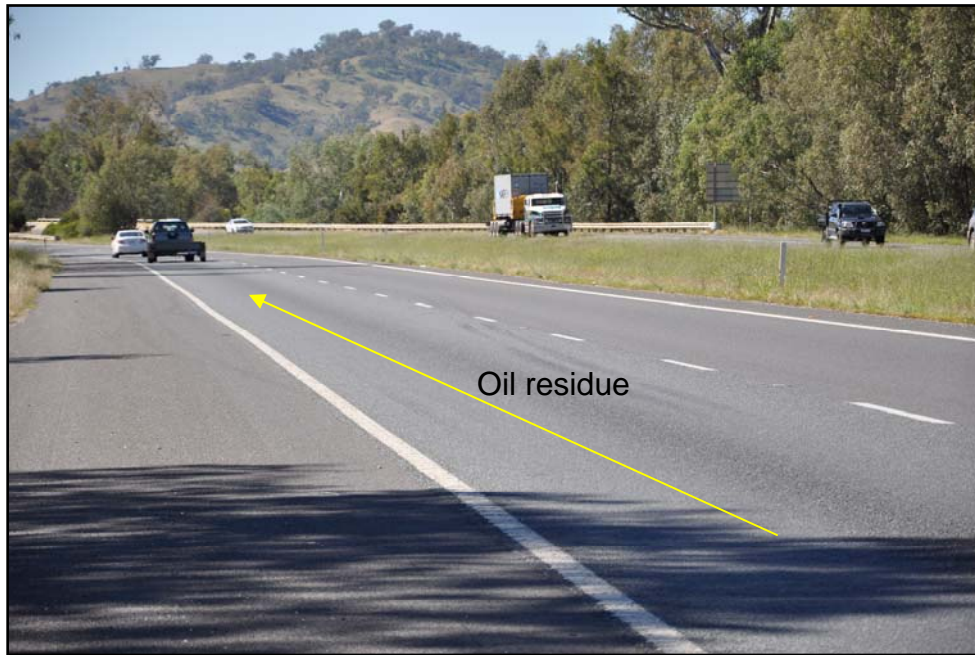
An inspection of the Hume Highway revealed an oil residue trail for several kilometres leading up to the point where the coach was stopped at the Albury off-ramp. This was consistent with a loose oil supply line working its way free and spraying oil under pressure over the hot turbocharger components, then dripping oil onto the roadway as the vehicle proceeded (see *Photographs 7 and 8*).

Photograph 7: Oil residue on the Hume Highway for several kilometres

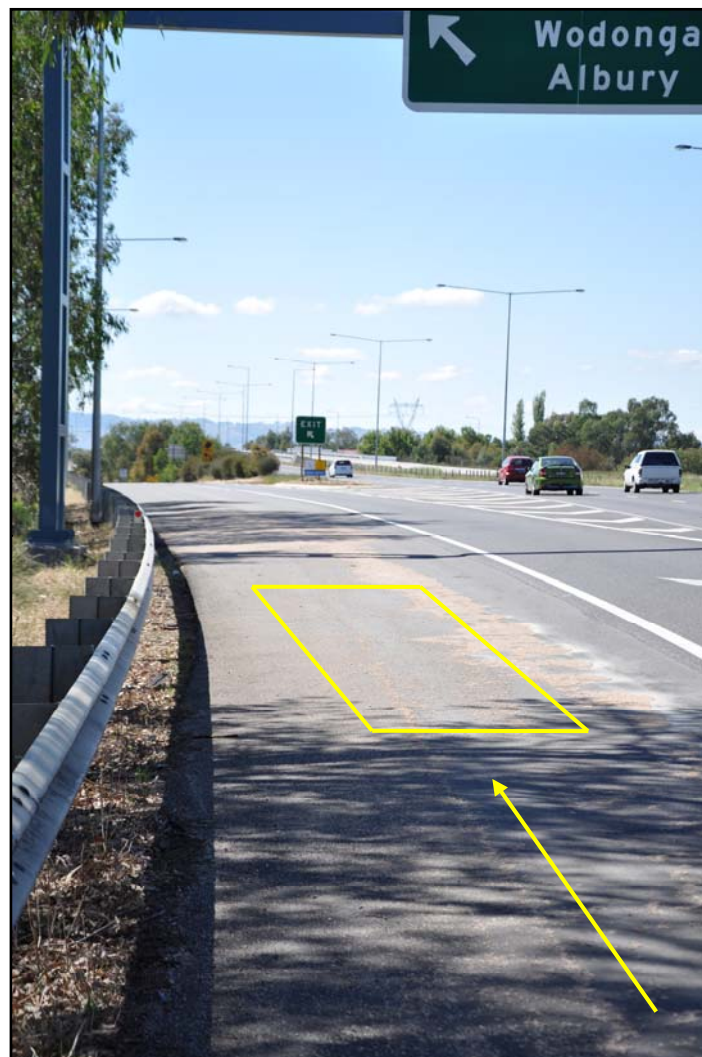
Photograph 8: Vehicle stopped just prior to Albury off-ramp

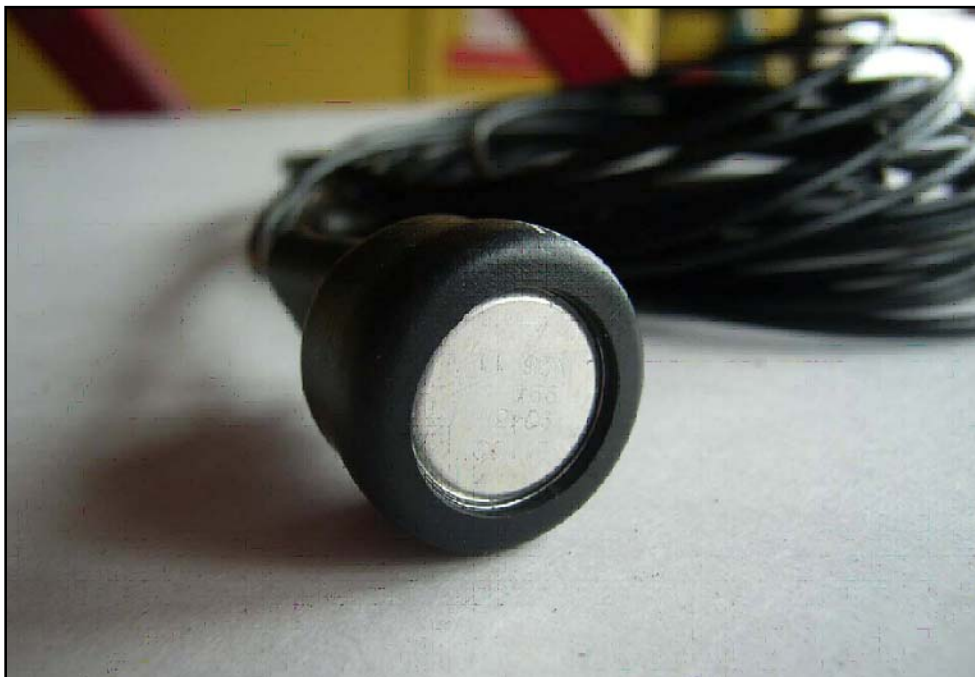
Photograph 9 shows a warning sensor similar to those typically fitted to Volvo B7R buses and coaches. Detection and activation of the system takes place automatically. In the event of a fire, the plastic coating around the detector probe melts and the internal wires contact, creating an open circuit which energises a relay. Once energised, the relay activates two red warning lights on the driver's dashboard, as well as an audible alarm to the bus or coach operator. The system does not operate independently of a power supply.

Photograph 9: Fire warning sensor fitted to B7R coaches
