# Safety Investigation Report

**Pedestrian Fatality  
Bondi Junction, NSW**

16 December 2020

**Investigation Reference I00222**

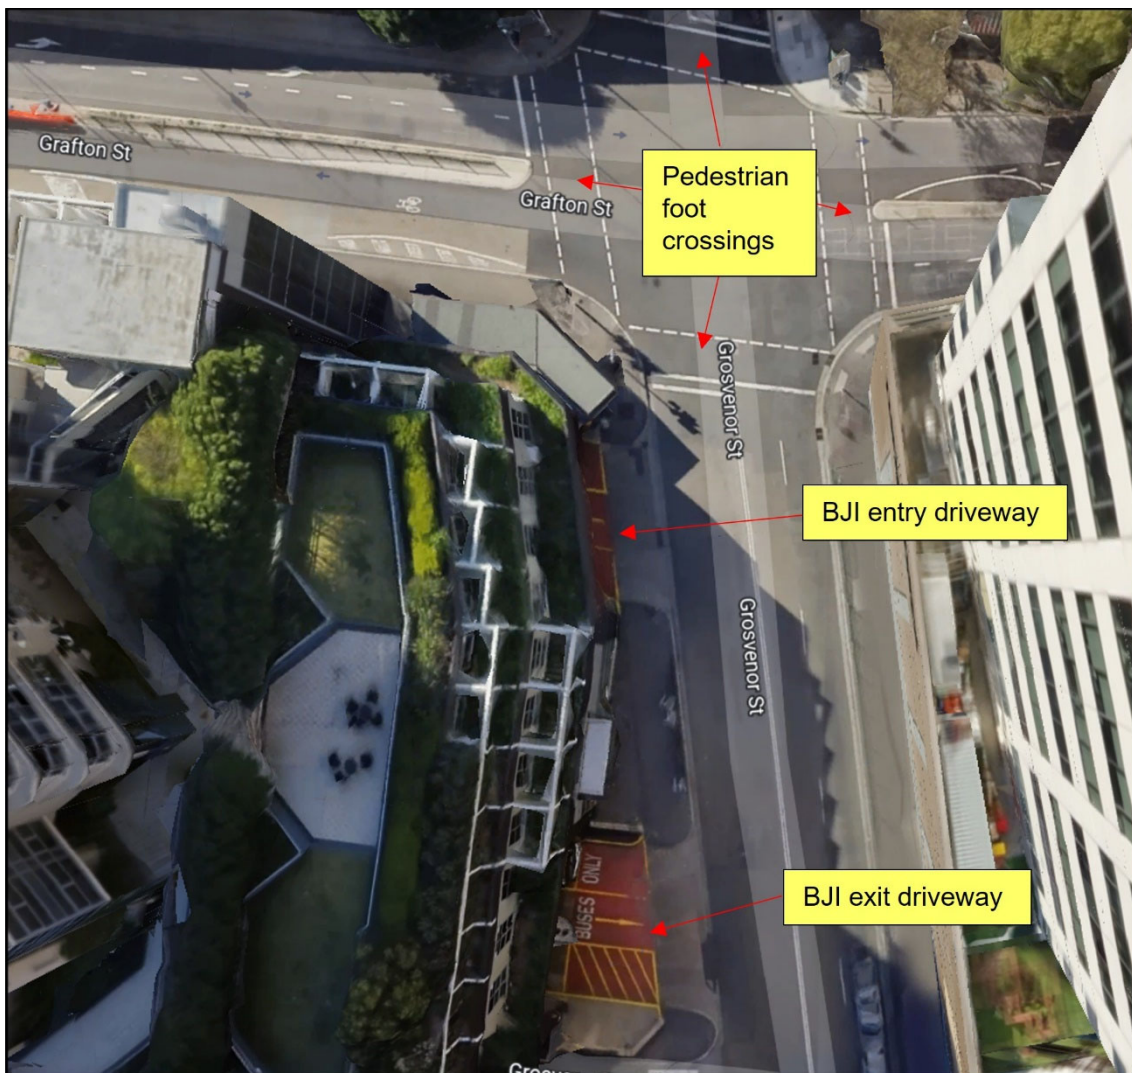
**Figure 1: BJI exit and entry locations off Grosvenor Street**

- 1.6 At 1008:58 the driver turned their head right in a southerly direction up Grosvenor Street. It is likely at this point the driver observed another bus travelling north on Grosvenor Street towards the Grosvenor Street BJI. At 1009:01 the driver executed a left-hand turn to exit the BJI onto Grosvenor Street. At 1009:04 the Grosvenor Street traffic lights were at stop (red). At 1009:06 a bus is captured in the off-side CCTV with that bus being behind m/o 8159 in Grosvenor Street. Shortly after, the driver turned their head in the direction of the near-side mirror.

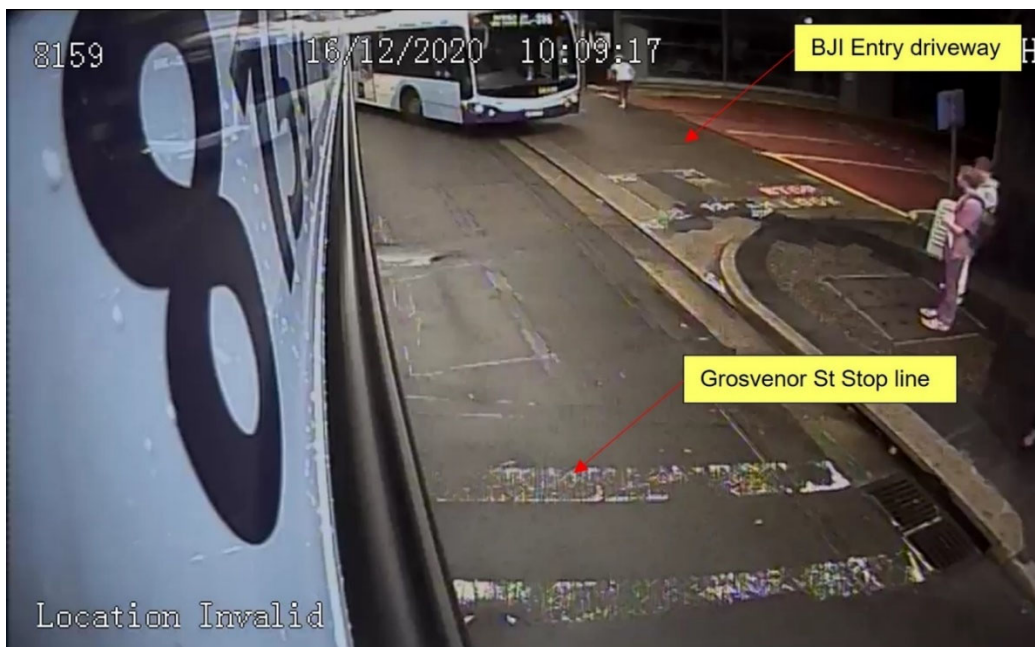
**Figure 2: CCTV view of bus trailing m/o 8159 into the Grosvenor Street BJI entry (1009:17)**

- 1.9 At 1009:17 the driver brought m/o 8159 to a complete stop with the park brake being applied. The driver's head was turned in the direction of the near-side mirror at this time with the bus trailing m/o 8159 having passed over the BJI driveway entry (Figure 2).

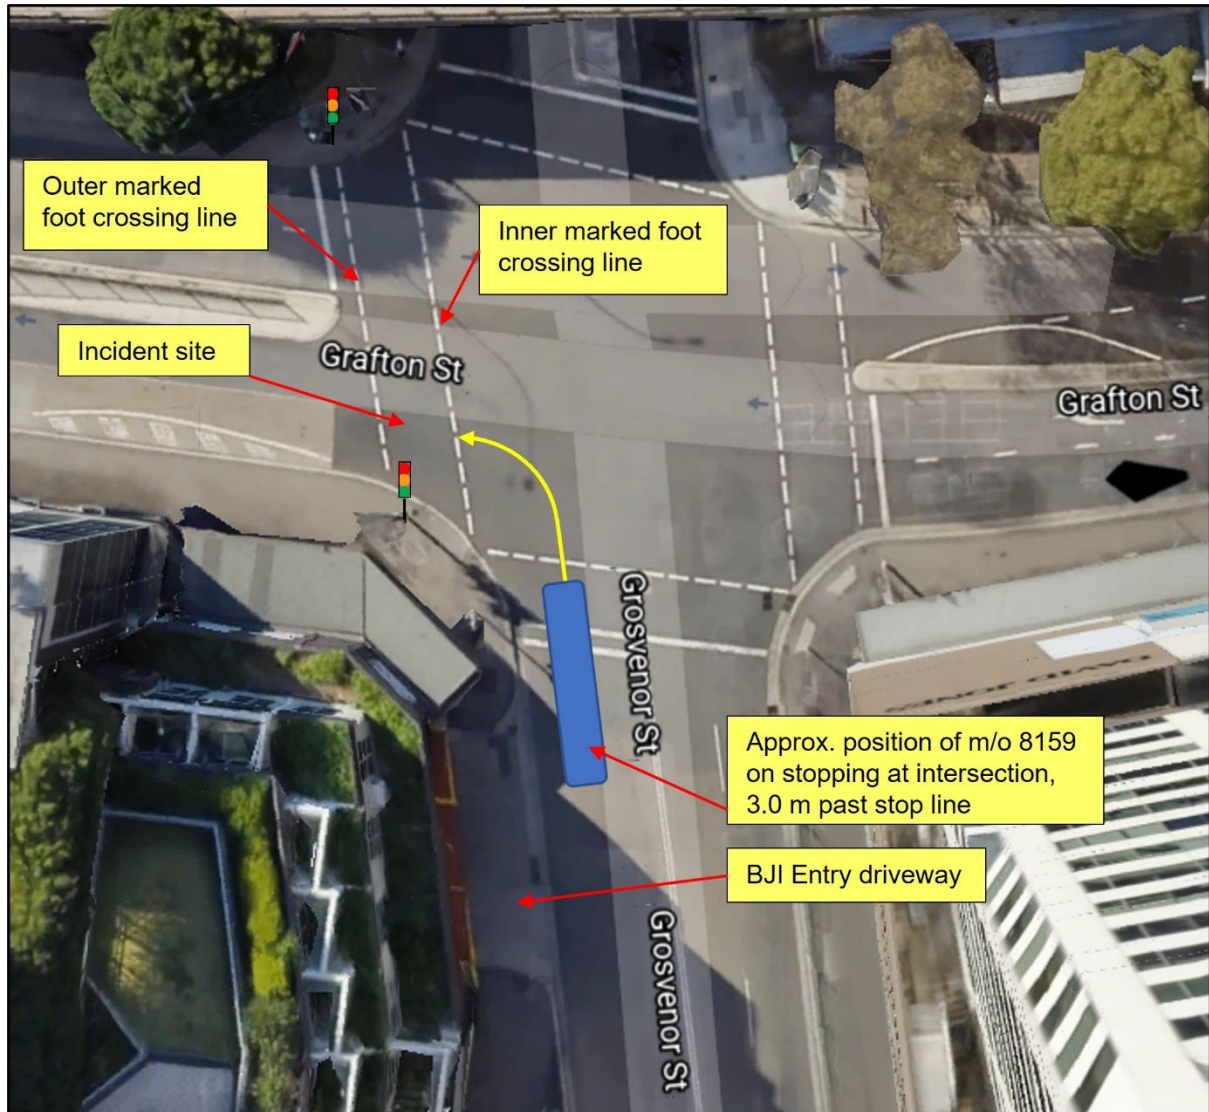
Figure 3: Grosvenor Street and Grafton Street incident location

- 1.10 At 1009:20 the driver then turned their head from the direction of the near-side mirror towards the ETS (Electronic Ticketing System) console located adjacent to the near-side of the steering wheel. In the stationary position the front of m/o 8159 is approximated to be 3.0 m beyond the Grosvenor Street stop line at the intersection (Figure 3).<sup>4</sup>

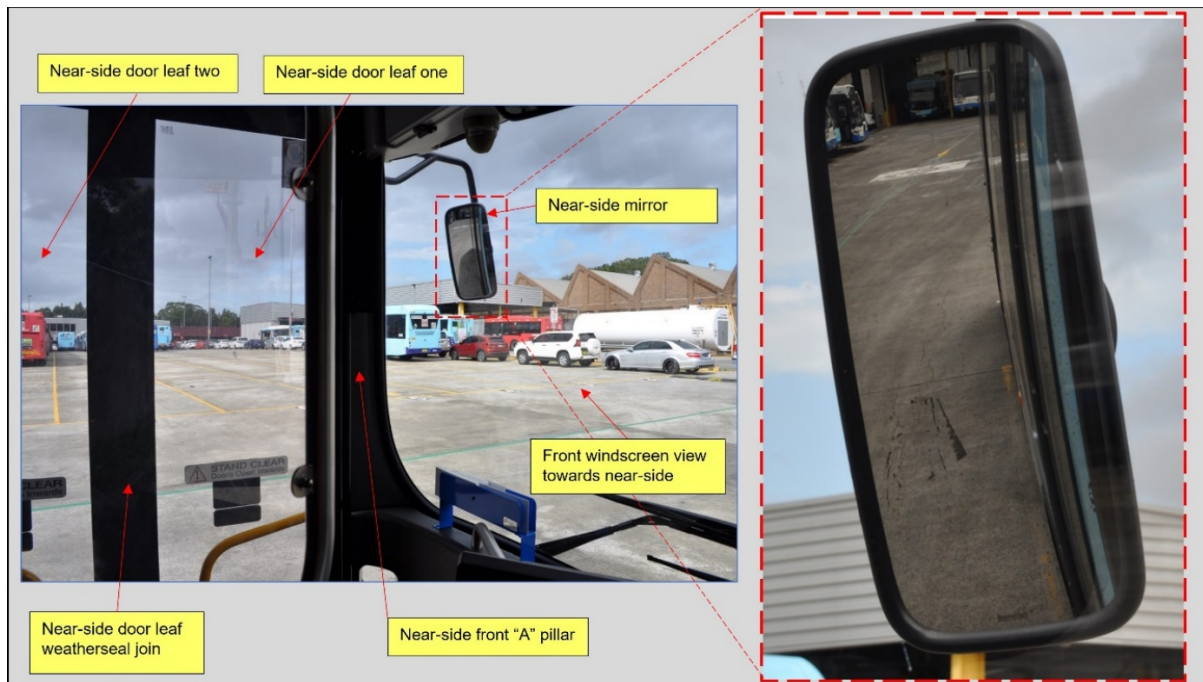
**Figure 6: View from driver's seat on m/o 8159 – front windscreen and near-side view of door leaves**

- 1.11 At 1009:39 the driver turned their head left towards the near-side mirror with the park brake released at 1009:41. The driver then turned their head right towards the off-side mirror. At this point, the bus began to move forward, the driver started turning the steering wheel anticlockwise to turn left and the Grosvenor Street traffic light was still at stop (red) (1009:42). One second later the Grosvenor Street traffic light turned green with the driver facing forward.
- 1.12 At 1009:44 the driver continued to turn the steering wheel anticlockwise and turned their head toward the near-side mirror (Figure 6). At this point the bus passed the inner pedestrian cross walk (PCW) line of Grosvenor Street as the driver moved their head down in the direction towards the near-side of the front

- 1.13 At 1009:48 the pedestrian is first identified via the bus CCTV positioned approximately 2 m from the Grafton Street kerb within the marked PCW lines and approximately 0.5 m to the right of the outer Grafton Street cross PCW line (Figure 3). At this point the driver's head was facing forward, as the front of the bus crossed over the inner Grafton Street PCW line. Shortly after the driver turned their head slightly towards the front windscreen near-side and then towards the near-side mirror. Within the same second the driver then turned their head back toward the front windscreen near-side. At that time the pedestrian is located adjacent to the centre of the glass near-side door leaf one (Figure 6).

- 1.28 The bus was a rigid body heavy vehicle that contained several known visual blind spots that a driver was expected to be cognisant of when manoeuvring the bus through a left-hand turn. The near-side blind spots were created by the A pillar, near-side door leaf weather seal join, and B Pillar. The driver's near-side mirror viewing area also provided sighting limitations that created a near-side blind spot forward from at least a third of the near-side front wheel arch (Figure 6 and Figure 7).

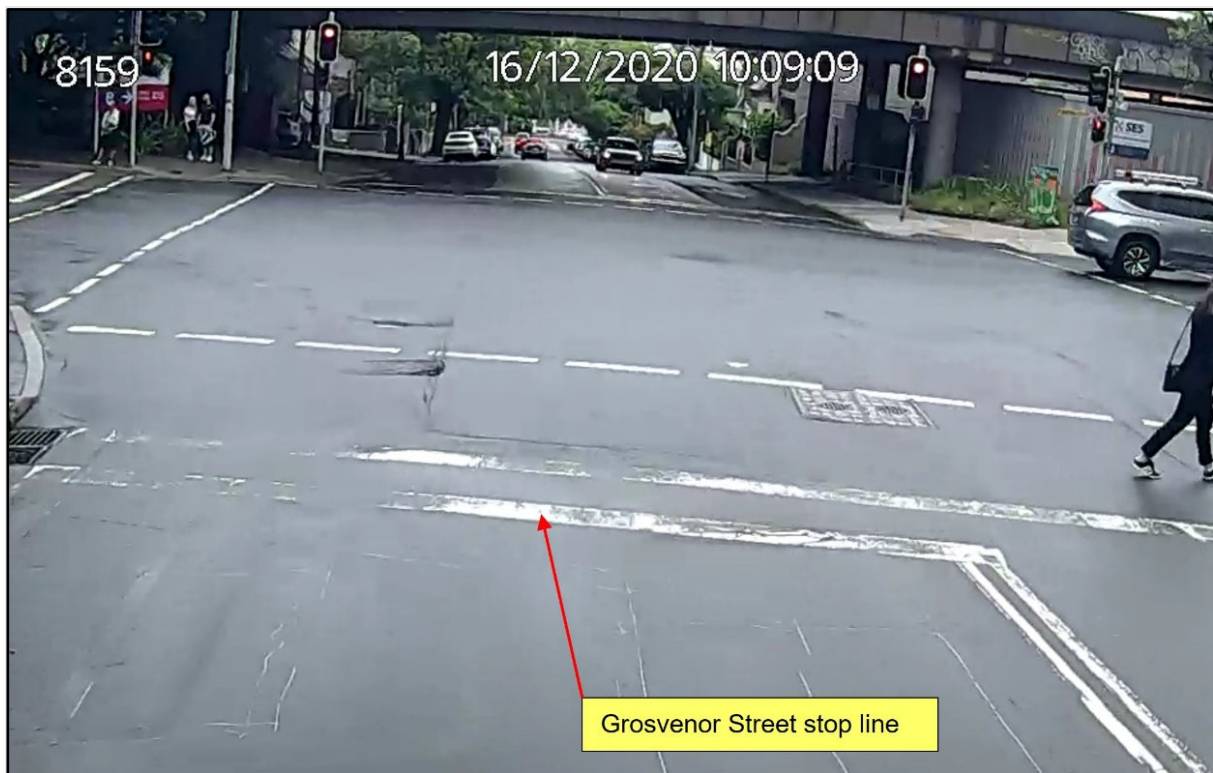
**Figure 11: CCTV image of Grosvenor Street stop line as m/o 8159 approached the intersection on 16 December 2020**

- 2.9 The condition of the Grosvenor Street stop line, with respect to its visibility, appeared worn as at the incident date, with the condition depicted in the forward-facing CCTV from m/o 8159 (Figure 11). If the stop line and PCW line were more visible, the driver may have been provided with a clearer reference point to stop the bus on approach to the intersection.

- 3.8 The Grosvenor Street stop line appeared worn at incident occurrence with areas of the stop line erased due to vehicle traffic wear. The reduced visibility of the worn stop line may not have provided an easily recognisable reference marking for a driver to position the bus correctly at the intersection.
