Safety Investigation Report

Rockfish 3 collision with John Cadman 3

Sydney Harbour, NSW

12 December 2021

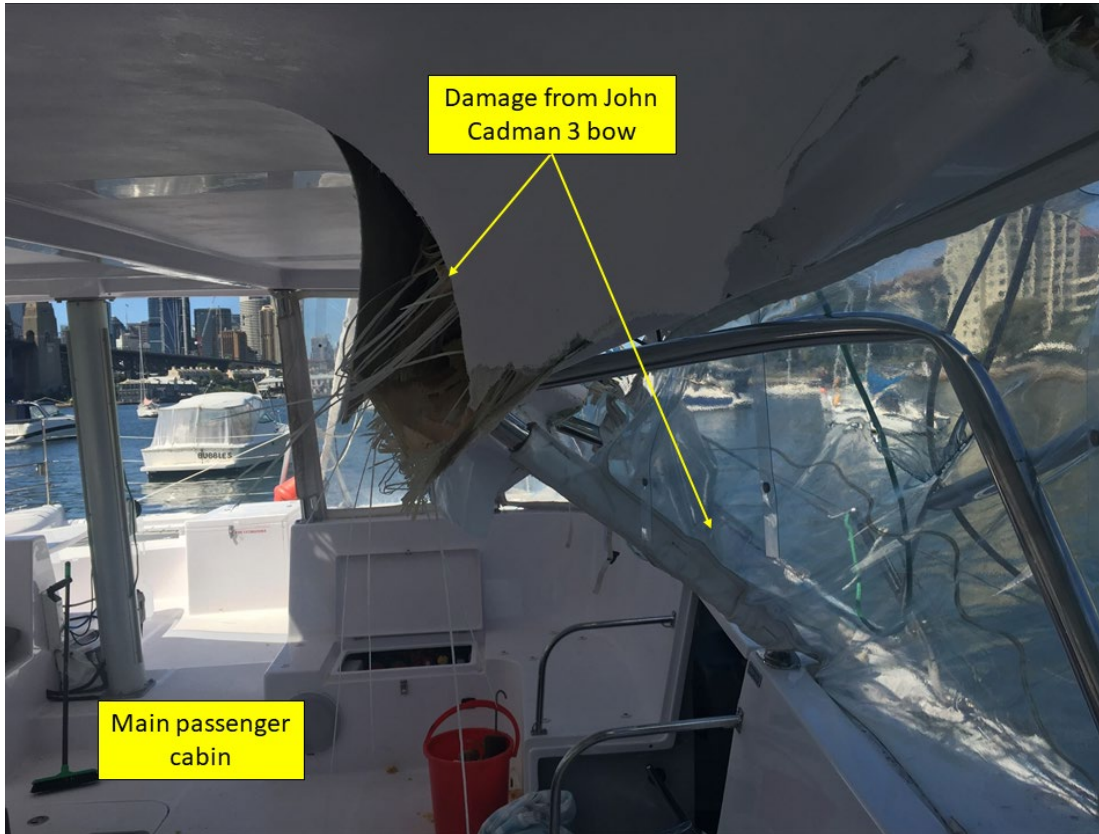
Figure 2: Internal damage to *Rockfish 3* main passenger cabin

- 1.15 *Rockfish 3* sustained substantial damage to the above-water structure in the vicinity of the passenger accommodation (see *Figures 2 & 3*).

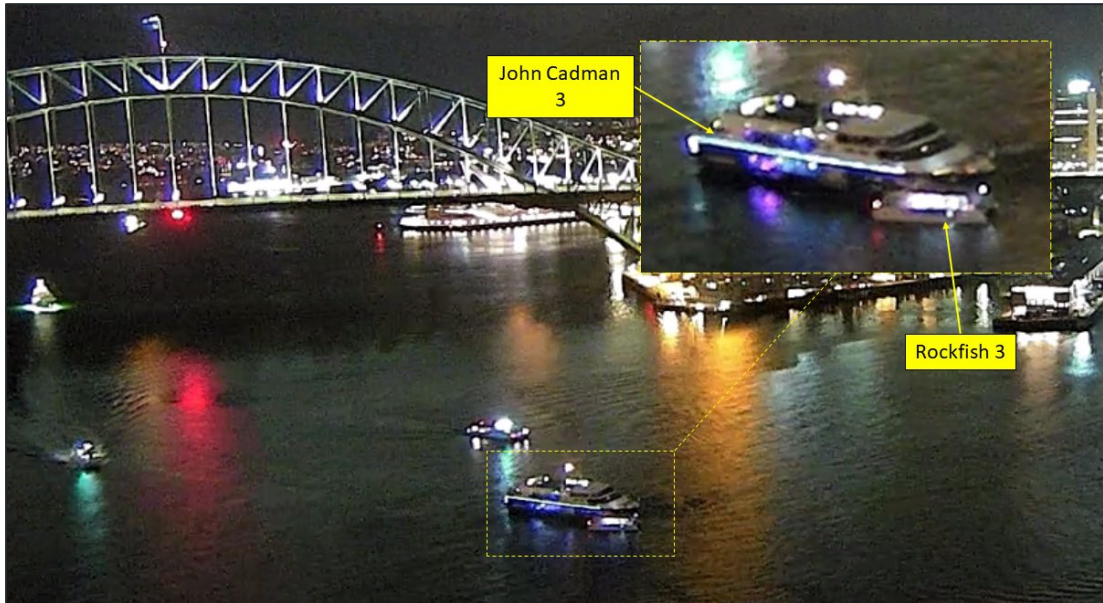
Figure 4: CCTV image from Blues Point Tower moments after impact

- 1.16 The impact also damaged the vessel's rigging and caused the mast to topple and become entangled on the *John Cadman 3*'s bow (see *Figure 4* & cover).

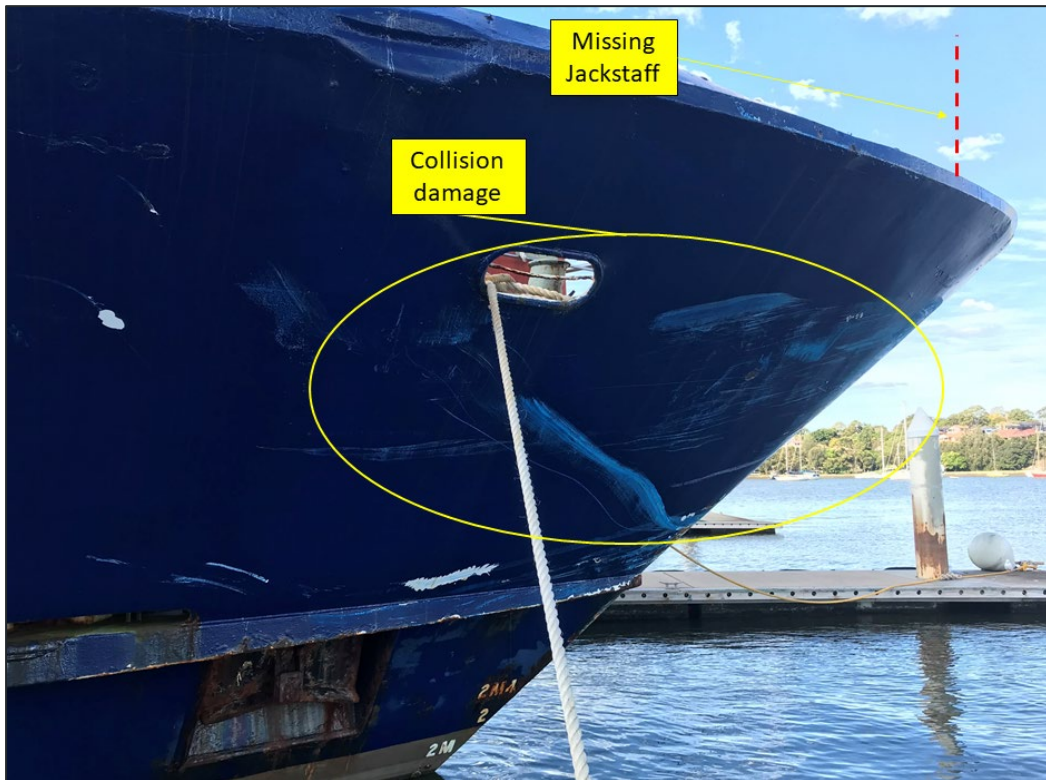
Figure 5: John Cadman 3 damage

- 1.17 *John Cadman 3* suffered minor paint scrapes and scratches. The vessel also sustained damage to the Jackstaff⁵ from the fallen mast and rigging (see *Figure 5*).

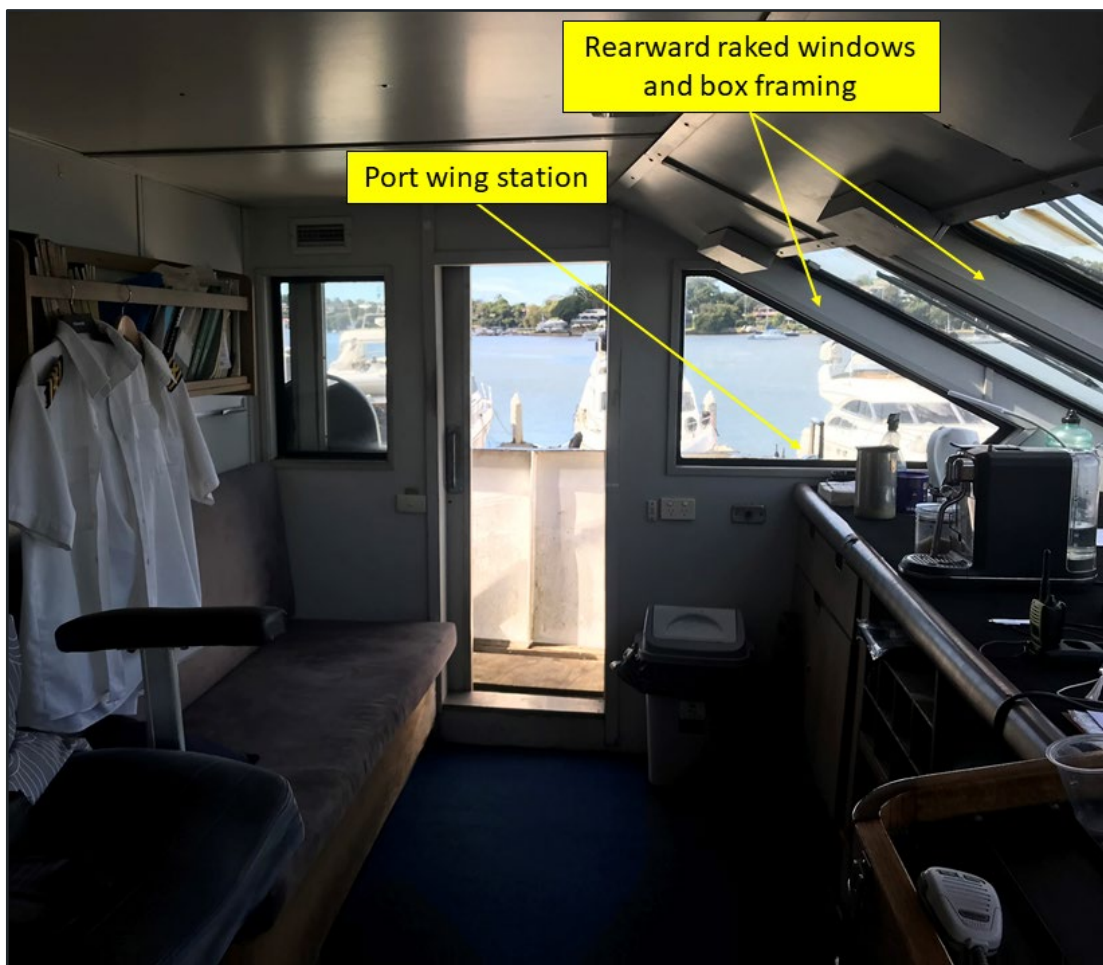
Figure 11: John Cadman 3 view to port from main helm station

- 2.17 *John Cadman 3*'s wheelhouse was located on the middle deck at the front of the superstructure (see *Figure 8*). The wheelhouse had three control stations: the main helm position and the two bridging stations (port and starboard).
- 2.18 The view from the main helm position, which was located on the centreline of the vessel, was either restricted or blocked due to the vessel's superstructure in several directions. The sleek design of the vessel's forward superstructure resulted in the wheelhouse windows being raked backwards from bottom to top (see *Figure 11*).
- 2.19 The windows were divided by heavy box type frames which obstructed the field of view, posing a challenge to maintaining a look-out from the main helm position. The obstruction to the field of view increased the further from directly ahead one looked, due to the rake of the window and the box design of the frames.

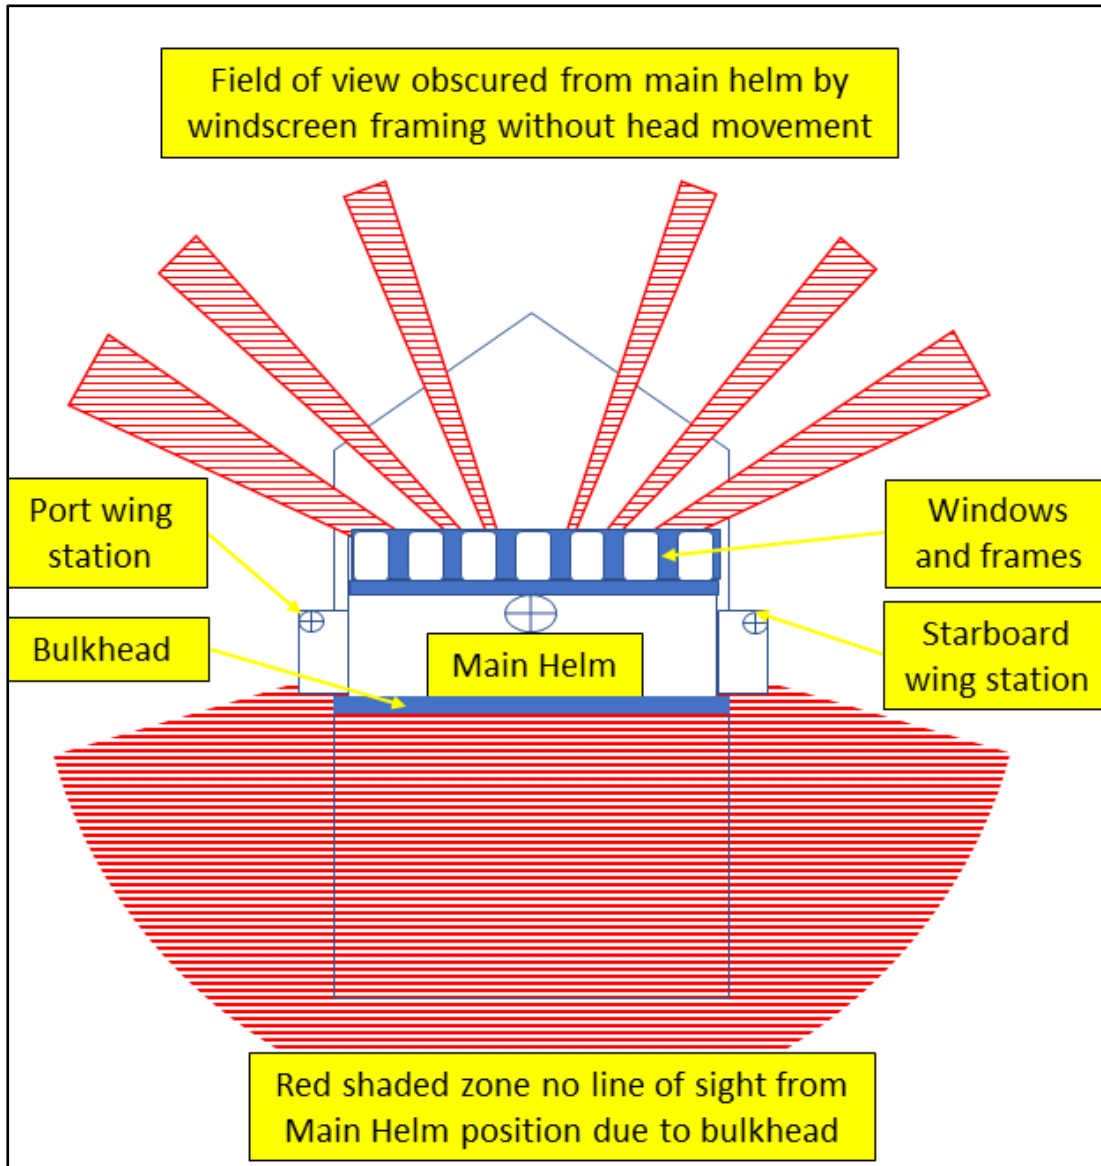
Figure 12: Plan field of view from *John Cadman 3* main helm station (not to scale)

- 2.22 The size of the blind spots created by the bridge window framing (wooding) varied depending on the angle of the viewer. For example, if a person stood on the starboard side of the wheelhouse, they had almost no view to the port bow²⁰ (see *Figure 13*).
- 2.23 The blind spots reduced as an observer made their way towards the centreline, but never disappeared.

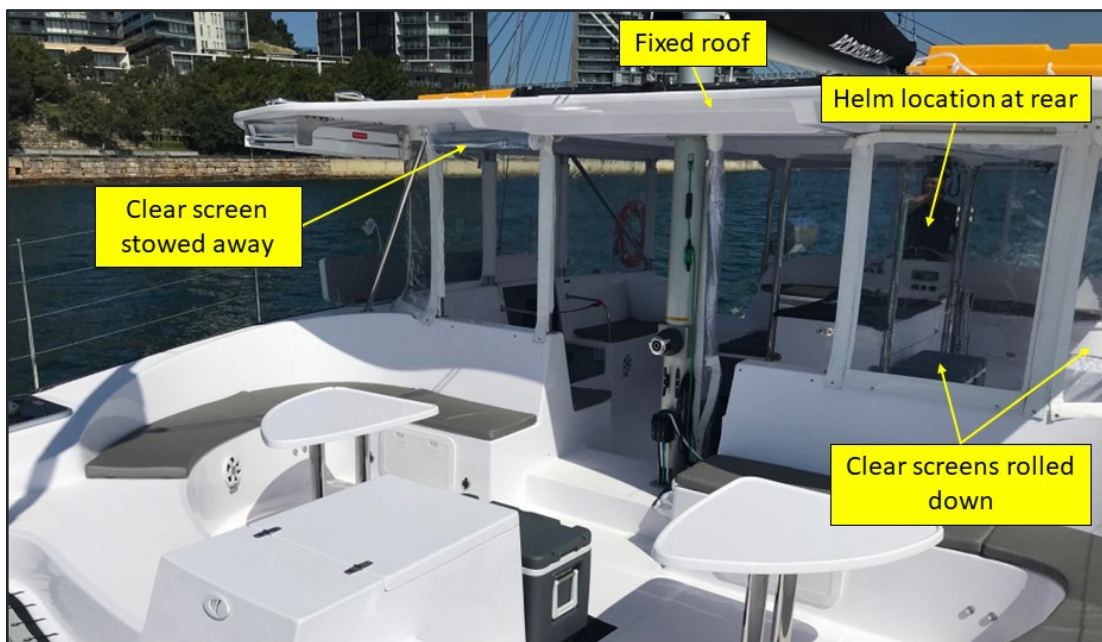
Figure 14: *Rockfish 3* looking towards rear showing cabin clears

- 2.25 The clears or clear vinyl boat screens were made from polyvinyl chloride (PVC). When new, the clears offered a relatively transparent view in daylight. Improper storage or ageing from the sun and elements could cause the clears to become hazy, significantly reducing transparency, and distorting images viewed through them.

- 2.27 At night, when cabin lights were illuminated, deployed clears reflected internal lighting and would have offered little to no vision of external hazards. Even with the cabin lights extinguished, light refraction from external sources could show on the clears, reducing visibility compared to angled glass. For this reason, clears were often rolled up to allow improved look-out at night.

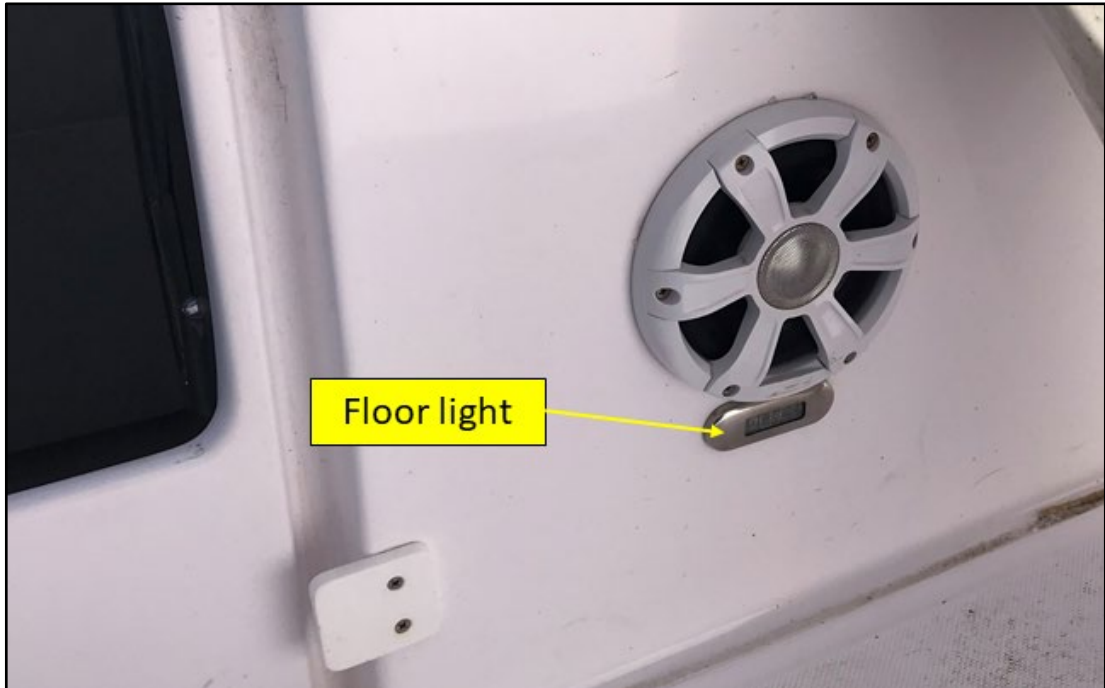
Figure 15: Floor light

- 2.28 *Rockfish 3* had several internal floor lights to provide illumination for night operations. The floor lights (see *Figure 15*) assisted passengers and crew to safely walk about the vessel. They offered reduced reflected glare which improved the crew's ability to maintain a proper look-out.

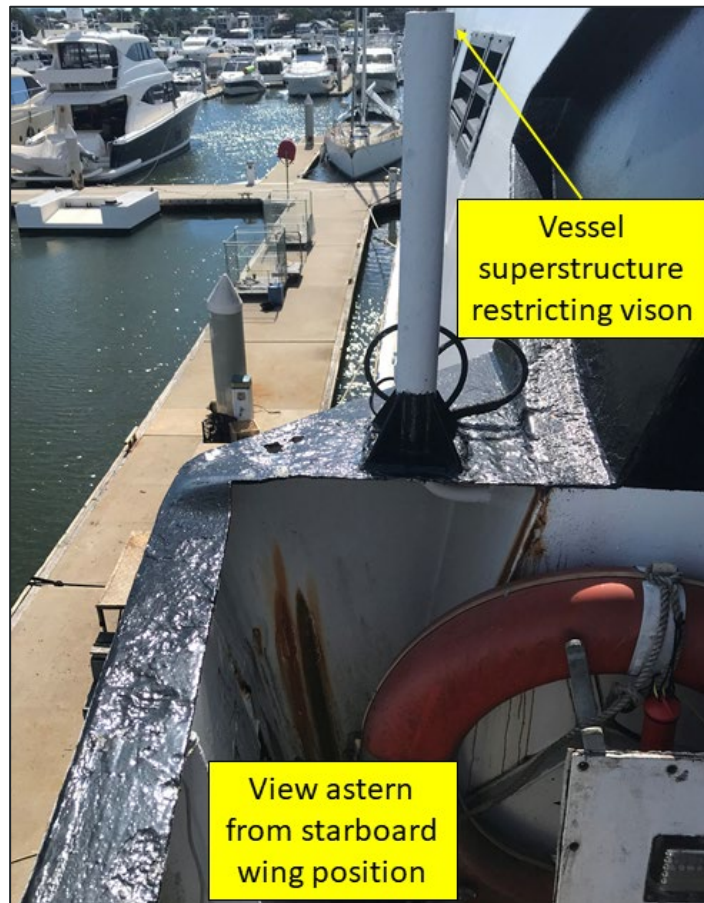
Figure 16: Line of sight astern starboard wing station

- 2.34 When the Master reached the port bridging, they confirmed that no vessels were overtaking on that side. The wing positions offered excellent vision to their corresponding side, but no vision directly astern or towards the opposite side (see *Figure 16*).

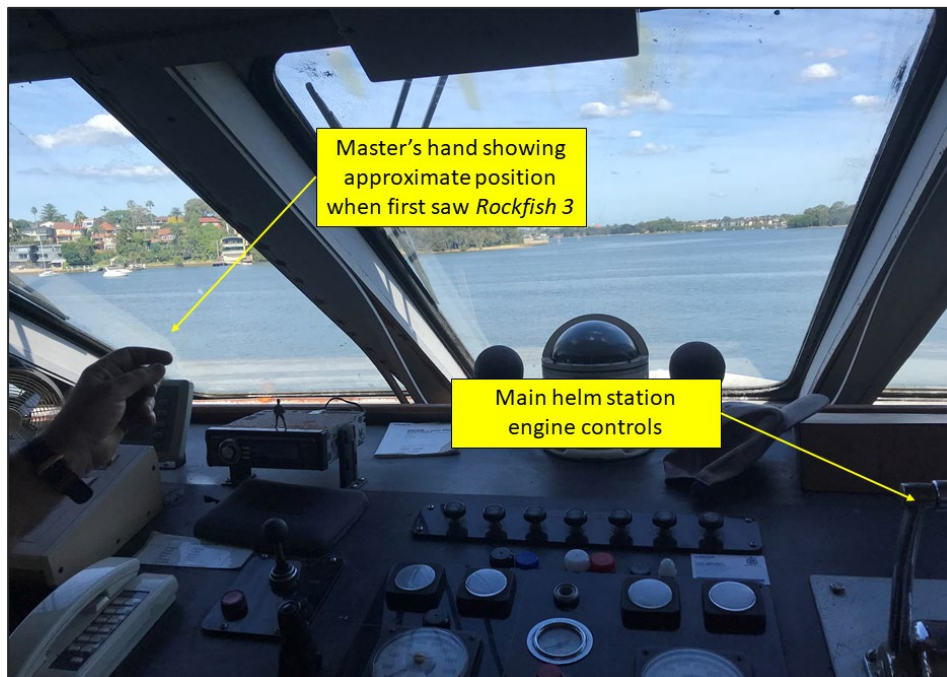
Figure 17: Approximate location of *Rockfish 3* when first sighted

was the location *Rockfish 3* approached from. It is likely that *Rockfish 3* was concealed by the window framing and out of the Master's line of sight.

- 2.37 It is also likely that when the Master checked ahead before going to the bridgewing to look astern, *Rockfish 3* was on the port bow to the south of the channel away from *John Cadman 3*'s intended path. The Master was focused on the task of checking behind the vessel and did not perceive any hazards in front of them.

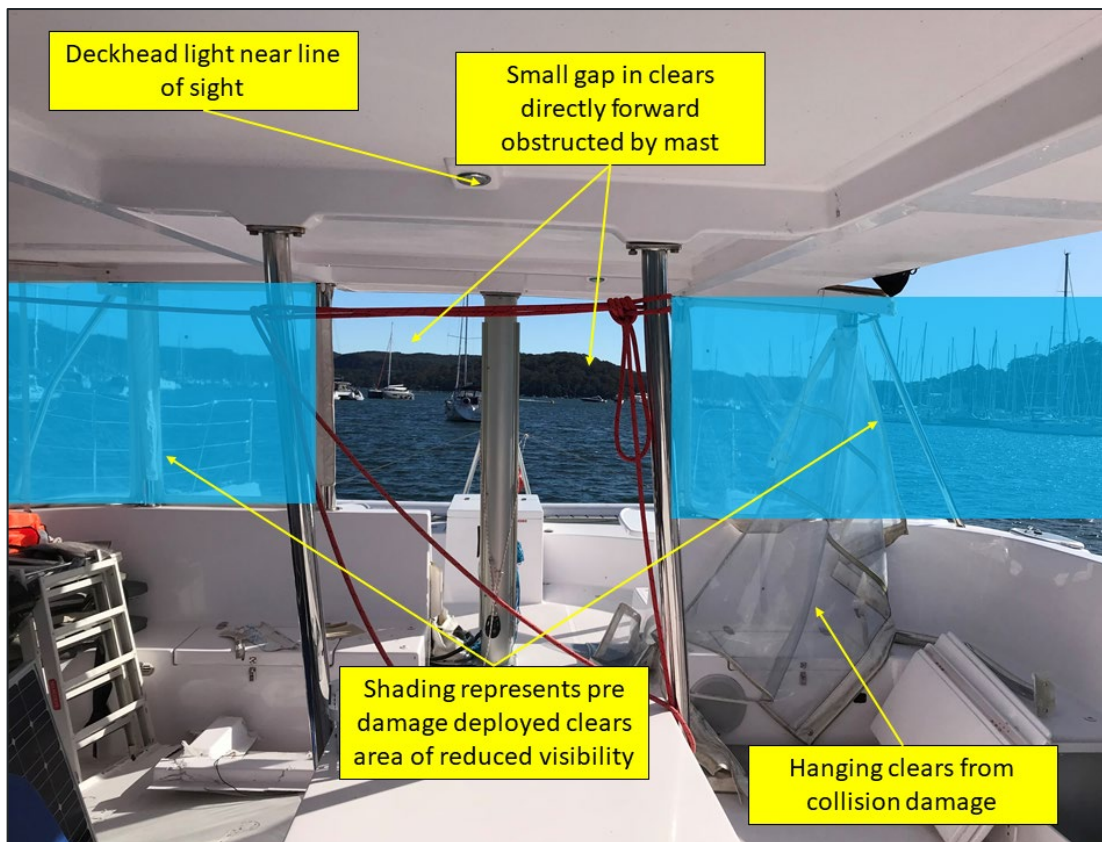
Figure 18: View from helm ahead, highlighting reduced visibility with clears in place

- 2.44 With the vessel clears lowered and cabin lights illuminated, the Master inadvertently reduced their capacity to maintain a proper and effective look-out. The Master was located at the rear of the lit cabin and only had a small area directly in front of them unobstructed by the lowered clears (see *Figure 18*). Either side of this gap, the Master had to look through the reflections on the clears to identify hazards to navigation.

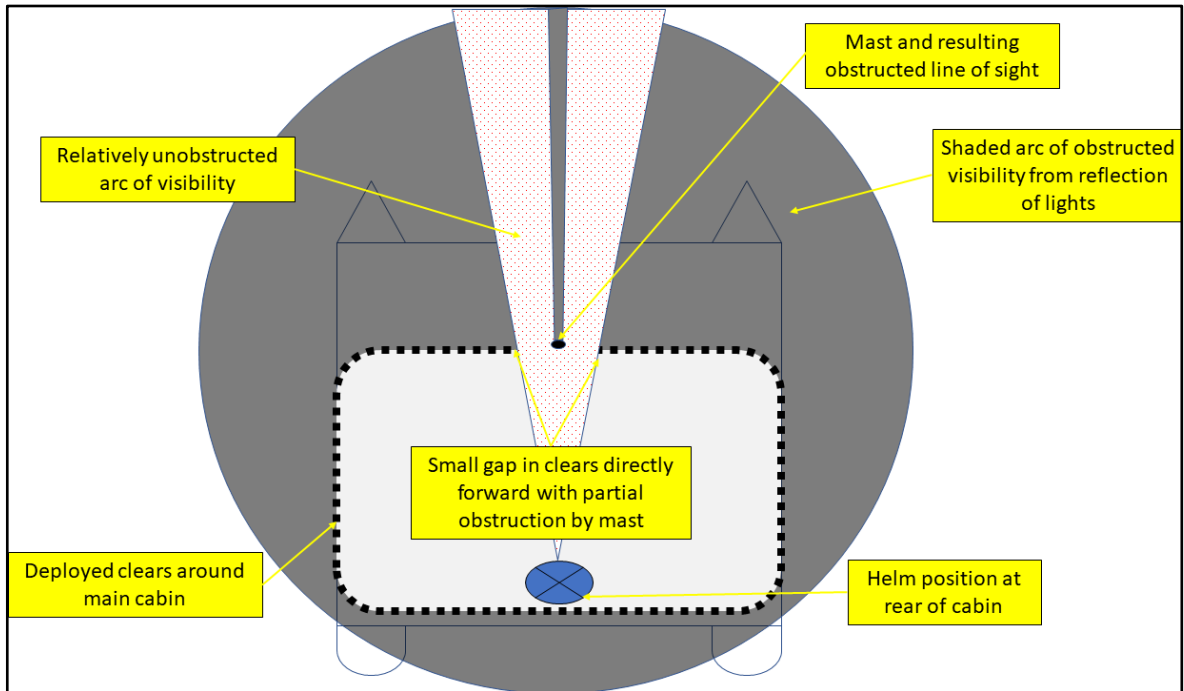
Figure 19: Plan representation of limited line of sight with clears in place and cabin lights on (not to scale)

- 2.45 With the clears lowered and cabin lights on, *Rockfish 3*'s Master sailed from King Street Wharf effectively with vision only through the gap in the clears, either side of the mast. Hazards in the arc of visibility, concealed by the clears or behind the shadow of the mast, were unlikely to be noticed by the Master at the rear of the vessel (see *Figure 19*) where he was positioned.
- 2.46 The risk posed by the decision to sail with the clears in place and the cabin lights on could have been mitigated by the placement of a trained look-out near the bow. In this incident, the crewman was engaged in cleaning rather than conducting the duties of a lookout.

- 2.47 When *Rockfish 3* was sailing towards the east along the southern shore of the Sydney Harbour Bridge Transit Zone, the Master would have had *John Cadman 3* in the port bow sector, and likely obscured by the clears. As *Rockfish 3* turned to port and towards the north, *John Cadman 3* would have momentarily passed through the sector without obstructed vision. *John Cadman 3* was most likely to have been observed by *Rockfish 3*'s Master as she passed through this sector. Once *Rockfish 3*'s turn placed *John Cadman 3* in the arc of visibility behind the clears on the starboard side, the larger vessel again became concealed from the view of *Rockfish 3*'s Master.

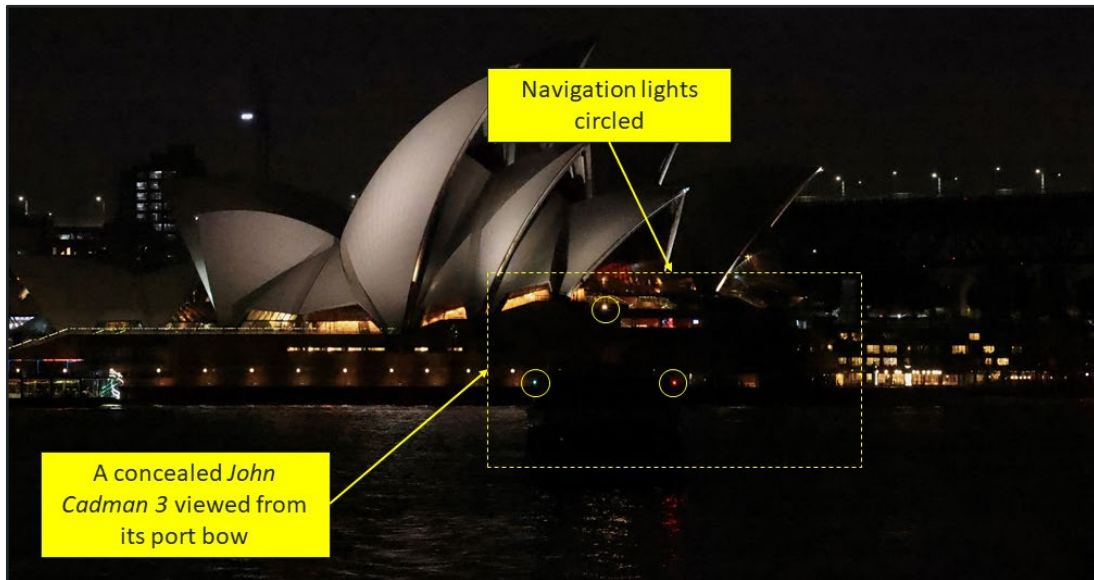
Figure 20: *John Cadman 3* concealed at night

- 2.49 However, from the lower line of sight of *Rockfish 3*'s Master, *John Cadman 3* with its dark blue hull was hard to identify. Similar images taken at water level reveal that even the white superstructure could disappear in the dark of night and the vessel's navigation lights could become lost in the confusion of background shore lighting (see *Figure 20*).

- 3.12 *John Cadman 3's* navigation lights may have blended into the background lighting of Luna Park. This may have detracted from *Rockfish 3's* Master's ability to identify *John Cadman 3* prior to the collision. The variable lighting conditions in the vicinity of the Sydney Harbour Bridge likely exacerbated the ability of a look-out to identify hazards and mitigate risks to safe navigation in a timely manner.
