Office of Transport Safety Investigations

# FERRY SAFETY INVESTIGATION REPORT

## COLLISION OF MV *FRESHWATER* WITH MANLY WHARF

22 June 2013

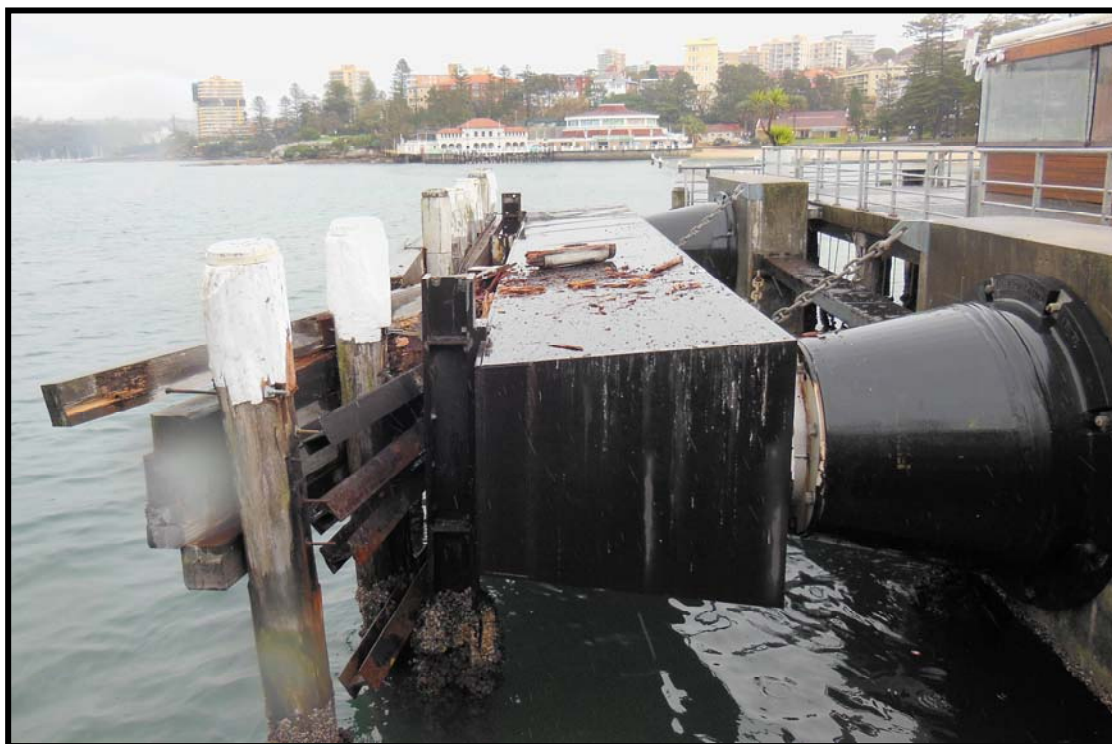
**Photograph 2: Manly Wharf western side backboard**

- 1.19 A large timber arrester structure (backboard) attached to timber piles is positioned approximately 5½ metres from the concrete promenade end of the Manly Wharf on the western side and is 15 metres in length. This is intended to act as a barrier separating vessels from the concrete promenade on shore in the event of a ferry overshooting the wharf (see *Photograph 2*).
- 1.20 The backboard was constructed of timber piles driven into the seabed with large timber beams fixed horizontally to the piles above the water. Behind the timber fascia beams are four steel RSJs also mounted horizontally. The structure also consists of a large metal casing which houses additional steel RSJs placed strategically within the casing to soften impact. The steel casing is attached to the concrete walkway of the wharf structure with two large rubber buffers which are also designed to absorb impact.

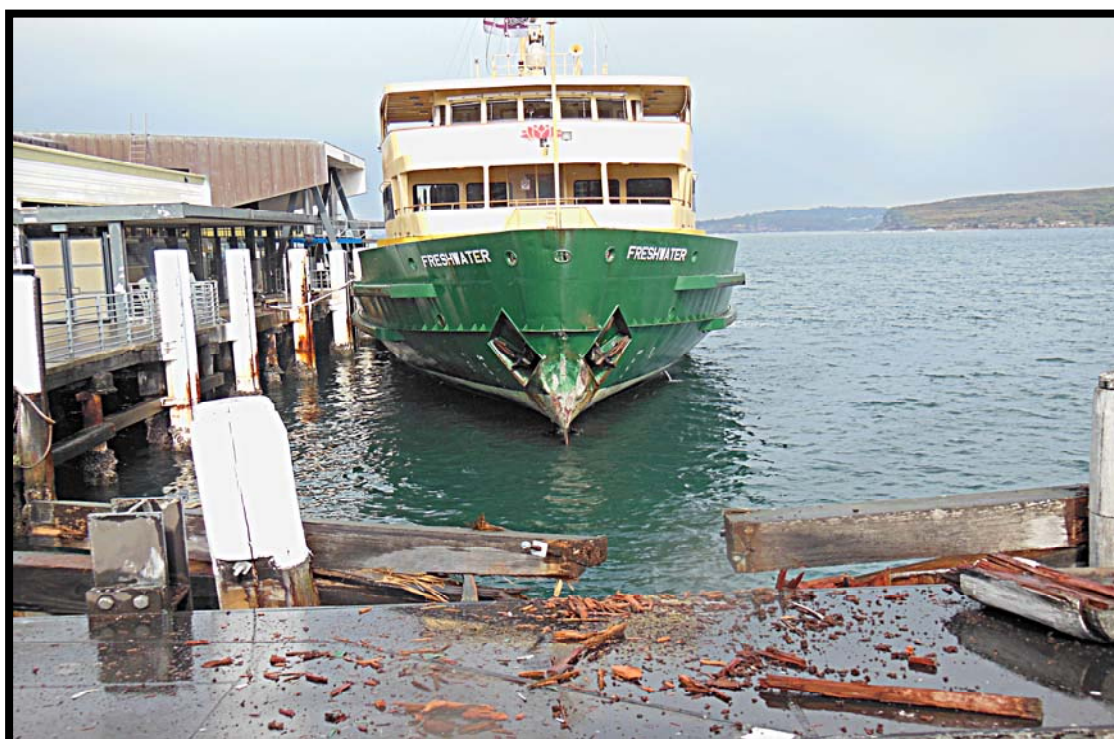
**Photograph 3: Damage from the collision**

- 1.4 The backboard suffered significant structural damage as a result of the impact. A pile was broken, its timber cladding was smashed and steel backing beams were bent.

- 1.23 The impact of *Freshwater*'s bow on the backboard snapped one of the vertical timber piles, snapped the horizontal timber fascia and dislodged steel RSJs. The rubber buffers attaching the arrester to the concrete walkway also showed slight creasing as a result of the cushioning impact. The extent of damage to the backboard can be seen in *Photograph 3*.

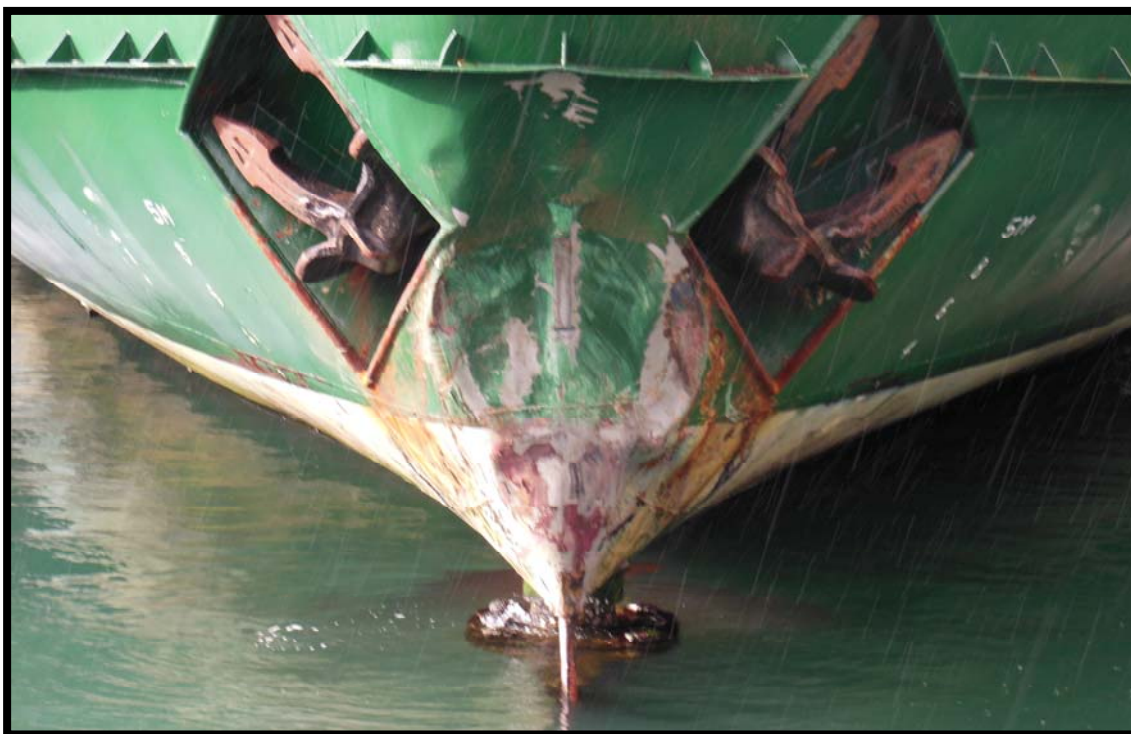
**Photograph 4: Damage to *Freshwater***

The bow of *Freshwater* suffered major damage in the collision with two tears to the steel hull plating, fortunately above the water line. The backboard suffered significant structural damage in the impact. A pile was snapped off, the timber fascia smashed and steel backing beams displaced and bent.

- 1.3 *Freshwater* sustained damage to the bow plating, which was dented inwards, and two tears to the hull plating near the stem of the ferry. The stem was also bent. Some damage was also occasioned to the inner frames in the bow section with the stem and hatch distorted.

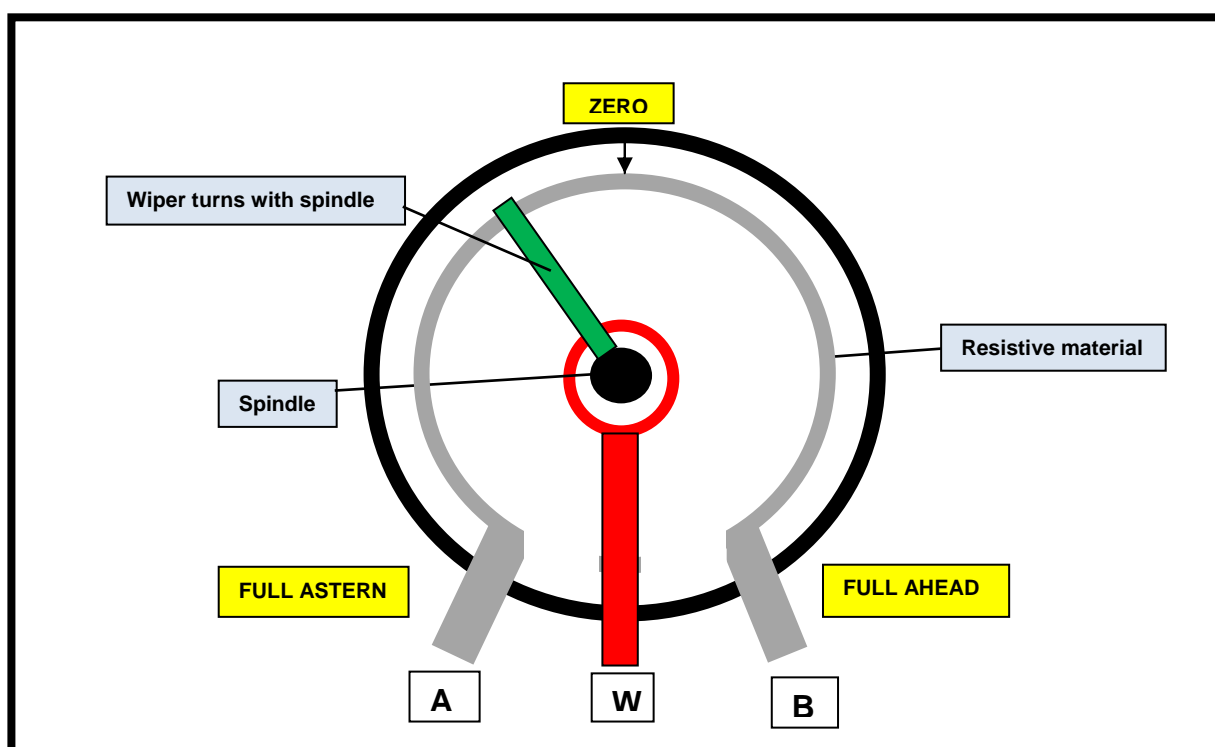
**Diagram 4: Potentiometer**

- 2.7 The XY lever uses two Bourns® potentiometers as position transducers. The potentiometer is a three terminal resistor with a sliding contact (wiper) that forms an adjustable voltage divider. *Diagram 4* shows the basic components of a typical potentiometer. *Photograph 5* shows the potentiometers involved in the incident.

- The zero position (zero thrust) corresponds to a position of the wiper (W) at 12 o'clock.
- The position of maximum ahead thrust is at 'B'.
- The position of maximum astern thrust is at 'A'.
- The position between 'A' and 'B', through the shortest distance, is the no thrust ('dead') zone.

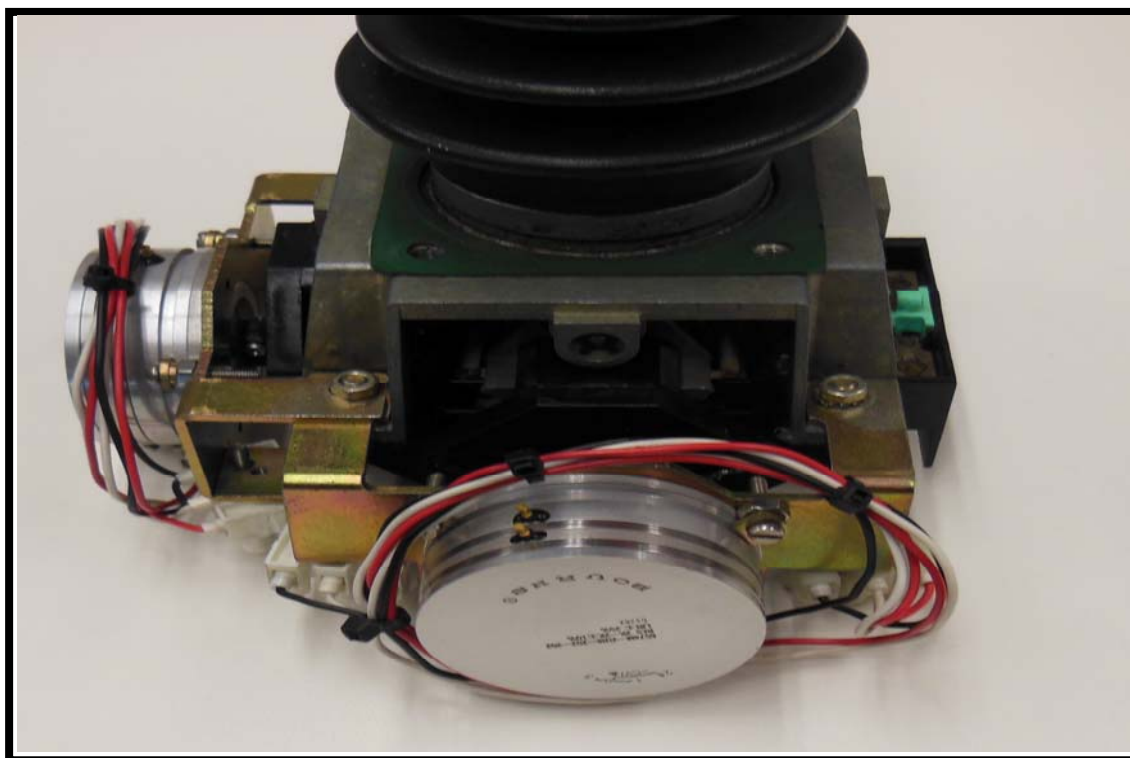
**Photograph 5: Control head showing potentiometers**

- 2.9 The potentiometer in action at the time of the loss of control was examined by HCF engineers and representatives from the propulsion control manufacturer, Wartsila. They concluded that the wiper was positioned at 'A' when the Master called for maximum astern thrust. However, it did not remain in the 'A' position. Instead, it turned through the 'dead' zone and positioned itself at 'B' which then engaged maximum forward thrust. The uncontrolled movement of the wiper was attributed to 'age related fatigue'.

- 2.10 The potentiometer failed when *Freshwater* was 18 metres from the backboard, travelling at 5 knots. This only provided 7 seconds for the Master to be able to revert to the backup system and so avoid the collision.

- 2.11 The Technical Maintenance Plan in vogue with HCF called for the annual testing of all potentiometers by Wartsila. It was determined that the potentiometer in operation at the time of the incident was last tested on 22 March 2013 at which time no faults were identified. The potentiometer was stamped 'week 38 2003', indicating that it had been in operation for 3 months short of 10 years. The specifications for the 6574 model Bourns®

potentiometer indicated the rotational life as being 25 million shaft revolutions. When in service, the ferries operate for periods of up to 18 hours per day for nearly all days of the year. With such constant use, the potentiometer could possibly have exceeded its specified rotational life expectancy.

- 2.15 When the cause of the control failure was established, all potentiometers on the fleet of Freshwater class ferries were immediately inspected and subsequently replaced. HCF has advised that the potentiometers in all Freshwater ferries will now be replaced rather than just tested annually.<sup>4</sup>
- 2.16 The damage to the bow section of *Freshwater* was repaired and the vessel inspected and cleared by RMS and Lloyd's surveyors for return to service.

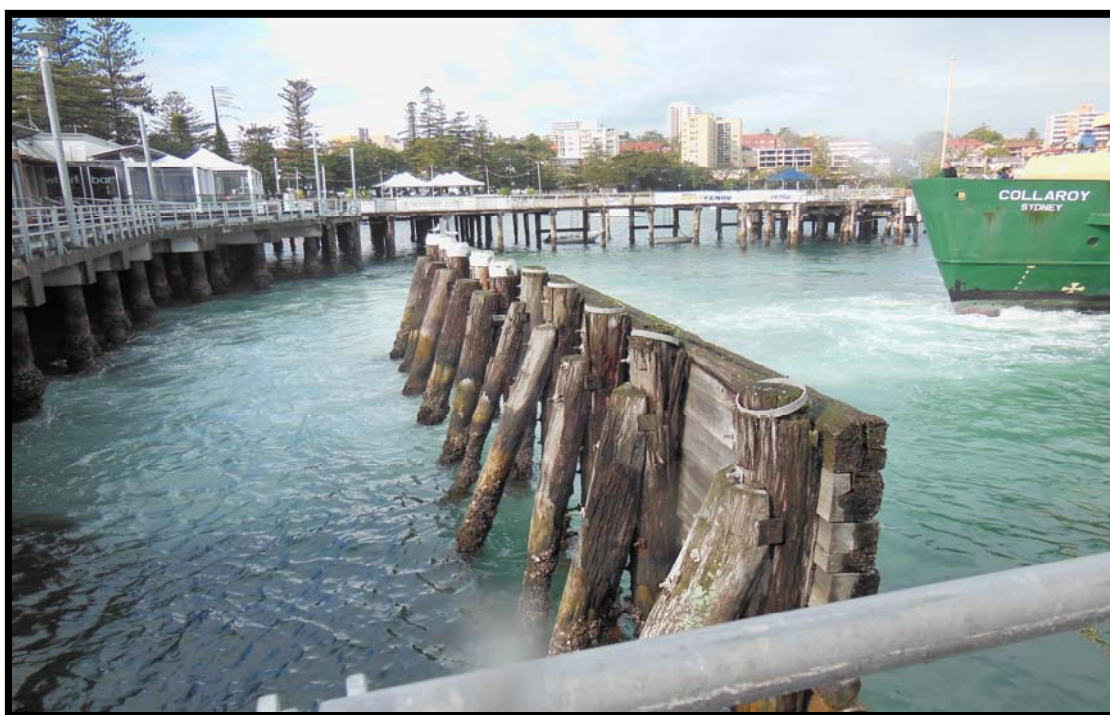
**Photograph 6: Manly Wharf eastern side backboard**

2.13 Immediately after the incident Manly ferry timetabled services continued utilising the eastern side of Manly Wharf. It was observed that the timber backboard on that side was of an inferior design and far less robust compared to the backboard on the western side. Its design and condition were such that it was considered unlikely to function satisfactorily and survive an impact of the magnitude that occurred in the collision with the backboard on the western side. (See *Photograph 6*)

- 2.14 Out of concerns for the adequacy of the eastern side backboard, HCF implemented particular procedures for all Freshwater ferries which included the requirement to approach the wharf at a greatly reduced speed.

- 4.2 Given the apparent comparative lack of adequate functional robustness of the backboard on the eastern side of the Manly Wharf, it is recommended that the Roads and Maritime Services undertake engineering and risk assessments to establish its current suitability for Manly ferry operations.

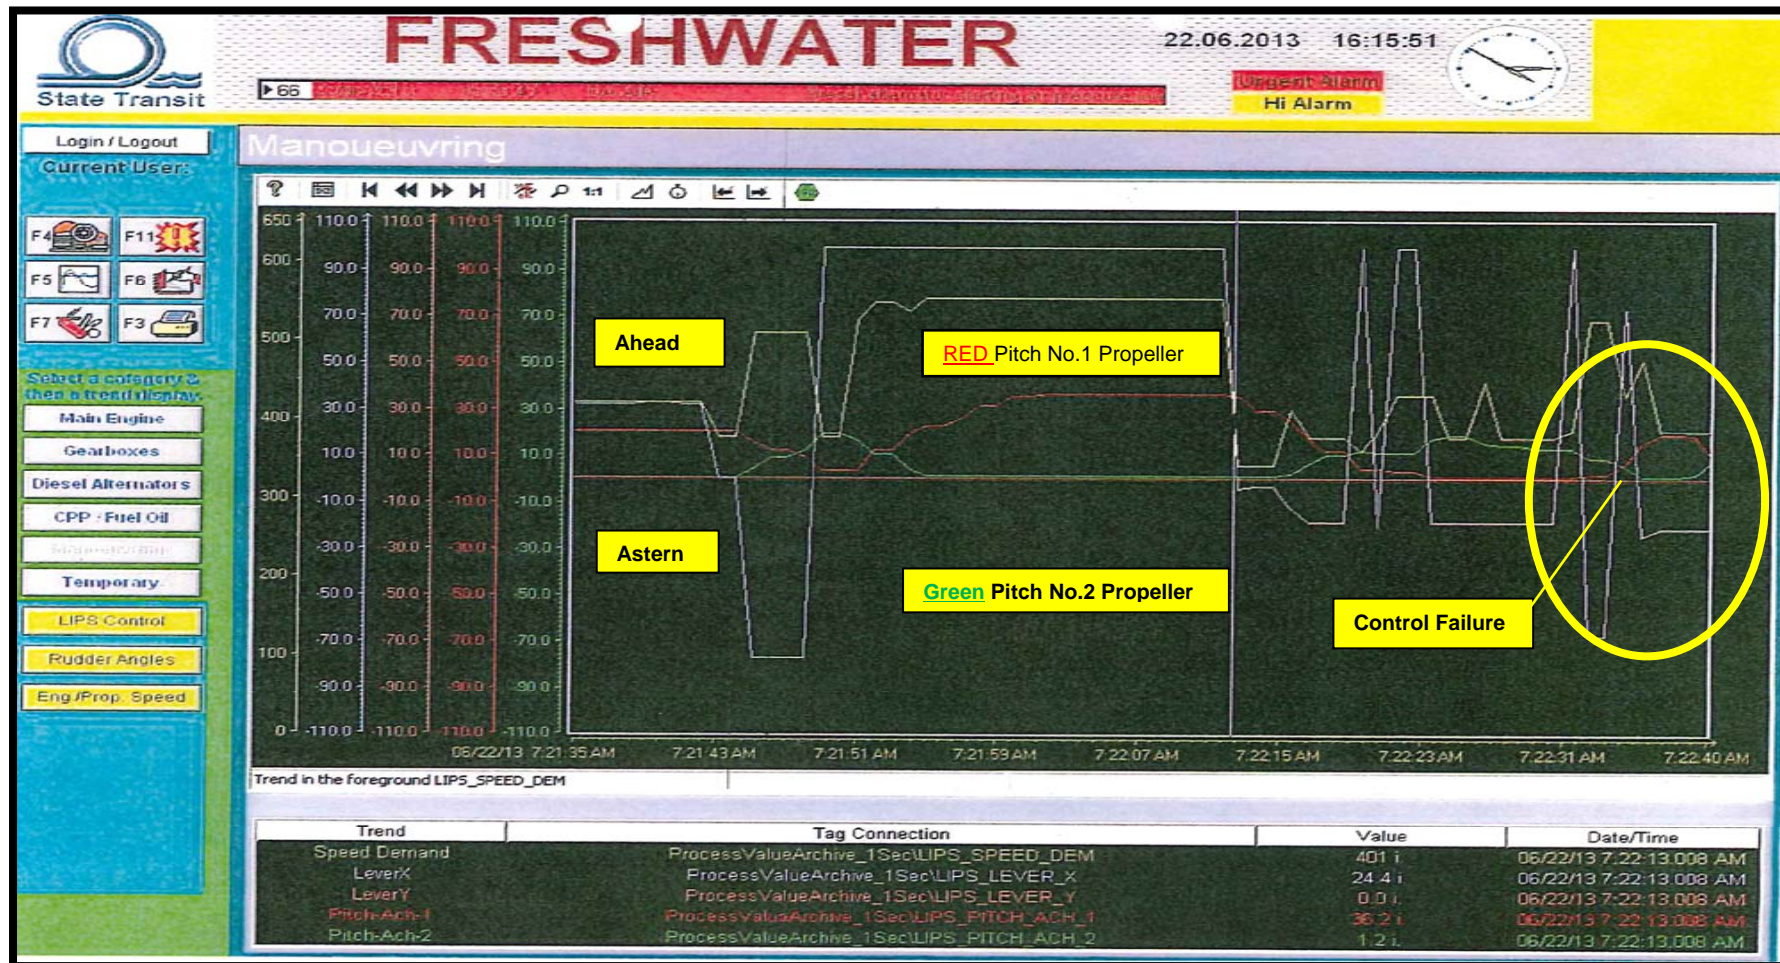
Graph showing pitch of No.1 and No.2 propellers

- 2.5 Downloads from the Siemens monitoring system provided information on the operation of the Wartsila control system on a second by second basis. An analysis of control signal and rudder angle records revealed that both LMP1 and LMP2 failed at 07:31:22.
- 2.6 The downloaded graph of the control commands shows that the No.2 (bow) propellers pitch was engaged in astern propulsion initially which then increased to full pitch astern momentarily. The graph then shows the No.1 (stern) propeller engaged giving full pitch ahead despite the XY lever still

being in the astern position. That is, engagement without the Master having selected a change. The Siemen's system downloads therefore served to corroborate the evidence from the CCTV footage and the Master's recollection of events. (See *Appendices 2 and 3*)
