RAIL SAFETY INVESTIGATION REPORT

NEAR HIT WITH WORKERS ON TRACK

SUMMIT TANK TO DOMBARTON SECTION

17 JULY 2012

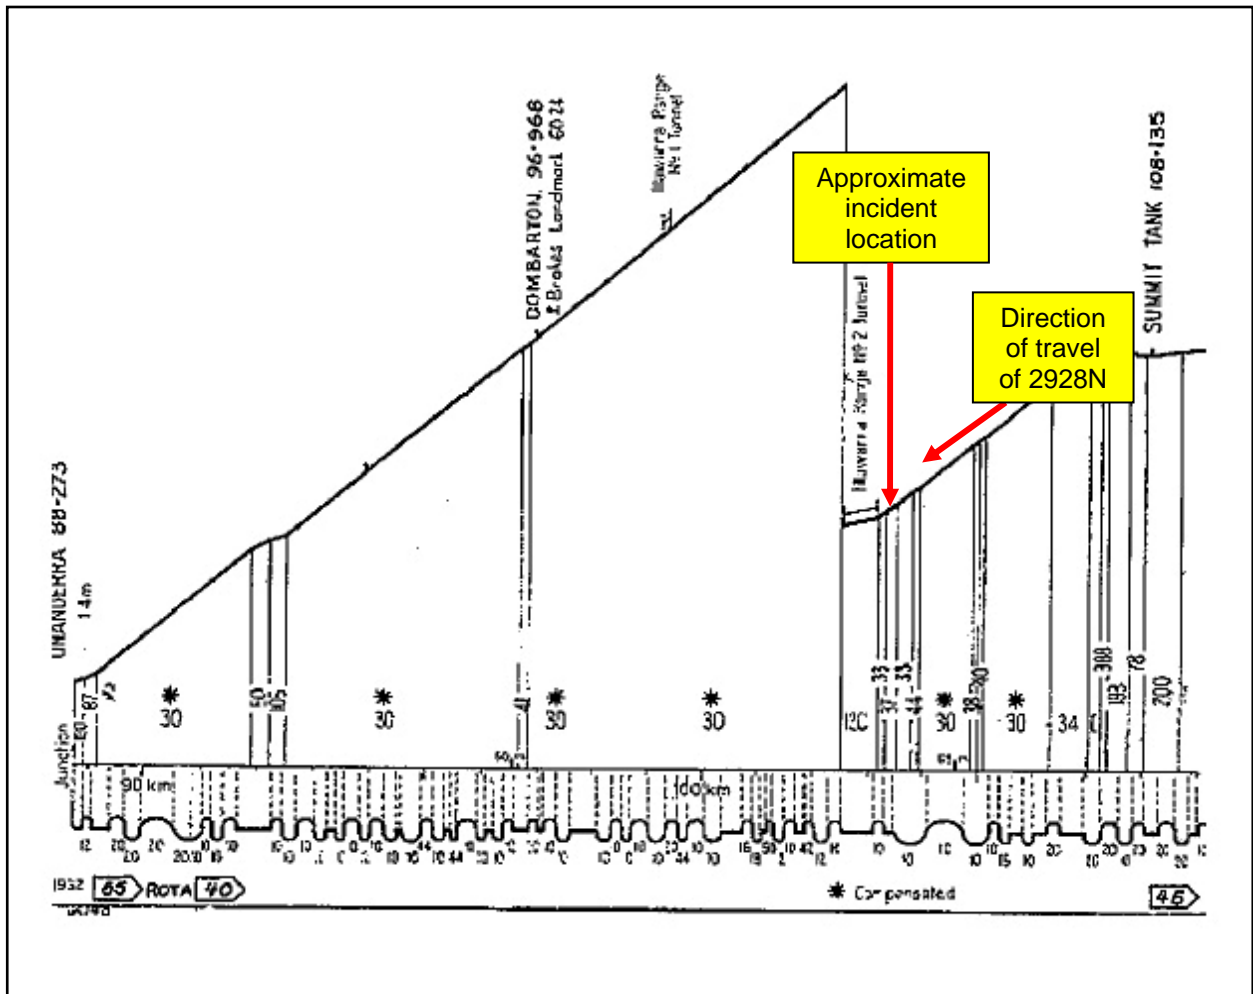
Figure 1: Illawarra Mountain Gradient Diagram

The Moss Vale to Unanderra Branch line is approximately 63 km in length and has one of the steepest grades in the NSW rail network. The last 20 km, which includes the Summit Tank to Dombarton section, has a near continuous descending gradient of 1 in 30 (see *Figure 1*). The speed limit on the track varies between Moss Vale and Unanderra but is signposted at 30km/h for freight services over the last 20 km of line.

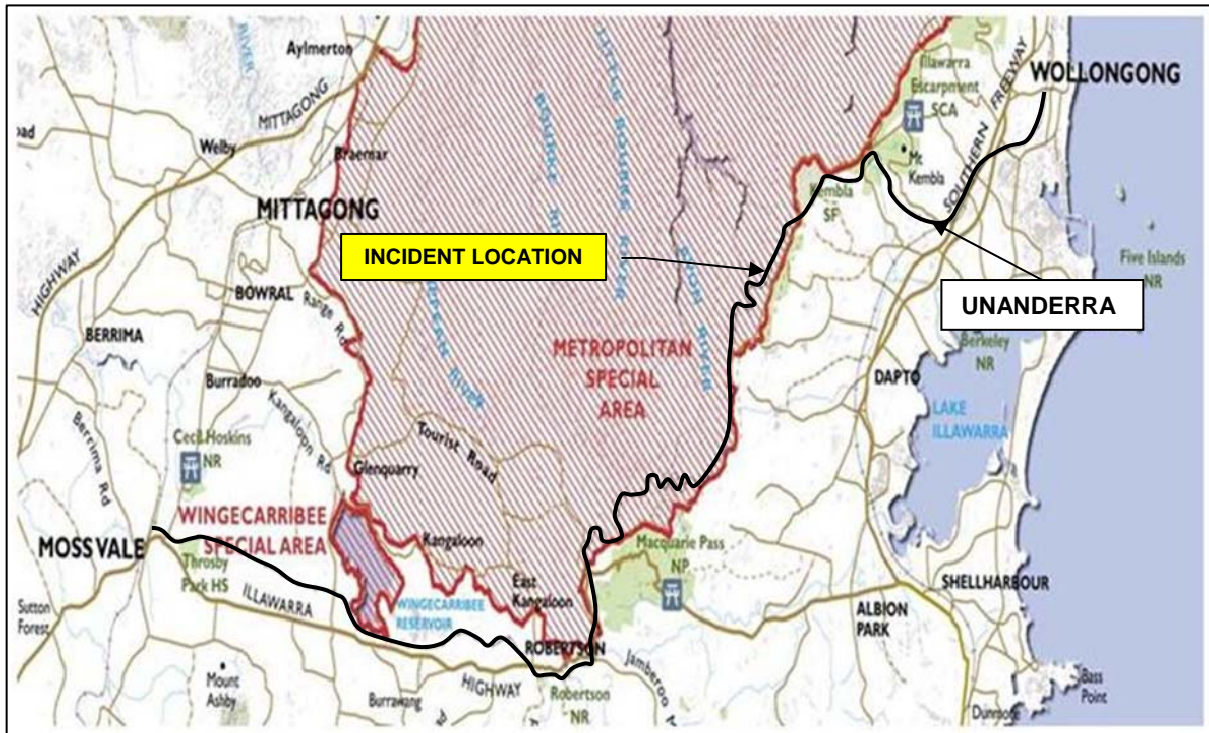
Figure 2: Incident location
 (Image courtesy of Sydney Catchment Authority)

The line supports the movement of intermodal freight, bulk commodities such as coal and grain, and passenger services. Train movements on the single line between Moss Vale and Dombarton and the double line from Dombarton to kilometrage 91.080 are controlled from NCCS under Network Rule ANSY 500 *Rail Vehicle Detection System*. In the ‘Up’ direction², the last signal controlled from NCCS is signal WG 1052³ just prior to Dombarton. The incident occurred on a winding section of the line as the train approached the Country end of the viaduct heading towards Unanderra (see *Figure 2*).

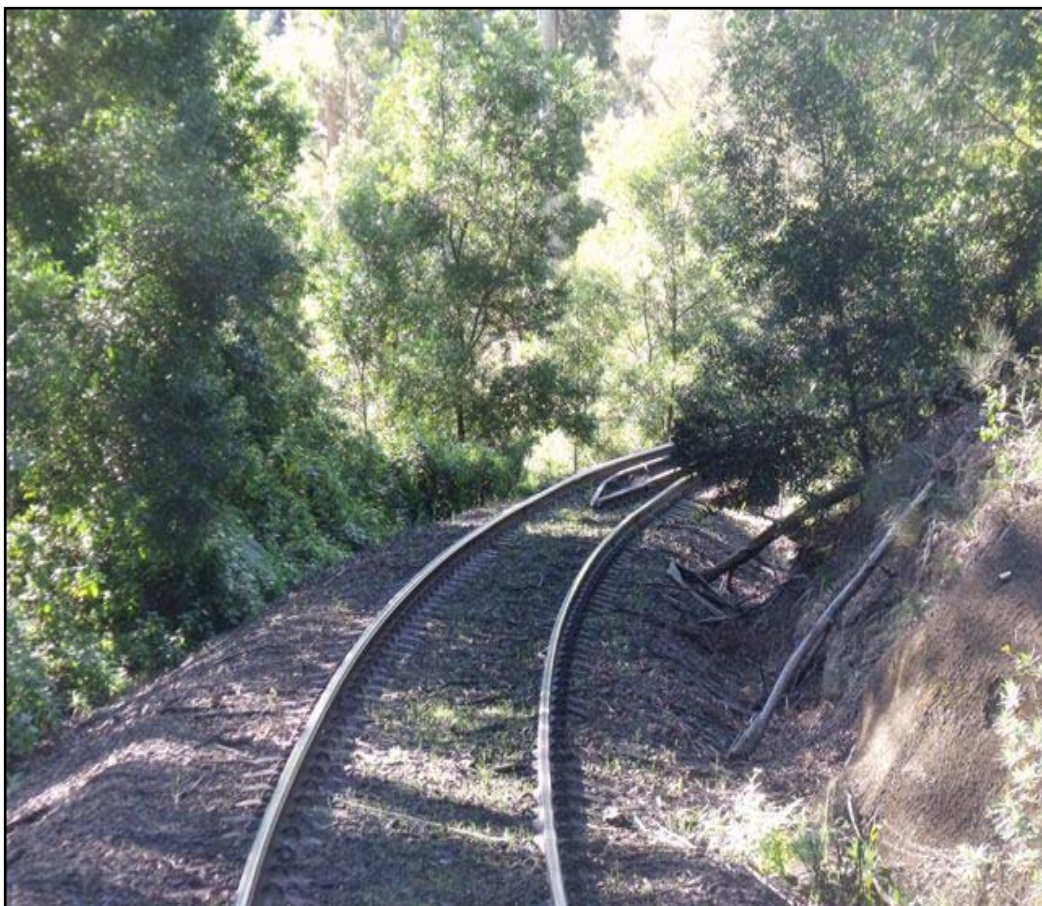
Access to the viaduct is via a fire trail approximately 15 km from the nearest access gate. Sighting distances for approaching rail traffic are restricted due mainly to vegetation and the curvature of the track. There is a walkway on the viaduct but it is in the danger zone and should not be occupied when rail traffic is passing as it does not constitute a safe place.

Photograph 1: View along the last curve on the approach to the viaduct (Country end)

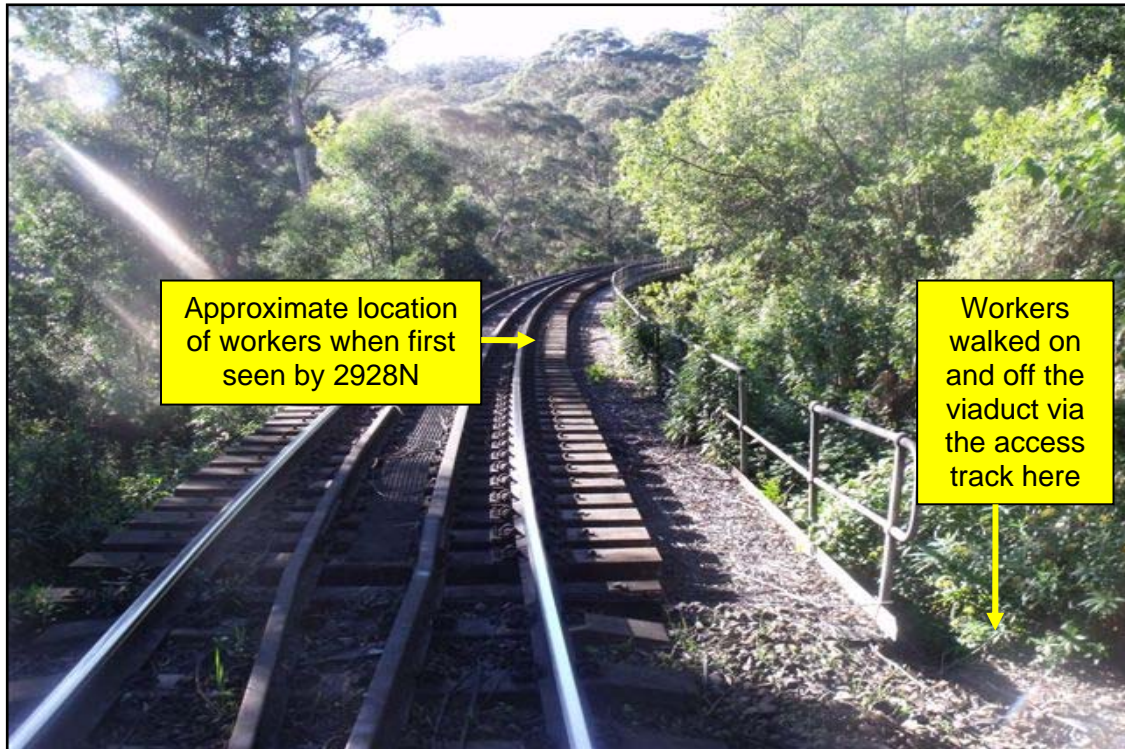
Photograph 2: Incident location viewed from the Country end
(Photo courtesy of Australian Rail Track Corporation)

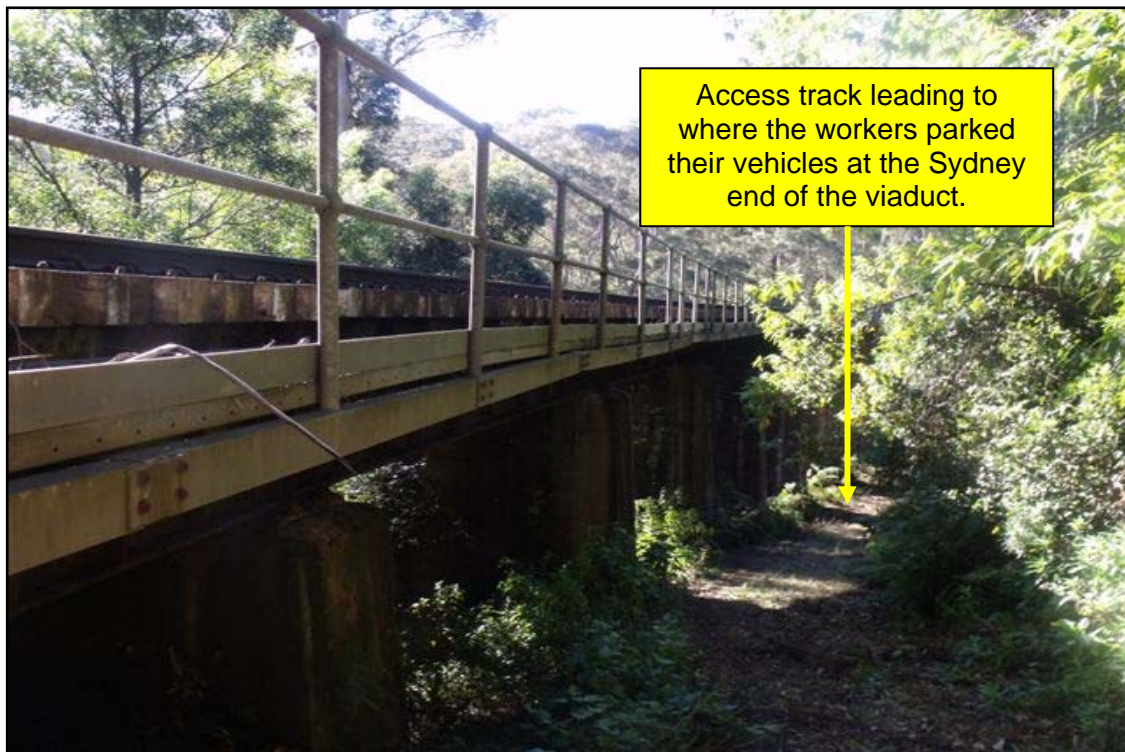
Photograph 3: Access road beside the viaduct
(Photo courtesy of Australian Rail Track Corporation)
