Office of Transport Safety Investigations

RAIL SAFETY INVESTIGATION REPORT

**TRAIN SERVICES OPERATED THROUGH BUSHFIRE AFFECTED
SECTION OF TRACK, LOCALITY OF HOLSWORTHY, NSW**

14 APRIL 2018

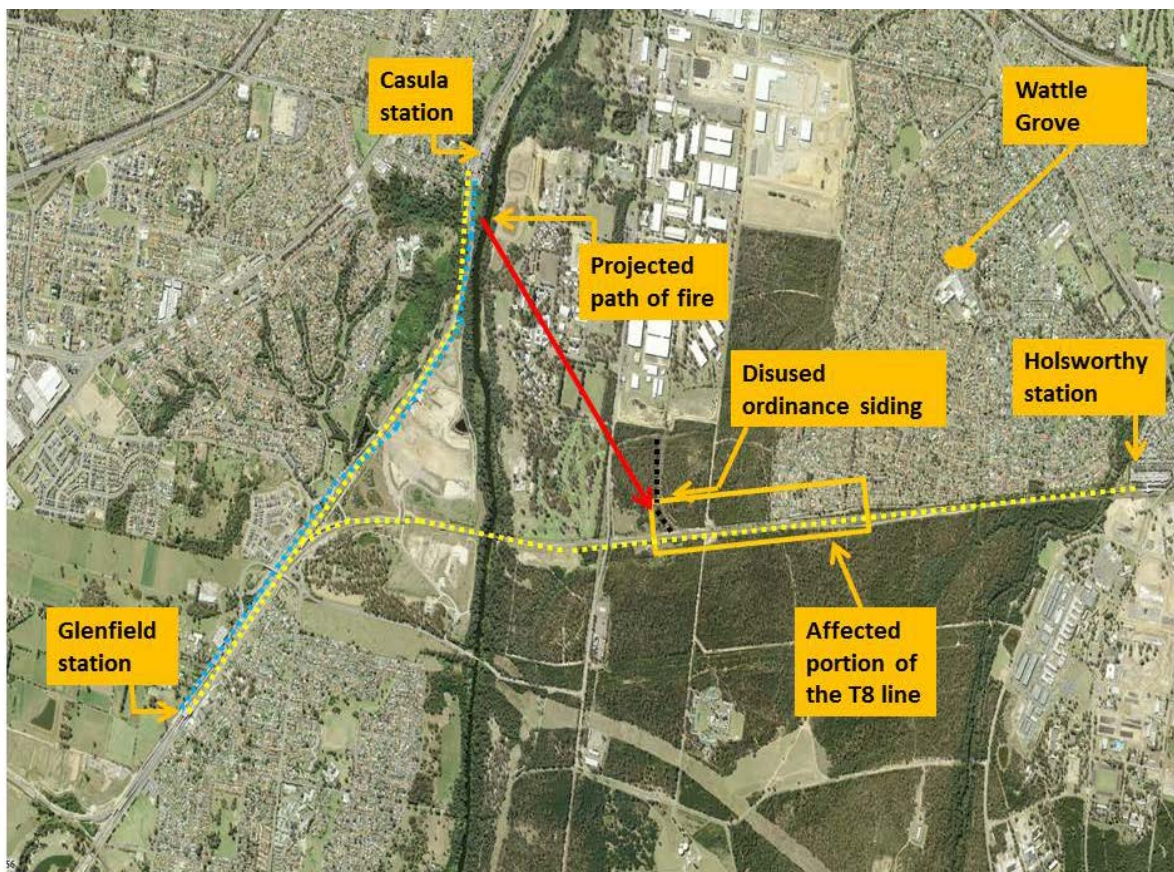
Figure 2: Second Aerial View of the area of interest: blue line shows the SSFL, yellow lines show the Sydney Trains rail network and black line shows the disused ordinance siding. The red arrow indicates the path of the fire. Yellow Box is the bushfire affected section of the T8 line.

- 2.7 The fire spread in a south-easterly direction which was likely due to the wind blowing in that direction (*See Figure 2*).
- 2.8 The first report of the fire on the T8 line between Holsworthy and Glenfield was made at 14:56 by the driver of train 66-L. At this time, the Sydney Trains signaller at Glenfield was unaware that this was the same fire which had progressed from Casula.

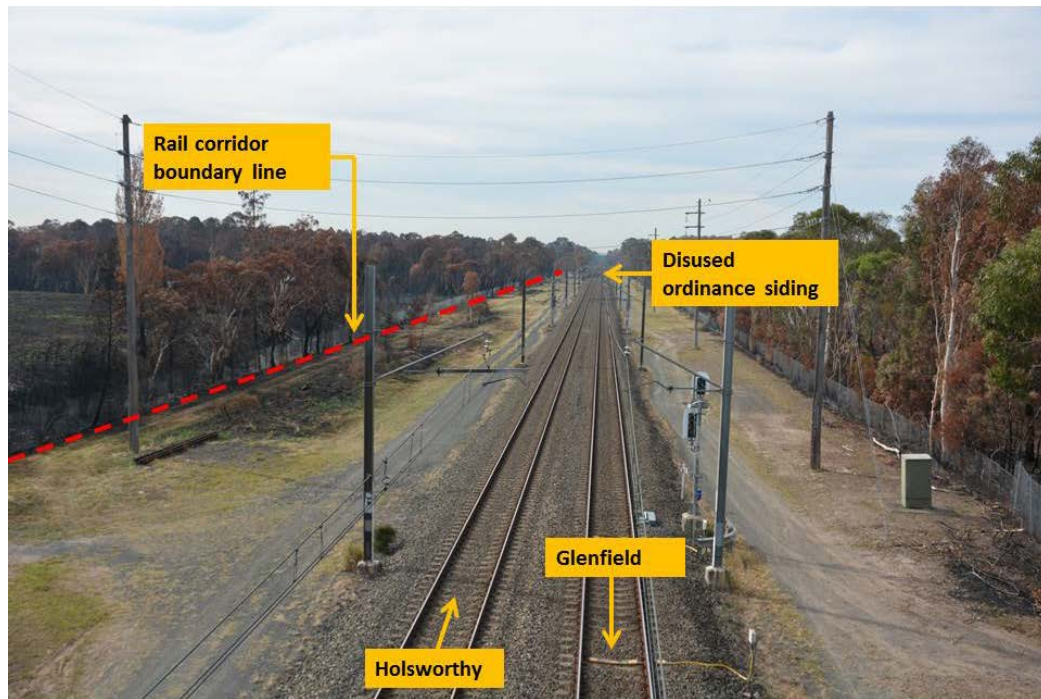
Figure 4: Rail corridor boundary line

- 2.9 During an interview with the driver of train 66-L, the driver advised that there was a large bushfire on the boundary line of the Sydney Trains T8 line near the disused ordinance siding (*See Figure 4 and 5*). The driver added that there were also smaller spot fires in the railway corridor.

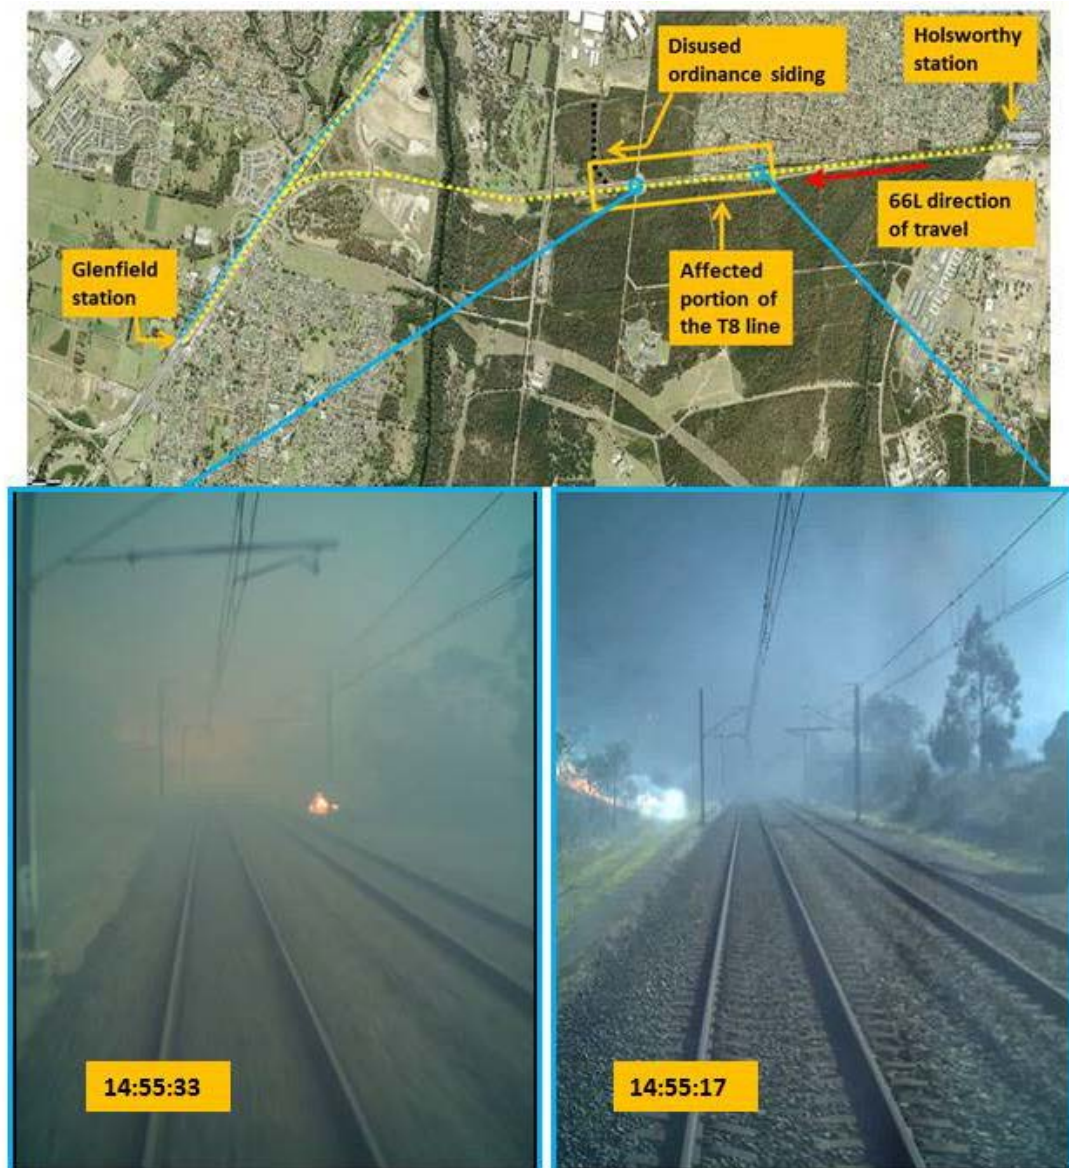
- 2.11 Examination of the front of train camera records for train 66-L shows spot fires near the railway corridor. Visibility was also reduced because of smoke, however when interviewed, the driver advised that the track signals were visible (*See Figure 5*).

Figure 5: Front of train camera footage for train 66-L showing spot fires and smoke

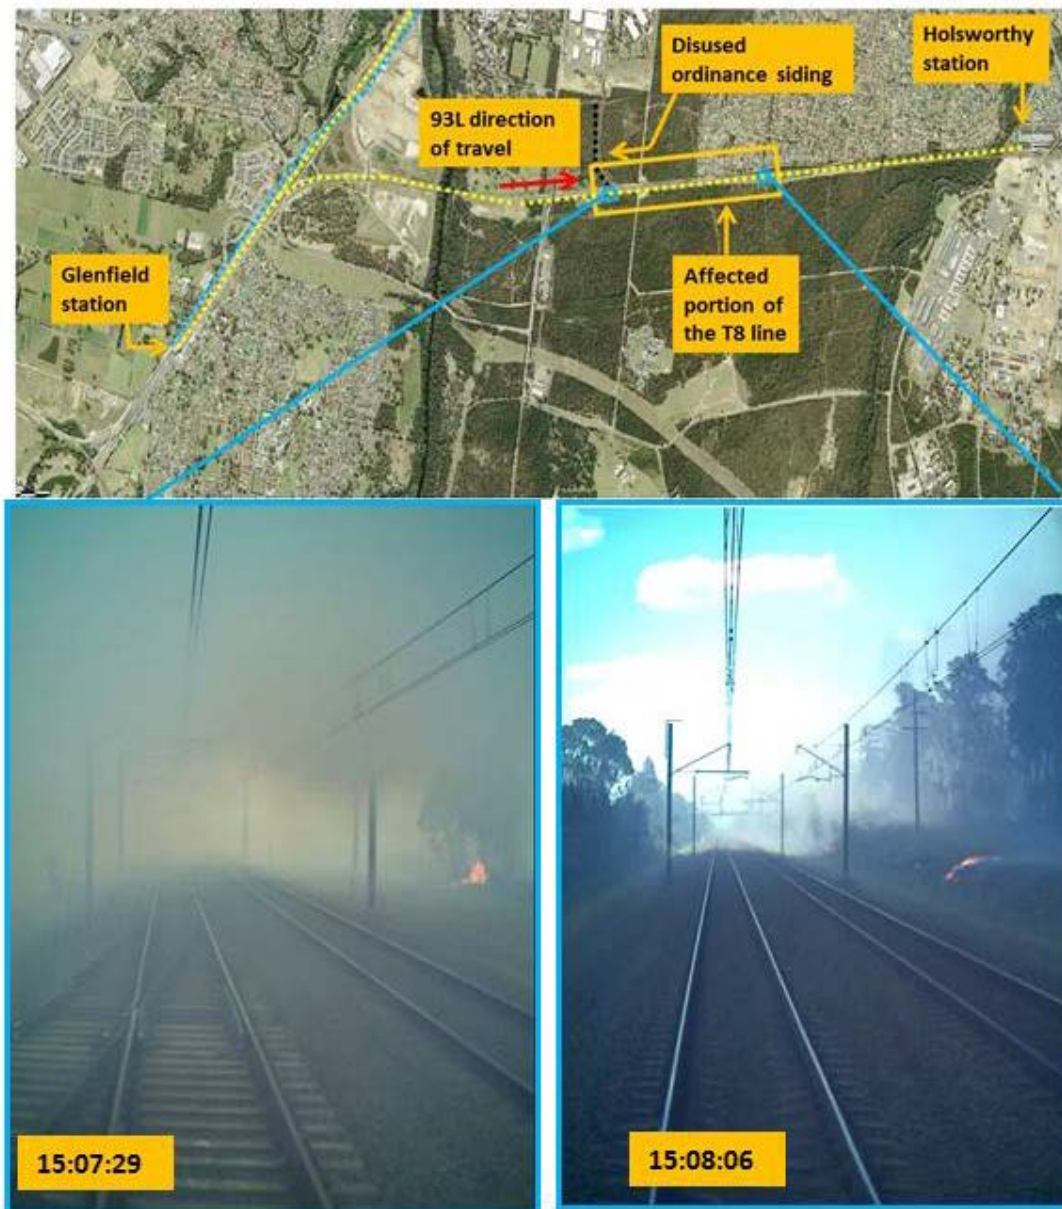
2.12 Examination of the front of train camera records for train 93-L showed spot fires near the railway corridor. At the time 93-L passed through the affected area, driver visibility appeared to have reduced due to an increased density of smoke (See Figure 6). The driver however advised that the track signals were visible.

Figure 6: Front of train camera footage for train 93-L

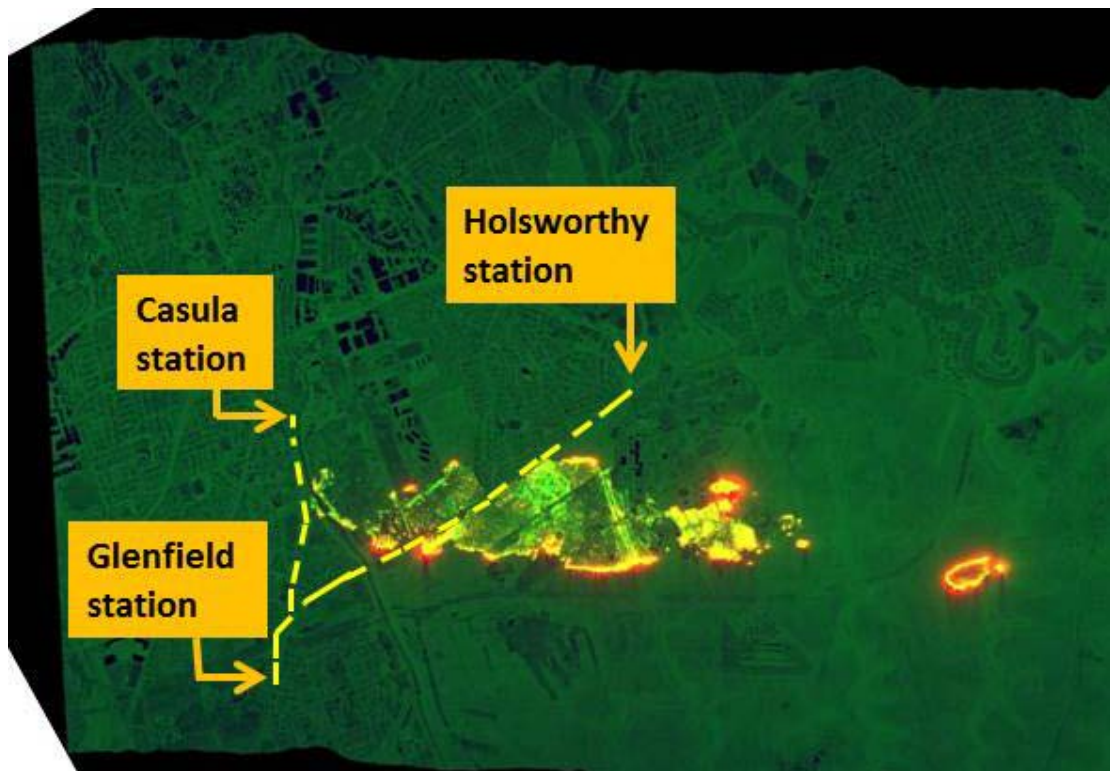
Figure 8: Line scan image of fire progression at 17:58

1. The fire progressed from the country end of Casula station to the disused ordinance siding adjacent to the T8 line between 14:16 and 14:51.
2. The fire likely crossed the railway corridor due to embers from wind blowing in a south-easterly direction between 14:51 and 15:10.
3. The fire progressed into bushland in a south and south-easterly direction after 15:10 (See Figure 8).

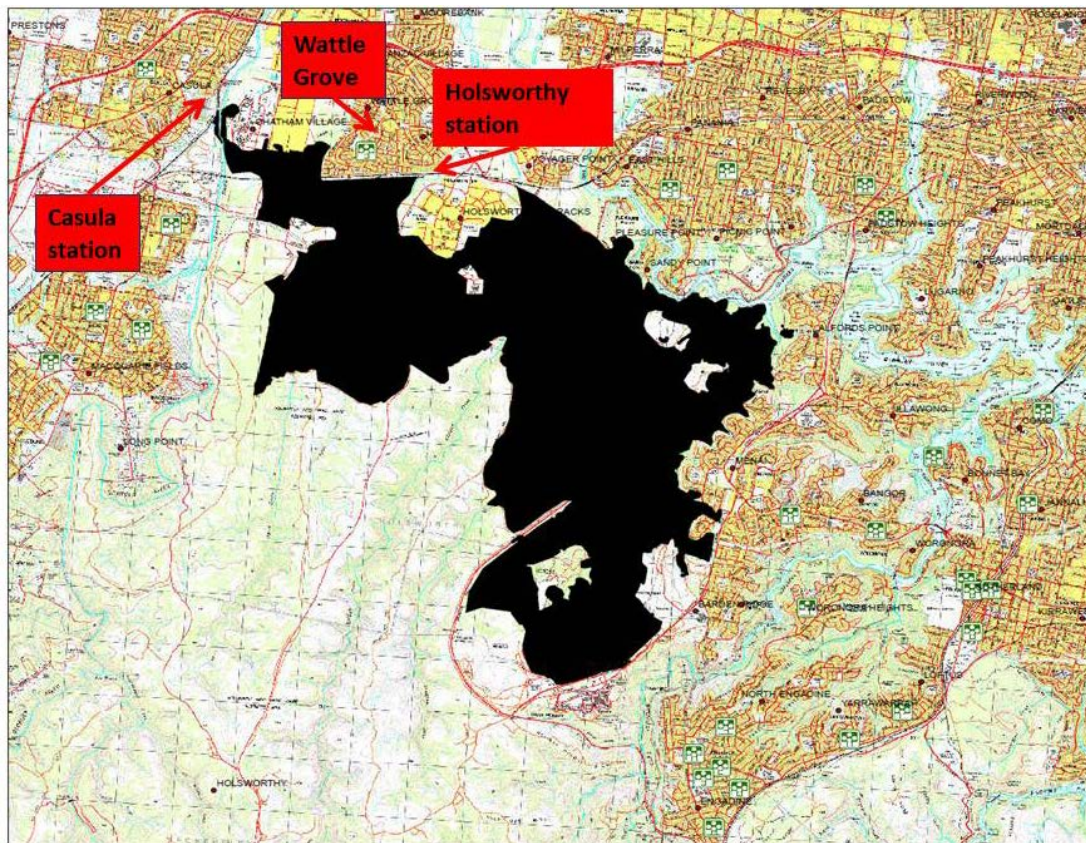
- 2.15 The fire then continued to progress in a south-easterly direction due to the north-westerly winds on the day. The fire also affected the suburb of Wattle Grove, which was adjacent to the affected T8 line (See Figures 8 and 9).

Figure 9: Final burn area

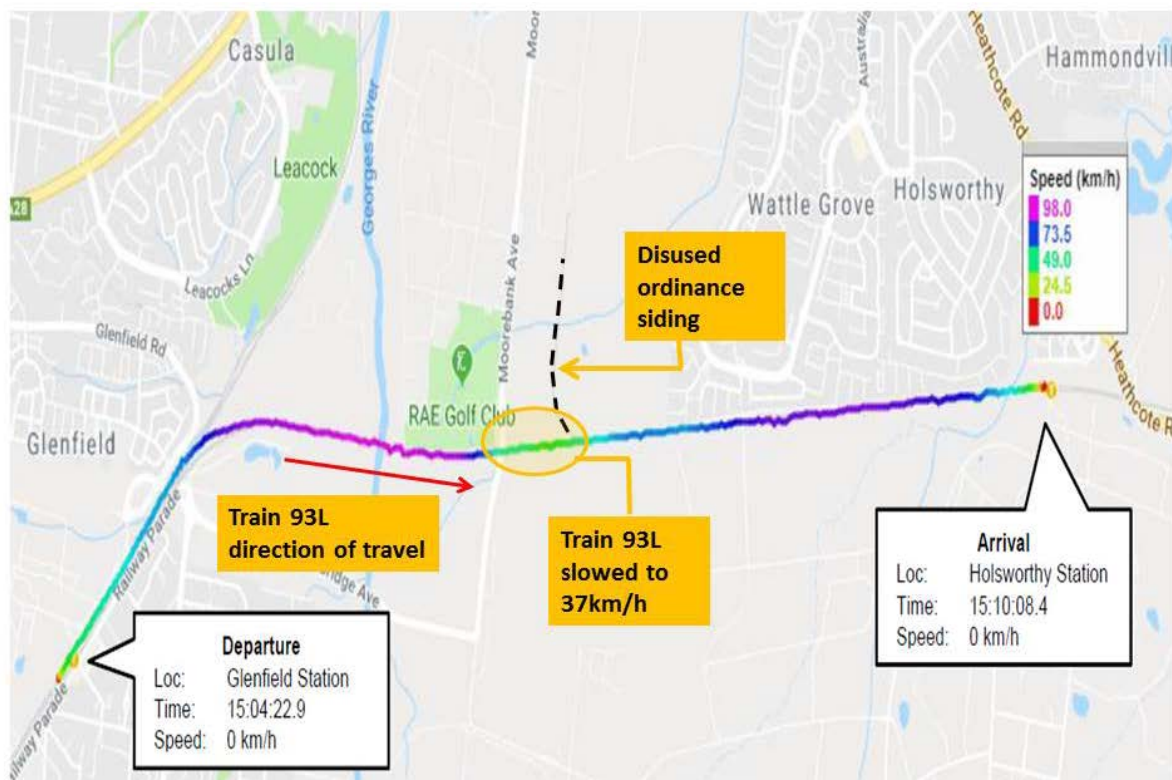
- 2.24 93-L entered the bushfire affected portion of the T8 line in the Up direction at 15:07:26
- 2.25 93-L left the affected portion of the line at 15:08:26
- 2.26 93-L arrived at Holsworthy station at 15:10:08
- 2.27 Train 93-L slowed its speed to 37 km/h as it travelled through the bushfire affected portion on the T8 line. This was determined from its on-board event recorder (See Figure 10).

Figure 10: 93-L train speed between Glenfield and Holsworthy stations

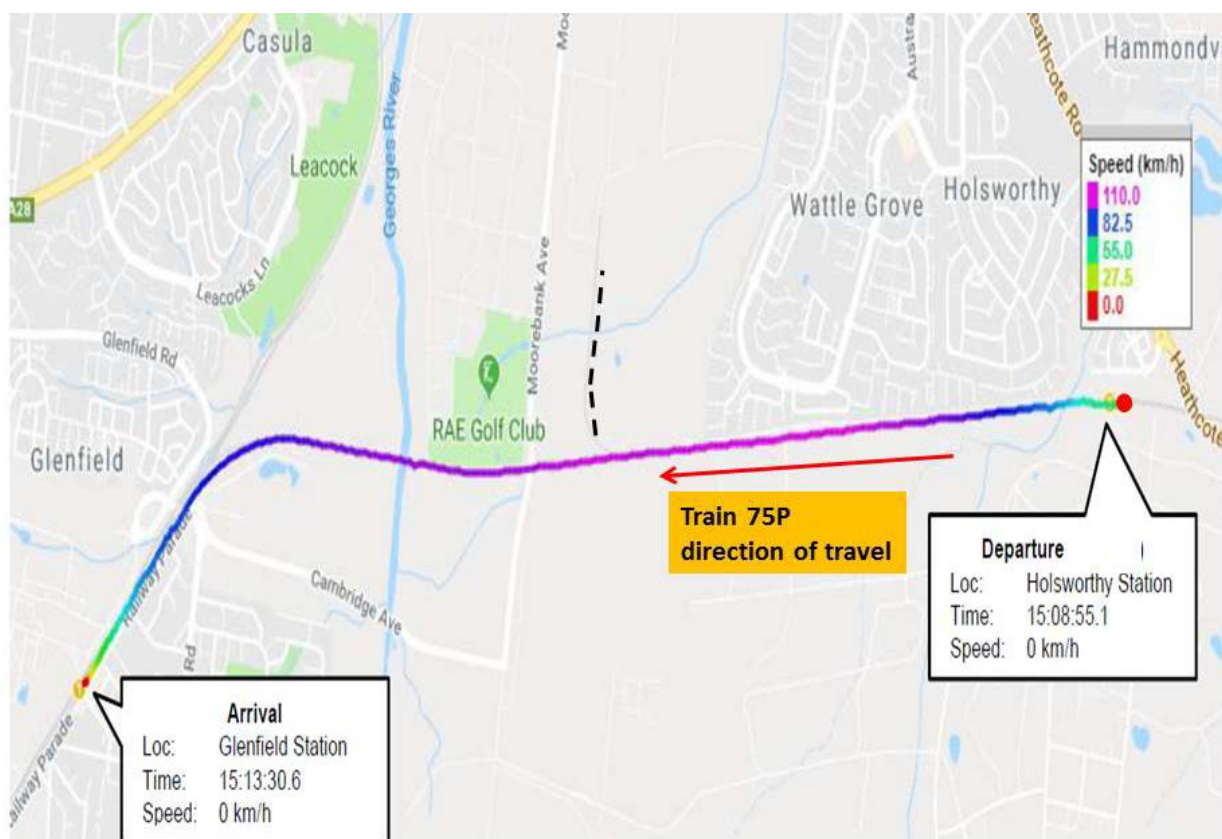
- 2.31 75-P departed Holsworthy Station at 15:08:55
- 2.32 75-P entered the bushfire affected portion of the T8 line at 15:10:21
- 2.33 75-P left the affected portion of the line at 15:10:54
- 2.34 75-P arrived at Glenfield station at 15:13:30
- 2.35 The smoke alarms in cars 1,2,3,7 and 8 were activated for a short period of time, likely as they passed through the bushfire affected portion of the line.
- 2.36 Train data logger recordings indicated no PEI alerts were made by passengers between Holsworthy and Glenfield station.
- 2.37 Train 75-P operated at the expected speed between Holsworthy and Glenfield stations. This was determined from its on-board event recorder (*See Figure 11*).

Figure 11: 75-P train speed between Holsworthy stations

2.38 By the time the conversation between the RMC Controller and Glenfield signal box was completed train 75-P was already in the affected section of track.

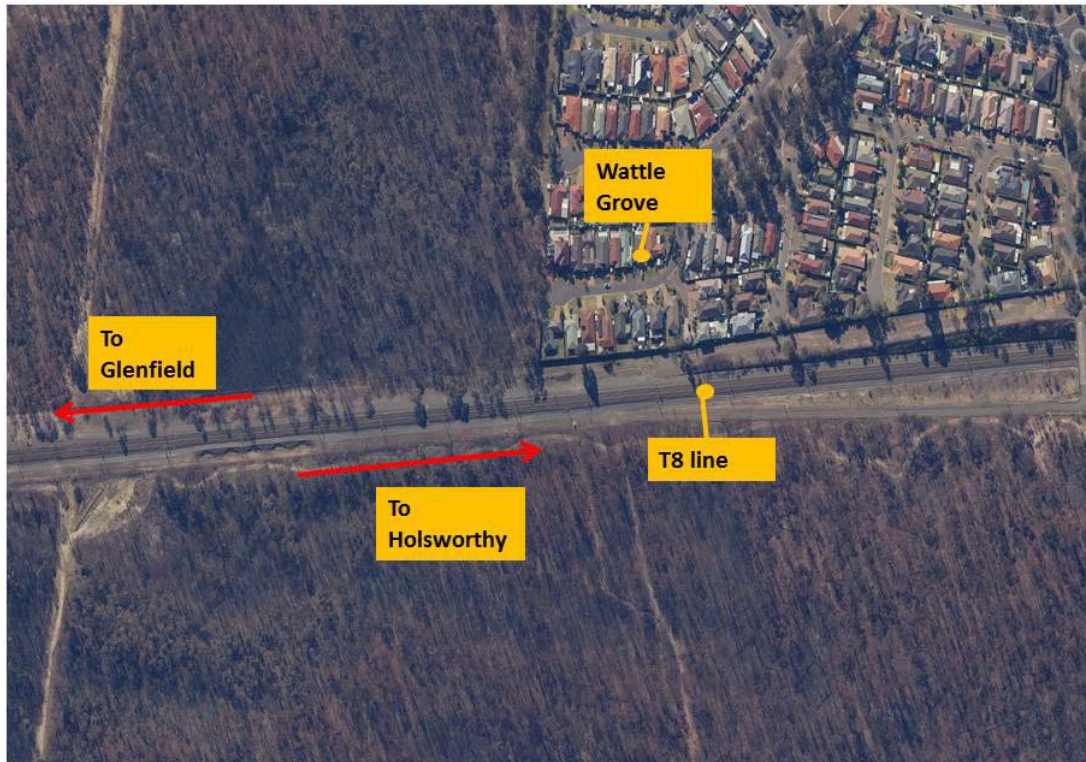
2.50 The section of track between Holsworthy and Glenfield intersected bushland on both sides of the railway corridor. The section of track also intersected bushland and the suburban area of Wattle Grove further in the Up direction (*See Figure 12*).

2.51 Isolated trees were observed approximately 8 m from the railway corridor on both sides, with dense bushland approximately 20 m from the railway corridor on both sides.

Figure 12: Aerial image showing a combination of bushland and the suburb of Wattle Grove surrounding the worst affected section of the T8 line
