RAIL SAFETY INVESTIGATION REPORT

TRAIN COLLISION WITH ROAD MOTOR VEHICLE

WOY WOY

2 SEPTEMBER 2011

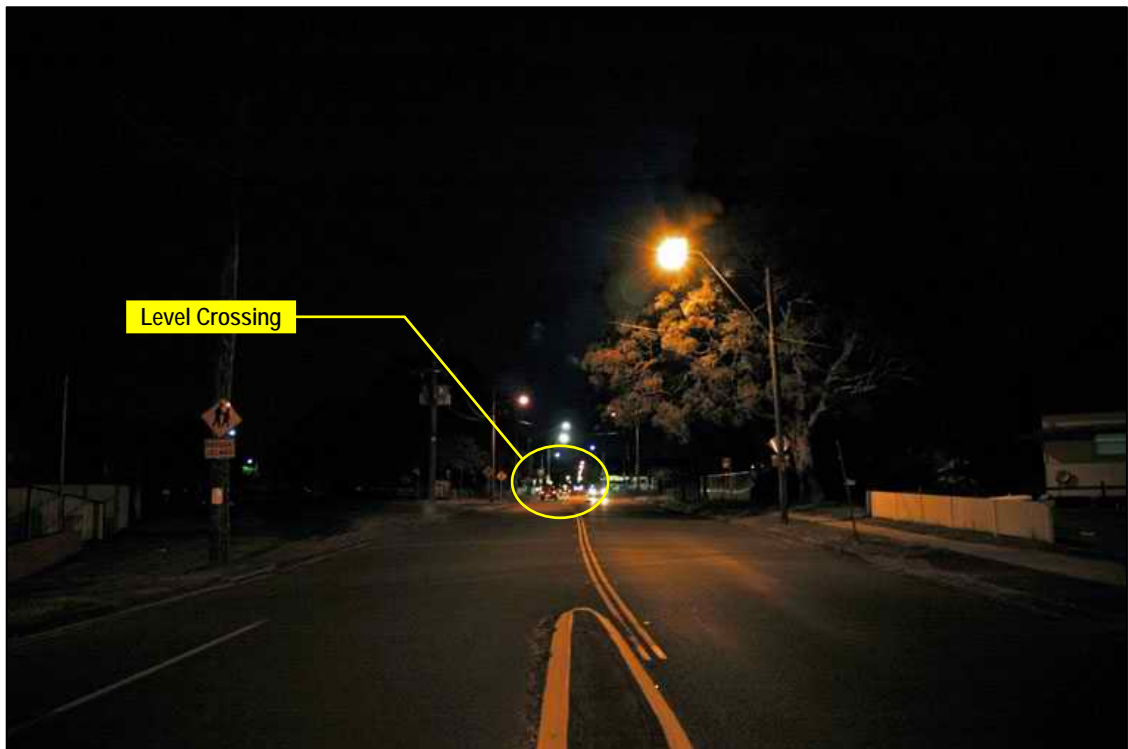
Photograph 3: RMV driver's view to level crossing

- 1.11 In the prevailing visibility conditions, the driver of the RMV had a sight distance to the crossing of approximately 150 metres (see *Photograph 3*) while the train driver's sight distance was approximately 300 metres.

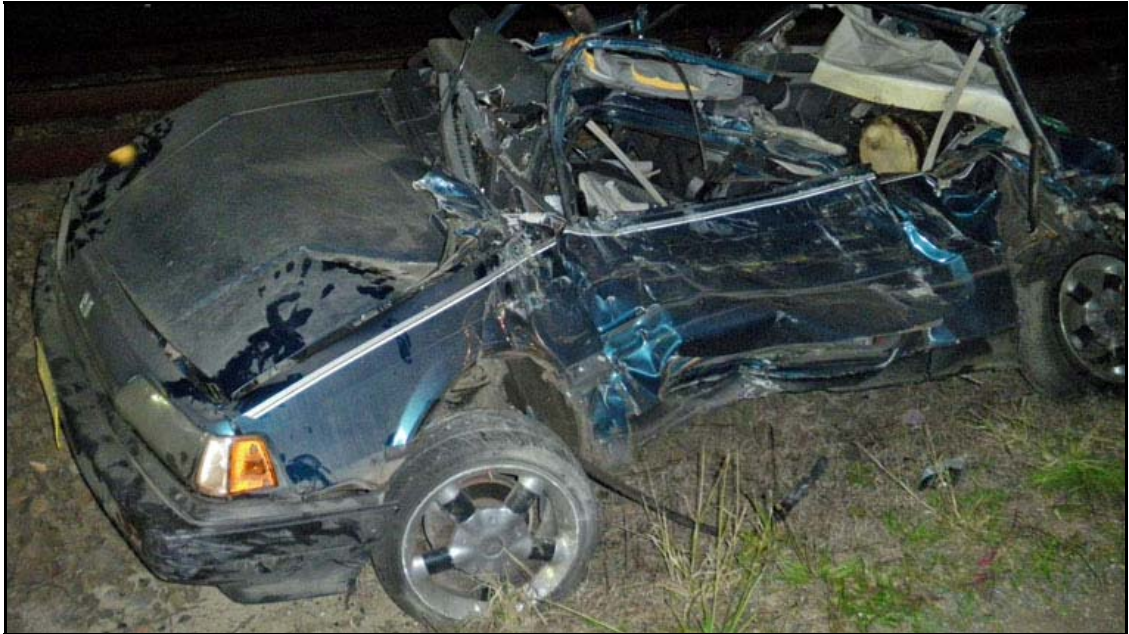
Photograph 5: Damage to RMV

- 1.28 After completion of a site inspection by RailCorp personnel and the OTSI investigator at 9.20pm, the RMV was towed from under 289G. At 10.10pm, after temporary repairs were completed, 289G departed the site for stabling and further damage inspection at Gosford. The RMV, which was destroyed by the impact, was removed from the site by tow truck (see *Photograph 5*).

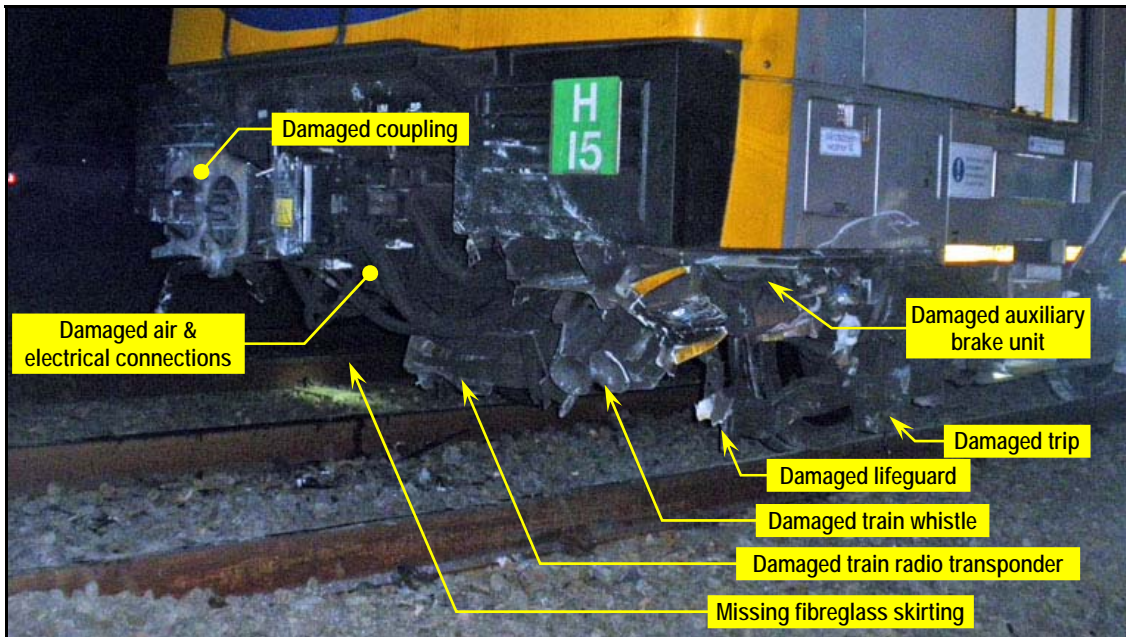
Photograph 6: Equipment damaged on leading car (6931) by the RMV

1.35 In spite of these systems, it was observed that, after the impact, the RMV had become wedged underneath the leading car (6931) of 289G and was pushed for 300 metres until the train came to a stop. It was also observed that the collision caused significant damage to various safety critical rolling stock components in the headstock region of the car, including couplings, communications equipment and brake equipment (see *Photograph 6*). Fortunately, the RMV did not break up during the incident and derail the train.

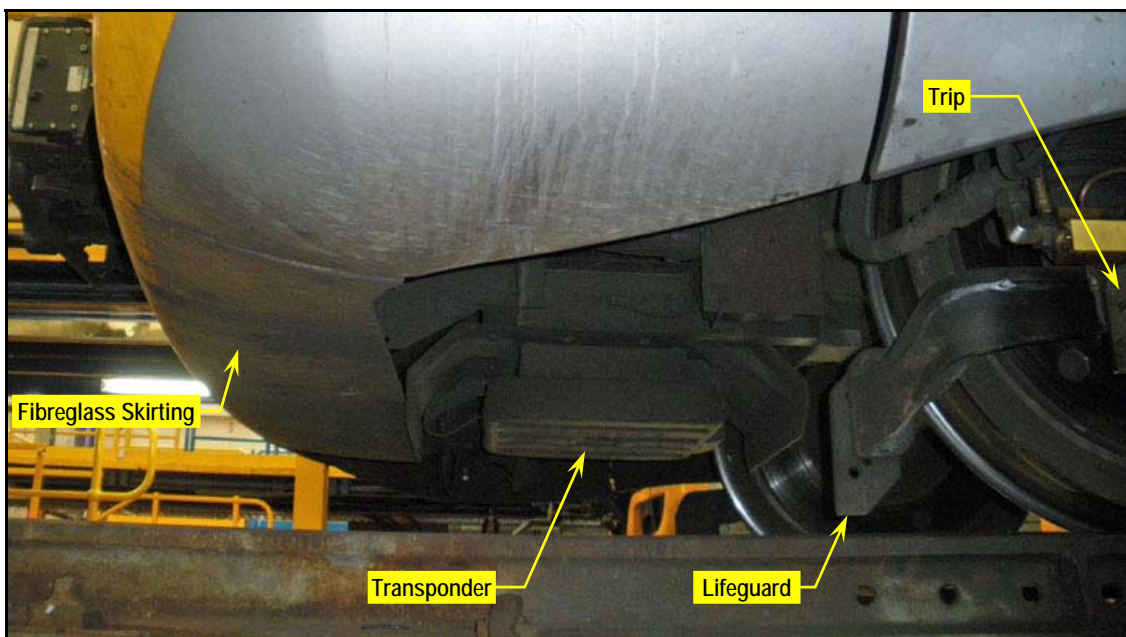
Photograph 7: Front underfloor arrangement of OSCAR EMU

1.36 Although OSCAR EMU sets are constructed to current international rolling stock engineering standards, it was observed that lifeguards, designed to clear only small obstacles or debris from the path of the train wheels, were mounted to the frame of the leading bogie to provide obstacle deflection and protection to the train wheels (see *Photograph 7*). No body-mounted obstacle deflection is fitted to the rolling stock to clear larger obstacles, e.g., RMVs, rocks, shopping trolleys, bicycles, trees or animals, from the path of the train.

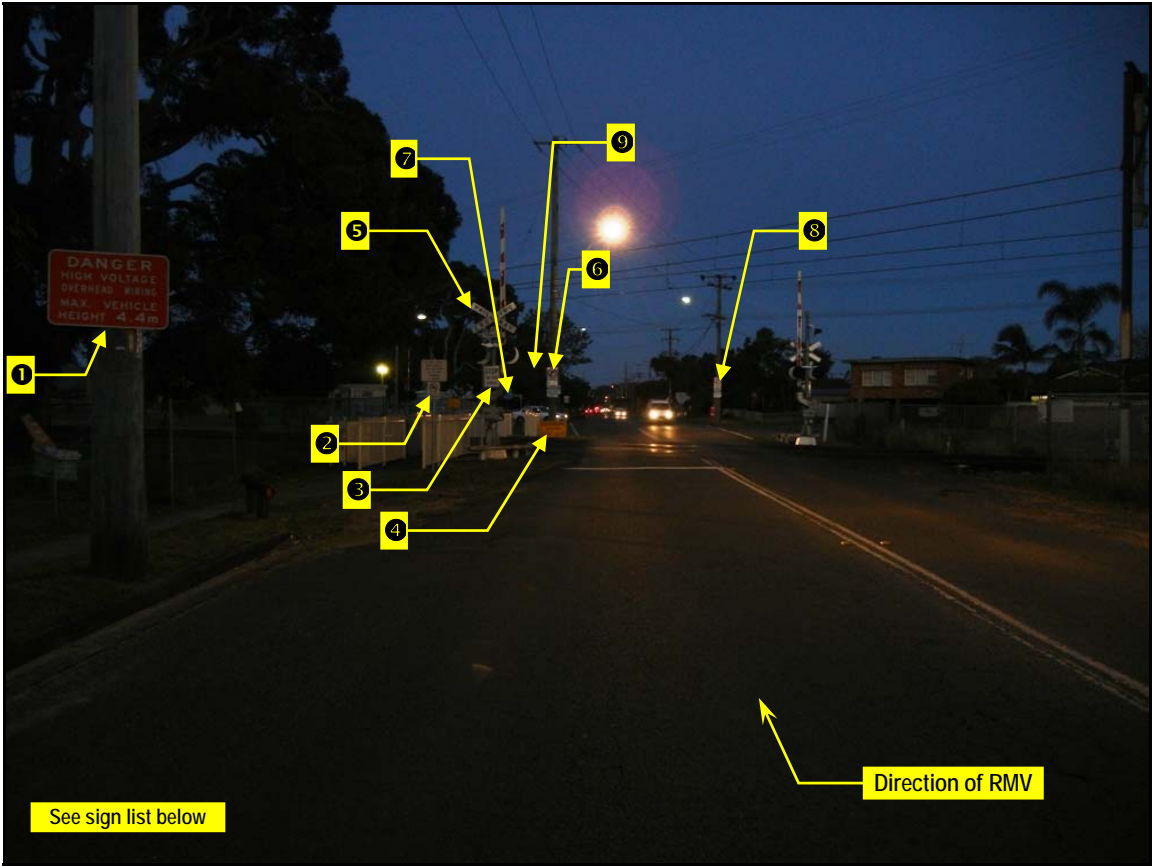
Photograph 8: Signage at RMV’s approach to crossing (dark conditions)

the road amongst many off-road visual distractions that were also in the RMV driver’s field of vision at the time, e.g., fencing, bus shelter, trees.

- 1.46 The first of these signs was positioned near or at his point of decision and, given his state of disorientation and heightened concentration, most likely caused an information overload that reduced the available time for him to decide when to turn his vehicle. Further, not all the signs in the RMV driver's view were relevant to road users; one providing directions for pedestrians and cycle riders using the pedestrian crossing.
- 1.47 While recognising the need to conform to the applicable Australian Standard for level crossing signage, the responsible authority should minimise signage and consider the overall visual environment presented to the driver approaching level crossings.

- 2.2 The number and variety of signage positioned in the vicinity of the crossing created information overload. [*Recommendation 3.1*]
- 2.3 There were no road markings providing a clear delineation of the roadway inside the rail corridor at the crossing. [*Recommendation 3.2*]

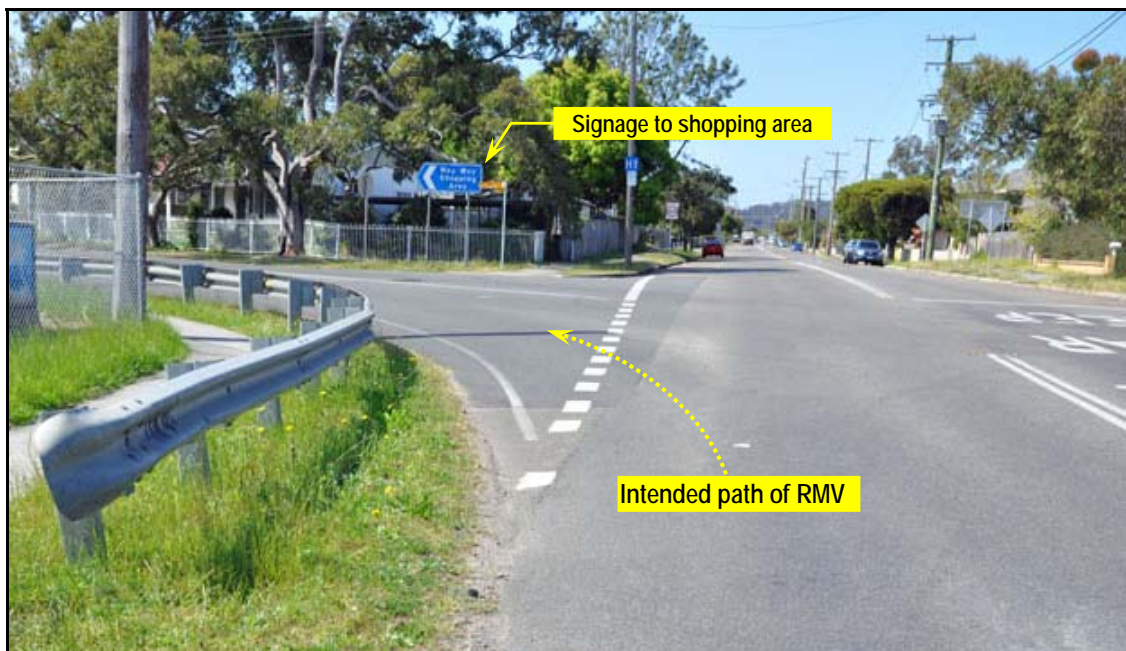
Photograph 9: Intersection and signage to Woy Woy Shopping Area

- 1.48 Although on a major thoroughfare, the sign indicating the direction to Woy Woy Shopping Area was positioned after the crossing and did not give the RMV driver any advance indication of the information he was seeking (see *Photograph 9*). Being unfamiliar with the area, looking for directions and street signs is likely to have diverted his attention from the road to trying to comprehend the information on the various signs.

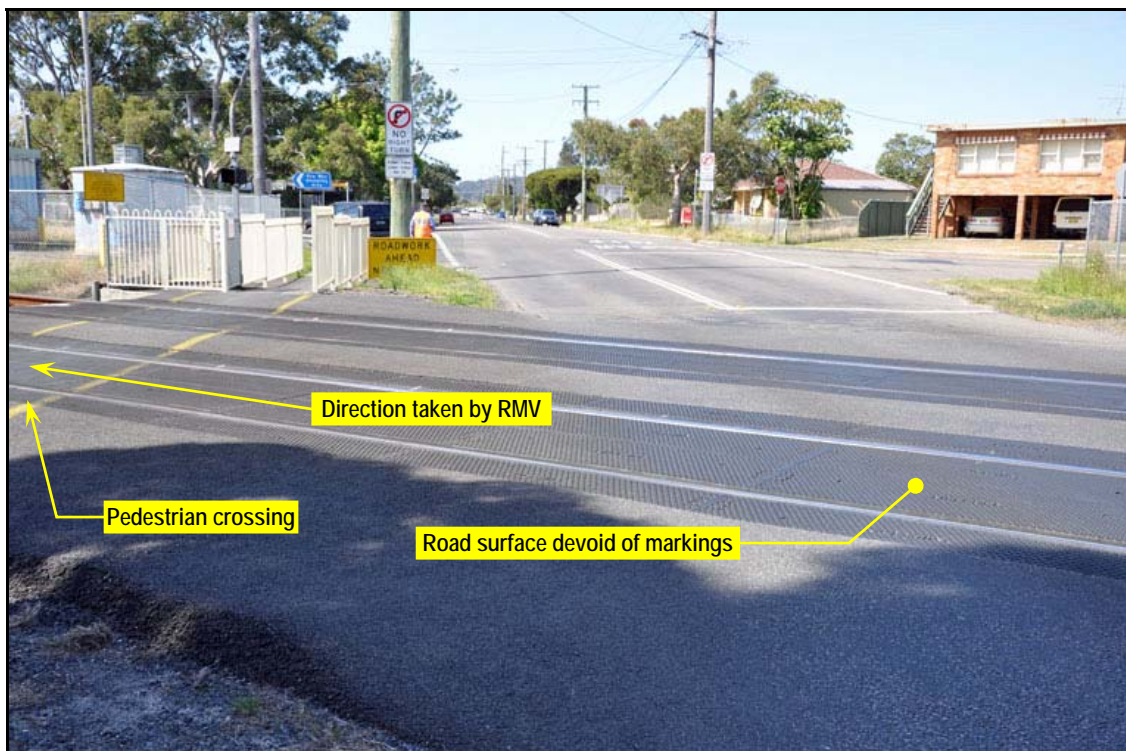
Photograph 10: Crossing surface devoid of road markings

- 1.50 The road markings conformed to AS 1742.7 with the crossing approach and exit marked with double white lines and kerbing on the Western side of the rail corridor to give lane delineation. However, there were no road markings within the rail corridor to provide visual continuity of the laneway over the crossing (see *Photograph 10*). The kerbing ceased prior to the boom gates and there was no kerbing between the Eastern side of the rail corridor and the Railway Street intersection. The only markings in the corridor were those which delineated the pedestrian crossing and these were in a worn state.

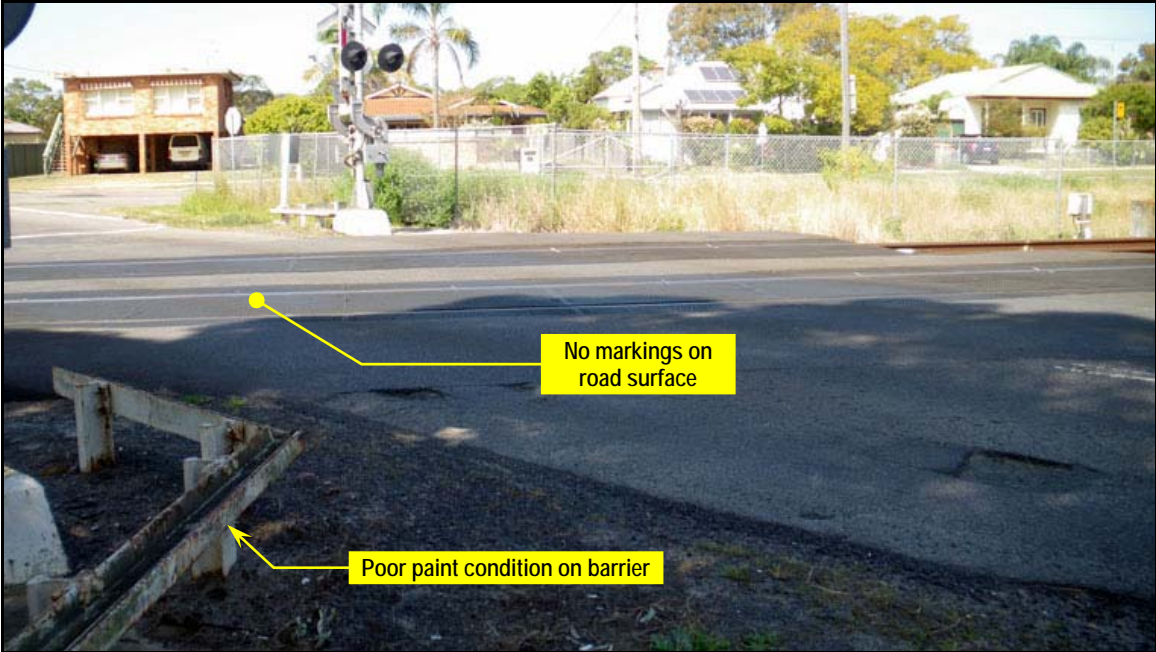
Photograph 11: Condition of barrier paintwork and road surface inside rail corridor

Further, the condition of the paintwork on the protective steel barrier surrounding the boom gate mountings was poor and reduced its visual impact (see *Photograph 11*).

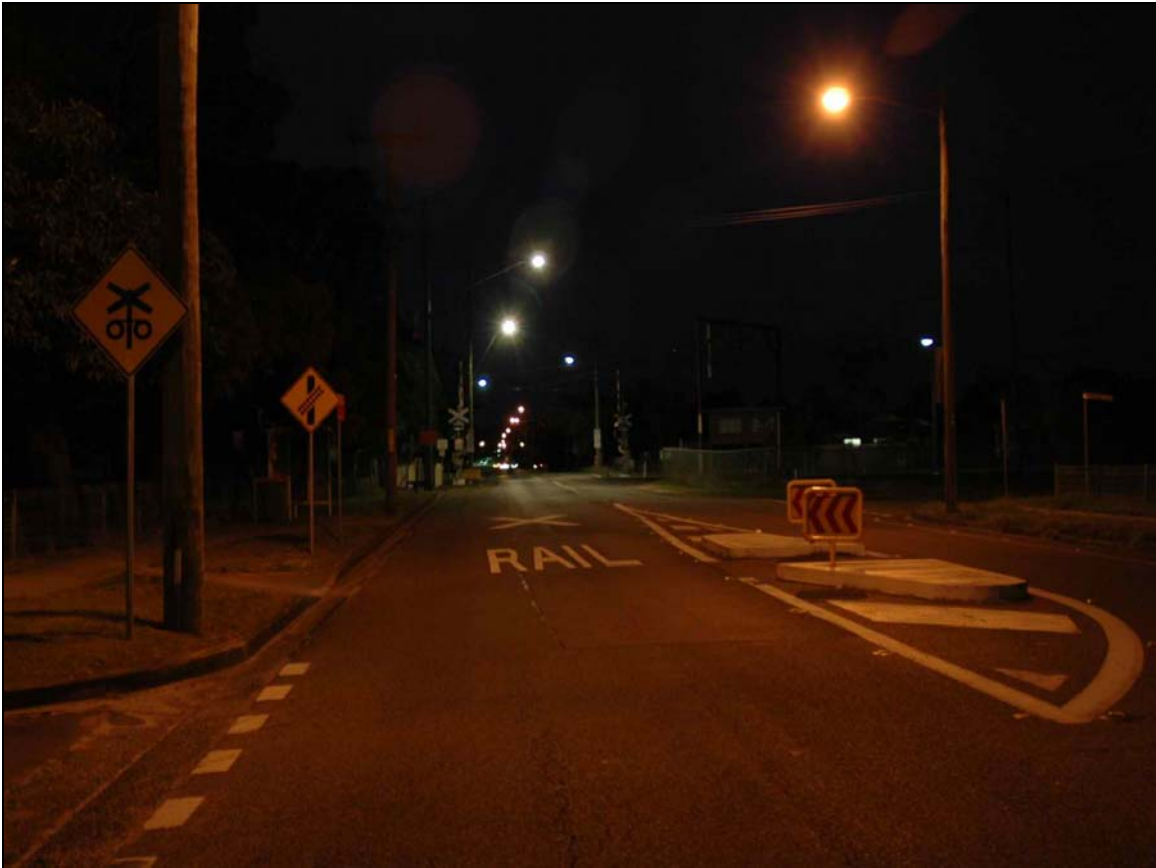
Photograph 12: Night time view of approach signage and pavement marking

1.52 The 'Rail X' pavement marking, as required by the Standard, was present approximately 60 metres before the crossing (see *Photograph 12*) in a serviceable condition and with good visual impact. The stop line was also present prior to the boom gate and in a serviceable condition.

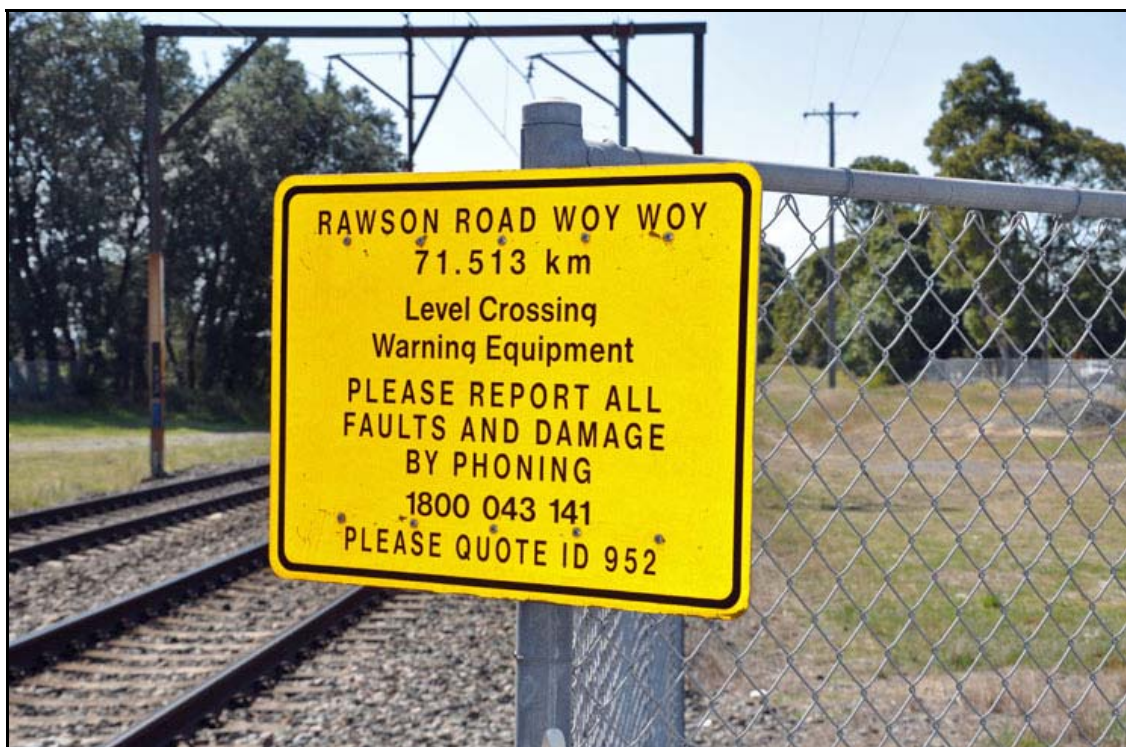
Photograph 13: Information signage for reporting defective level crossing equipment

1.53 Signage at level crossings throughout the Network provides contact information for persons to report malfunctioning or damaged level crossing equipment (see *Photograph 13*). However, passers-by on the night commented that the signage did not provide any relevant contact information or details in its script for reporting emergencies. While the telephone number listed on the sign is manned 24 hours, seven days a week, it is not direct to the RMC but to the Infrastructure Operating Centre. The operator is required to act as a third party to relay any reports or information of accidents or emergencies at the crossing to the Train Control area in the RMC. As such, valuable time could be taken in providing immediate alerts to trains in the area.
