Safety Advisory SA04/23

Managing fire risks on domestic commercial vessels

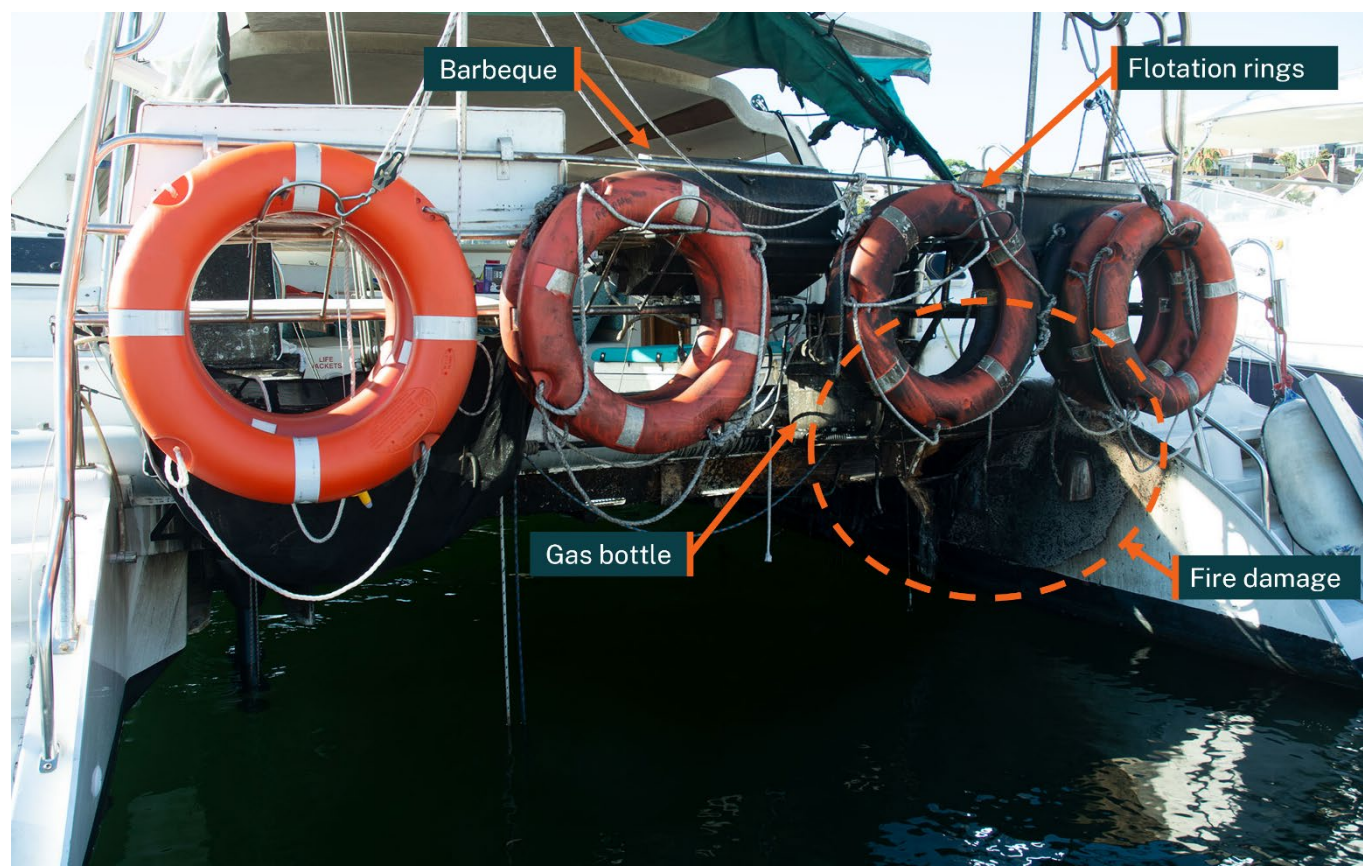
The Office of Transport Safety Investigations (OTSI) inspected the vessel and identified that the fire had started in the starboard engine compartment. The starboard engine fell from the vessel into the harbour as a result of the fire.

- flotation rings were stored near the barbeque and gas bottle which would make retrieval difficult if the barbeque caught fire (Figure 1). Smoke and flames from the engine fire also prevented access in this incident

Figure 1: Flotation rings and fire damage

Source: OTSI. The image was modified to remove the vessel identification number from the flotation rings for the purposes of the Safety Advisory. The fire damage to the hull where the starboard engine caught fire is highlighted.

- storage of safety equipment in a readily accessible area
 - provision of safety equipment at the muster point.
- Ensure all crew are trained/inducted in these emergency procedures, are aware of the vessel's safety equipment, and how to access and use this equipment during emergencies.
