Safety Advisory SA03/23

Securing bus batteries, cabling and protective covers

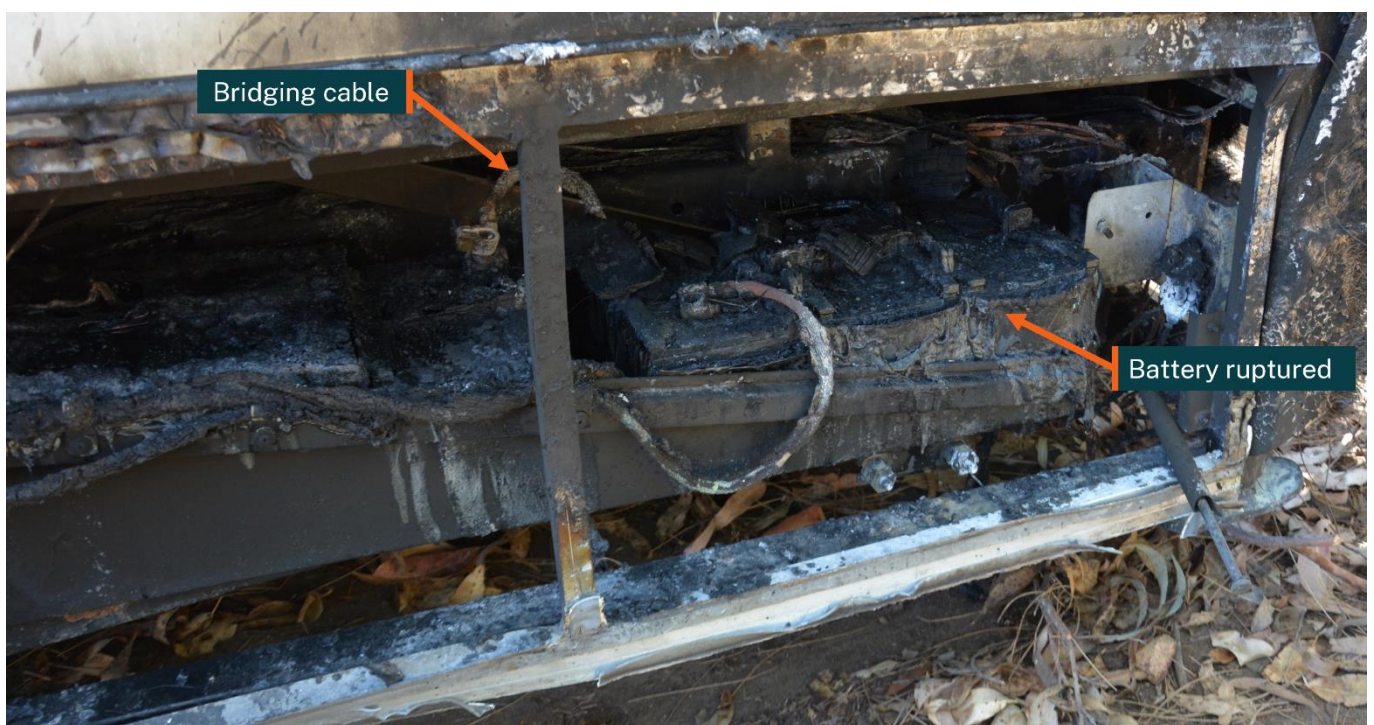
Figure 1: Umina Beach bus fire battery compartment

One battery was found to be missing the top cover and the sides were deformed outwards at the top, likely the result of the battery exploding (Figure 1). The battery bridging cable showed marks consistent with arcing on the battery compartment frame. It was unclear if this was the cause or

consequence of battery failure and fire. OTSI inspected two other buses of the same model and found that the configuration of the battery bridging cable increased the risk of the cable rubbing on metal components (Figure 2) which can result in cable abrasion. The loud ‘bang’ that the driver and resident heard was likely the battery exploding.

- battery mounting bracket became loose with the bridging cable abrading and short circuiting to the frame;
- bridging cable installed in a position that could have abraded and short-circuited to the frame; and/or
- internal battery fault.

- Refer to the OEM standards as applicable, ensure mechanics and staff have sufficient guidance and training to correctly position battery cables and mounting brackets.
- Inspect their fleet battery terminals, cables, mounting brackets and packing and secure/replace if loose or incorrectly placed.
- Replace/repair any damaged cables and mounting brackets.
