# Safety Advisory SA05/23

## Close quarters situations in the Sydney Harbour area

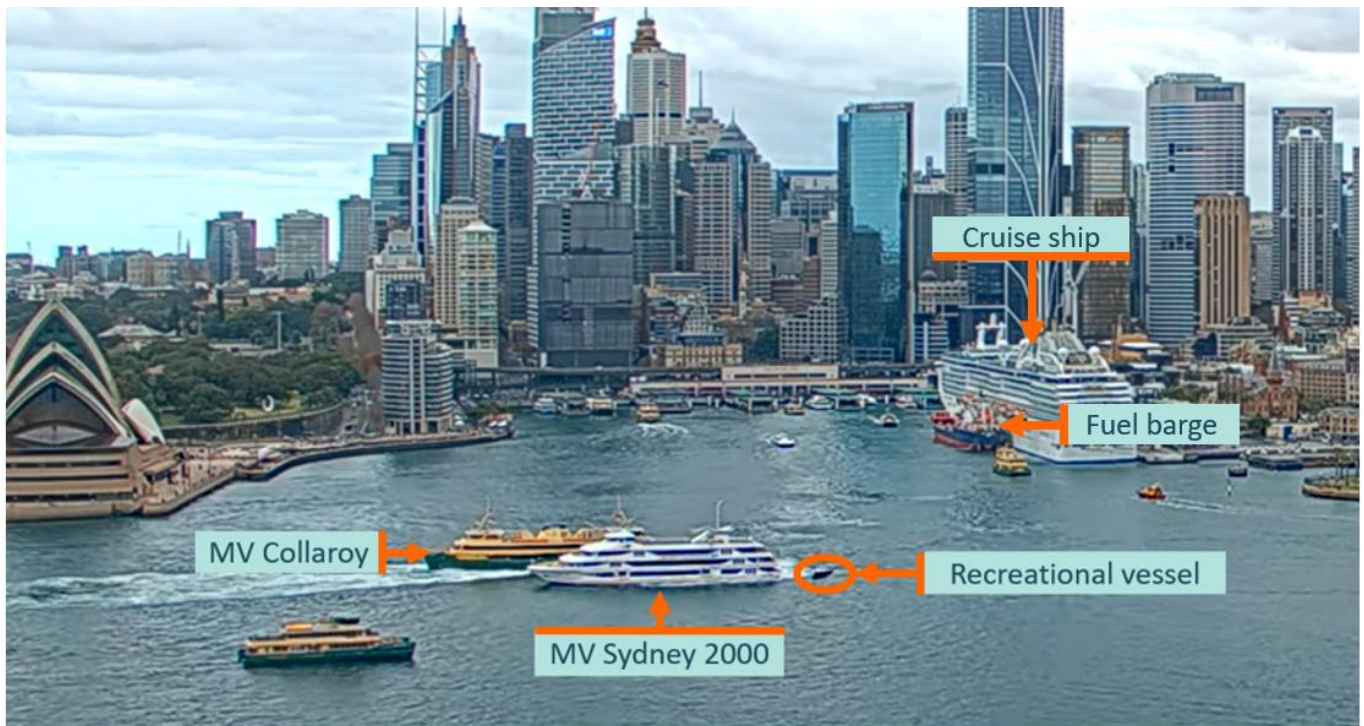
On the afternoon of Sunday 4 June 2023, there was a close quarters situation involving MV Collaroy, which was conducting a timetabled ferry service, and a charter vessel, MV Sydney 2000. MV Collaroy was tracking from the west to enter Sydney Cove and MV Sydney 2000 was departing Sydney Cove for a route to the east.

As the vessels approached each other, both Masters performed avoidance manoeuvres, with the vessels coming into close proximity. As the two Masters manoeuvred to avoid collision, a third vessel, a small recreational craft, narrowly avoided colliding with MV Sydney 2000. There were no reported injuries or damage to any vessel.

With differing plans and expectations between the two Masters, the distance and proximity between the vessels reduced. When it became apparent to each Master that the other was not tracking as expected, both Masters manoeuvred to avoid a collision.

**Figure 1:** Close quarters situation near Sydney Cove, 4 June 2023
