Bus Safety Investigation Report

Bus fire m/o9340 — Lane Cove Tunnel, 14 April 2022

Investigation Reference I02024

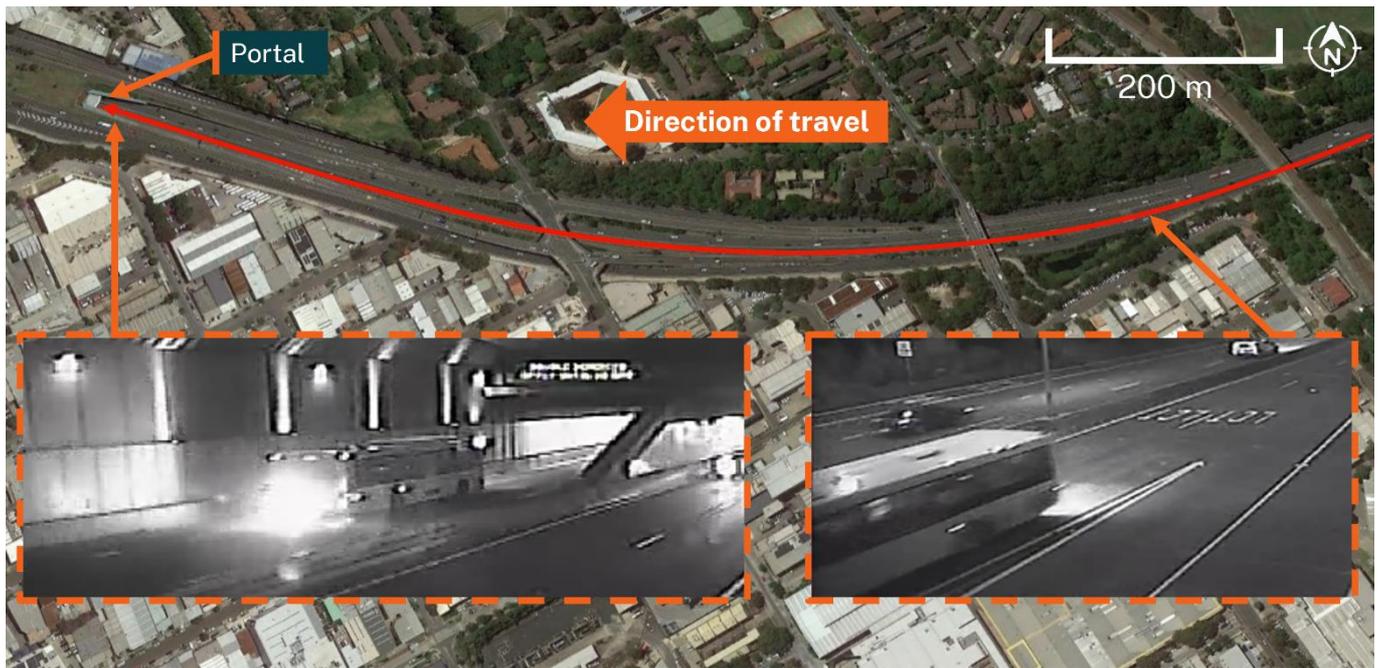
Figure 1: Approach of bus m/o9340 towards the Lane Cove Tunnel

- 1.5 At 2012 bus m/o9340 entered the LCT portal while on fire (Figure 1). A passenger on the rear seat was recorded on the bus CCTV waving their hand in front of their face before partially covering their face with a piece of clothing. Shortly after, that passenger appeared to have observed flames through the window of the bus and alerted the driver and other passengers.

The image shows the path travelled by bus m/o9340 before entering the tunnel in Lane 1. The two inset images show the fire as viewed from the roadside cameras, initially as glowing on the road surface and then visible flames at the rear of the bus as it was entering the tunnel.

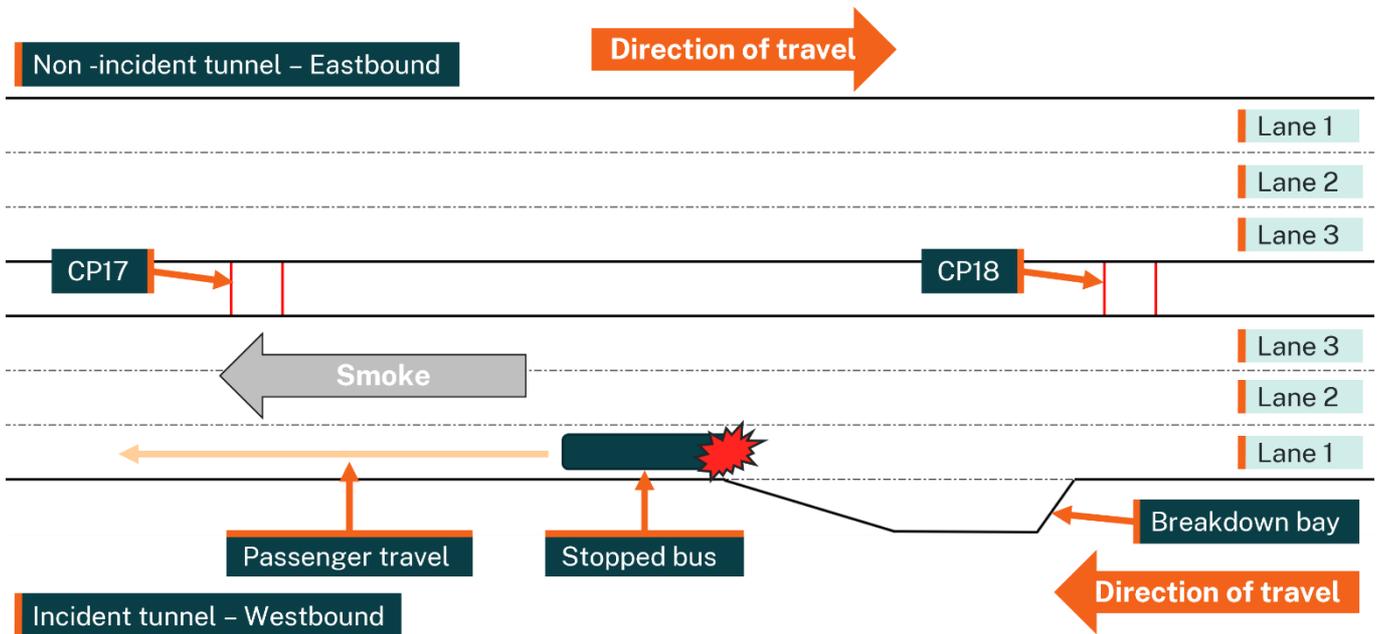
Figure 2: Bus stopping location

The diagram shows the stopping location of the bus relative to the breakdown bay and cross-passages 17 and 18. The cross-passages are shown as CP17 and CP 18 which connected the incident and non-incident tunnels. The area upstream of the fire was free from smoke.

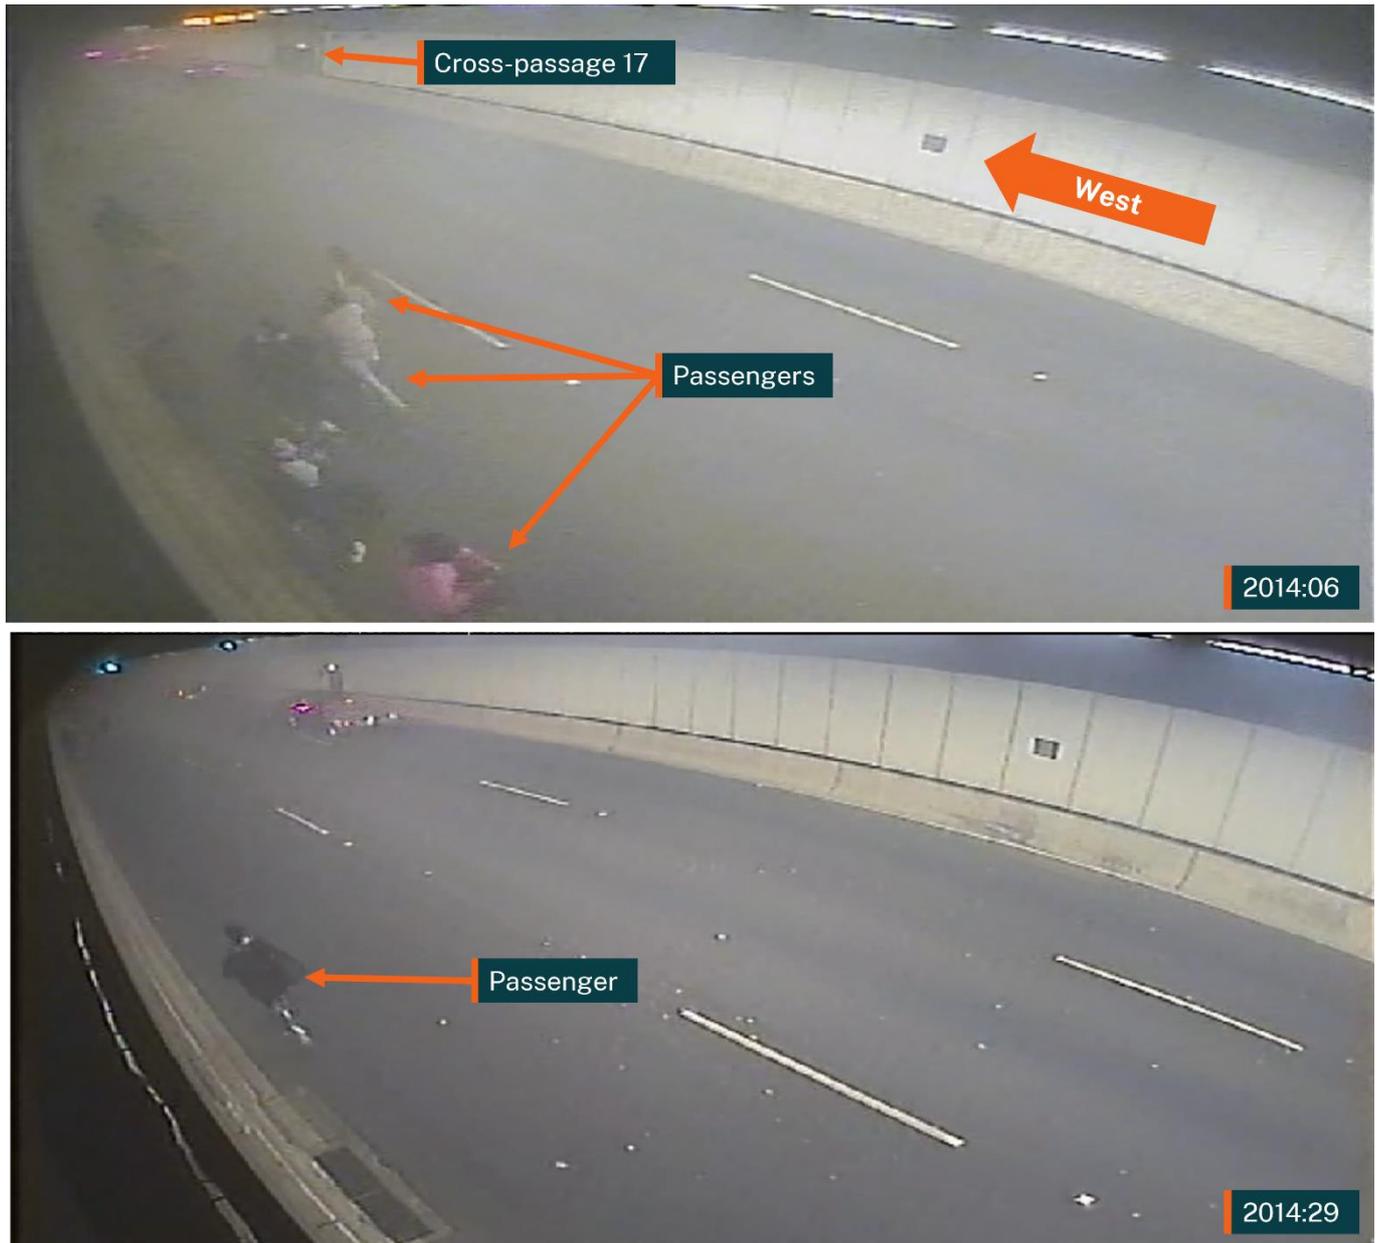
Figure 3: Passenger movements

The upper image from camera TVR747 shows the passengers walking immediately ahead of the bus in Lane 1, with cross-passage 17 visible in the distance. These pedestrians were not detected by tunnel pedestrian detection systems. The lower image from camera TVR746 showing a single passenger after they had walked approximately 60 m further along the tunnel and west of cross-passage 17. This passenger triggered the alarm to TCRO's which initiated the emergency response.

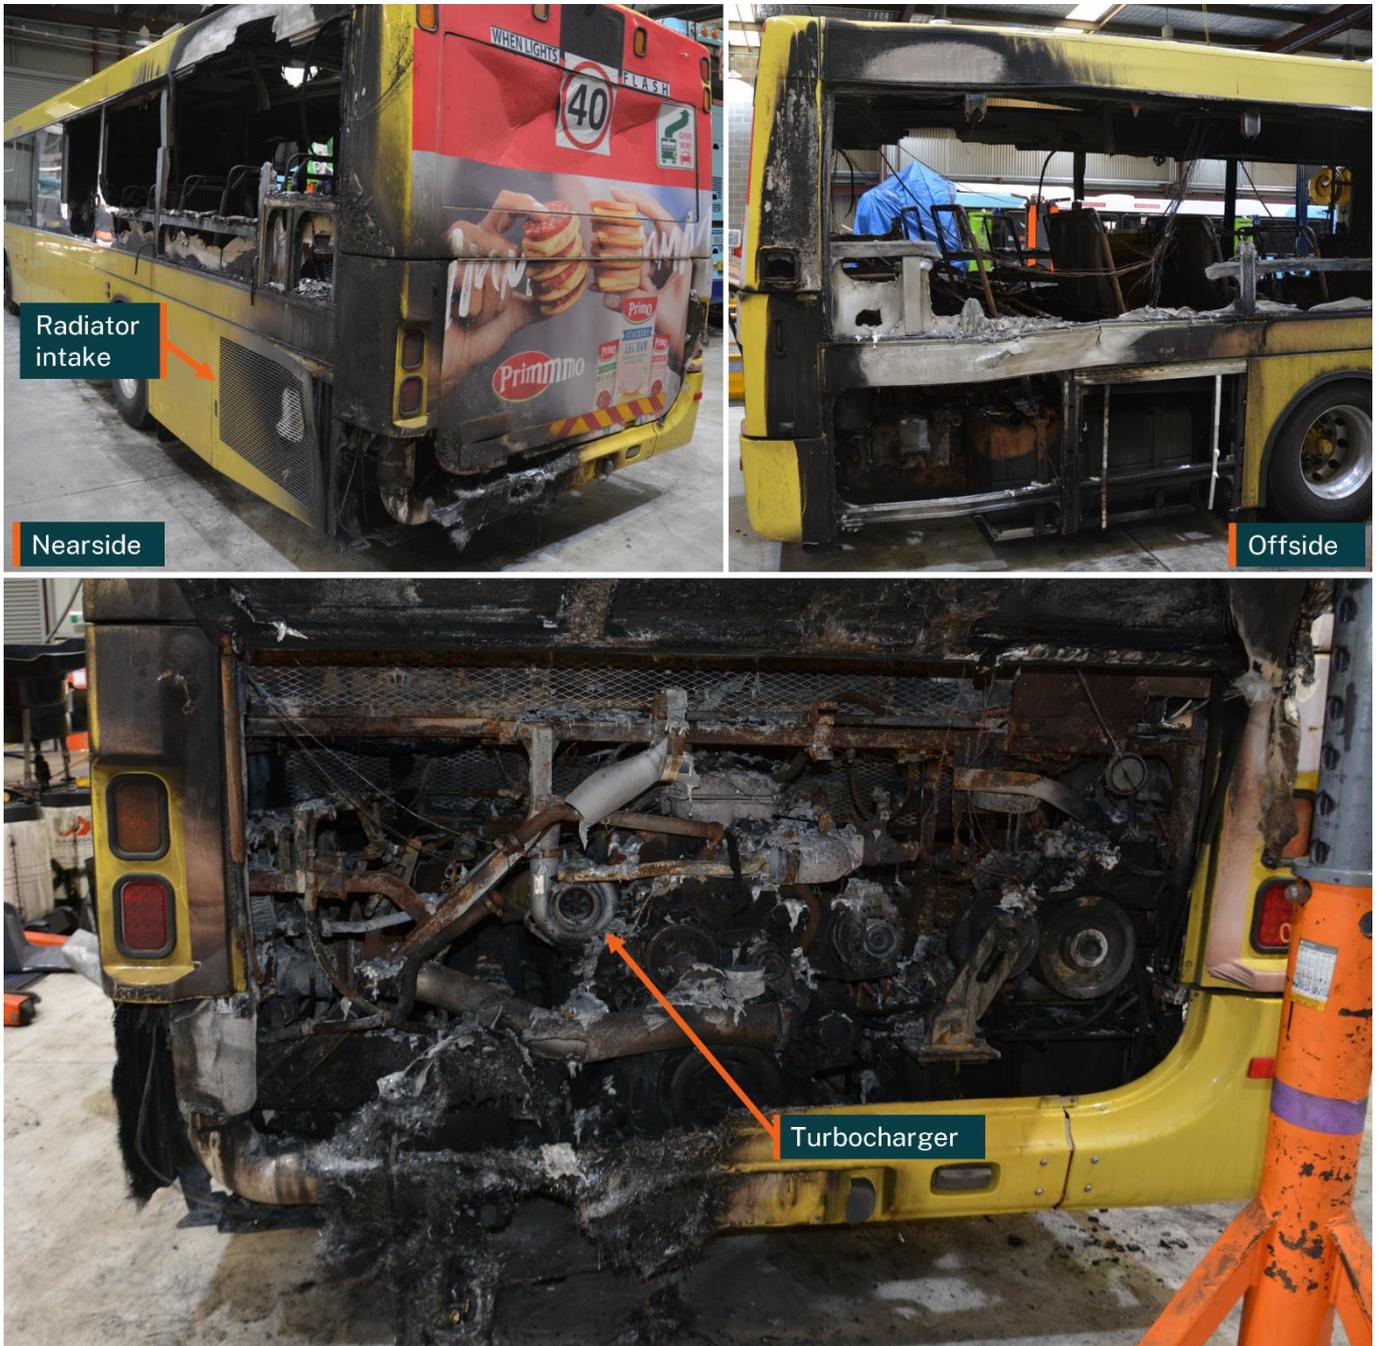
Figure 9: Bus m/o9340 fire damage

- 2.4 The engine bay was significantly damaged due to the intensity and duration of the fire (Figure 9). The bus burnt from at least 2011:33 until around 2045 when the deluge system was turned off.

- 2.5 On the nearside of the engine, coolant pipework and the hydraulically driven cooling fan were positioned. While the engine was running, both systems and associated fluids of coolant and hydraulic oil were pressurised. Any leaks of either oil or coolant near a hot surface or other source of ignition can cause a fire. The cooling fan would possibly blow a fluid leak on the nearside across the engine bay exhaust and turbocharger (Figure 9).

- 2.6 Inspection of the hydraulic fan motor and pipework found that it was heat affected with damage to the flexible hydraulic hosing although there were with no obvious signs of a high-pressure leak. The investigation could not eliminate the possibility of a leak at a fitting or seal.

- 2.8 There was no high amperage electrical wiring on the nearside of the engine bay. Inspection of the electrical wiring on the offside did not identify any arcing or short circuits. The starter motor and battery cables were damaged in the fire but there was no arcing or spalling on the cables.

- 2.9 It is extremely unlikely that the source of the fire was a fuel leak (diesel) or electrical fault in the engine bay as the bus operated, while on fire, for at least two minutes, with no reported or observable loss of power. Furthermore, an oil leak from the engine was unlikely to have initiated a fire as the oil was near full after the fire, with approximately 35-38 L remaining.

- 2.10 Due to the extent of the damage, it was not possible to determine the source of the fuel that initiated the fire beyond either hydraulic oil or coolant. The ignition source was likely a hot

surface (turbocharger or exhaust) as there were no other significant heat sources near the fire initiation point.

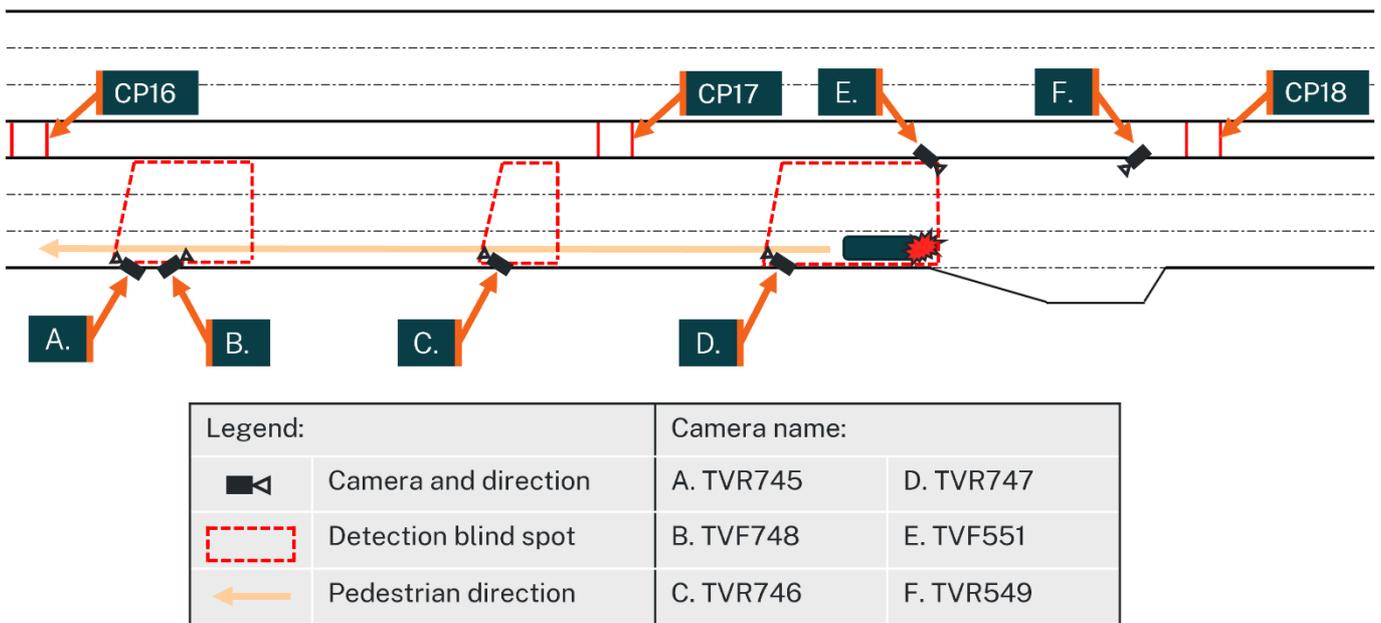
Figure 10: Westbound tunnel with camera locations and detection blind spots

2.37 The configuration of the CCTV within the tunnel provided visual coverage for the entire tunnel, although, it was found there was not the same coverage for the automatic visual incident detection system (AVIDS). Traffic events could occur between the AVIDS detection zones along the tunnel without the TCROs being alerted to the incident. The detection blind spots for the Westbound tunnel between cross-passage 16 and 18 are shown in Figure 10. Based on the configuration and positioning of the cameras used for the AVIDS, it is likely that there were similar detection blind spots along both tunnels.

The diagram (not to scale) shows the stopping location of the bus and movement of the pedestrians relative to the camera positioning and cross-passages (CP). The approximate detection zone blind spots are shown for the section of the westbound tunnel between CP16 and CP18 which was over a distance of about 240 m. The forward-facing cameras B and E did not have AVIDS capabilities.

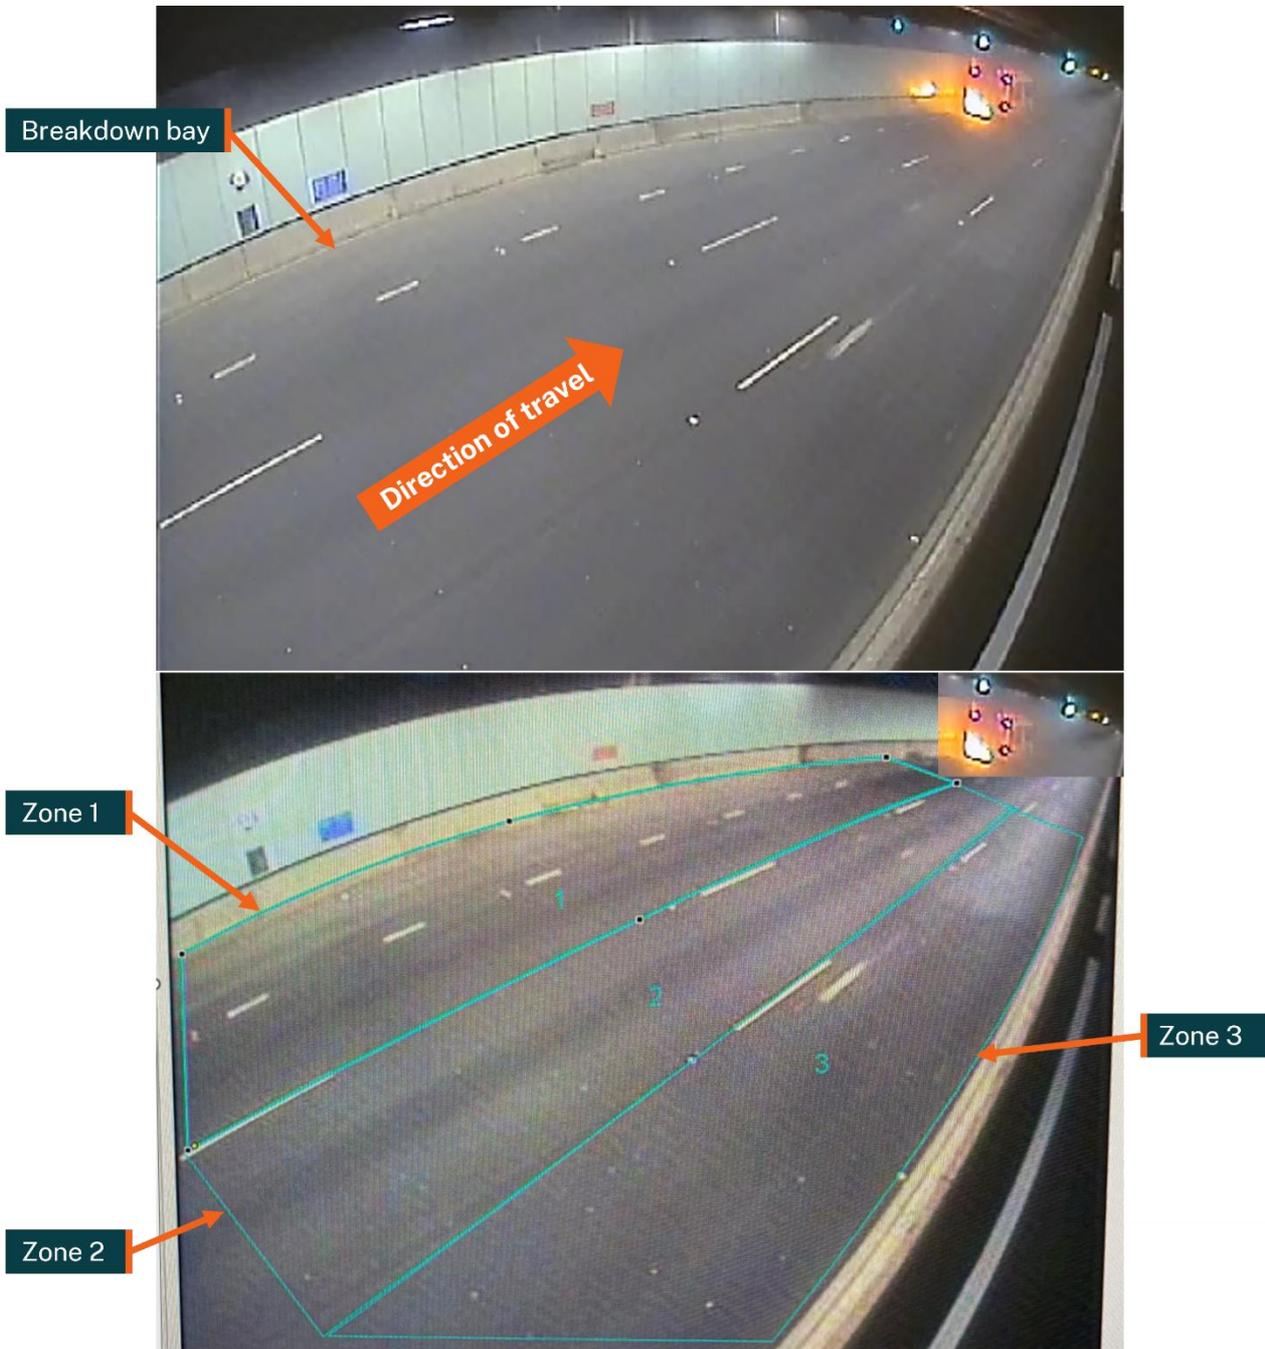
Figure 11: Bus stopping location and stopped vehicle detection zone

2.41 Had the bus stopped within a detection zone, it is probable that the TCRO's would have been alerted to the bus and fire after about 15 seconds. Instead, the stopped bus and fire was not detected for almost 3 minutes.

The upper image shows the bus stopped in the tunnel as seen from camera TVR549. The lower image shows the stopped vehicle detection zones with the stopped bus overlaid on the image.

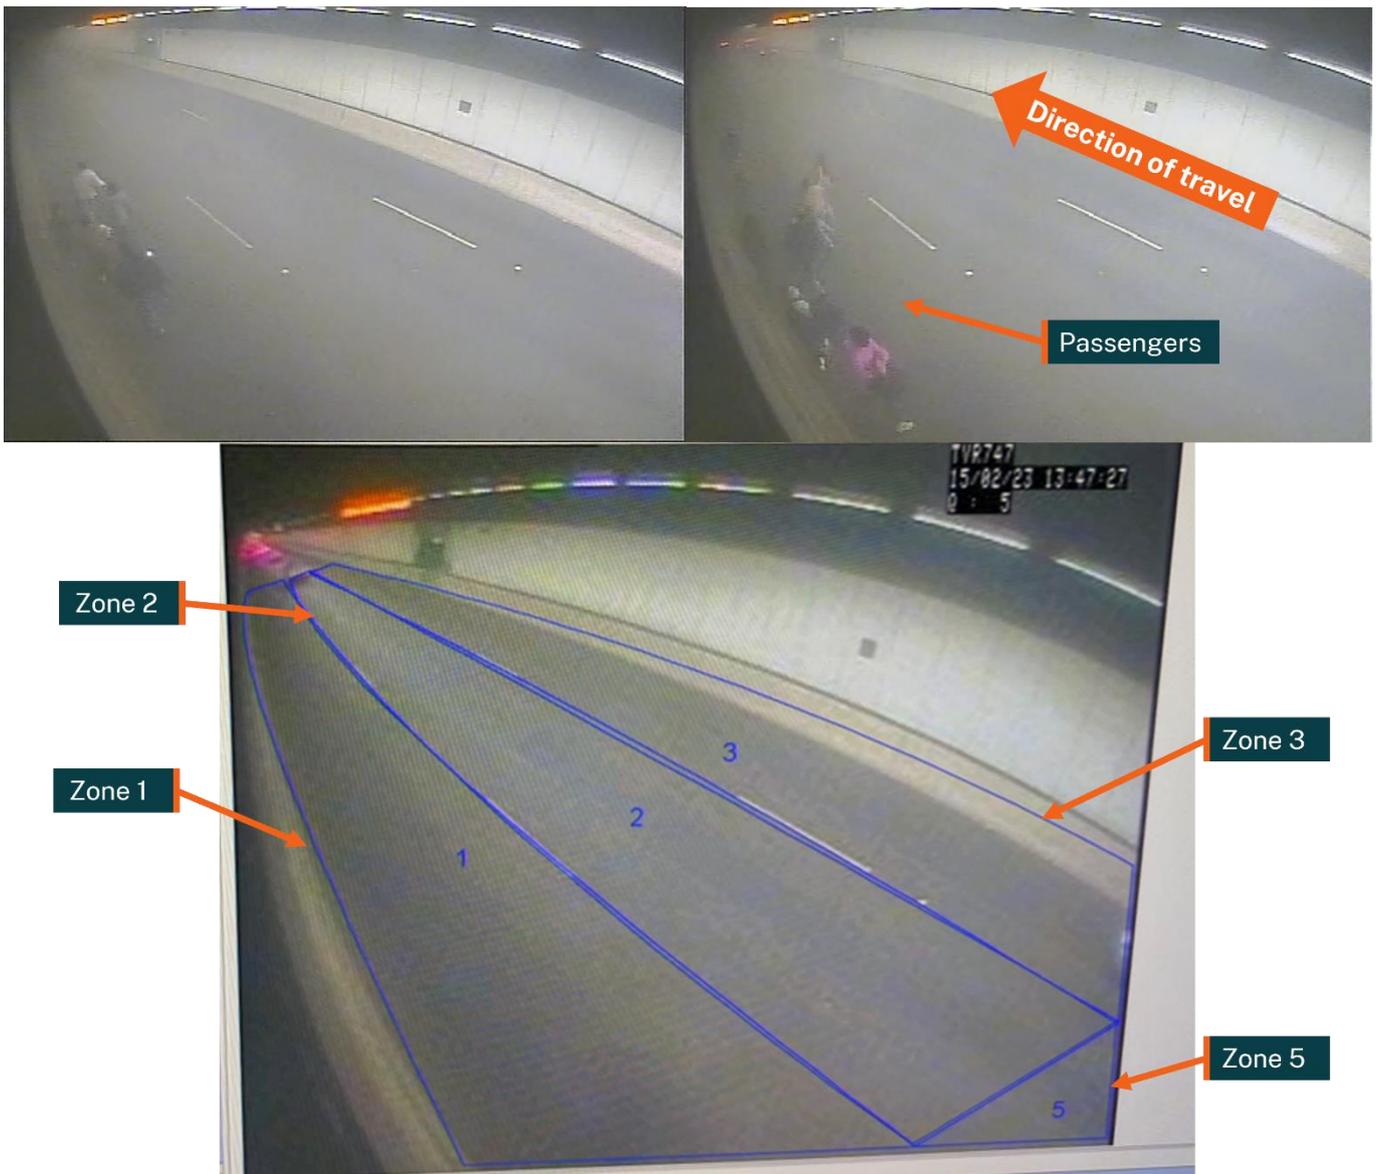
Figure 12: Pedestrian movements and pedestrian detection zone

The upper images shows the pedestrians that were not initially detected as seen from camera TVR747 with the lower image showing the pedestrian detection zone for the camera.

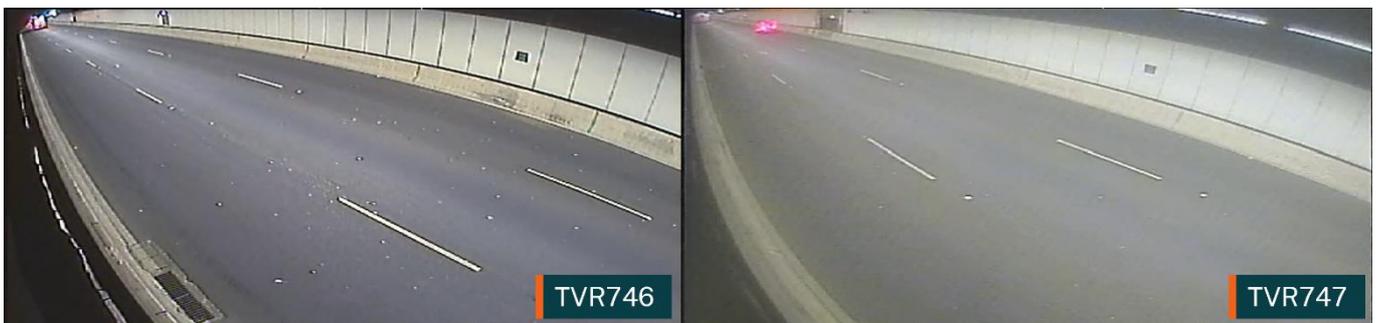
Figure 13: Camera image comparison between TVR746 and TVR747

- The video quality for the camera TVR747 was less than camera TVR746 that detected some pedestrians about 30 seconds later (Figure 13). The system had the ability to provide camera quality ratings, although the quality rating at the time of the occurrence is not known. Post incident the camera was found to have reduced image quality of 5 out of 10.
- Smoke from the fire was visible and can affect the detection capabilities of the AVIDS which relies on differences and changes in pixels between video frames.
- The detection of pedestrians requires their feet to be visible in the frame and where multiple persons are moving closely it would be more difficult for the system to detect the individual pedestrians. Additionally, objects larger than 2 m are not considered as pedestrians and the multiple persons likely appeared larger than the threshold for pedestrians.

The image on the left shows the recorded video from camera TVR746 prior to the fire compared to image on the right for camera TVR747 at the same time.
