Bus Safety Investigation Report

Bus Fire 2169ST Camperdown, NSW
13 January 2022

Published
November 2023

Investigation Reference I02019

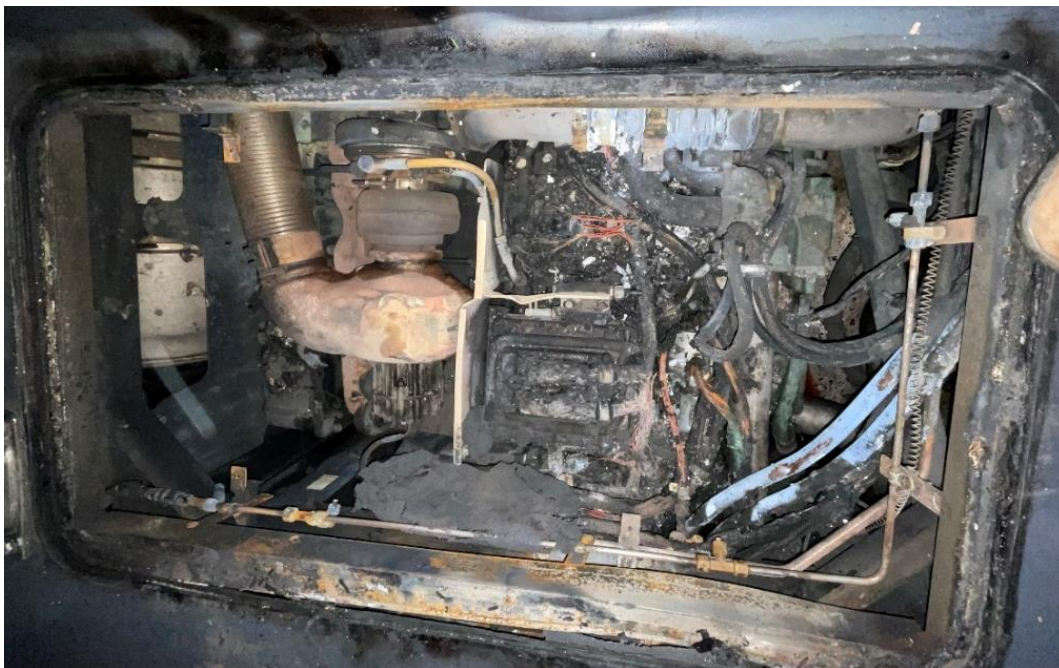
Figure 6: Damage to engine assembly viewed from interior access panel

- 1.34 The fire was confined to the rear of the engine bay from approximately the area of the transmission to the rear of the engine bay causing considerable damage to the upper surface of the engine assembly and components located in the rear upper engine bay area (Figure 6).
- 1.35 Heat and flame damage was evident on the rear panels above the engine bay access hatch and the O/S rear engine bay access panel (Figure 7).
- 1.36 Examination of the engine bay found no evidence of residual oil or diesel fuel.

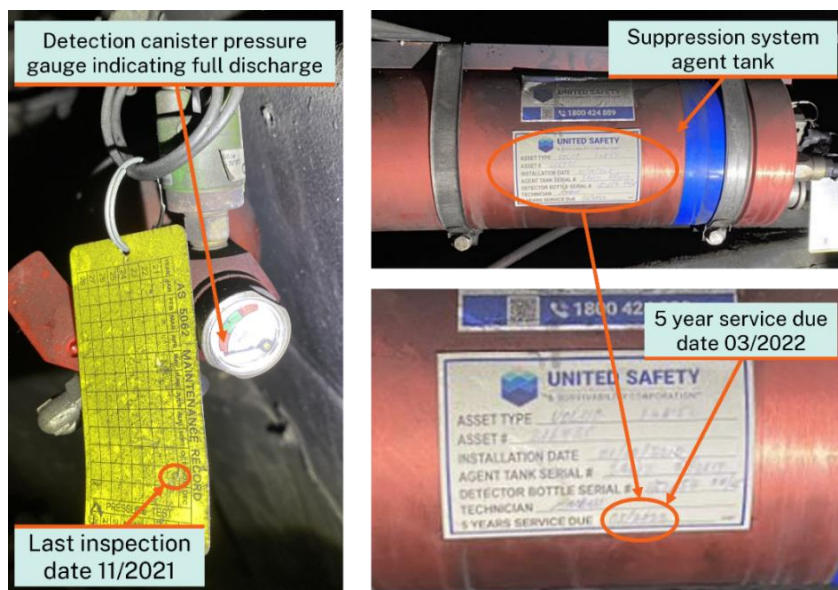
Figure 12: Fire suppression detection cannister and agent tank

- 1.53 The EBFSS was last serviced on 30 November 2021 in accordance with the six-month inspection criteria. The five yearly service and hydrostatic pressure check was due in March 2022. On inspection, following the incident, both the agent tank and detection canister had fully discharged (Figure 12).

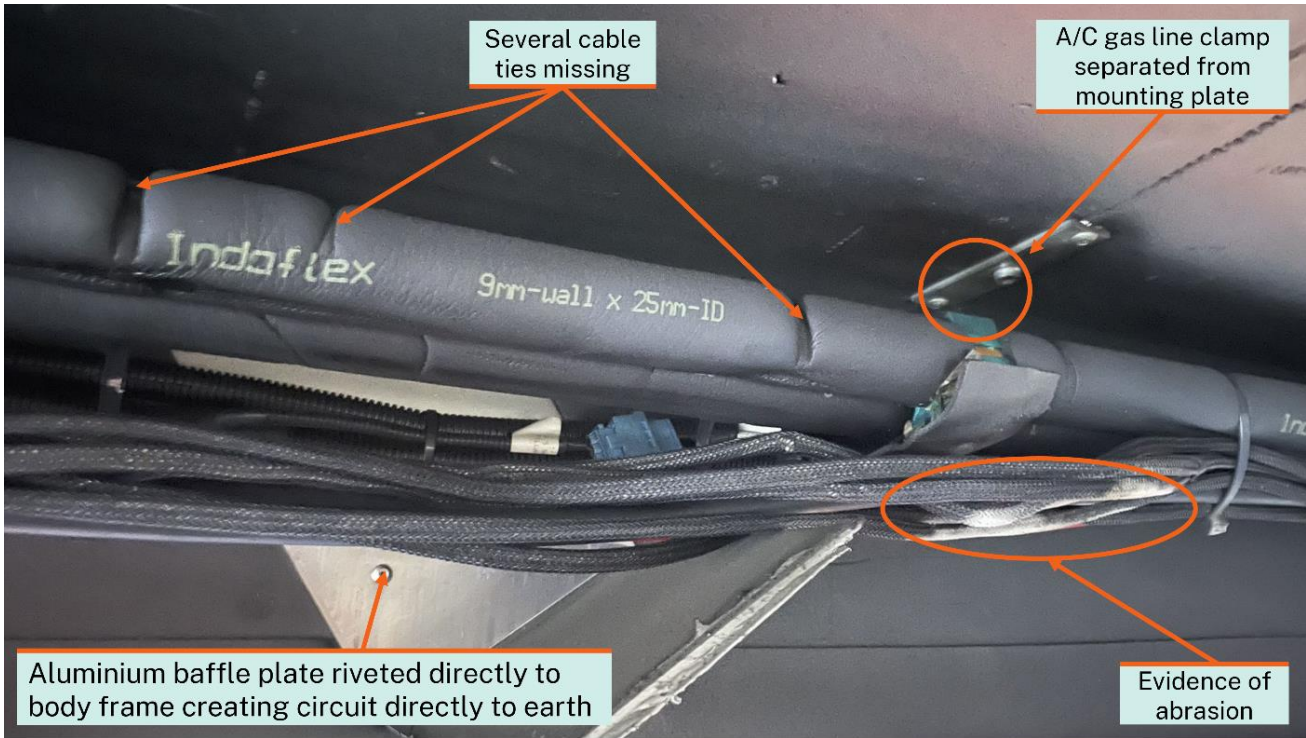
Figure 14: Unsupported A/C gas lines, A/C wiring and main feed cables

- 1.55 In this area, there were several wiring looms associated with the A/C system, saloon area wiring, and the main A/C gas supply and return lines. Examination identified that numerous cable ties were missing or had broken, over a section of wiring looms approximately four metres in length. The cable ties were designed to secure the wiring looms to the A/C gas lines (Figure 14, Figure 15).

- 1.57 Abrasion patterns from contact with other components were also observed on several of the cable bundles in this area and on the main positive feed cable to the A/C roof pod unit (Figure 14, Figure 16).

- 1.58 Also in the immediate area, the A/C gas line clamp securing bolt had dislodged from its mounting plate, which was still attached to the roof frame of the bus (Figure 14).

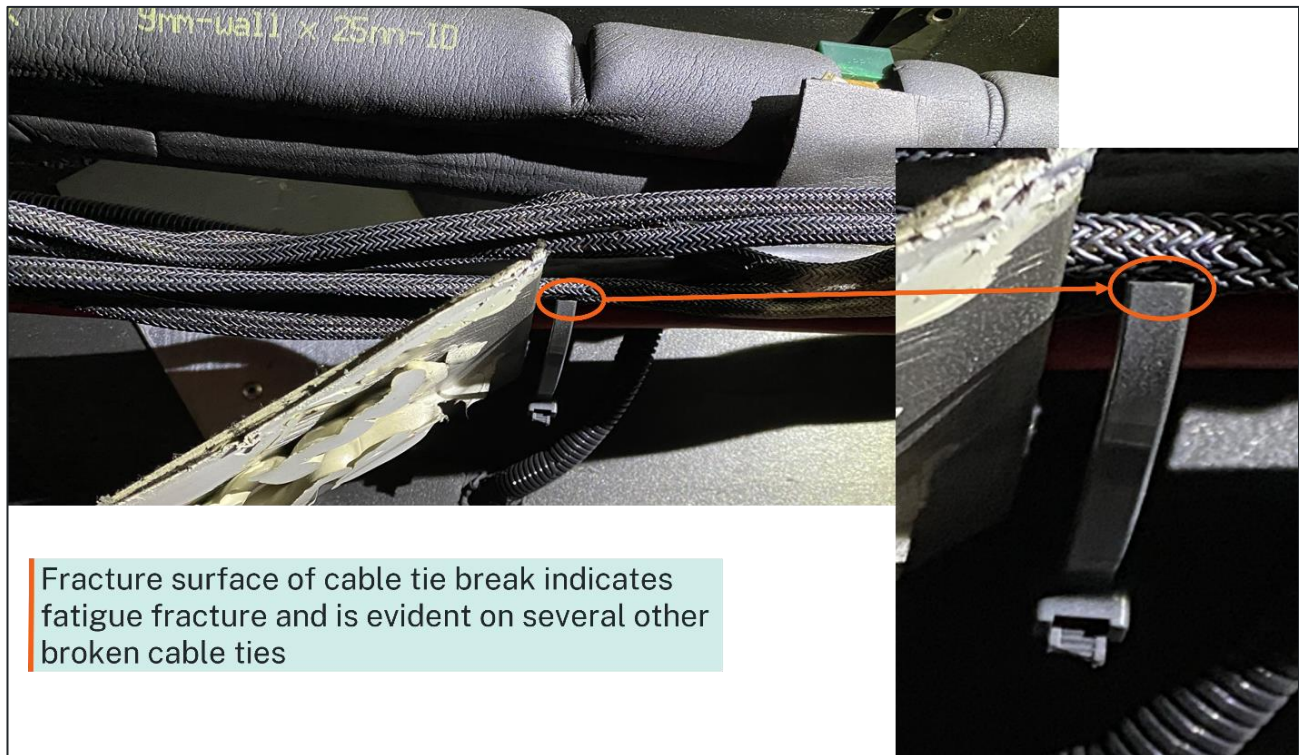
Figure 15: Broken cable tie supporting wiring loom

- 2.63 During the post incident inspection of 2169ST, the cable ties securing cabling in the O/S rear A/C duct were discovered to be fractured. This enabled the cables to chafe against several surfaces potentially exposing the cable conductor. Once exposed, the conductor can come into contact with metal surfaces increasing the risk of an electrical short circuit.³⁴

- 2.64 The fracture pattern of cable ties differed from those normally seen from the pattern found when cable ties are cut, such as with side cutters. However, the fracture surface observed was consistent with fatigue fracturing and embrittlement.³⁵

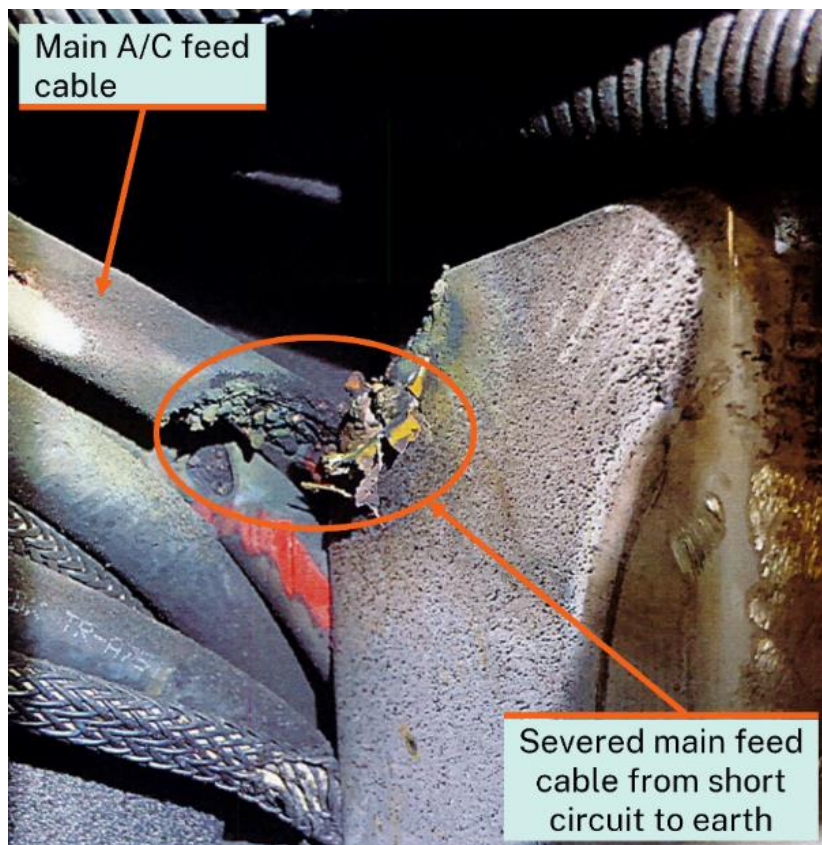
Figure 17: Cable abrasion between main A/C feed cable and saloon light loom

- 1.63 During the investigation, evidence was provided to OTSI that indicated other buses of this type, in the TSW fleet, had experienced main A/C cable abrasion. Figure 17 shows an example of the main positive A/C cable completely severed due to an electrical short circuit¹¹ between the cable conductor and the rear main body hoop frame. This area was immediately adjacent to where the cable abrasion was evident in bus 2169ST.

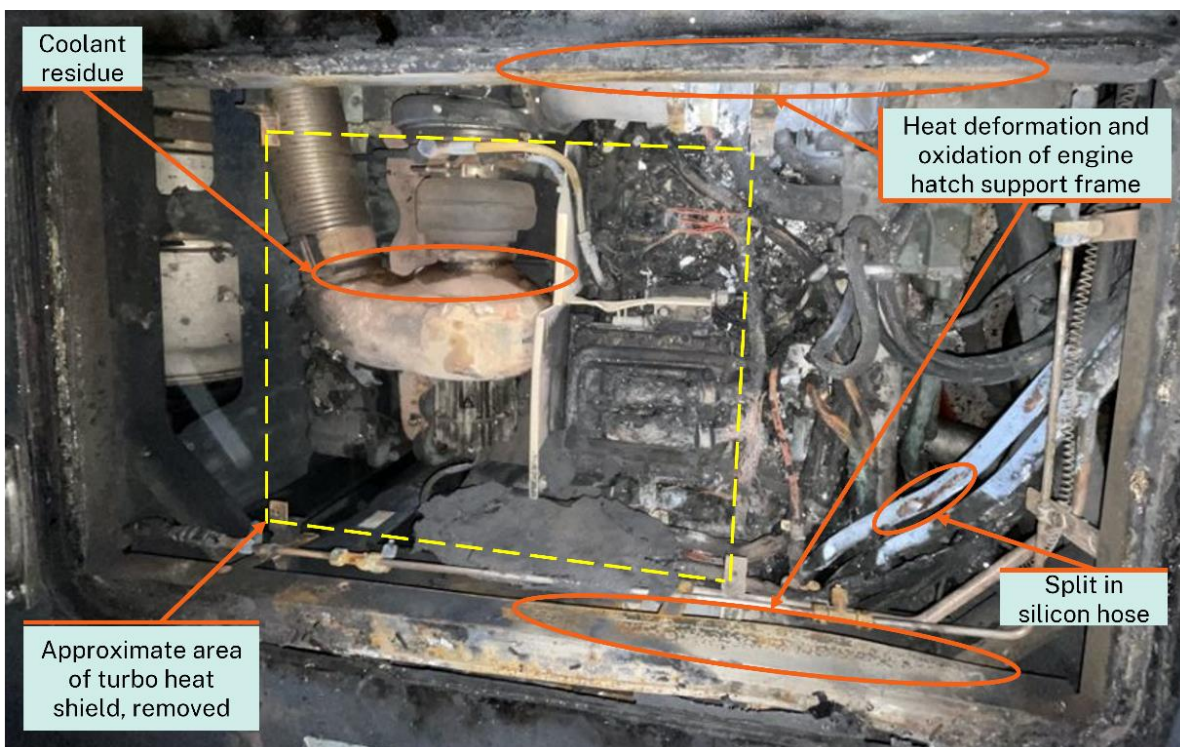
Figure 18: Heat patterns and coolant residue

- 2.19 The frame of the engine floor hatch also indicated a high level of concentrated heat adjacent aligning with the expected path of the coolant from the split in the heater hose. During a fire, protective coatings like paint are often consumed. Surface corrosion will then form on the exposed steel surfaces. Rust results from oxidation of the steel, and is a chemical reaction, which is temperature dependent. Exposure to elevated temperatures in a fire can cause thermally enhanced oxidation of the steel (Figure 18, Figure 19).

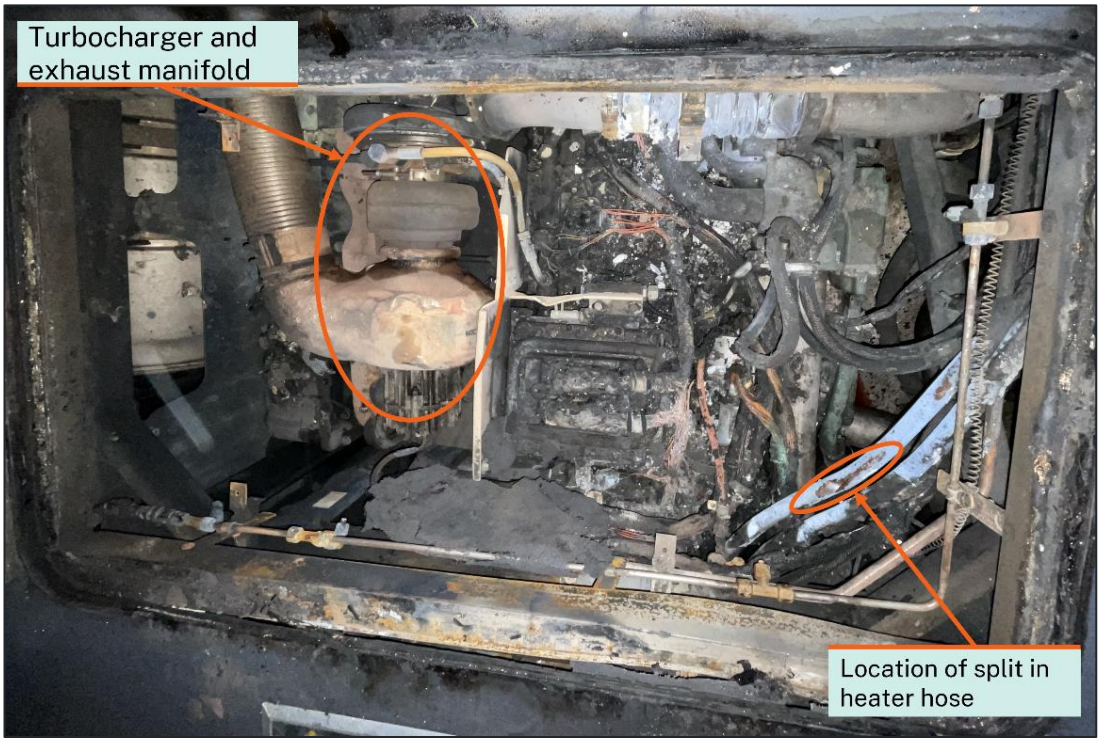
Figure 19: Location of damaged hose and turbocharger

- 2.6 The hoses were fitted as original equipment by Volgren, the bus body manufacturer.
- 2.7 The defect in the hose likely allowed ethylene glycol-based coolant, under pressure of approximately 0.75 bar (10.87 psi), to contact hot engine components in proximity, including the exhaust manifold and or turbocharger. Both of which are located on the O/S, upper surface of the engine assembly (Figure 19).

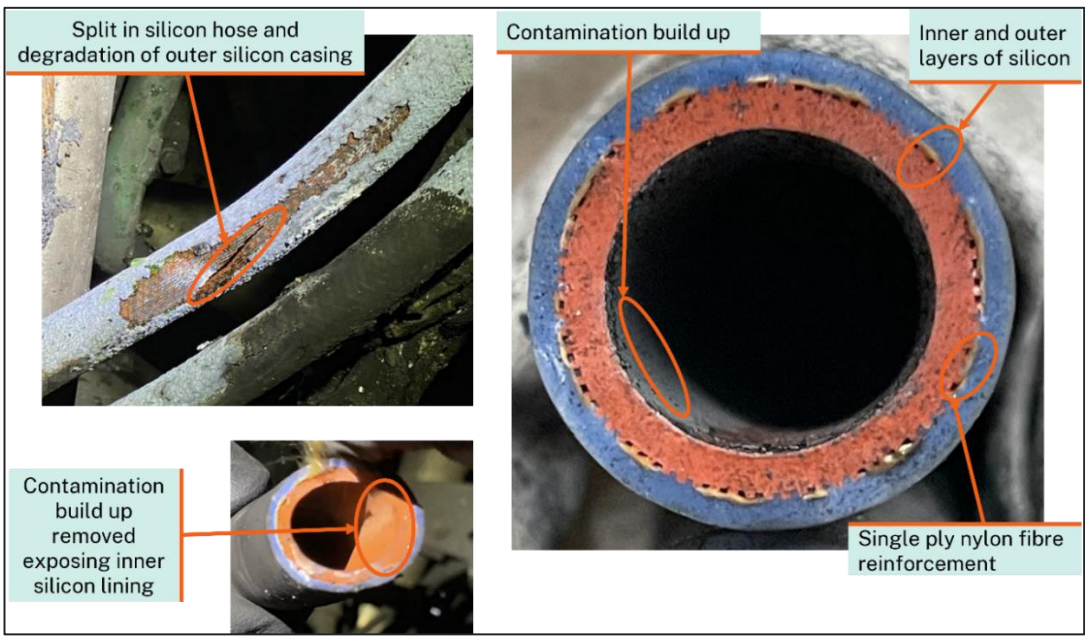
Figure 20: Damage to silicone hose and cross section construction

- 2.5 Adjacent to this area, a longitudinal split in one of two silicone hoses was identified. These silicon hoses transferred heated coolant from the engine to the saloon heater matrix. This split was consistent with a failure of both the inner silicone liner, nylon reinforcement layer, and outer silicone cover.

2.21 The defective hose was one of two hoses connected to the cooling system of the engine that ran forward to supply heated coolant to the saloon heater matrix. The hoses were of silicone construction with a single ply nylon fibre reinforcing layer (Figure 20).

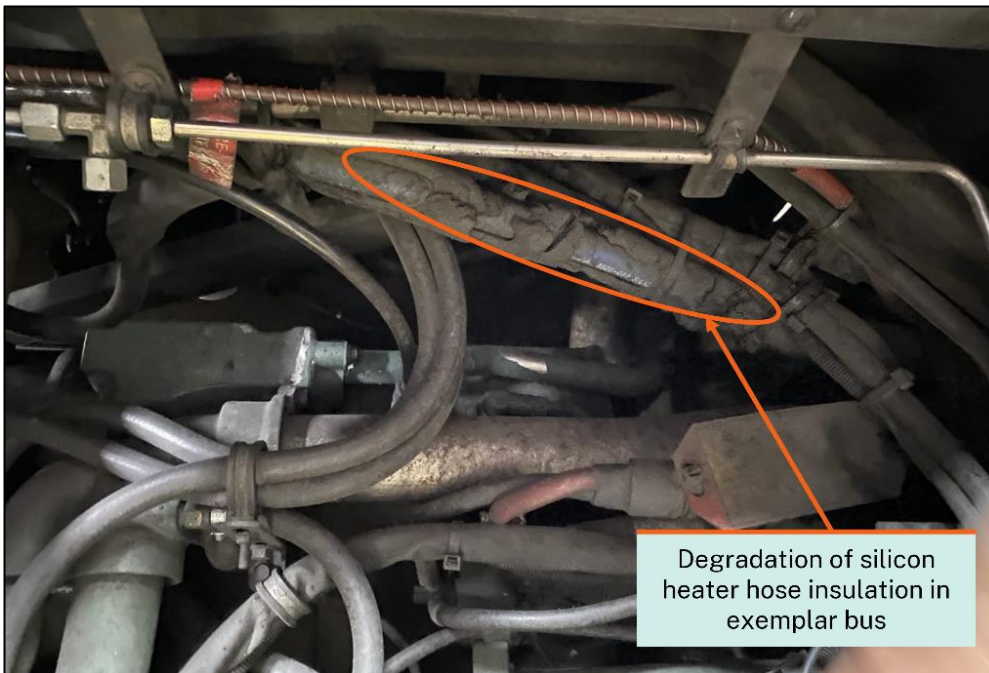
Figure 21: Degradation of silicon heater hose outer insulation in exemplar bus

2.22 Examination of an exemplar bus of the same make and model revealed that identical silicone heater hoses passing through the engine bay were covered in an NBR/PVC¹⁹ based closed cell, flexible elastomeric foam insulation. The purpose of this insulation was to protect the silicone hose from contaminants and ambient engine bay temperatures.

2.23 Figure 21 shows degradation of this insulation of the exemplar bus, exposing the silicone hose to ambient engine bay temperatures.

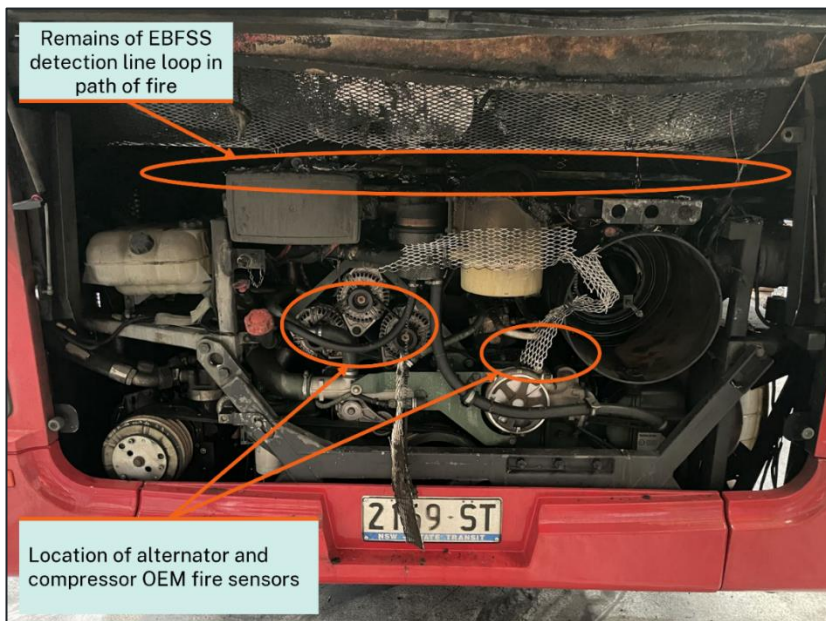
Figure 22: Location of EBFSS detection loop and OEM fire sensors

- 2.39 The OEM fire alarm sensors were located adjacent to the starter motor, air compressor and alternators and are below the level of the EBFSS detection line (Figure 10, Figure 22).
