# Rail Safety Investigation Report

Rail Worksite Protection in NSW — Report 1 Picton, 16  
August 2022

**Rail Worksite Protection in NSW – Report 1**

Investigation Reference I02022

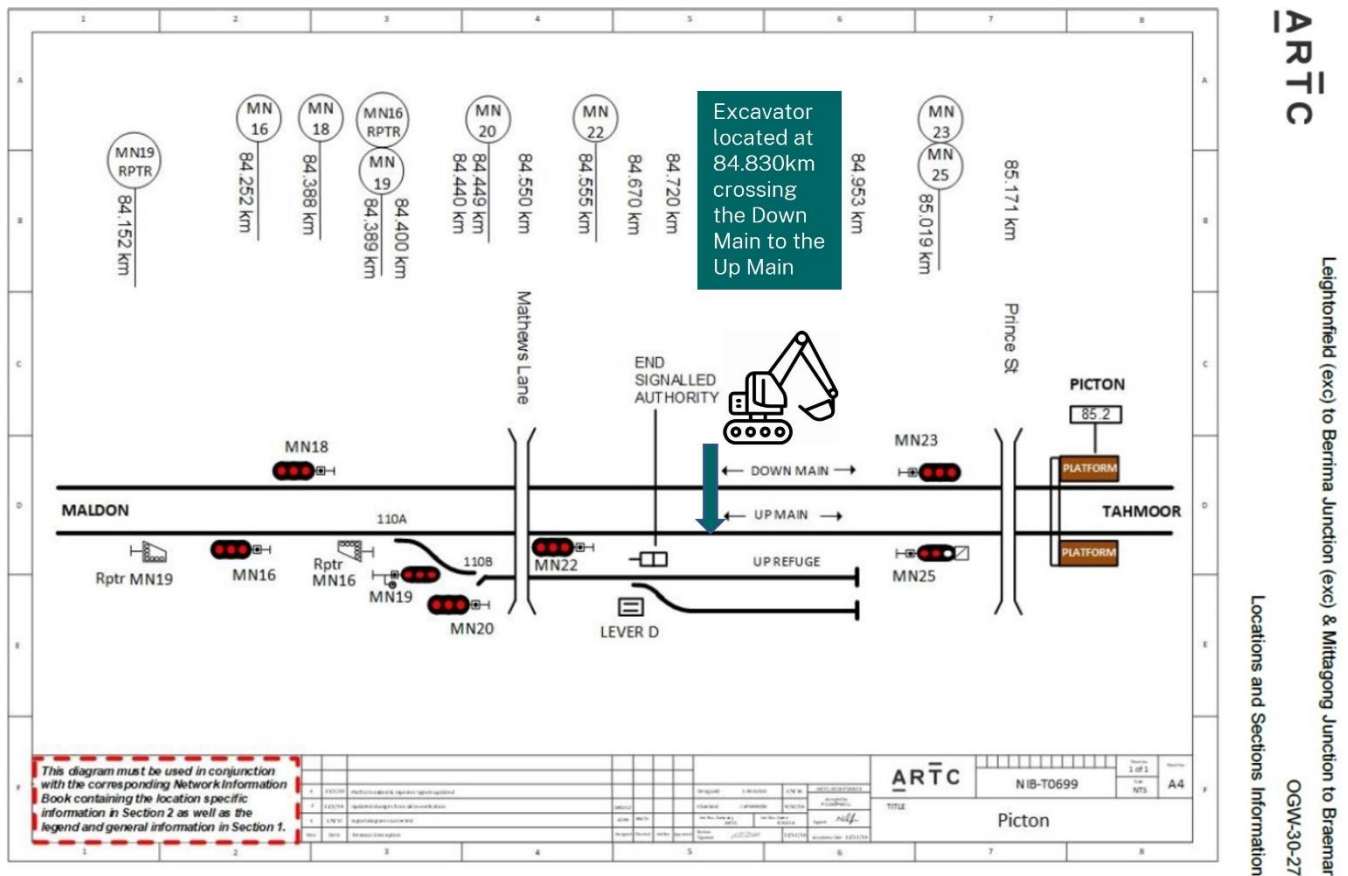
Figure 1: Picton Yard

- 1.35 The rail network at Picton consists of two main lines, the Up and Down Main line, and two refuge sidings (see Figure 1). The Up Main line directs rail traffic to the north towards Sydney, and the Down Main heads south towards Goulburn. Picton is unusual because of the topography and the curve of the rail line. At this location, the Up Main line directs rail traffic towards Sydney to the north but faces south and the Down Main line faces north. A location south of Sydney would normally have the rail lines in the opposite orientation. The physical direction of the track runs south-west until Maldon where the line turns to the north, curves around after Picton station, then heads back in a southerly direction towards Goulburn (see Figure 2).

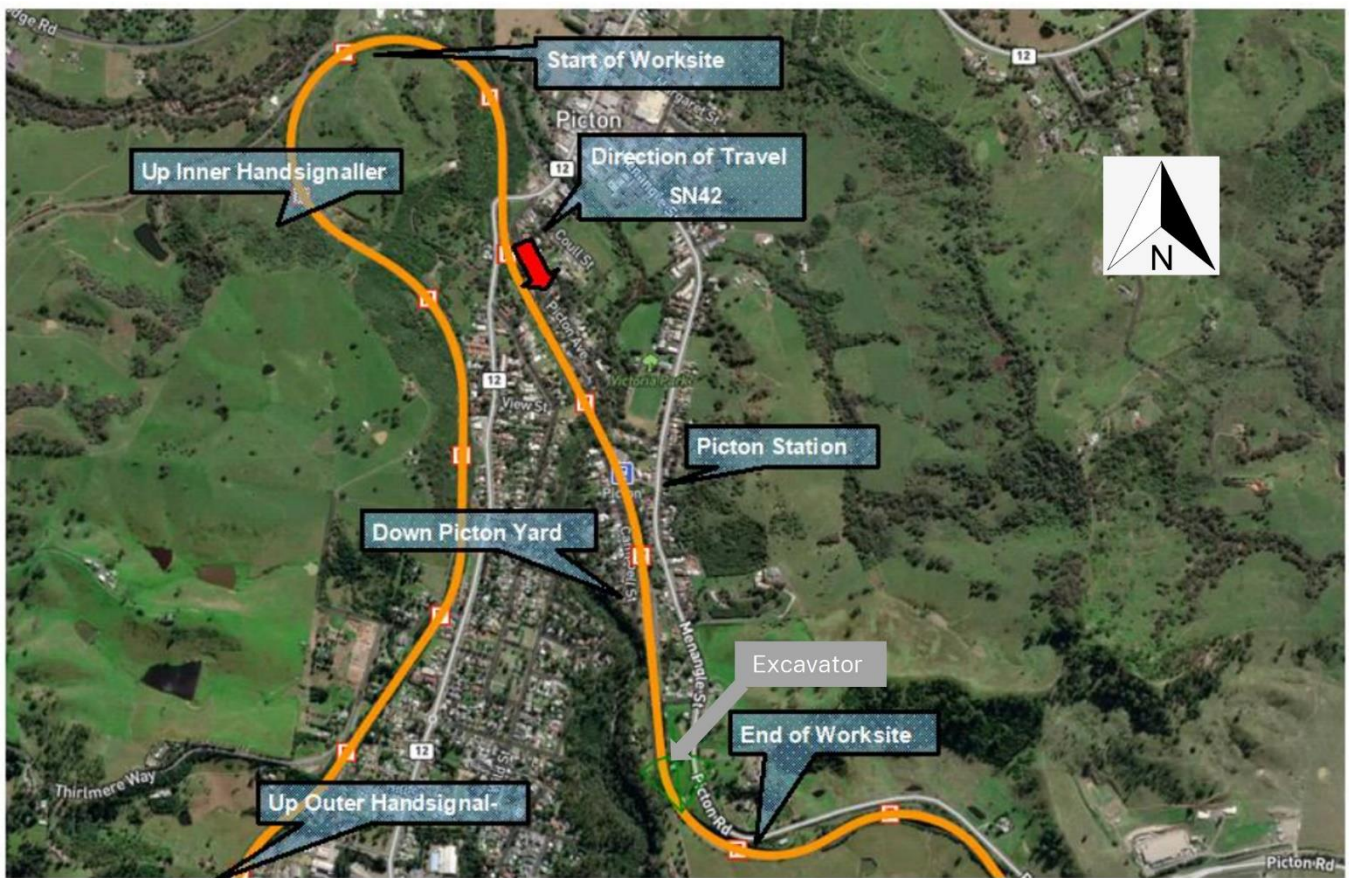
Figure 2: Incident details

- 1.23 At 0942, SN42 departed Picton platform 1 and proceeded towards Sydney. The driver of SN42 reported seeing an item of plant (the excavator) on the track ahead that was on the adjacent Down Main line. The train was reported to be travelling at approximately 30 km/h at this point. When the driver realised the excavator was on the Up Main, they stopped the train near the 85.000 km mark, 50-100 m away from the excavator.

1.28 The incident occurred at Picton on the Main South rail line between Sydney and Goulburn at approximately 84.830 km (Figure 2).
