Safety Alert SAL01/24

28 February 2024

Bus and coach rollaways: review your risk controls

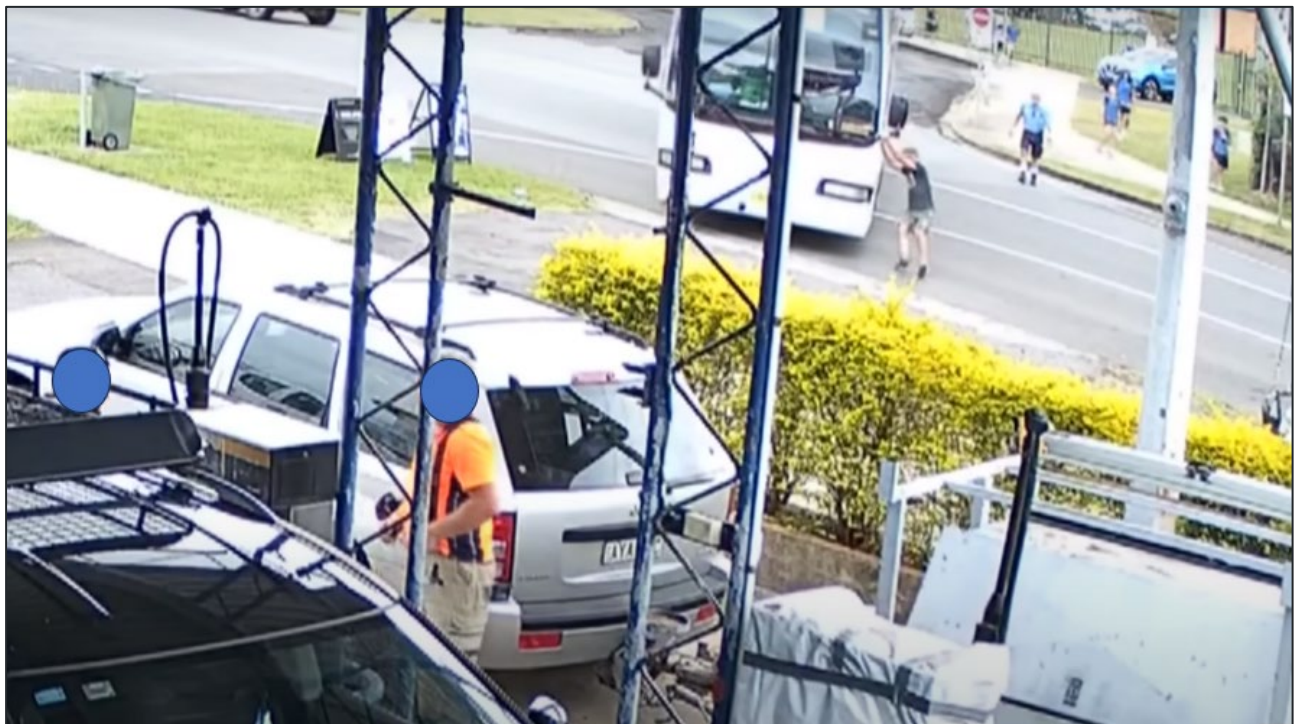
While students boarded the bus, the driver alighted to talk with a teacher but did not apply the park brake before exiting the bus, which was left in neutral gear. With the bus door open, the door brake system remained active, keeping the bus stationary.

The bus driver activated the external door close switch under the front bumper. The door of the bus closed, with the driver stood outside on the footpath and the students inside the bus.

Within seconds of the door closing, the bus started to roll away towards the mini mart. At that time, there were vehicles parked at the fuel bowser and people standing directly beside one bowser, refuelling their cars.

As the bus crossed the centreline of the road, it was on a trajectory for a direct collision with a vehicle and trailer parked in front of the fuel bowser (Figure 1).

Figure 1: Screenshot from mini mart CCTV of unmanned rollaway

It was later reported that a student onboard the bus steered the vehicle to the right of the refuelling area and applied the foot brake, bringing the rollaway bus to a stationary position.

No injuries were sustained in the incident and there was no damage to the bus or any infrastructure. The bus was inspected post incident, with no unserviceabilities of the braking or door systems identified.

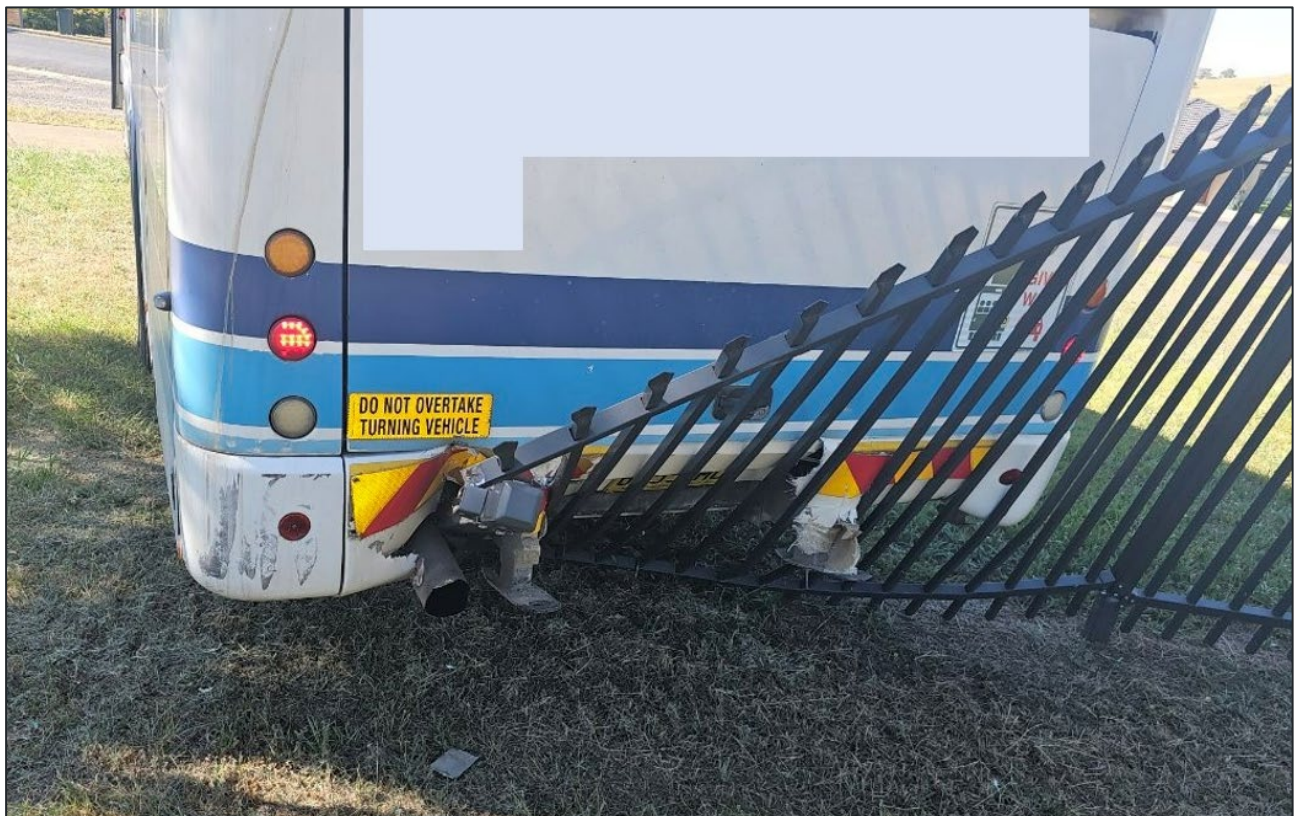
The driver, who was unfamiliar with the coach as it was not the usual vehicle they drove, reported experiencing electrical issues, followed by problems closing the front door, with students onboard. The driver contacted their company to report the issues. It was reported that the company instructed the driver to try cycling the front door, using the external door closure switch.

The driver alighted and activated the external door closure switch which closed the passenger door with the driver outside the coach. It is highly likely that the park brake was not engaged.

The coach rolled backwards, mounting the curb and coming to a stop after colliding with the school fence. No injuries were reported but there was minor damage to the coach and fence (Figure 2). The bus was inspected post incident, with no unserviceabilities of the braking or door systems identified.

Figure 2: Post rollaway position of coach
