Bus Safety Investigation Report

Bus rollaway and collision

Wilsons Valley

5 September 2022

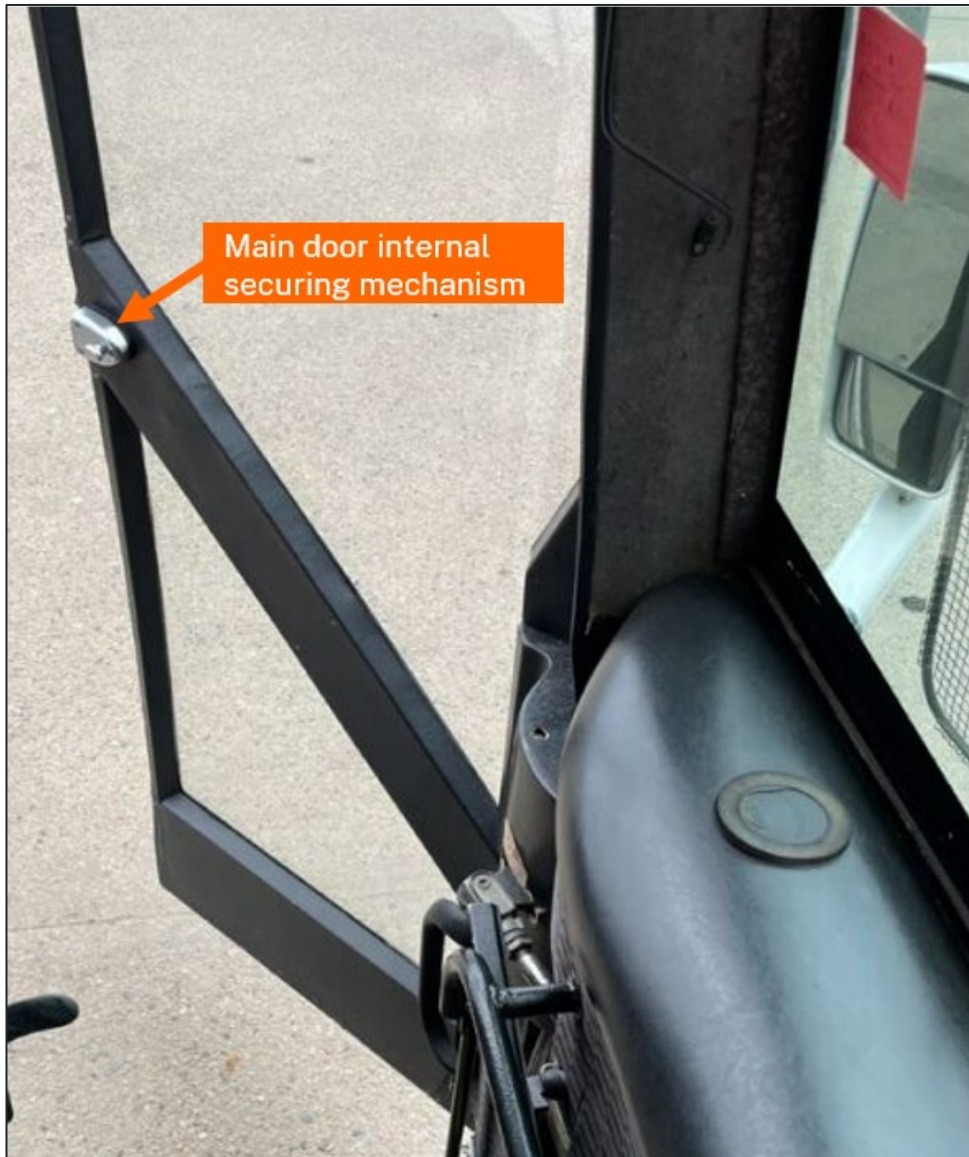
The primary driver then secured the door with the internal locking mechanism (Figure 1). The primary driver later reported that this action was to stop wind noise created when the door was not properly closed while the coach was in motion. The primary driver was seated in the tour guide seat at this time.

Figure 1: Coach TV5251 main door showing internal securing mechanism

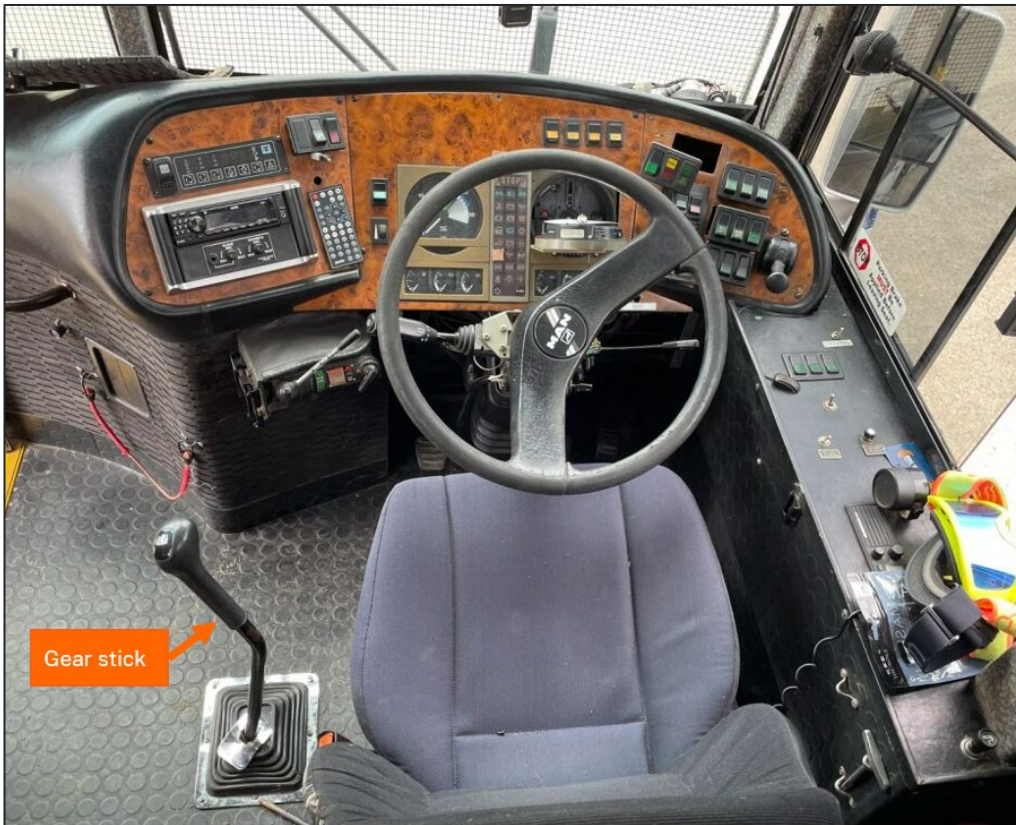
It was later reported that the primary driver gripped the gear stick (Figure 2) and tried to force it into a gear, then hold it in position, as they considered that the transmission had neutralised.

Figure 2: Coach TV5251 driver's position

Source: OTSI. Note: image taken post-incident during investigation examination with some alarm coverings removed. Switch blocks were dislodged from the dash panel as a result of the collision impact.

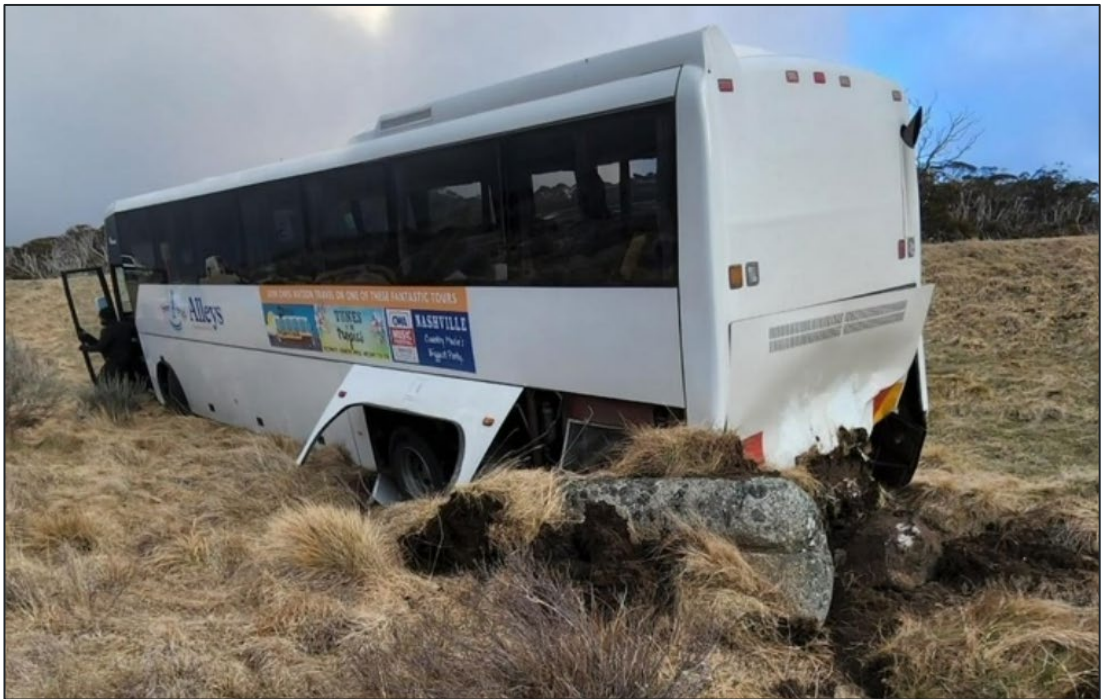
The coach sustained damage mainly limited to the rear of the vehicle (Figure 3).

Figure 3: Coach TV5251 in final resting position after the rollaway

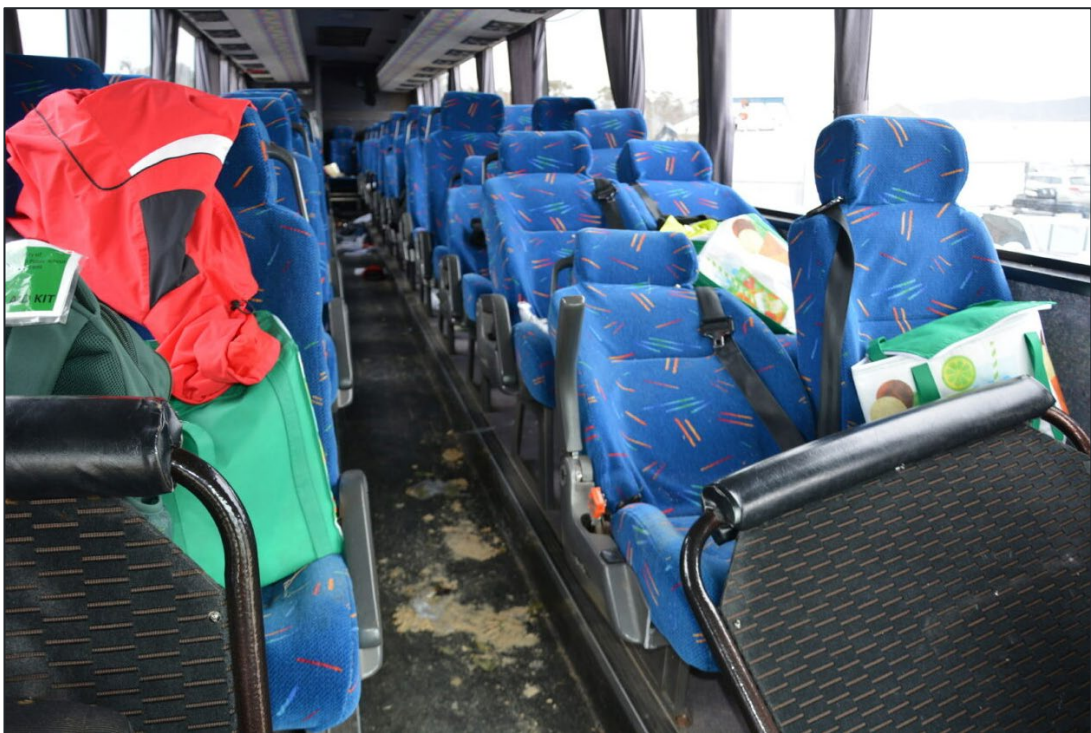
Damage to the coach seating indicated the impact forces that the passengers were subjected to when the vehicle collided with the rock outcrop (Figure 4).

Figure 4: Interior of Coach TV5251 showing damage to internal seating

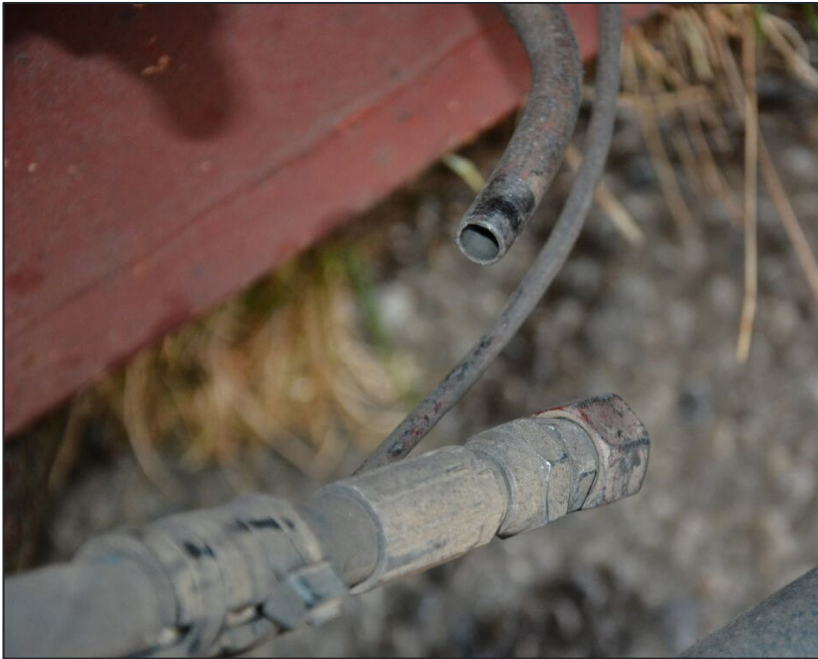
OTSI's post incident inspection of the involved coach identified separation of the vehicle's offside⁴ front brake line at the chassis connection point (Figure 5). It is likely that this failure initiated a significant loss in air pressure for which the air braking system was unable to compensate.

Figure 5: Separation of TV5251's offside front brake line

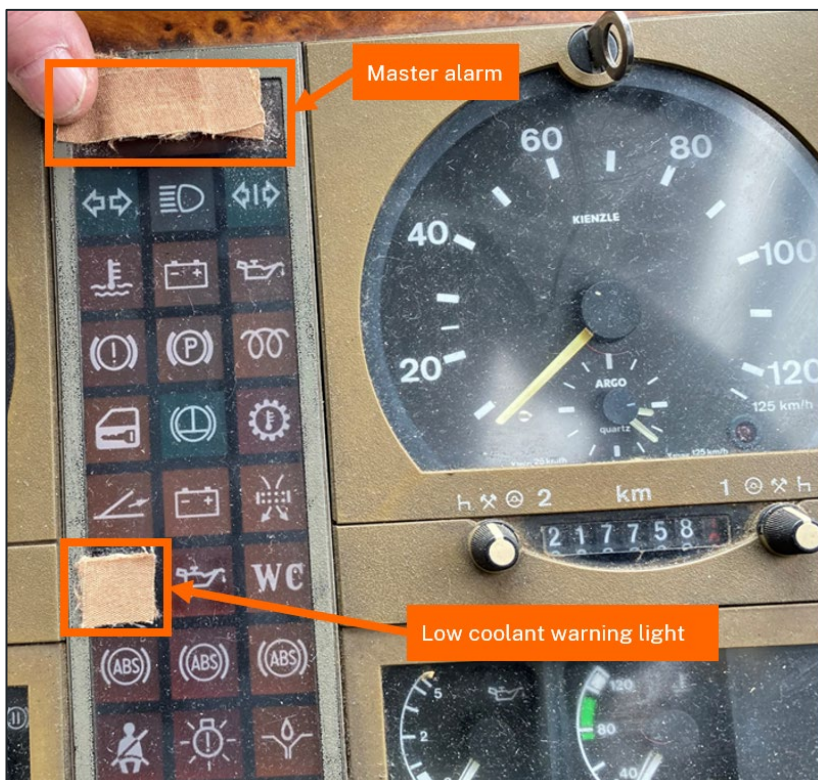
On post incident inspection of the coach, in conjunction with the National Heavy Vehicle Regulator (NHVR) Inspectors, pieces of adhesive plaster bandage were found covering the master alarm light and low coolant warning light on the driver's dash panel (Figure 6).

Figure 6: TV5251 dash alerting panel showing alarm lights covered at time of incident

Due to the faulty low coolant warning system, the master alarm and low coolant warning lights remained constantly illuminated. This presented a false visual indication to the driver while operating the vehicle.

However, the master alarm light also provided several other indications, including low air system pressure. Covering this visual alarm disabled it as a system alert and removed a safety critical indication to the snow driver that there was a brake system fault.

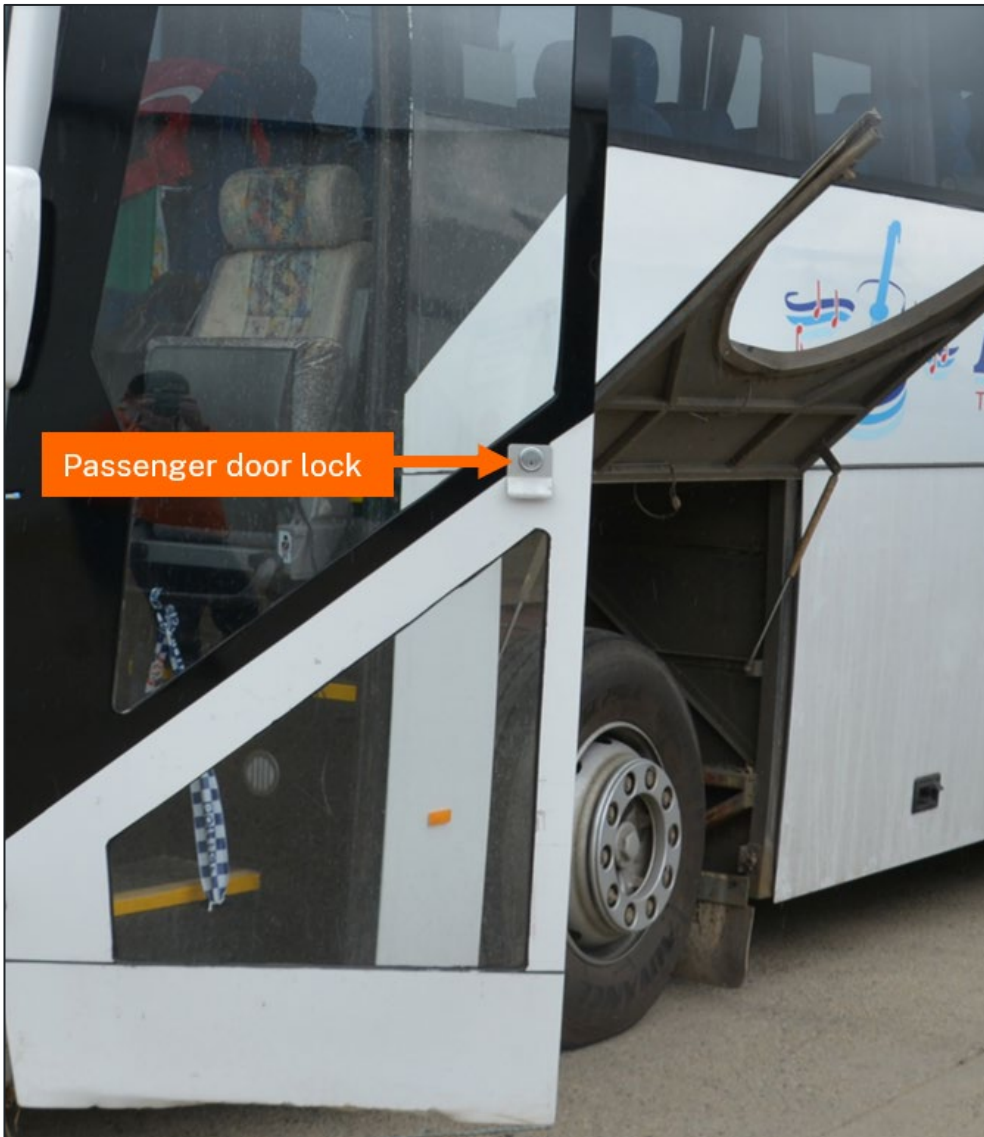
Low air system pressure likely contributed to the inadequate closing force of the passenger door, at the time the coach left Smiggin Holes, which was a potential missed opportunity to identify insufficient pressure in the air system before the vehicle was operated further.

Due to the reduced closing force of the passenger door, which was the only exit door, the coach was then operated from the snow chain bay to the incident site with the interior door lock enabled. Locking the door from the interior disabled the exterior emergency exit device, with the passenger door unable to be opened from the exterior (Figure 7).

Figure 7: TV5251 main door

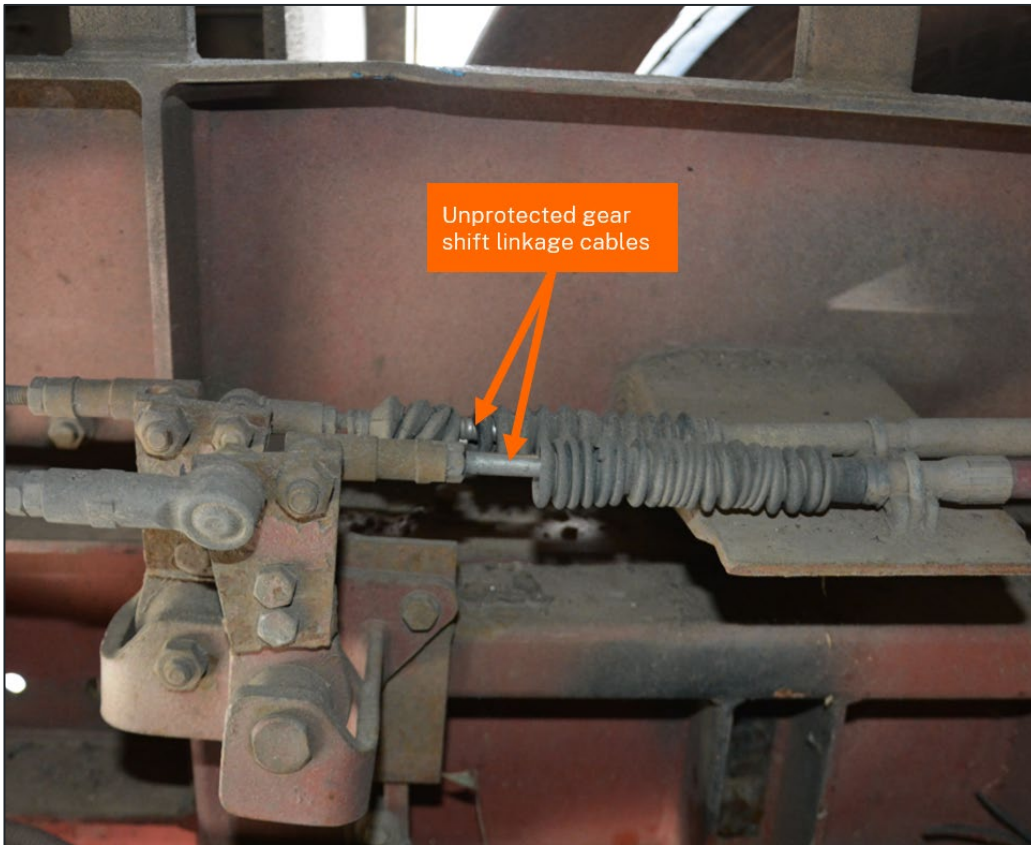
Post incident, OTSI identified that TV5251's gear shift linkage cables were exposed where the protective rubber boots had separated (Figure 8), allowing road environment contamination of the cables. It is highly likely that this contamination resulted in the gear shift requiring additional force to operate.

Figure 8: TV5251 unprotected gear shift linkage cables
